## Inspection Photos

Location Name: TEP ROCKY MOUNTAIN LLC BOSELY /GM 34-14

Location ID: 334753

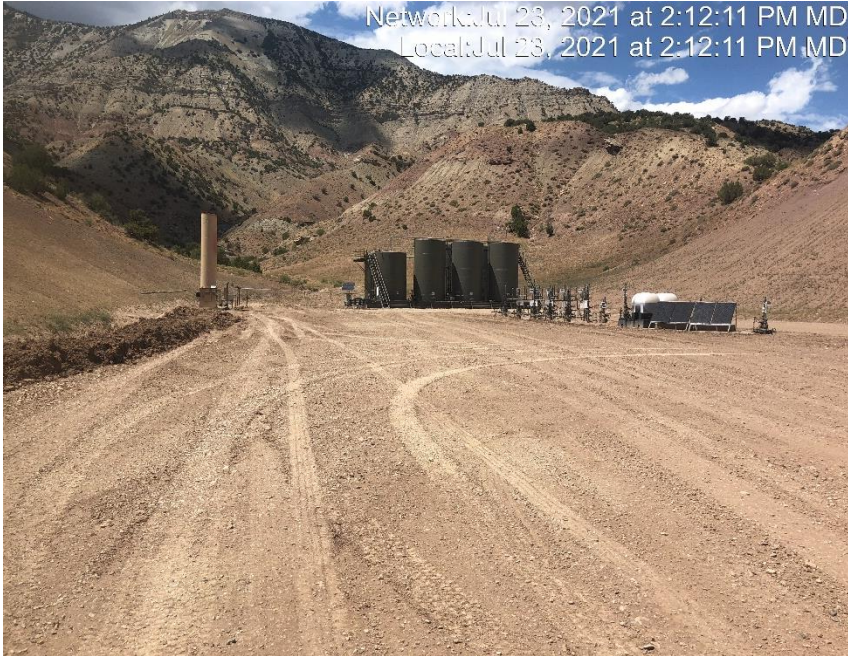
Photo #4581 from entrance to location.

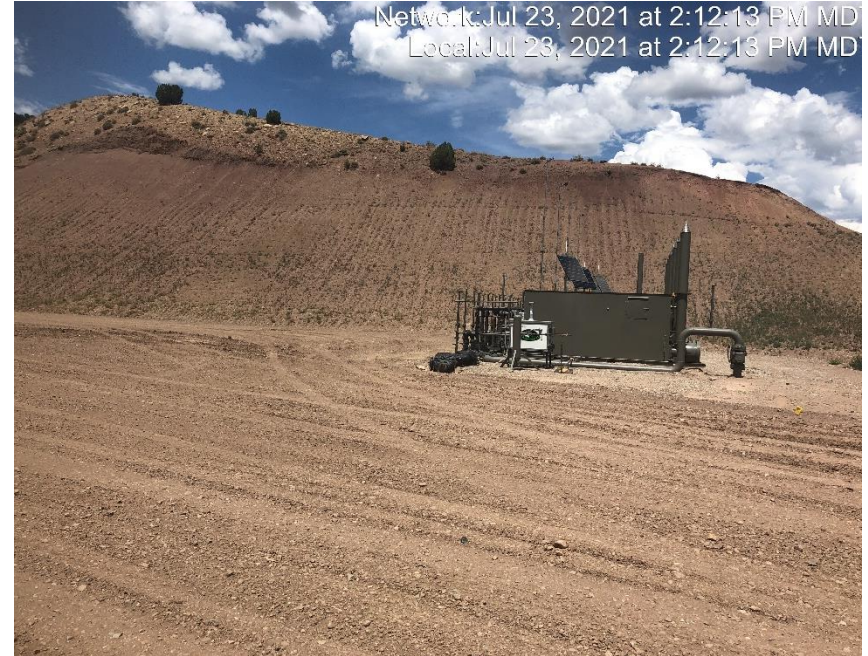
Photo #4582 from entrance to location.

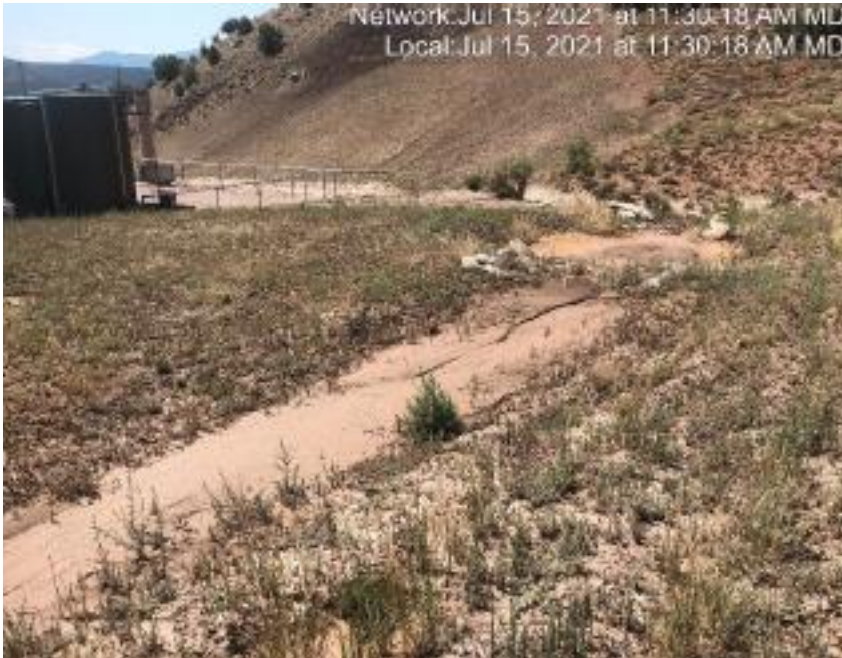
**Photo #4437 From inspection #699803405 conducted on 7/15/21.**

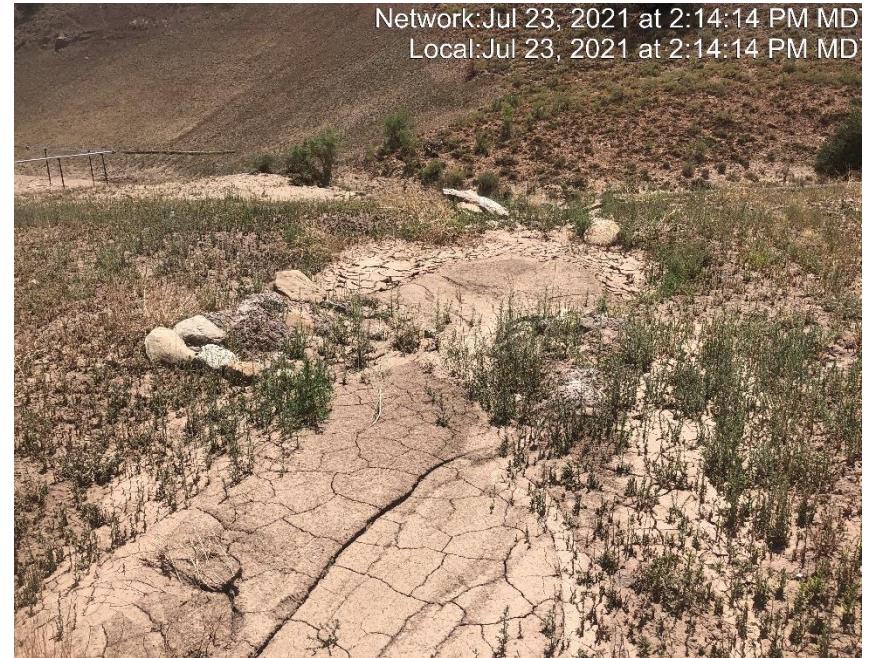
**Photo #4584 Sediment trap filled with sediment.**

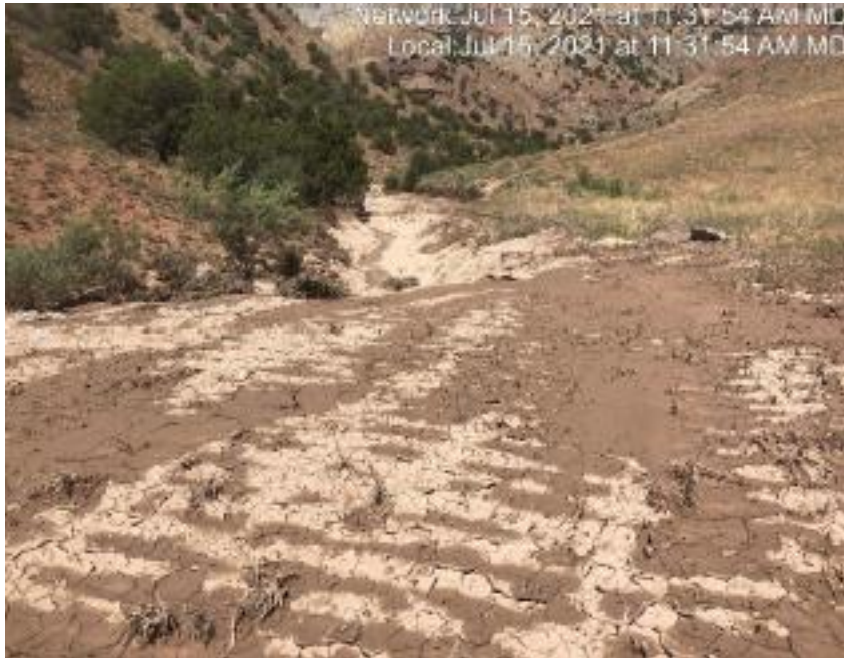
**Photo #4437** From inspection #699803405 conducted on 7/15/21.

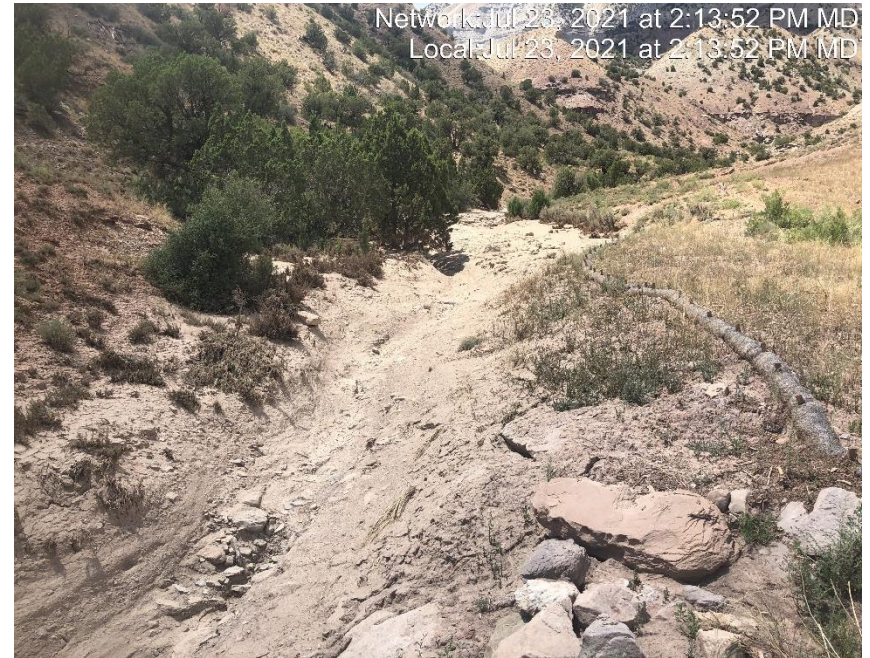
**Photo #4583** drainage up stream of location.

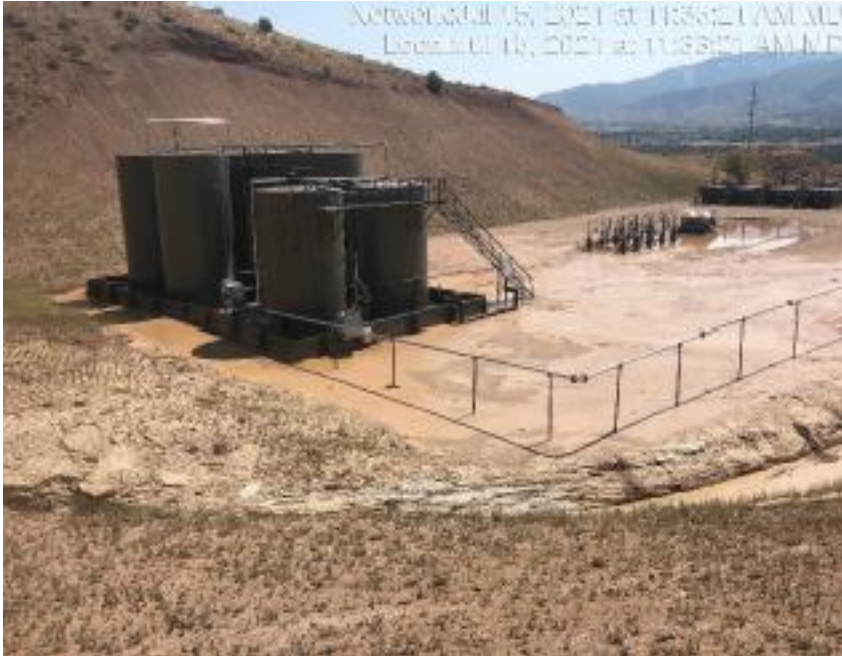
**Photo #4440** From inspection #699803405 conducted on 7/15/21.

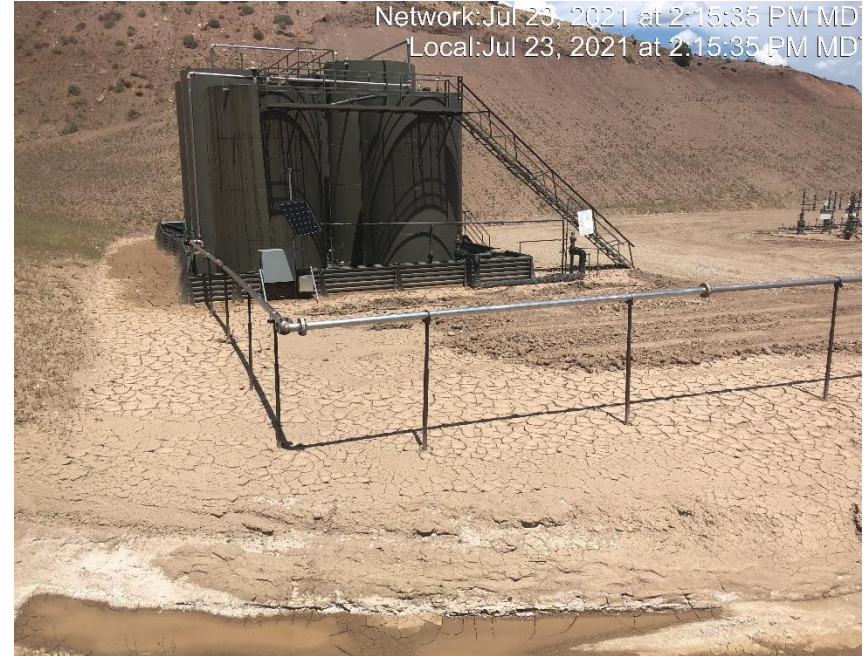
**Photo #4586** Sediment encroaching on equipment.

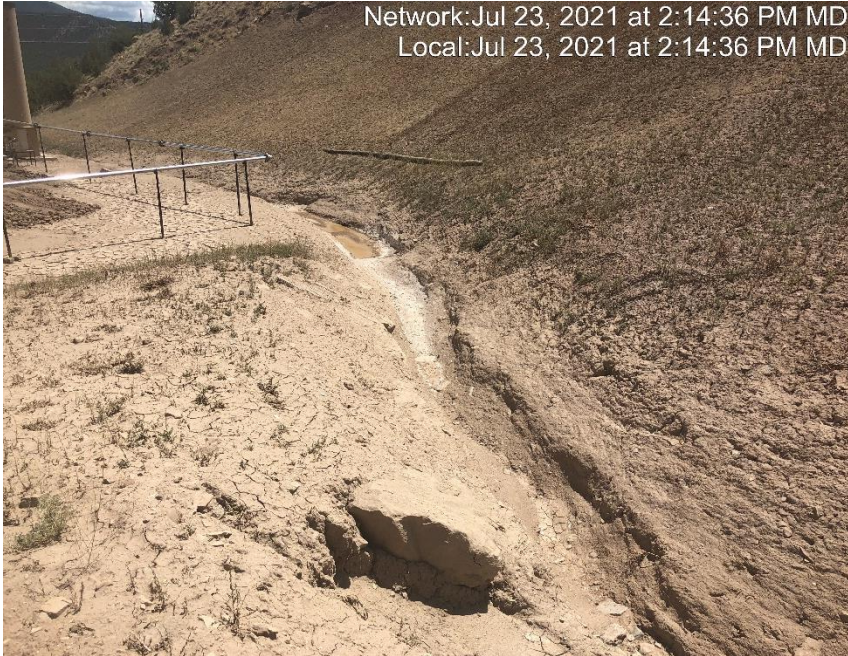
**Photo #4585 Velocity checks have not been installed.**

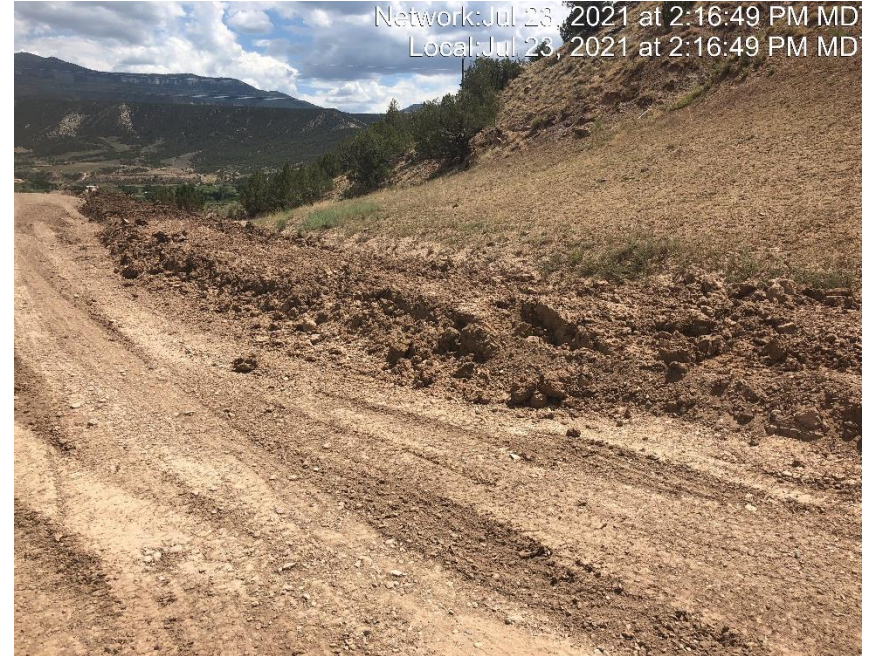
**Photo #4588 Sediment has been bladed to the edge of ditch.**

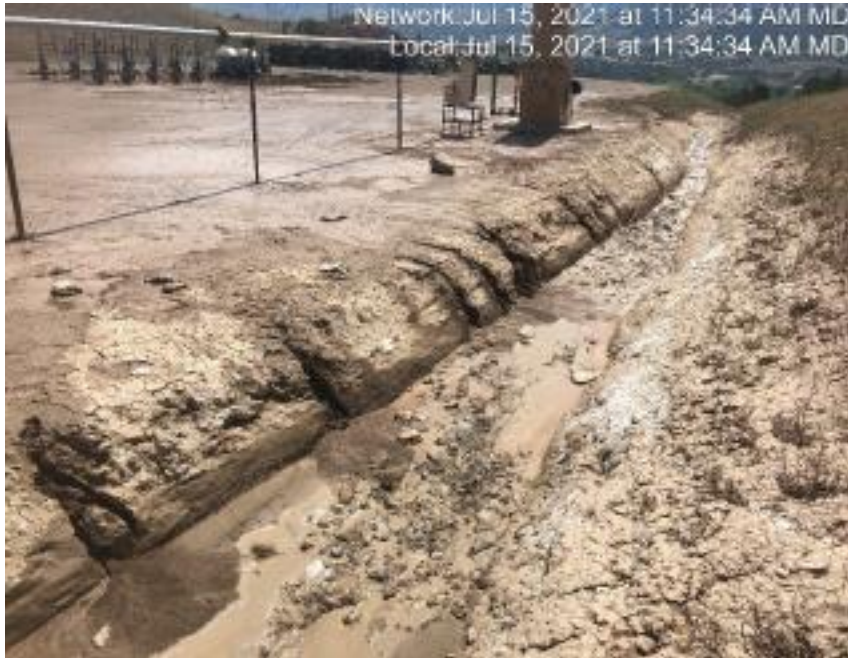
**Photo #4441** From inspection #699803405 conducted on 7/15/21.

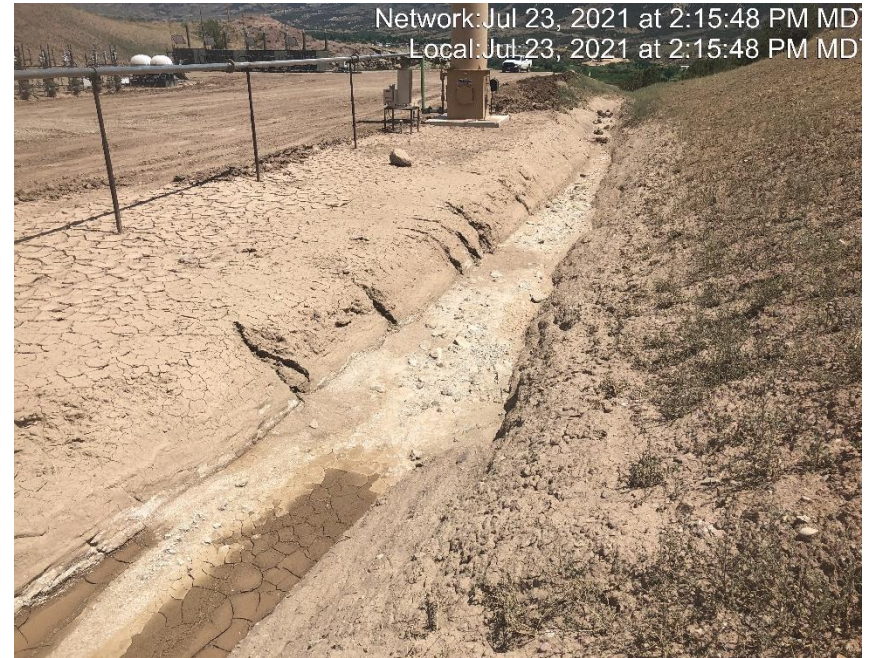
**Photo #4587** Ditch shows signs of subsidence.

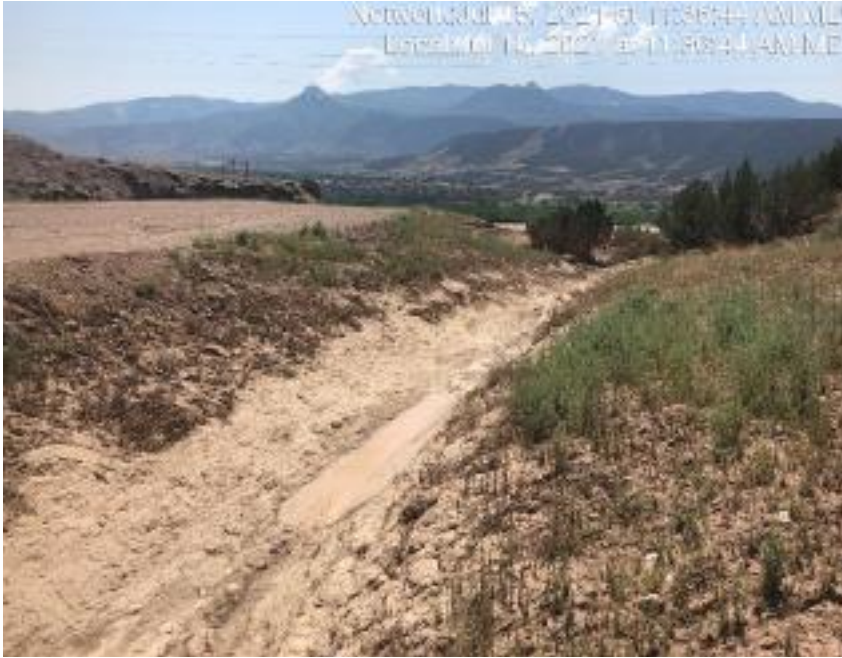
**Photo #4443** From inspection #699803405 conducted on 7/15/21.

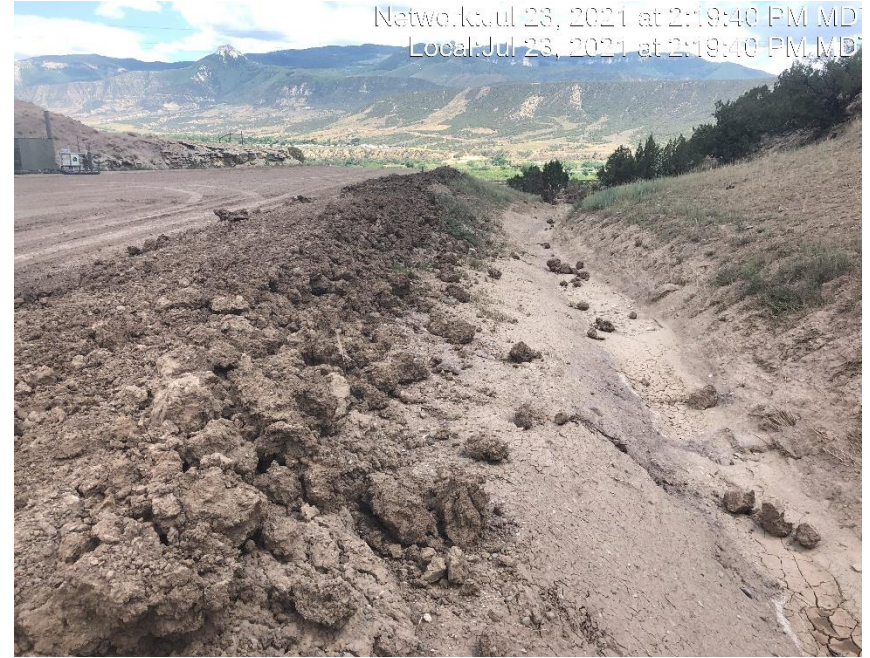
**Photo #4589** Sediment has been bladed into ditch.

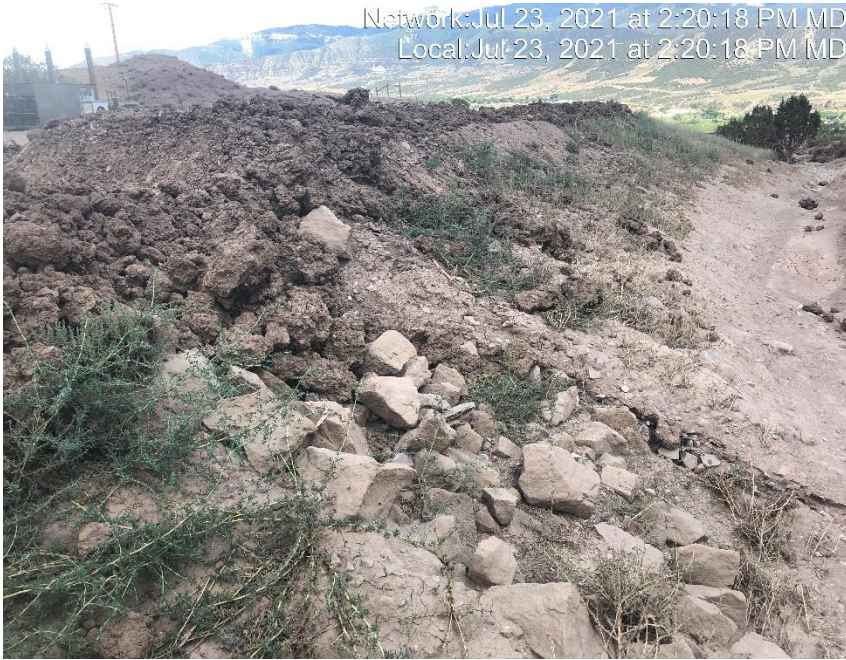
**Photo #4591 Sediment has been bladed into BMP.**

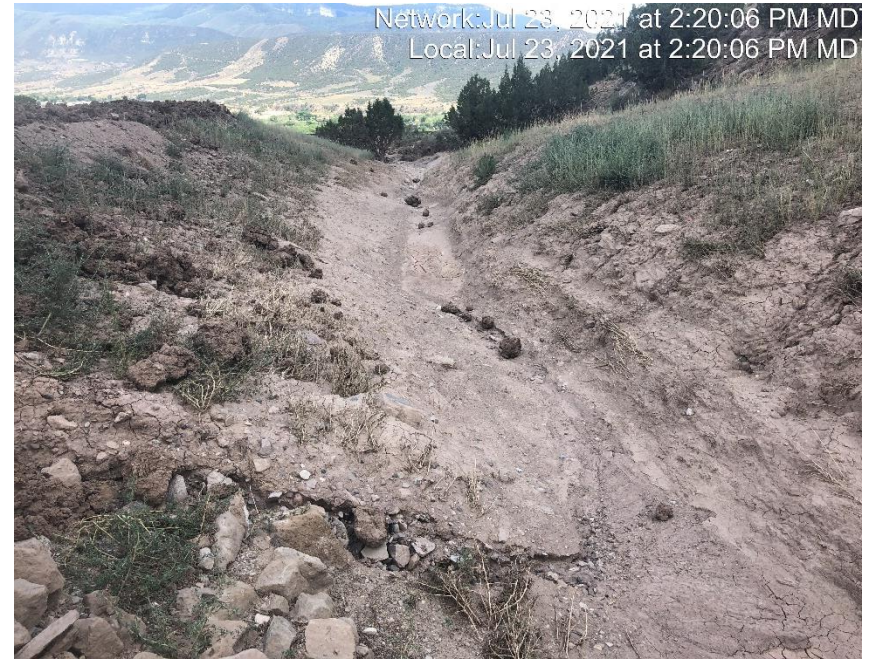
**Photo #4592 Sediment has been bladed into ditch.**

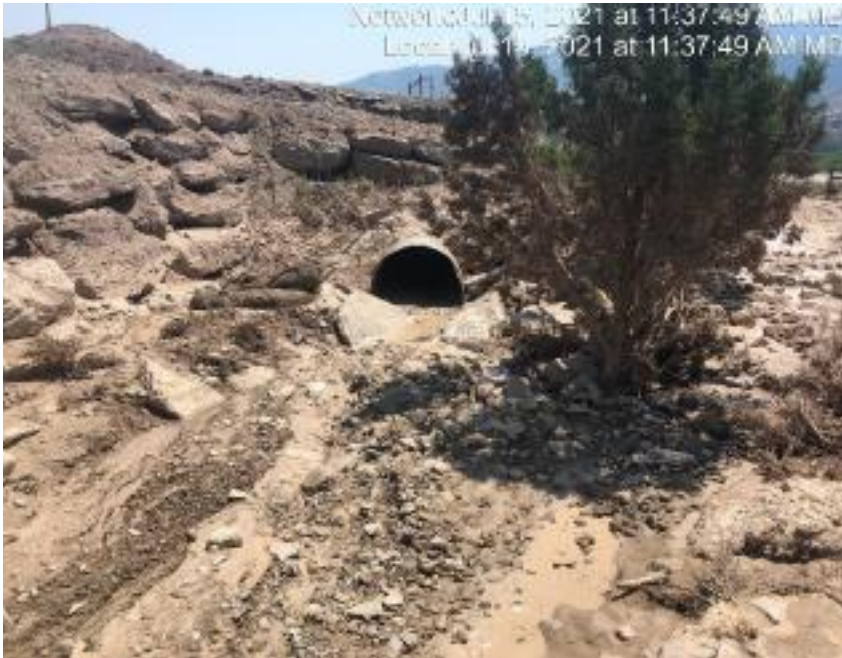
**Photo #4445 From inspection #699803405 conducted on 7/15/21.**

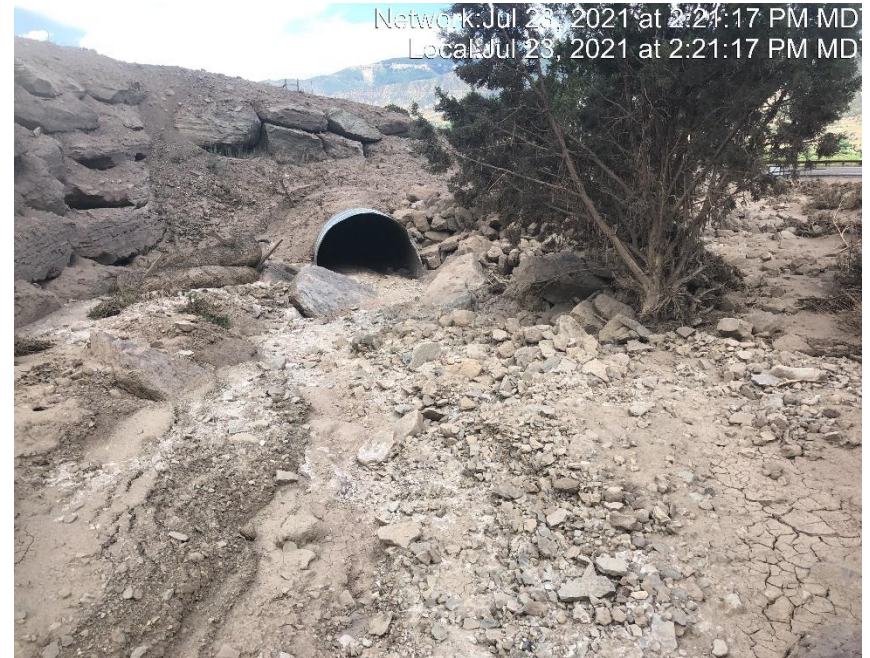
**Photo #4593 Inlet of culvert under access road.**

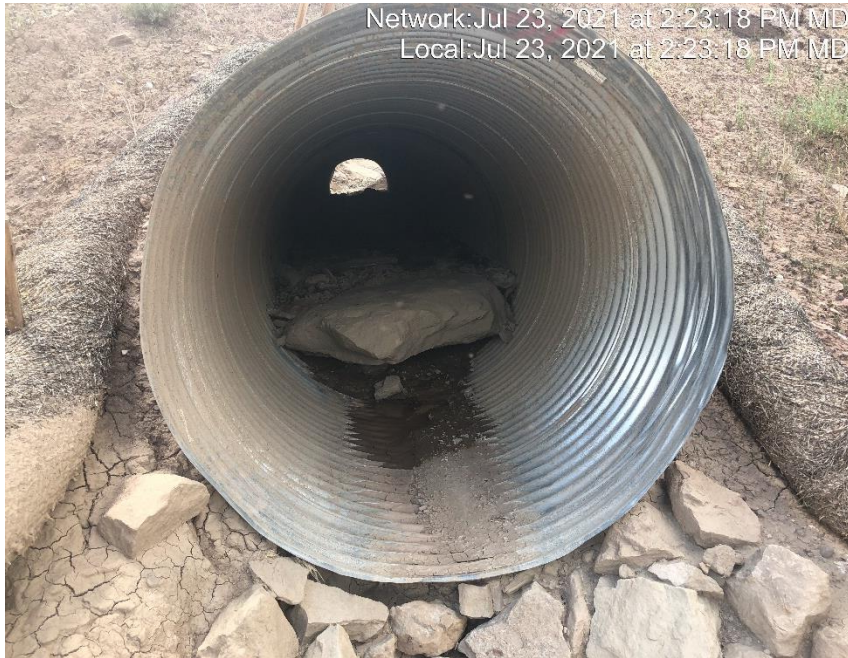
**Photo #4595 Culvert capacity reduced do to sediment and debris.**

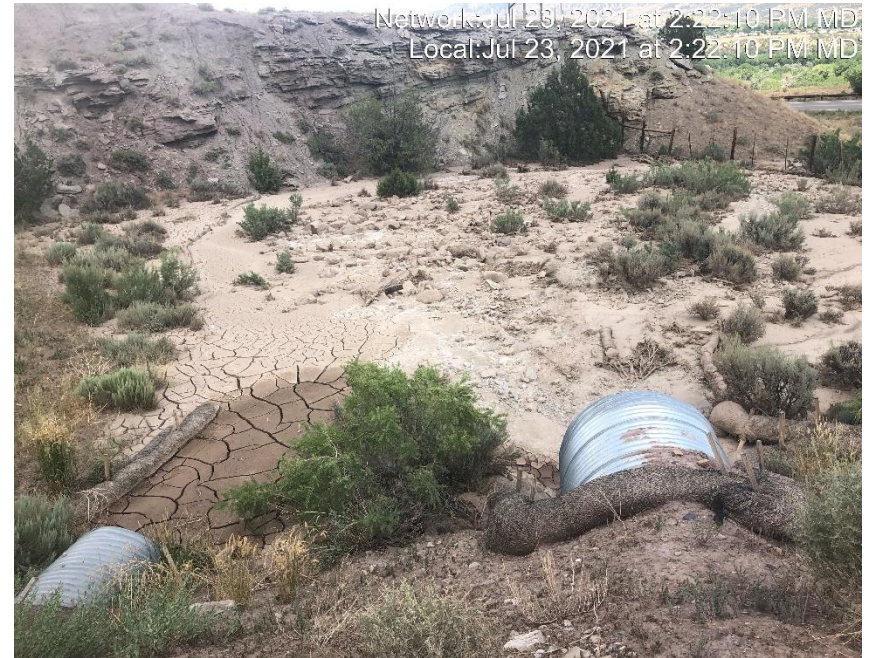
**Photo #4594 Outlet of culvert.**

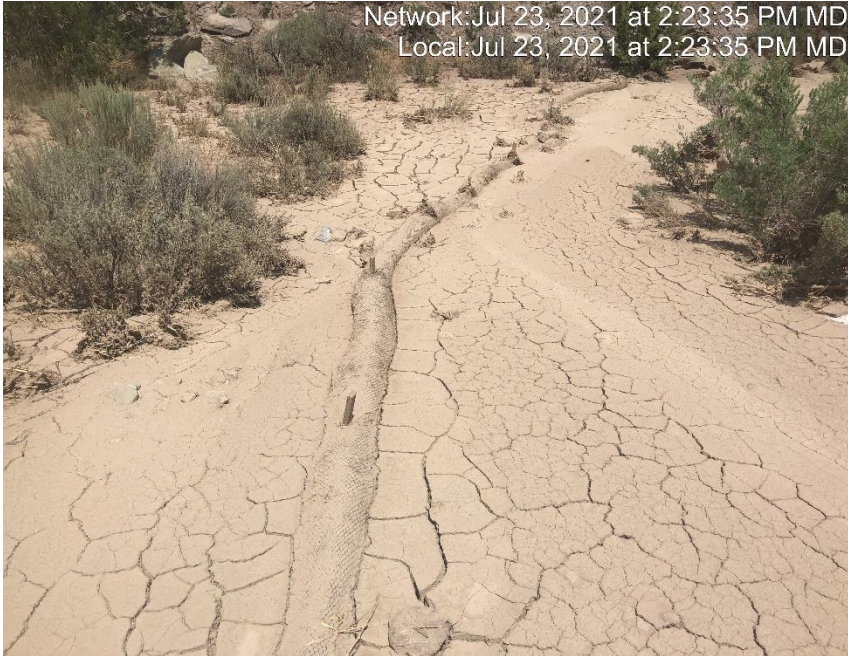
**Photo #4596 Waddles have not been maintained.**

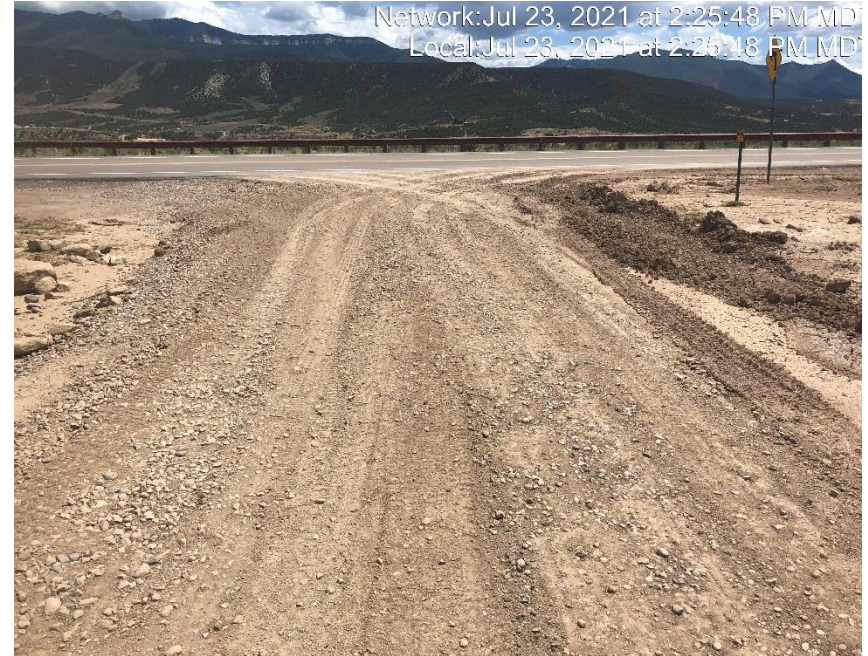
**Photo #4600 Tracking BMP has not been implemented.**

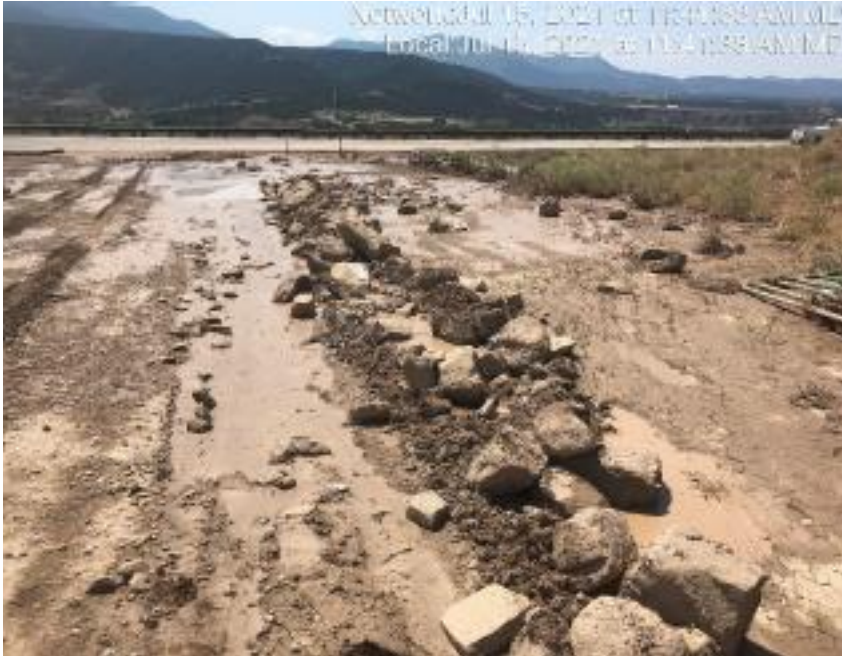
Photo #4449 From inspection #699803405 conducted on 7/15/21.

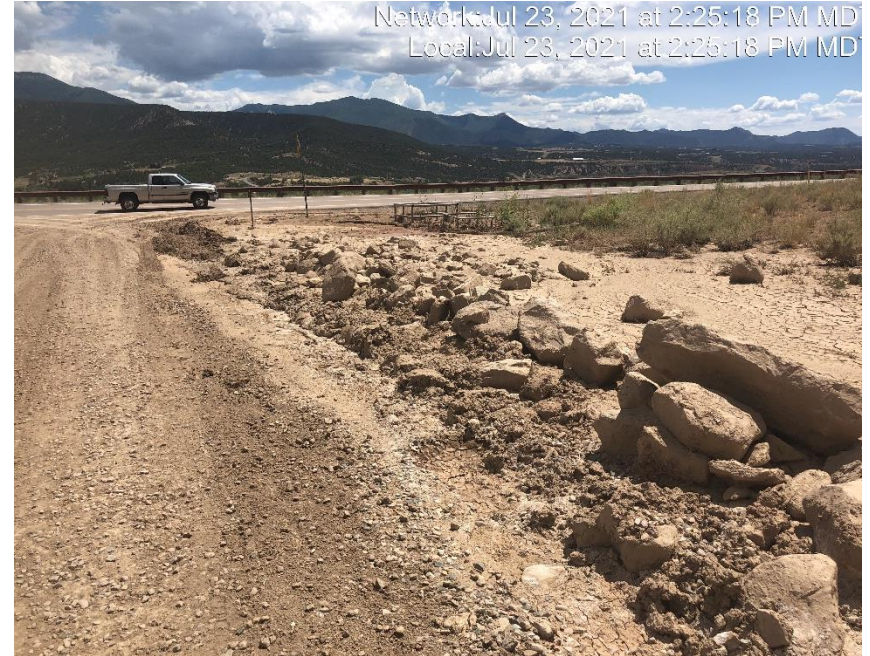
Photo #4598 Sediment and debris that was transported on to HWY 6.

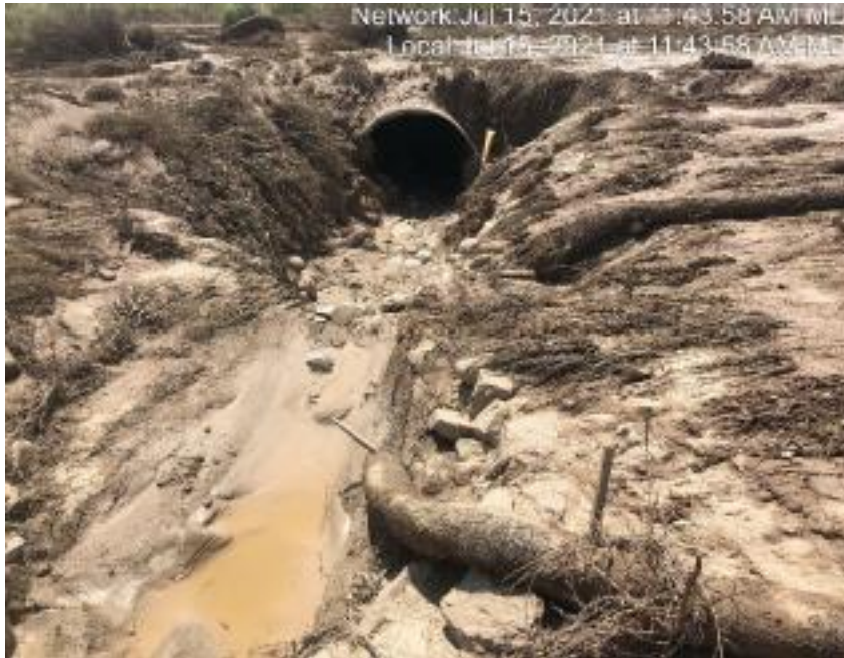
**Photo #4451** From inspection #699803405 conducted on 7/15/21.

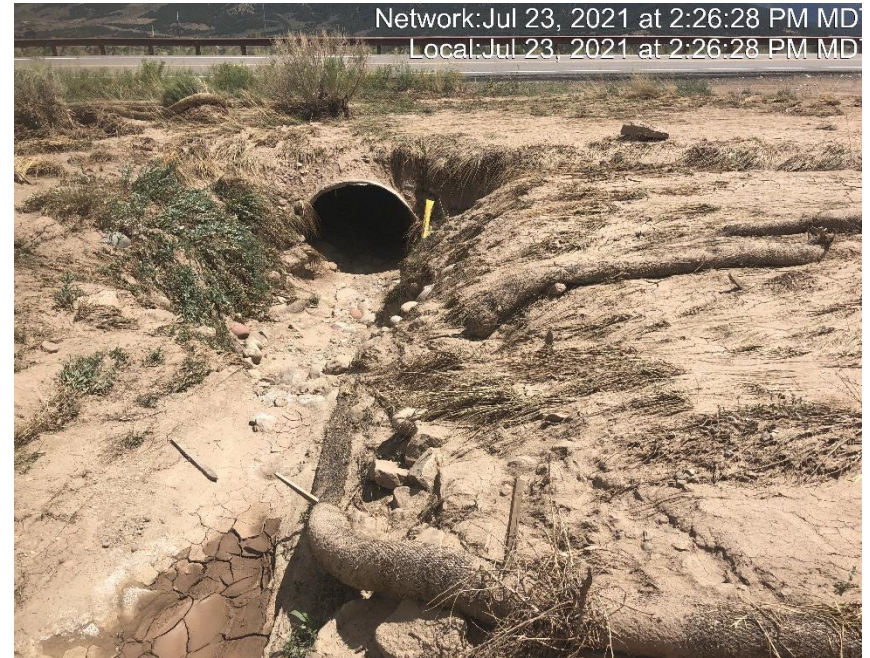
**Photo #4602** Inlet of culver that runs under HWY 6.
