Inspection Photos

API: 071-08589

Operator: EVERGREEN NATURAL RESOURCES

Inspection Date: 7/27/2021

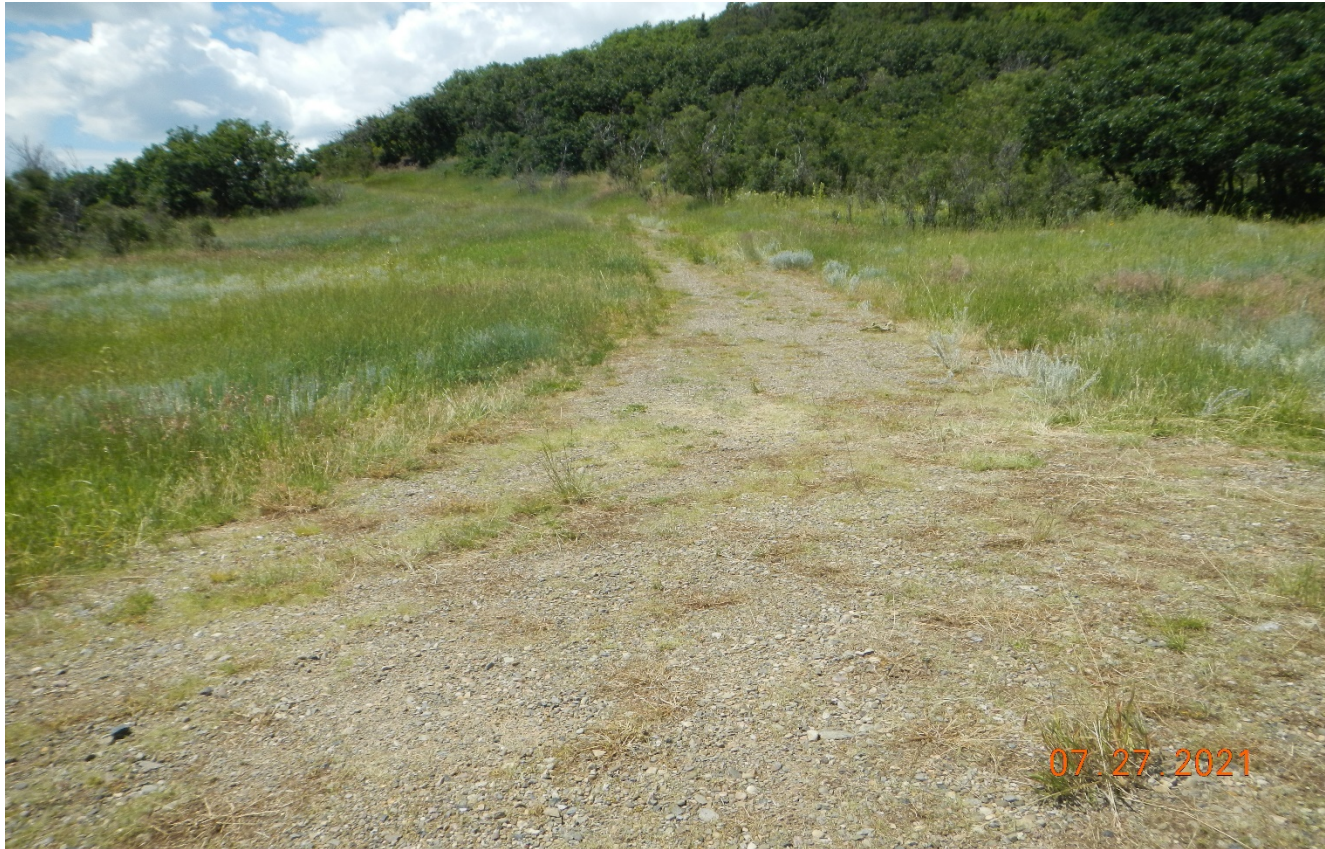
Photo 1. Facing southwest toward the access road which remains per approved variance.

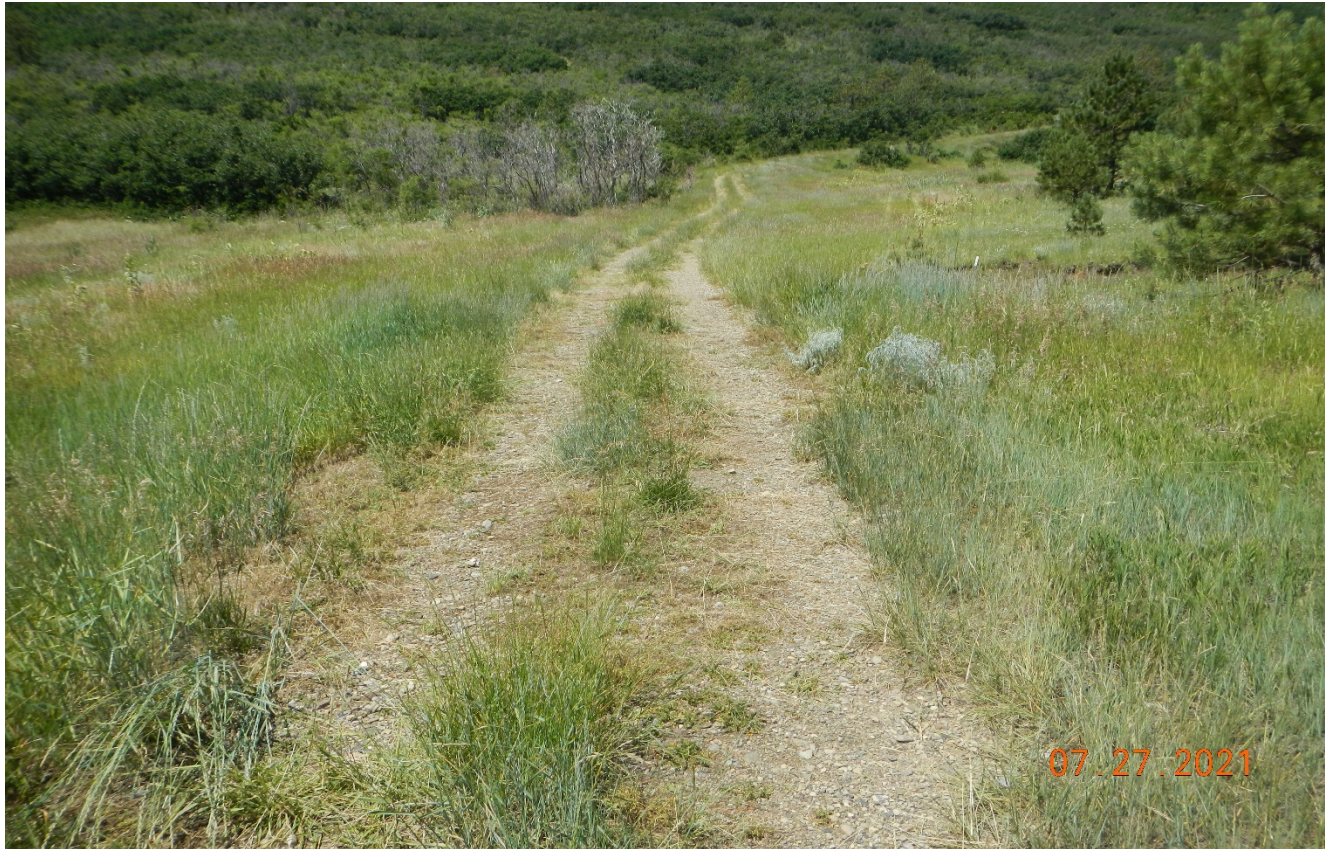
Photo 2. Facing southwest along the access road. The access road is stabilized with vegetation and gravel.

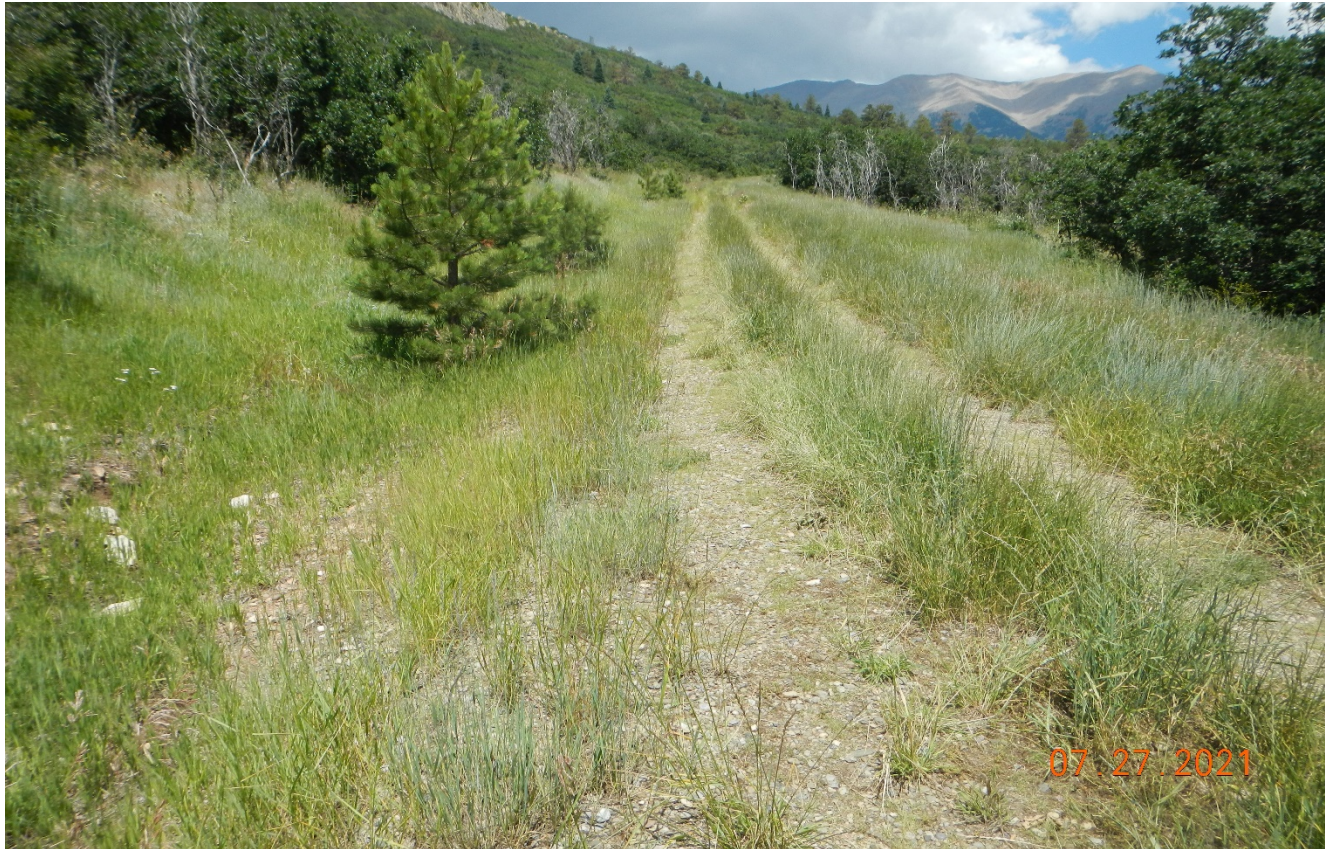
Photo 3. Facing northwest along the access road. The access road is stabilized with vegetation and gravel.

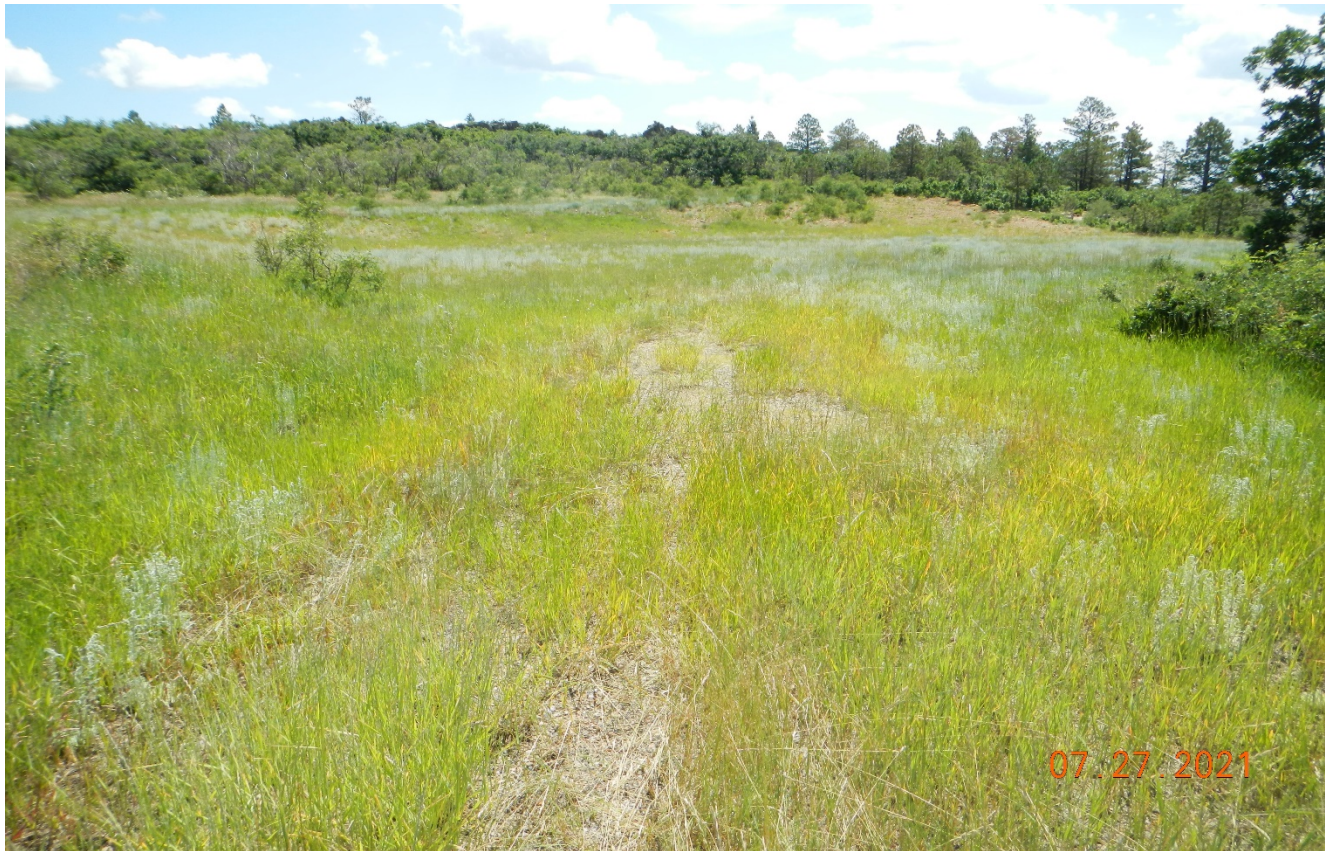
Photo 4. Facing southeast toward the location. The vegetation has established throughout the location.

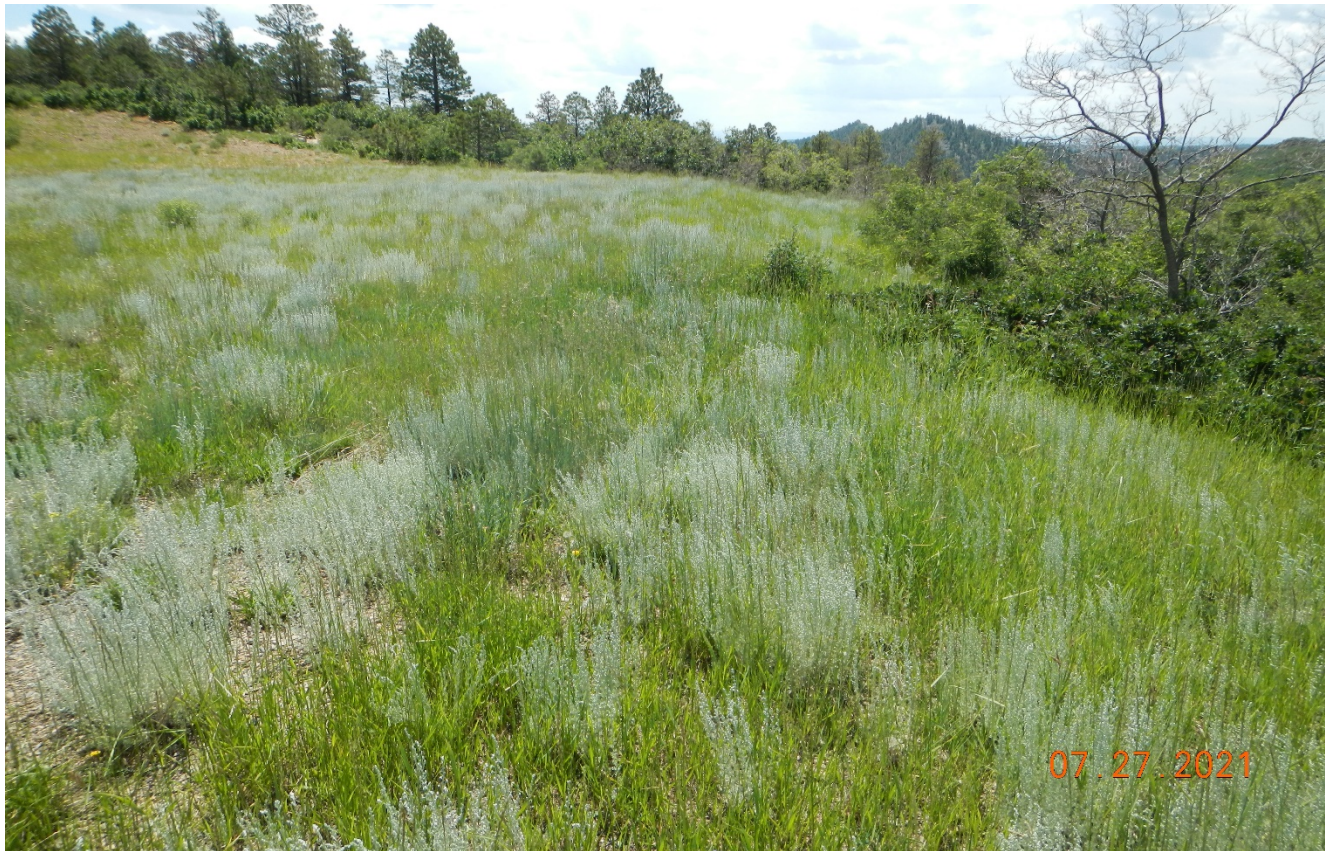
Photo 5. Facing southeast along the fill slope which is stabilized with vegetation cover.

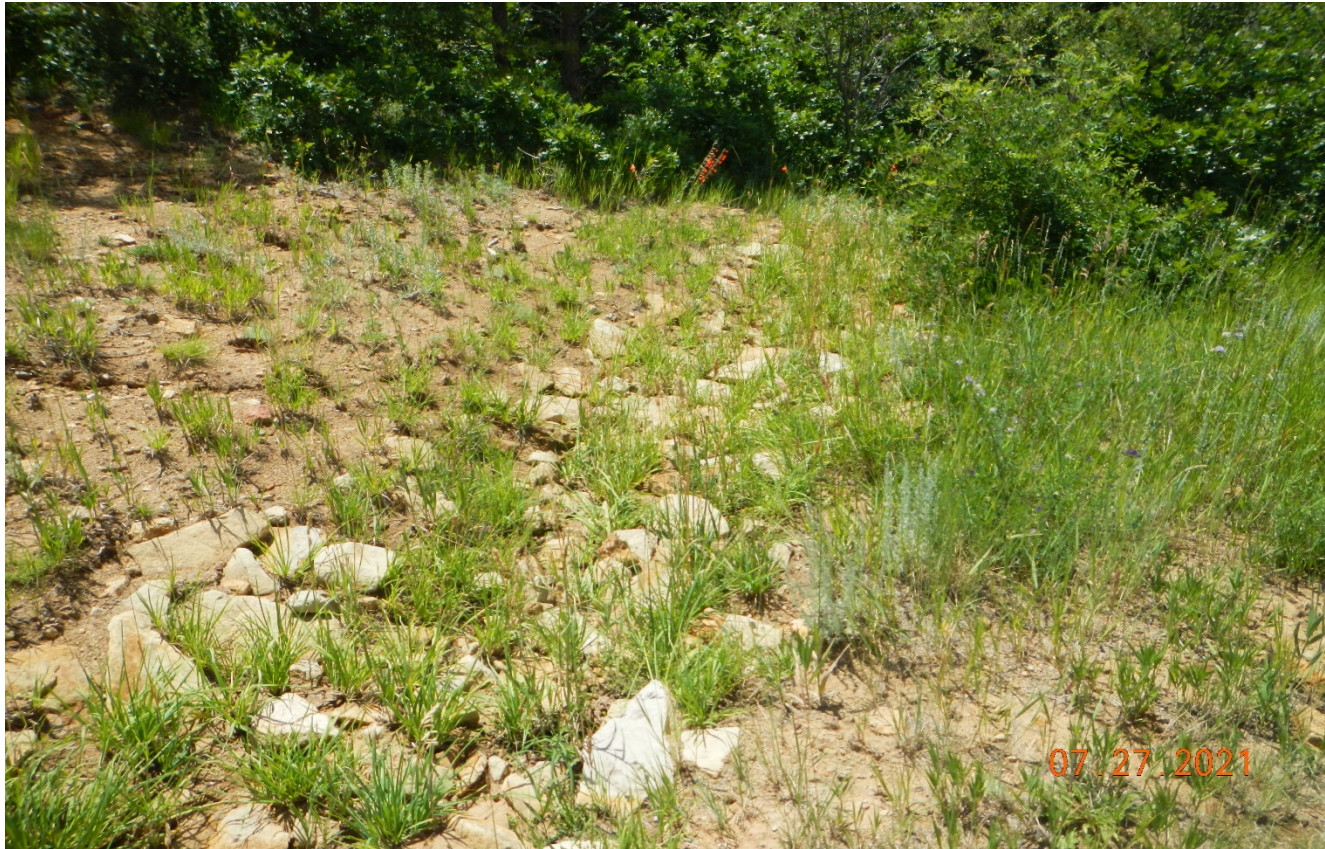
Photo 6. There is rock rip/rap installed for stormwater drainage at the south side of the location.

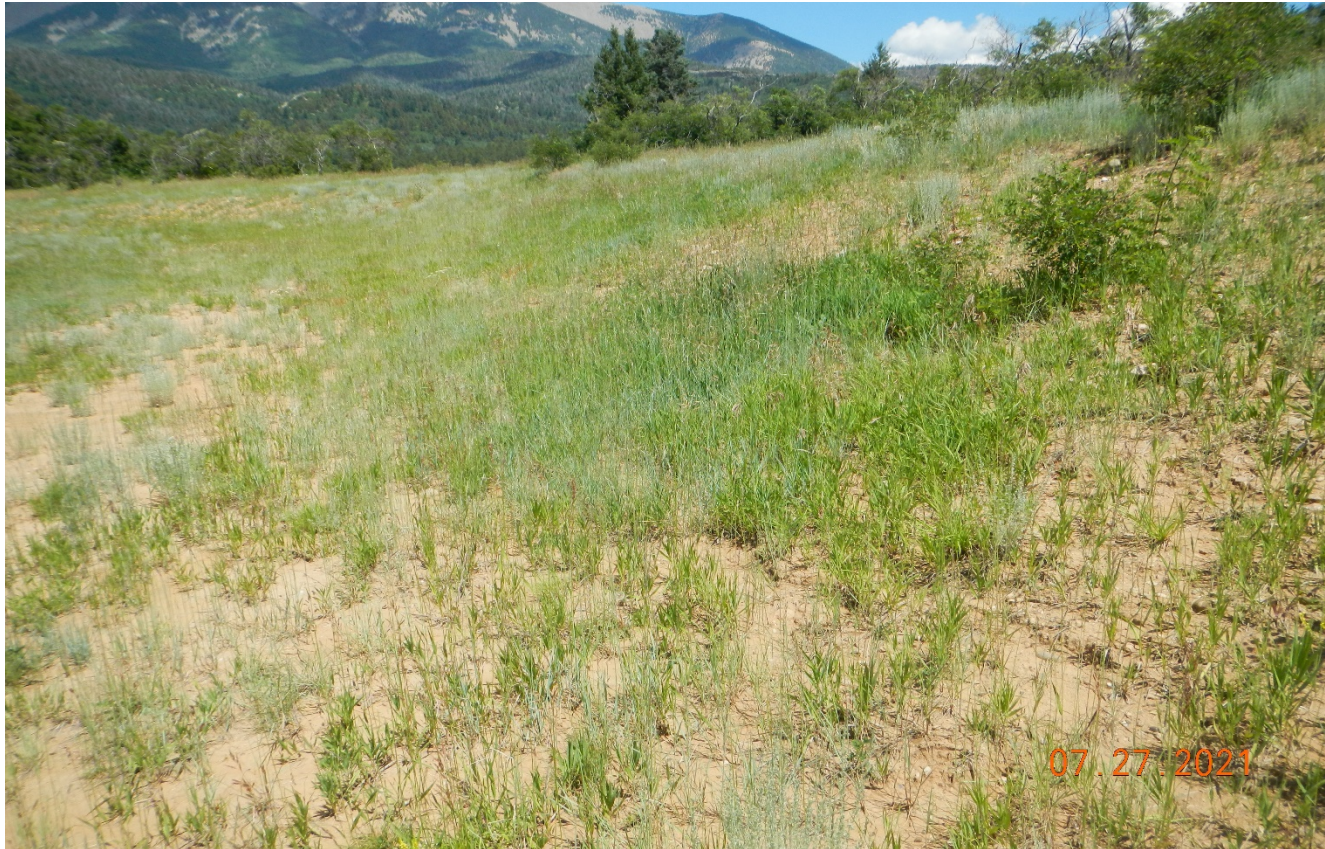
Photo 7. Facing northeast along the cut slope which is stabilized with vegetation cover.

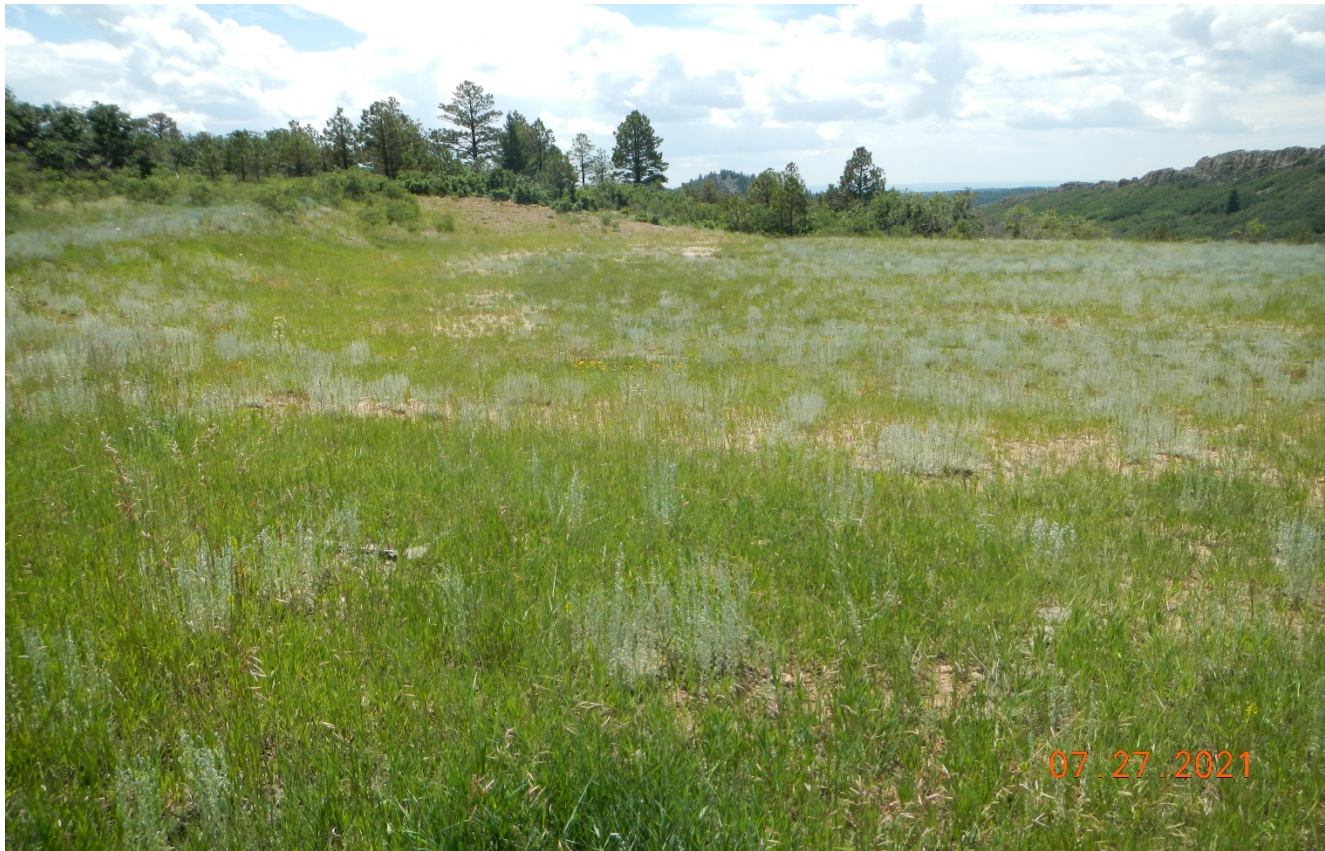
Photo 8. Facing southeast toward the location.
