Inspection Photos  
Operator: Simcoe  
API: 067-07336  
Date: 7/27/2021

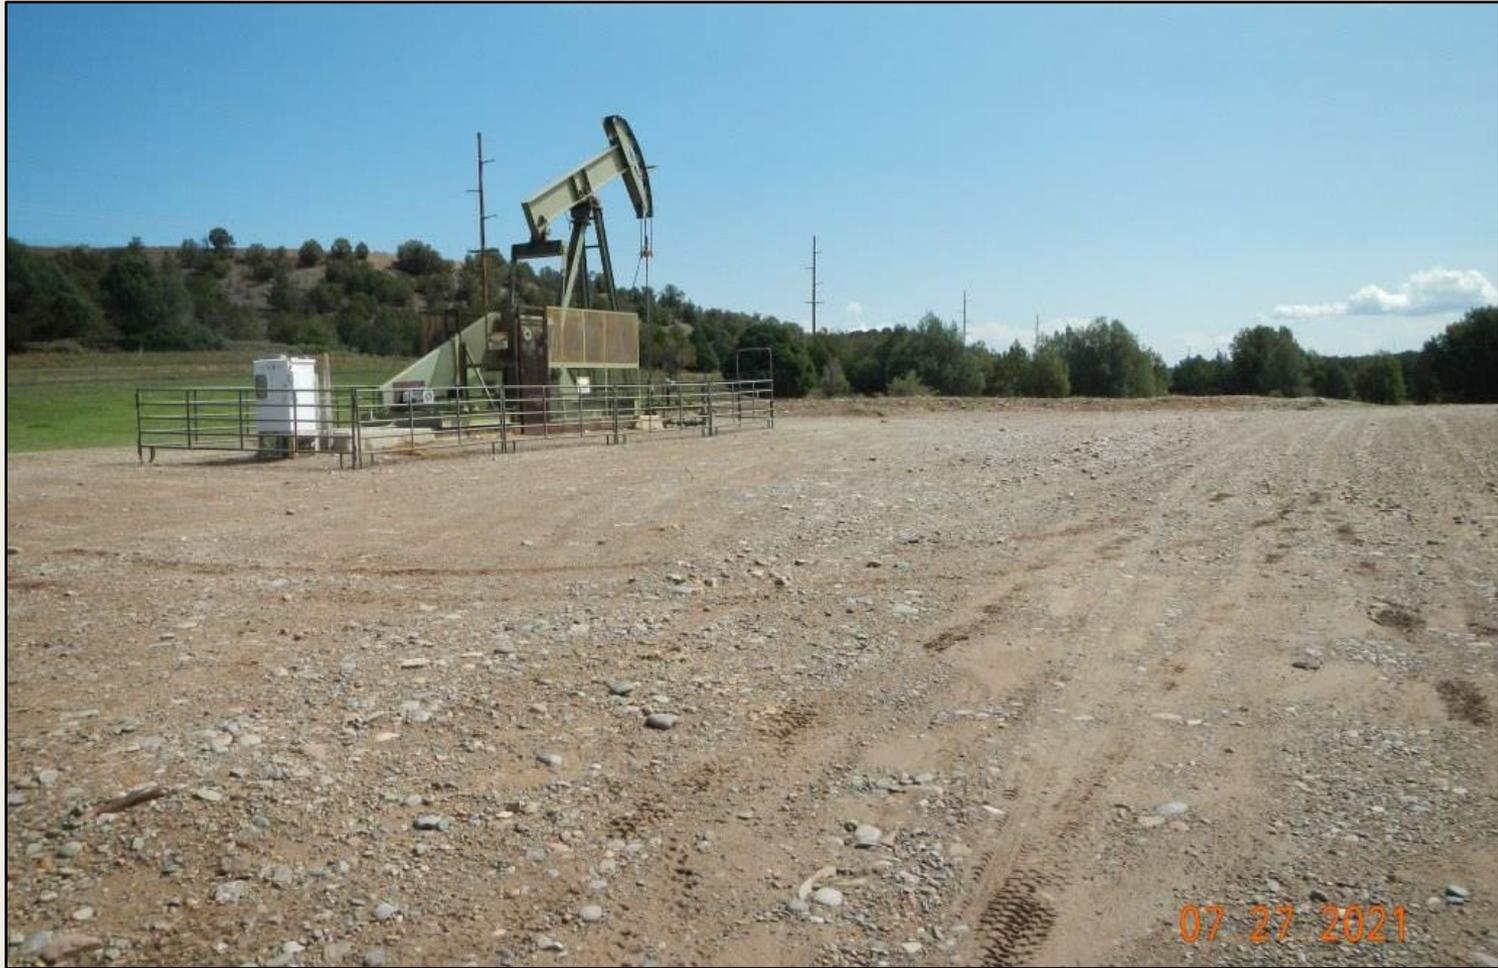
Photo 1. View of the project area from the well pad entrance facing center.

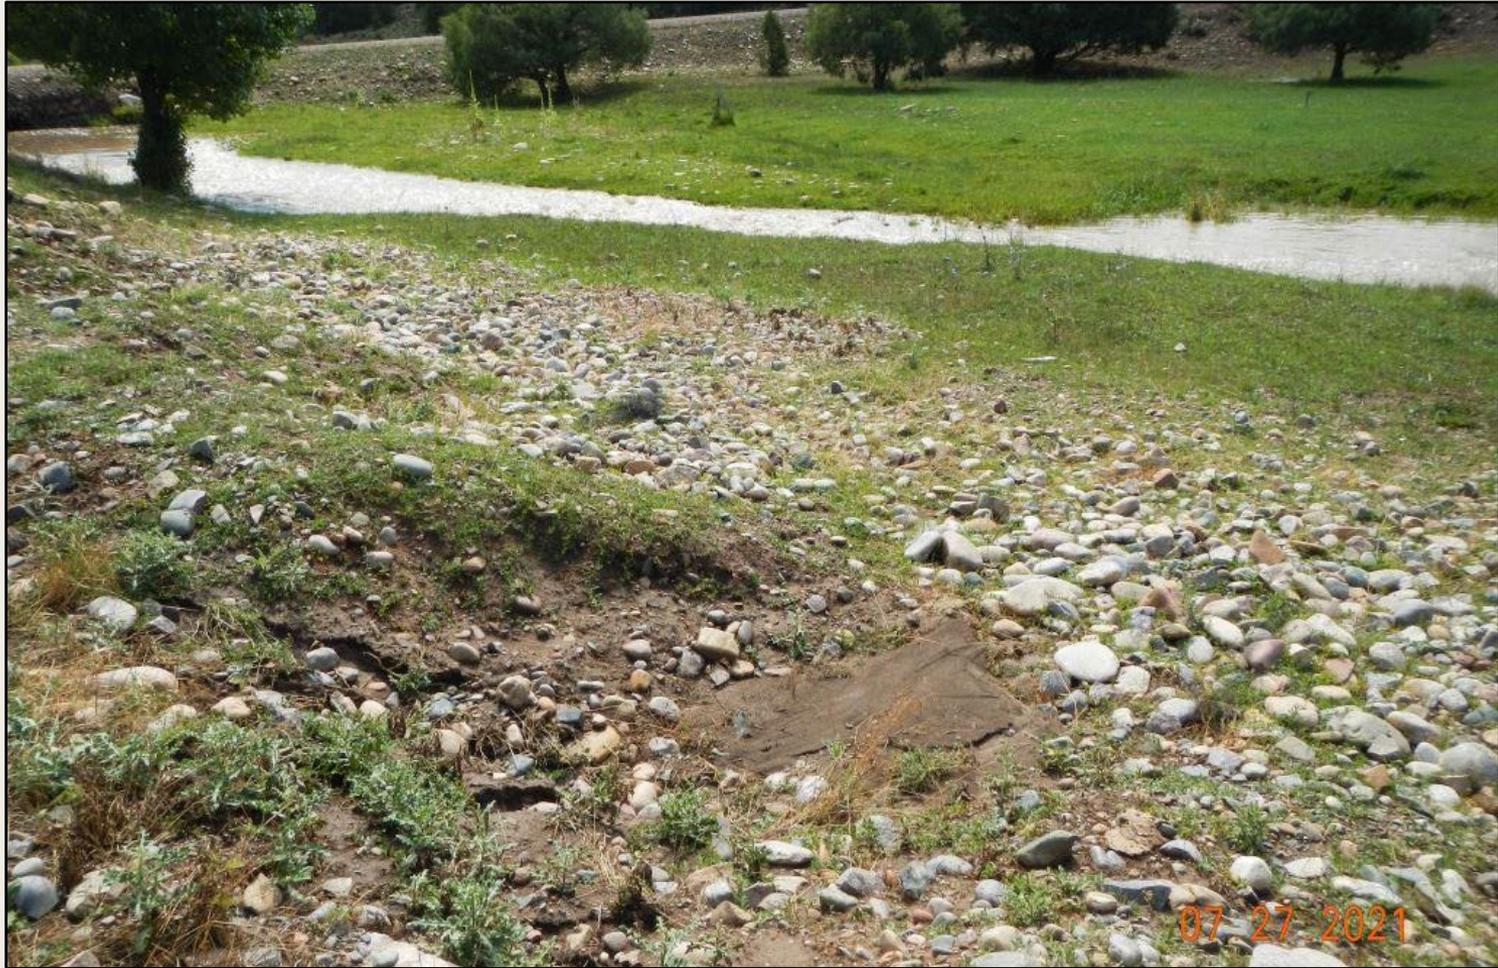
Photo 2. View of erosion occurring and sediment discharge occurring within the southern project area. Stormwater BMPs need to be installed to stabilize erosion and prevent discharge into the Florida River.

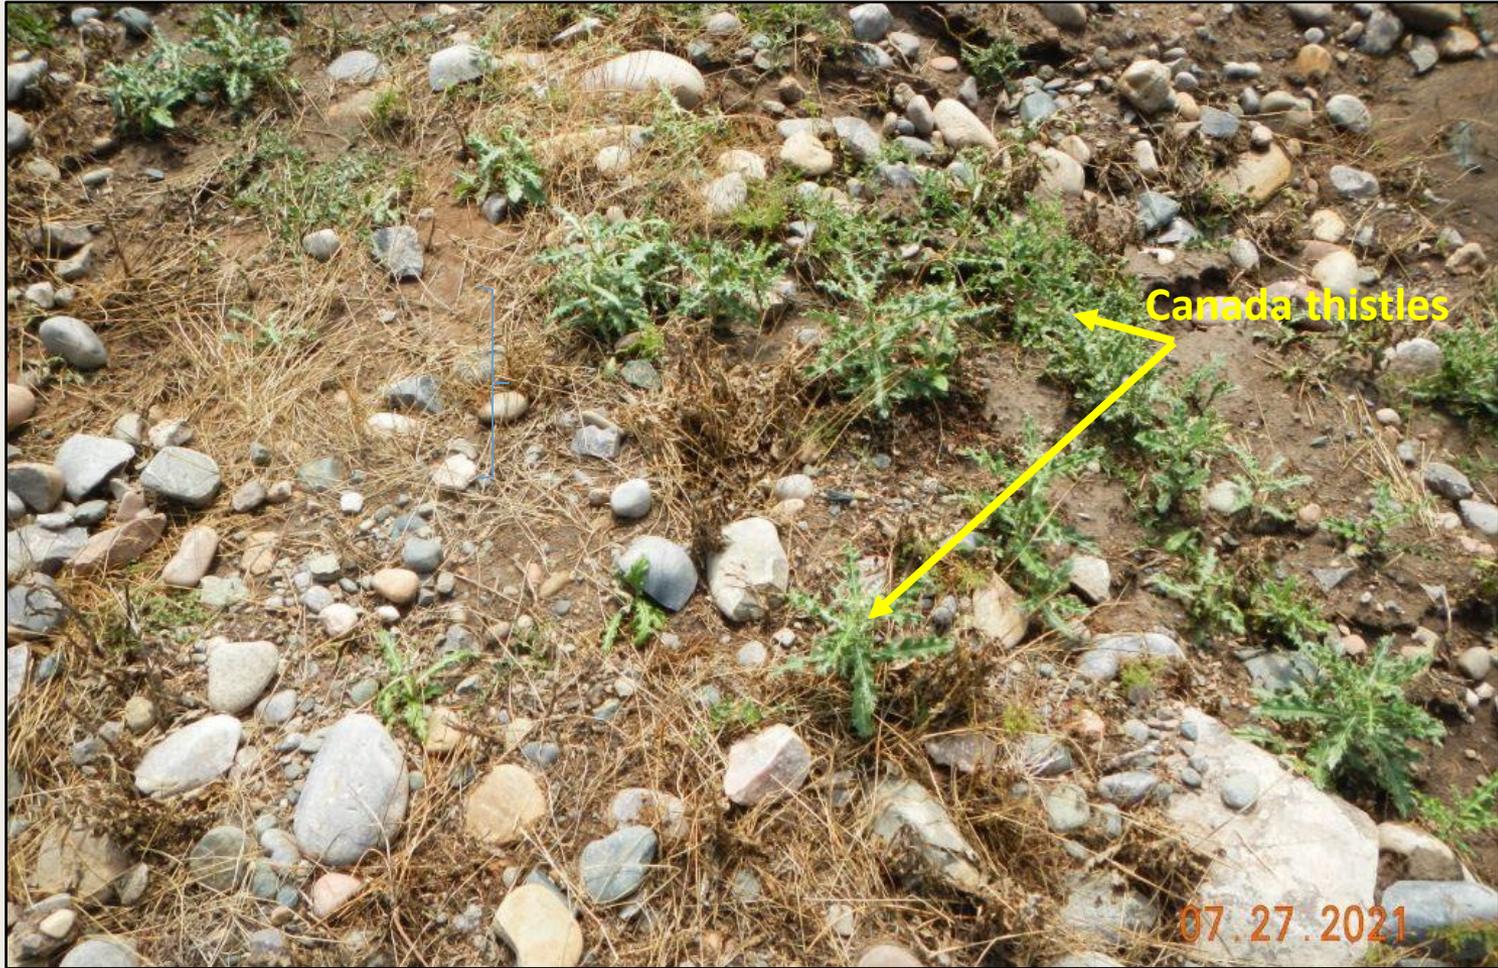
Photo 3. View of Canada thistles observed on the southern fill slope. Approximately 150 individuals observed.

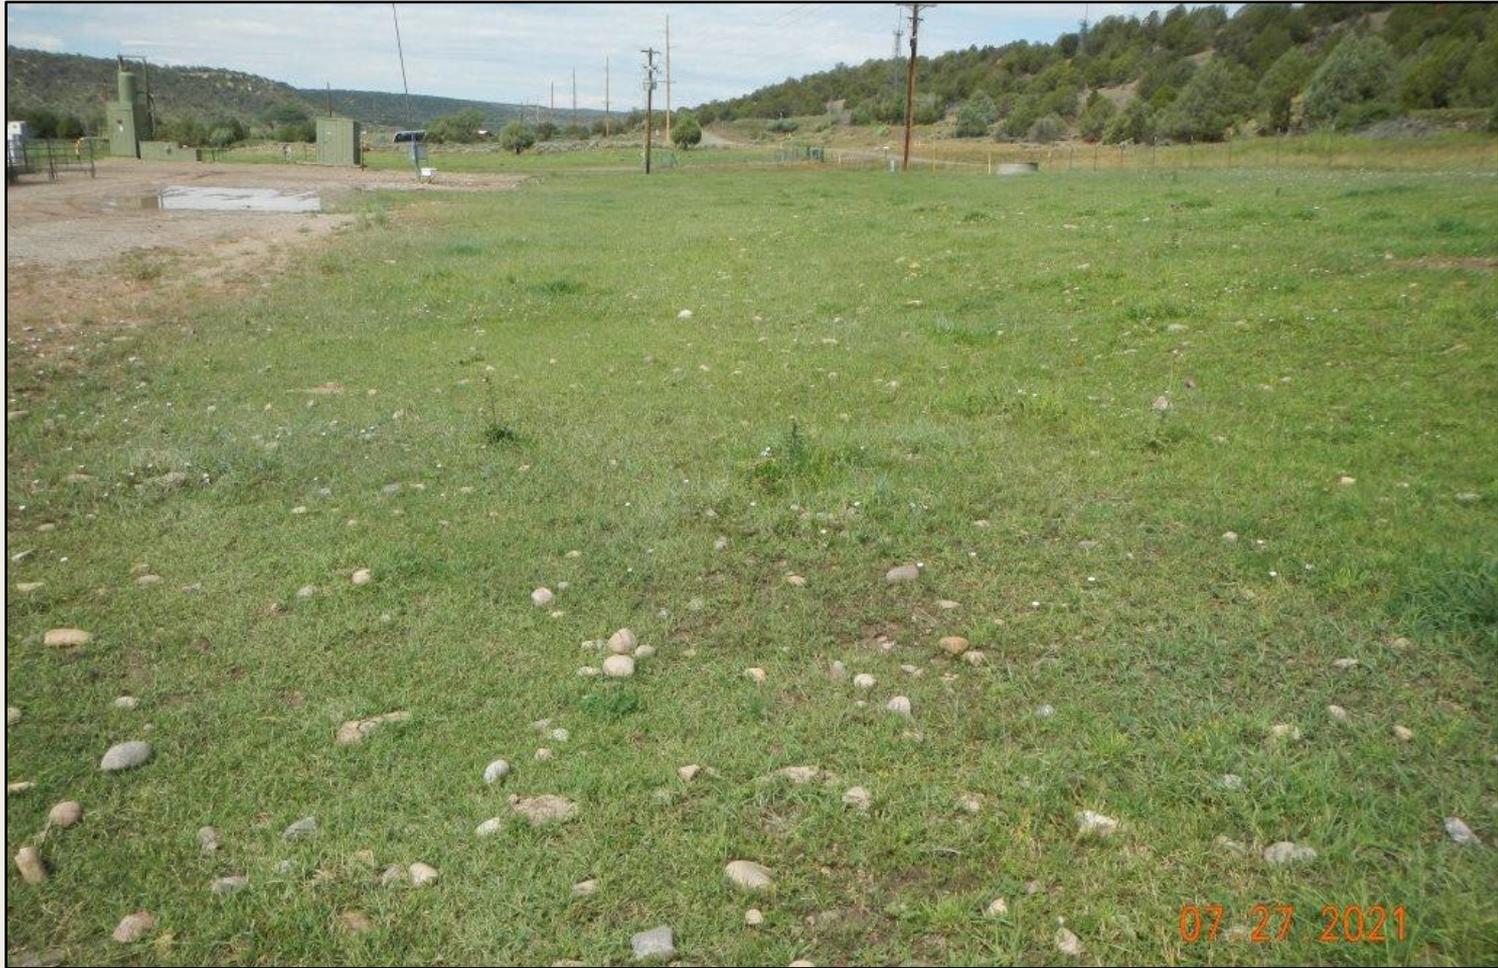
Photo 4. View of the northern project area from the northeastern corner facing westward. Revegetation is progressing with grasses typical of irrigated grass field such as orchard grass, tall fescue, and perennial ryegrass.

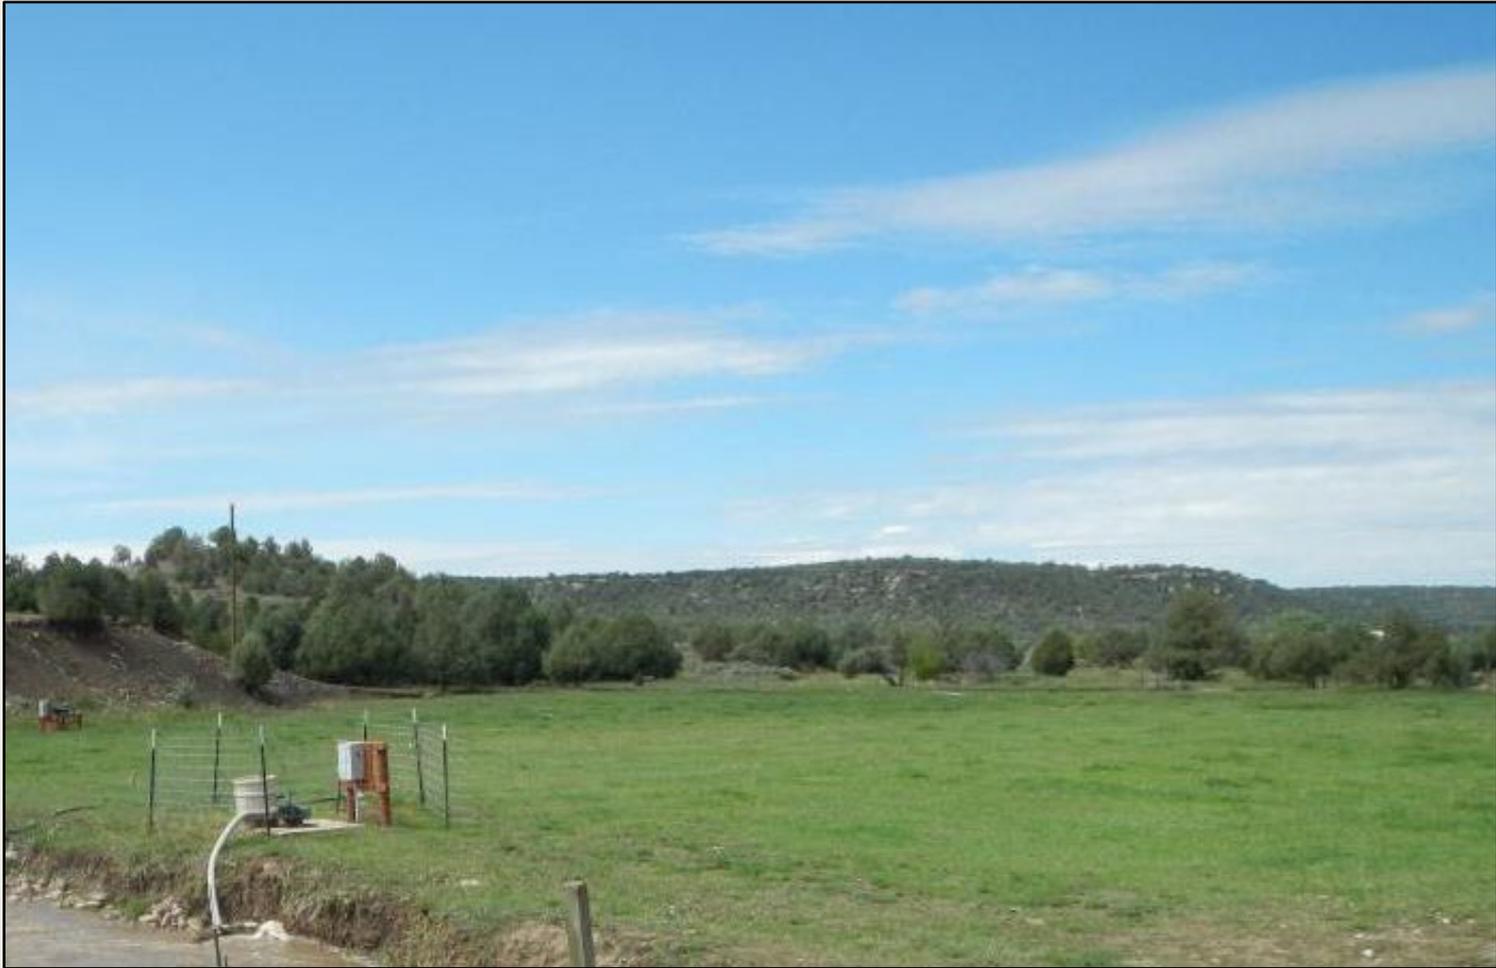
Photo 6. View of the reference area comprised of irrigated grass field with irrigated grasses such as those described in Photo 5.
