Inspection Photos  
Operator: Simcoe  
API: 067-08773  
Date: 7/27/2021

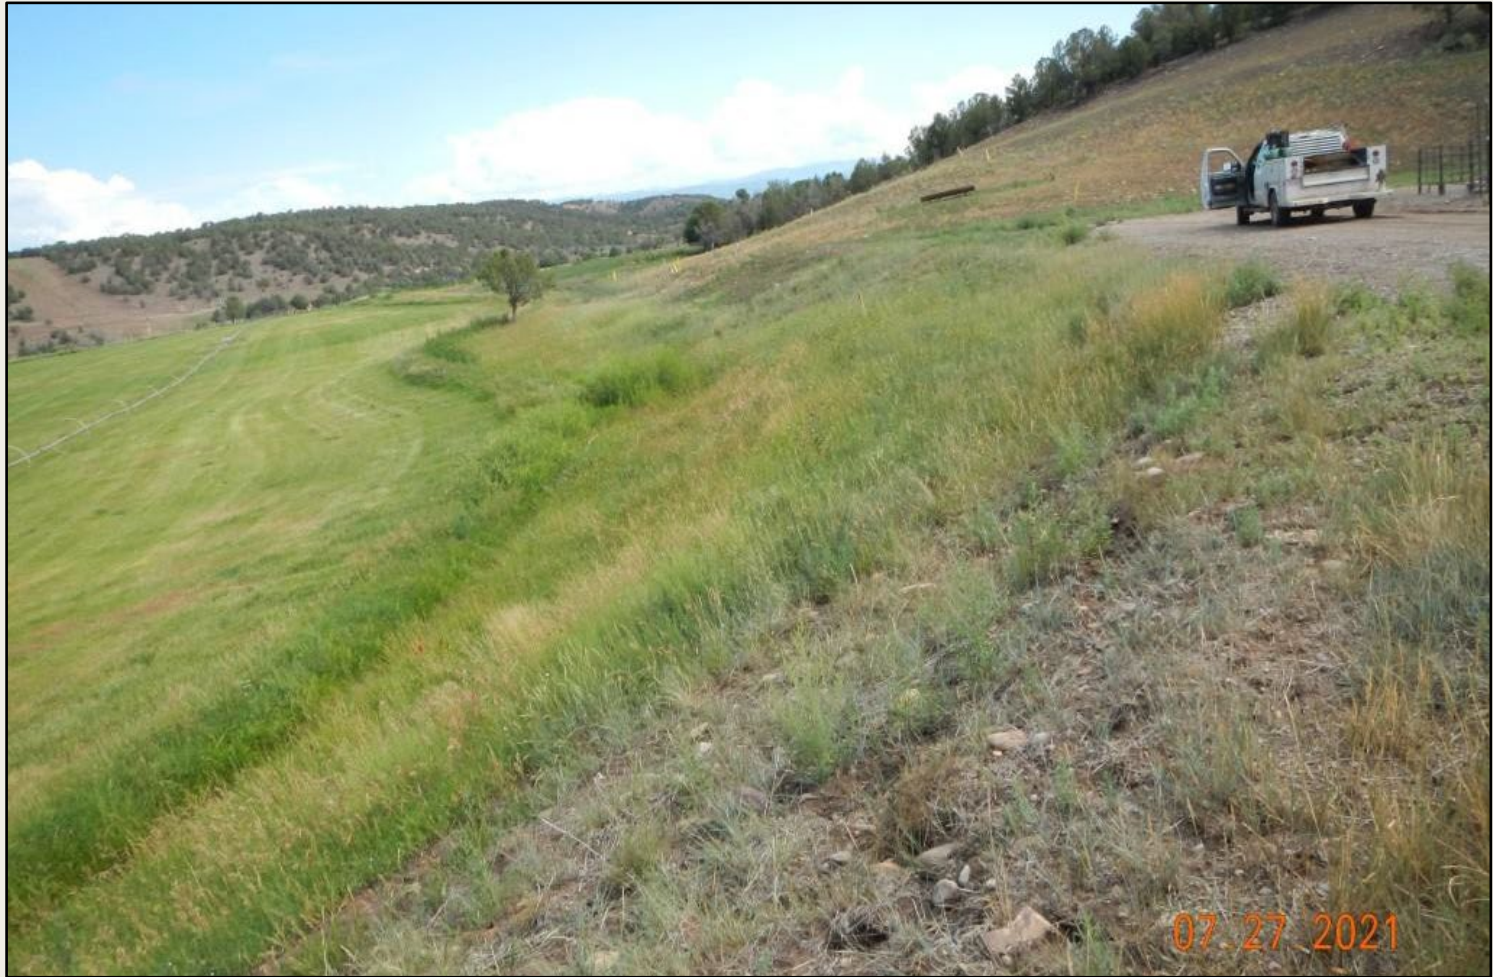
Photo 1. View of the western project area from the western edge facing northeastward. Revegetation is progressing with western wheatgrass and smooth brome.

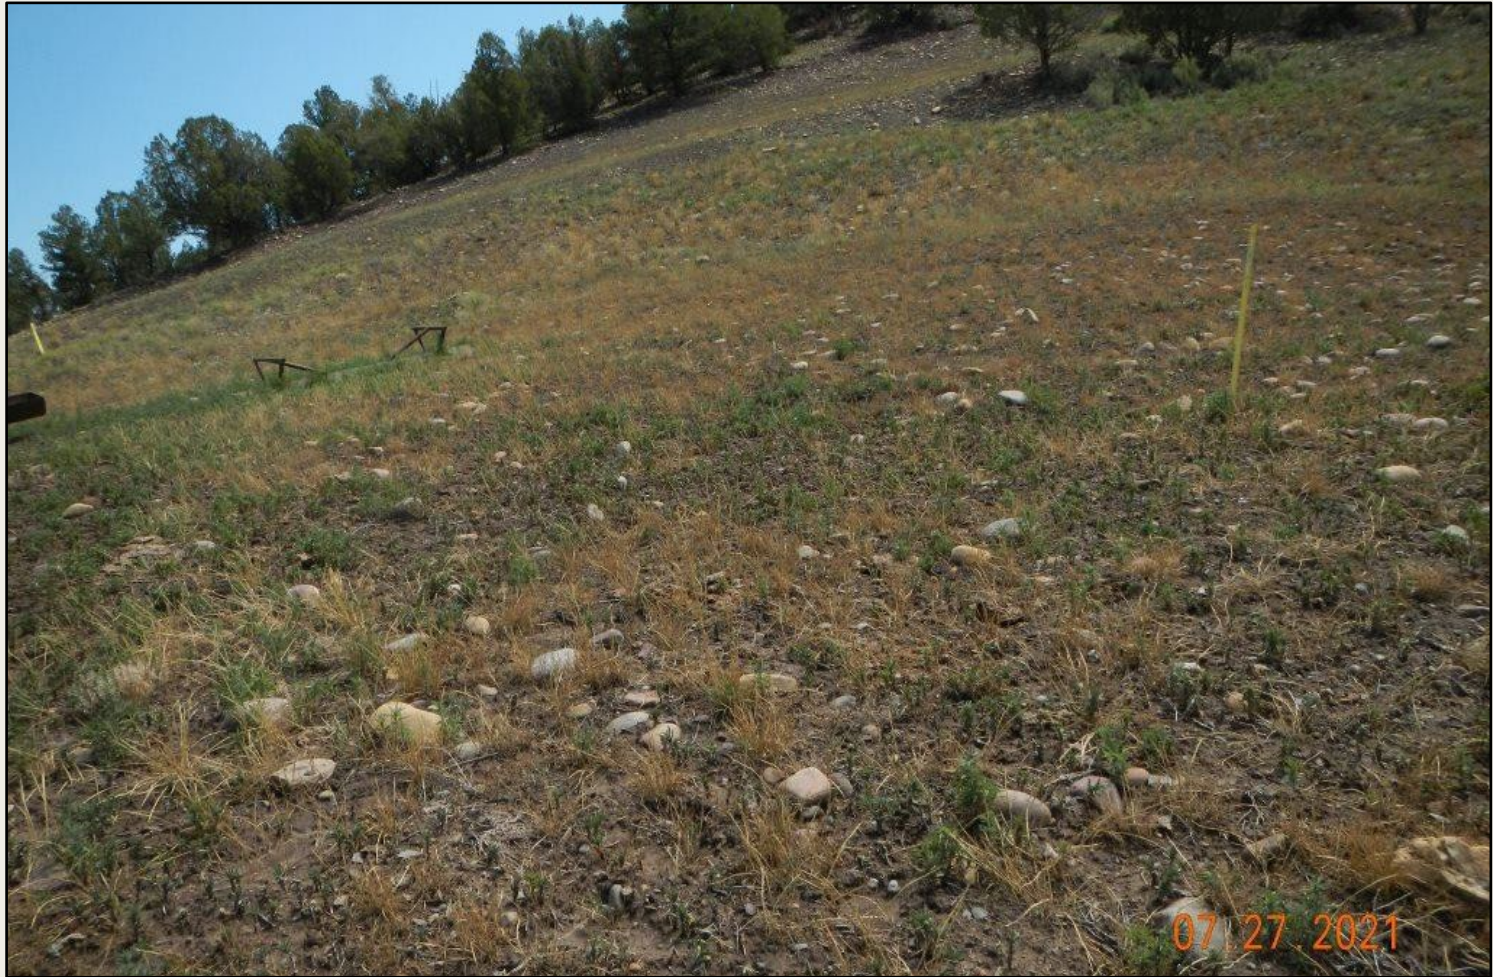
Photo 2. View of the northern portion of the interim reclamation area facing northward from the edge of the working area.

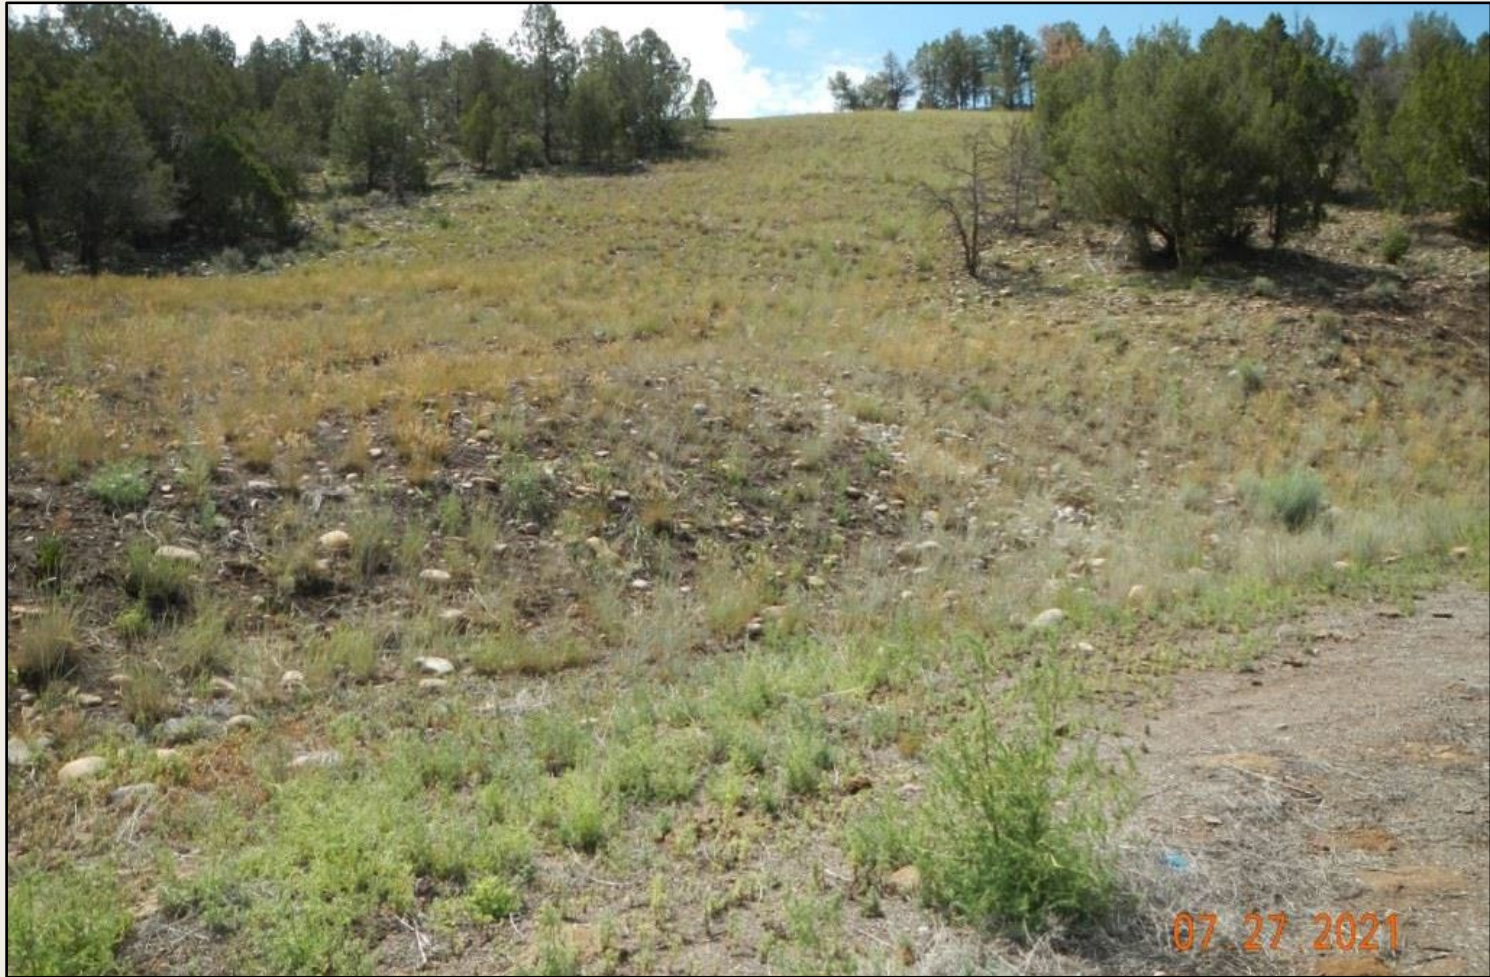
Photo 3. View of revegetation progressing along the pipeline running through the southern project area.

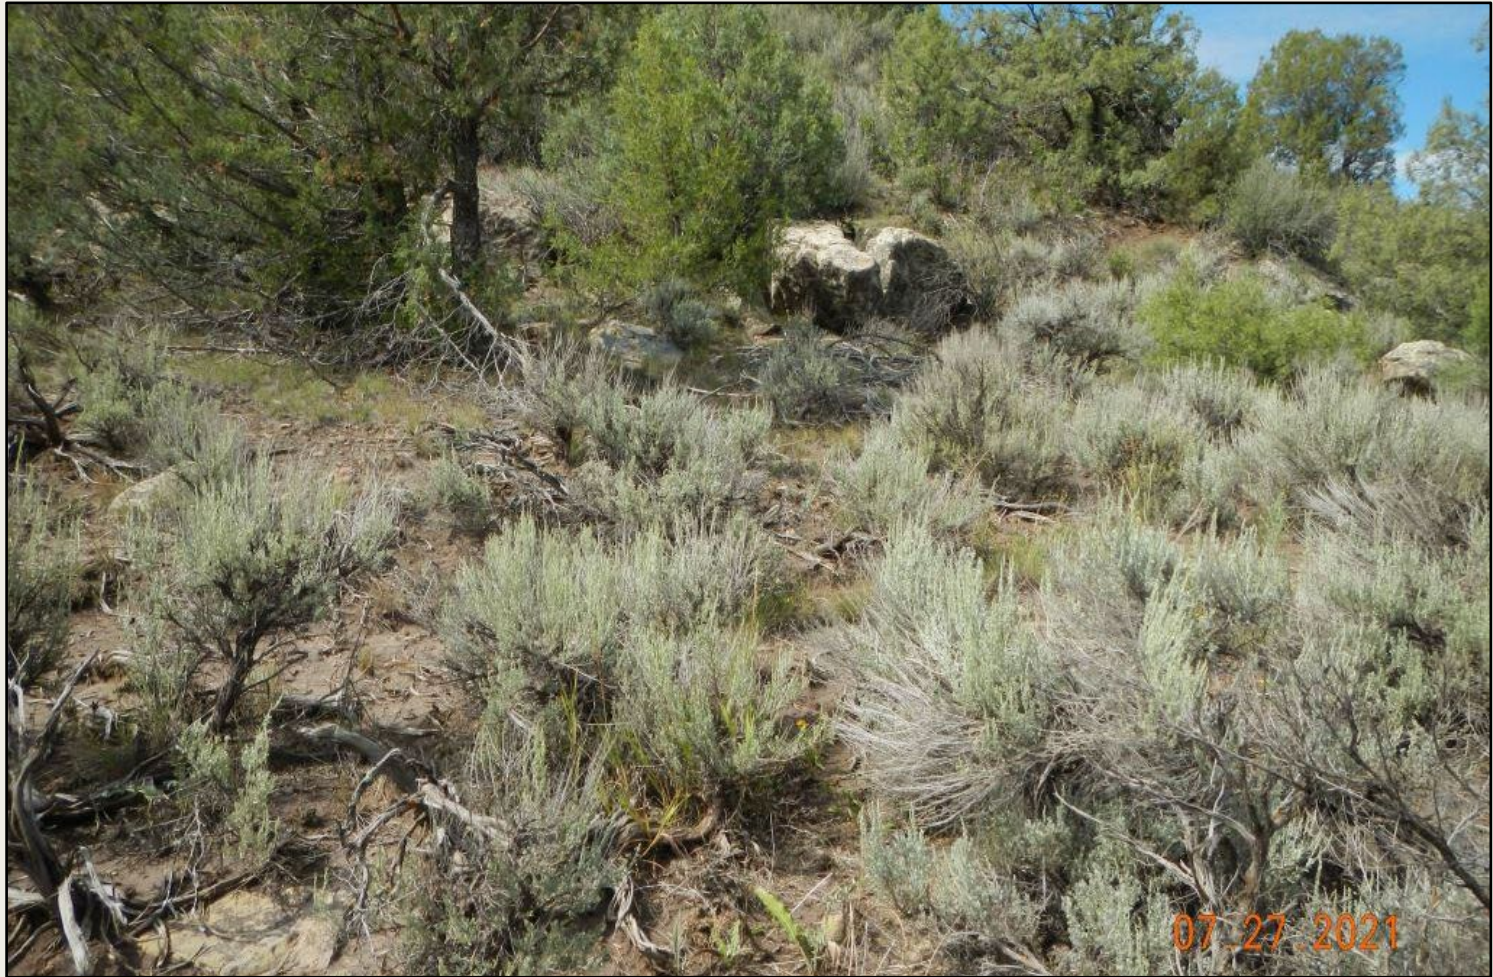
Photo 4. View of the reference area comprised of pinyon and juniper woodland with big sagebrush, mules ears, Indian ricegrass, and prickly pear.
