# Inspection Photos

API: 071-09475

Operator: OGRIS OPERATING LLC

Inspection Date: 7/29/2021

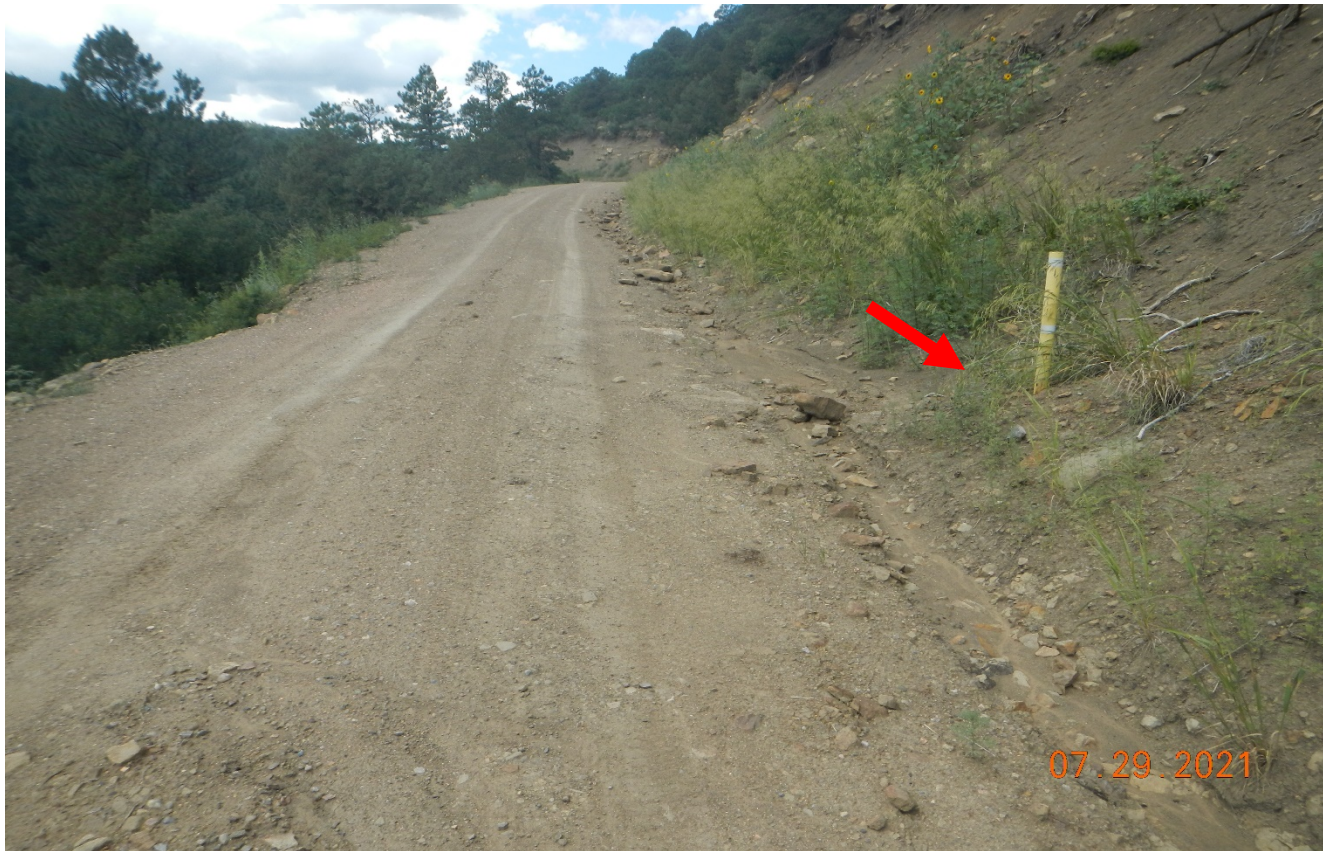
**Photo 1.** There are multiple culverts along the road that are filled in with sediment.

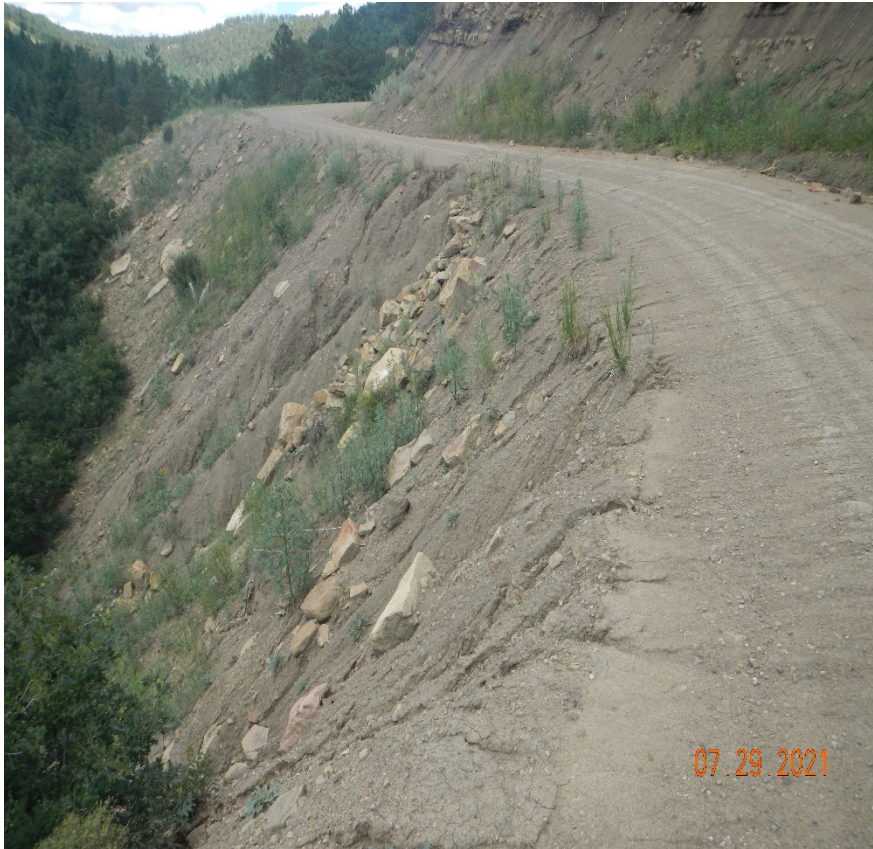
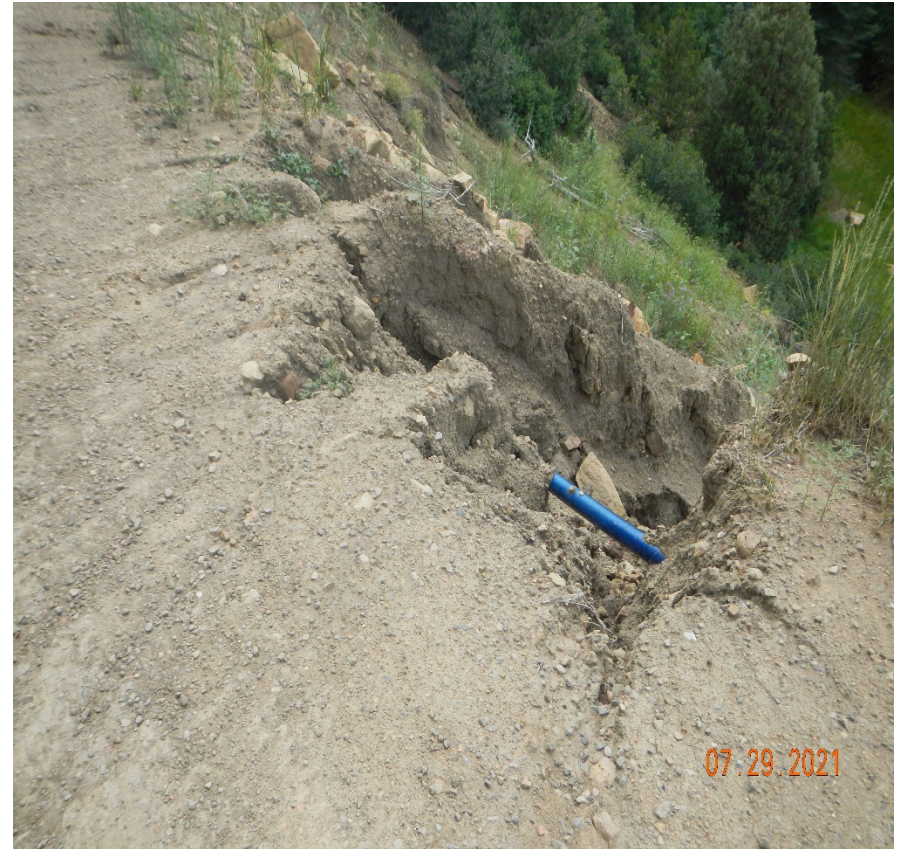
**Photo 2.** Facing west along the main road at Lat/Long:37.1099,-104.94878. Erosion has occurred along the fill slope of the road. This area needs to be repaired and stabilized. Previous corrective action was not performed.

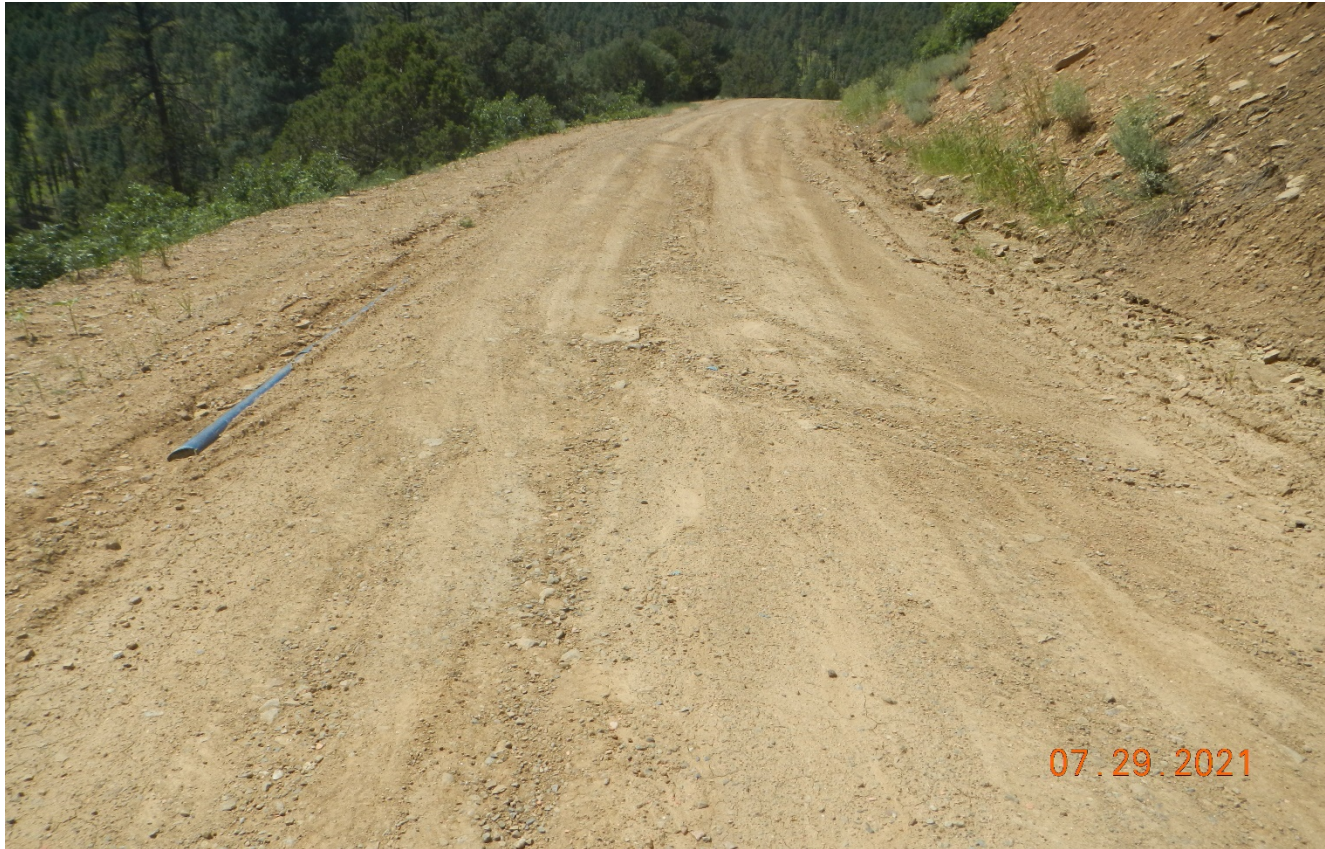
**Photo 3.** This area of the road was where there was significant rutting. The road was graded but was not stabilized.

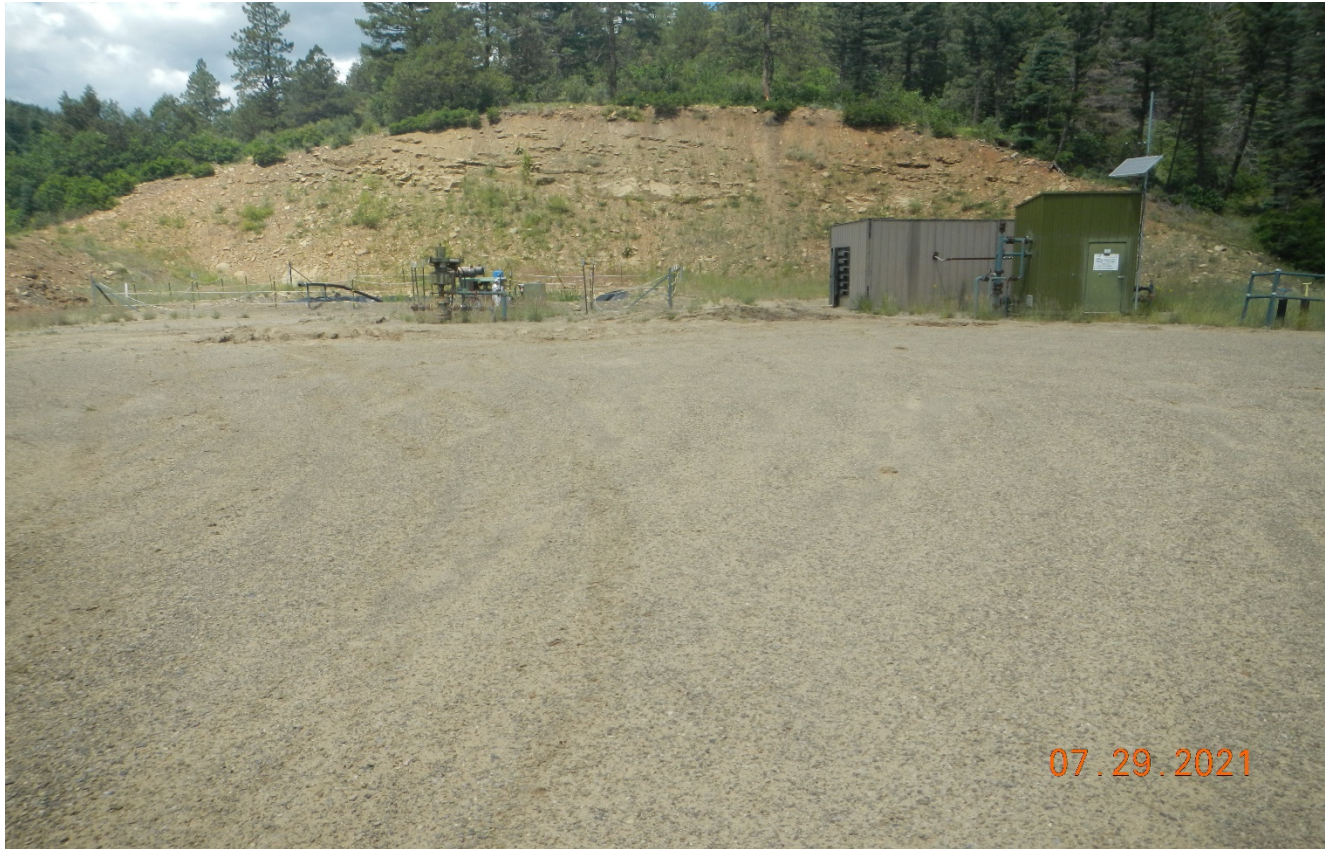
**Photo 4.** Facing toward the location.

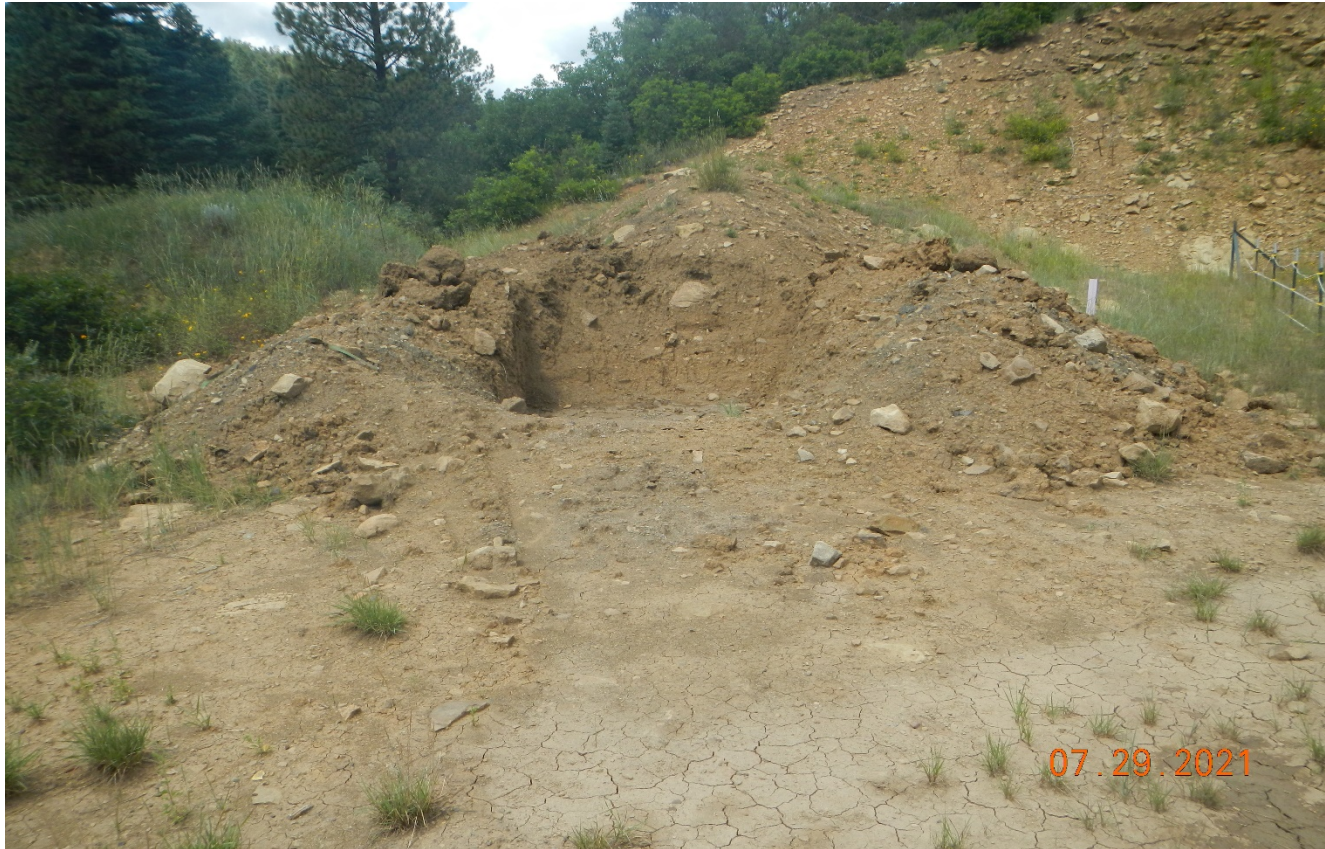
**Photo 5.** The soil pile at the location was disturbed and needs to be resloped and stabilized.

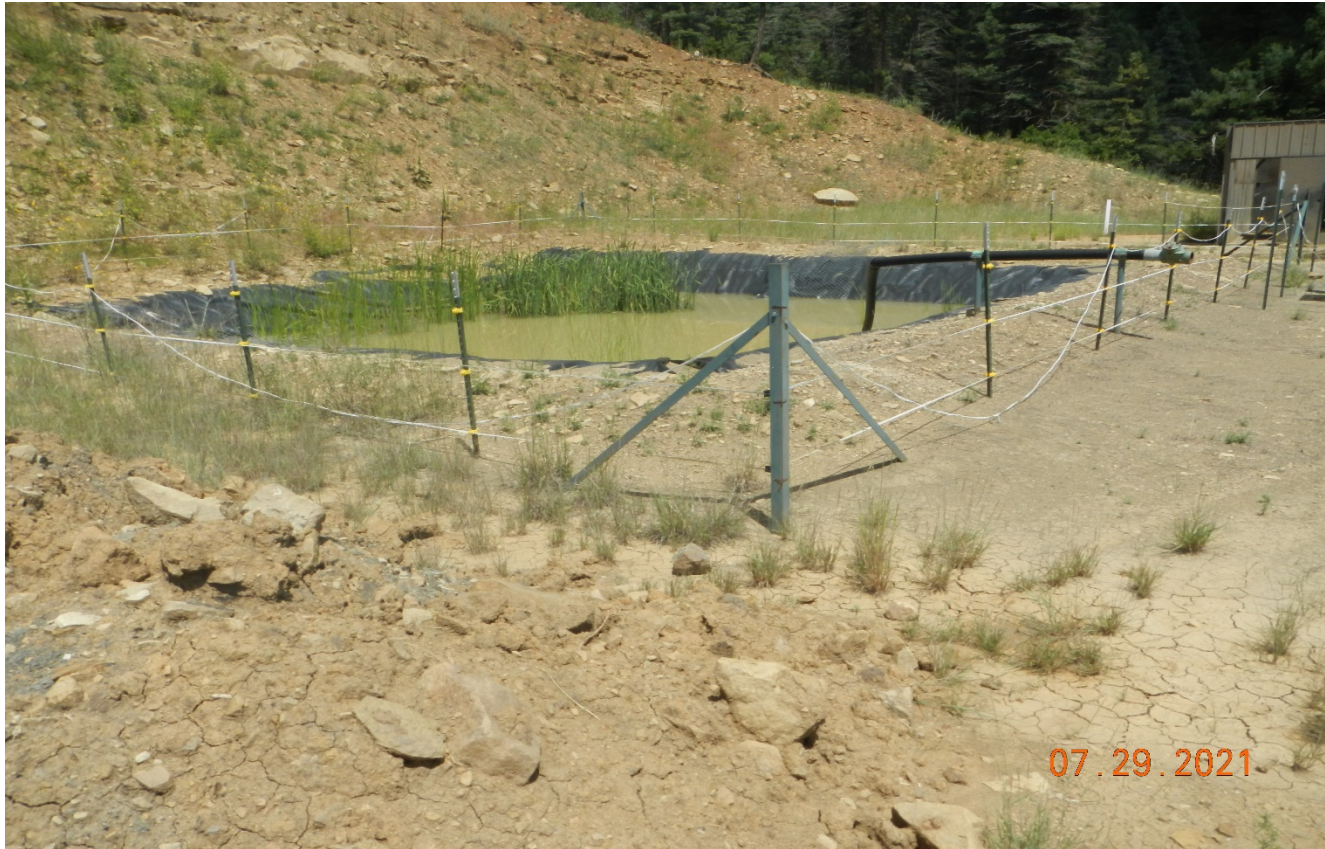
**Photo 6.** The fence around the pit is not maintained. This issue has been previously observed and needs adequately fenced and maintained.
