# Inspection Photos

API: 071-07944

Operator: OGRIS OPERATING LLC

Inspection Date: 7/29/2021

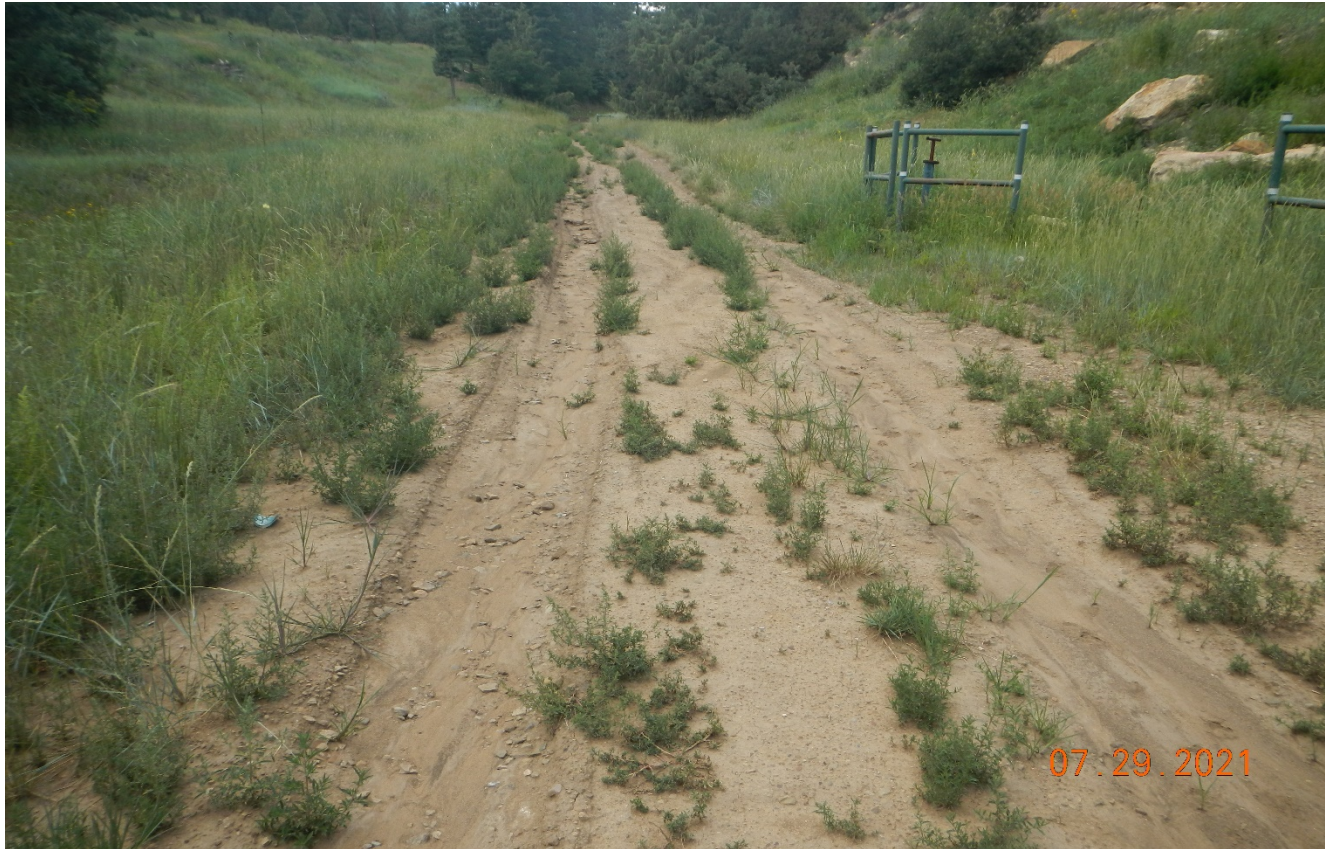
**Photo 1.** Facing west toward the access road at the canyon bottom near AC 1-16. The road in the canyon bottom is not maintained or stabilized. Previous corrective action was not performed. Vehicle rutting and erosion was not repaired.

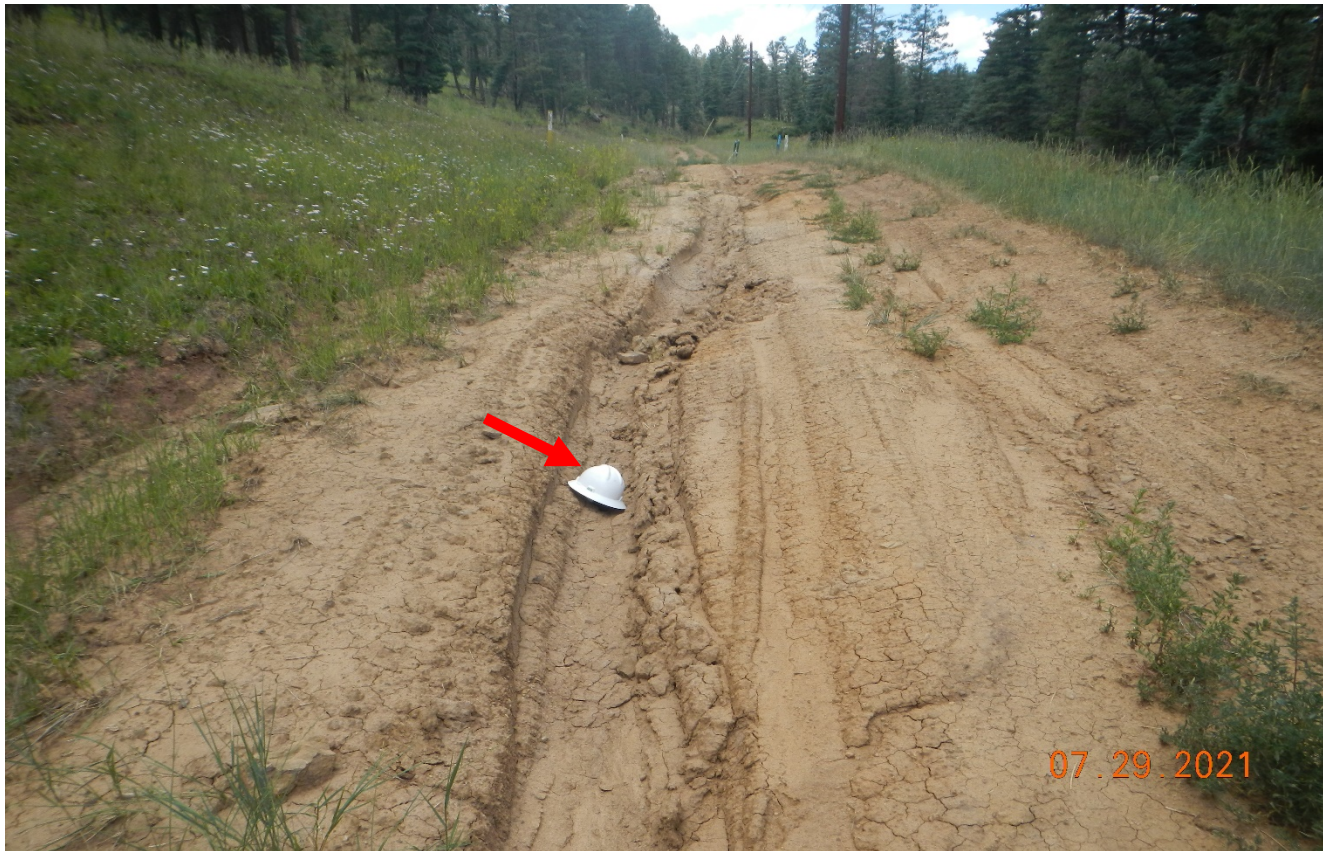
**Photo 2.** The road along the canyon bottom is not stabilized and maintained. Vehicle rutting and erosion has not been repaired. Arrow points to hard hat for scale.

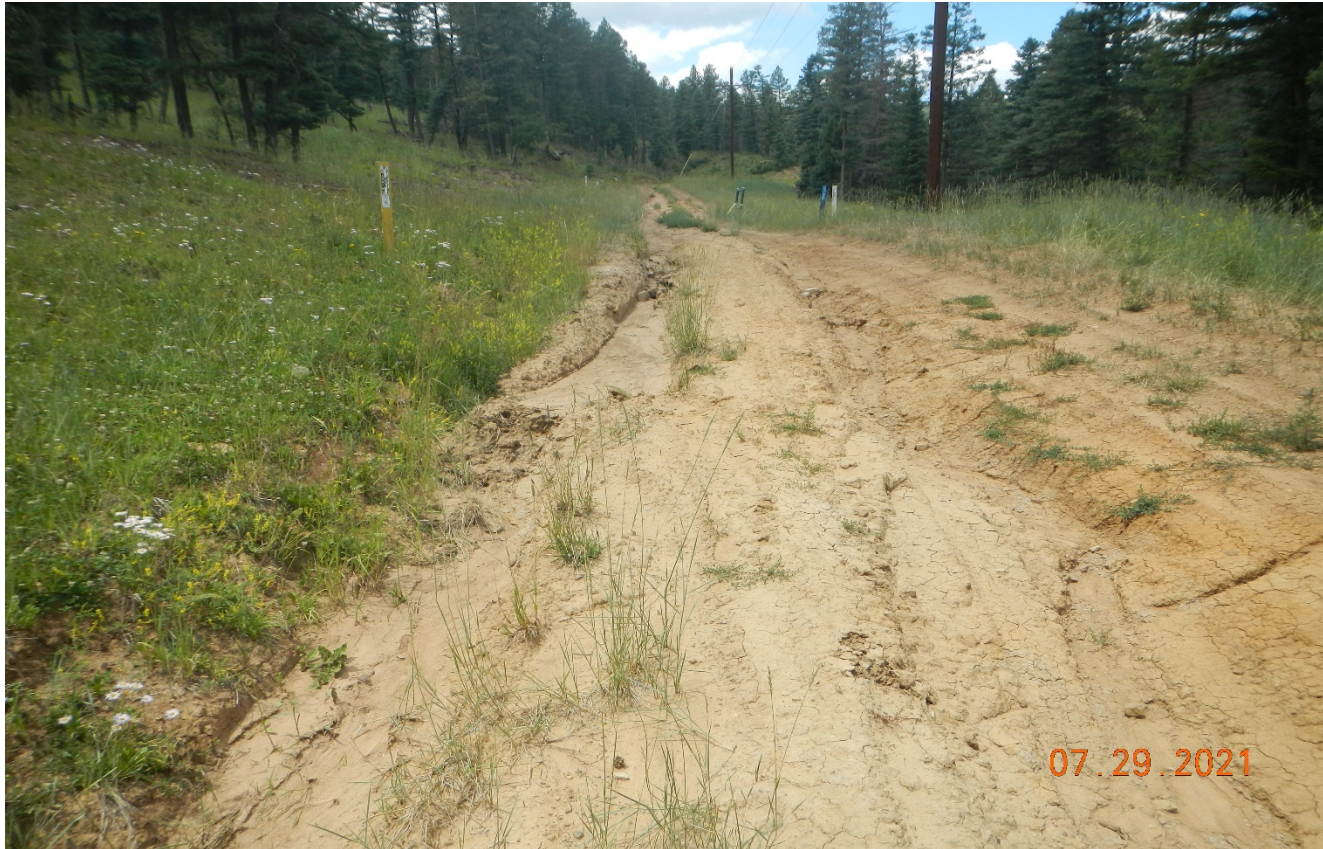
**Photo 3.** The road along the canyon bottom is not stabilized and maintained.

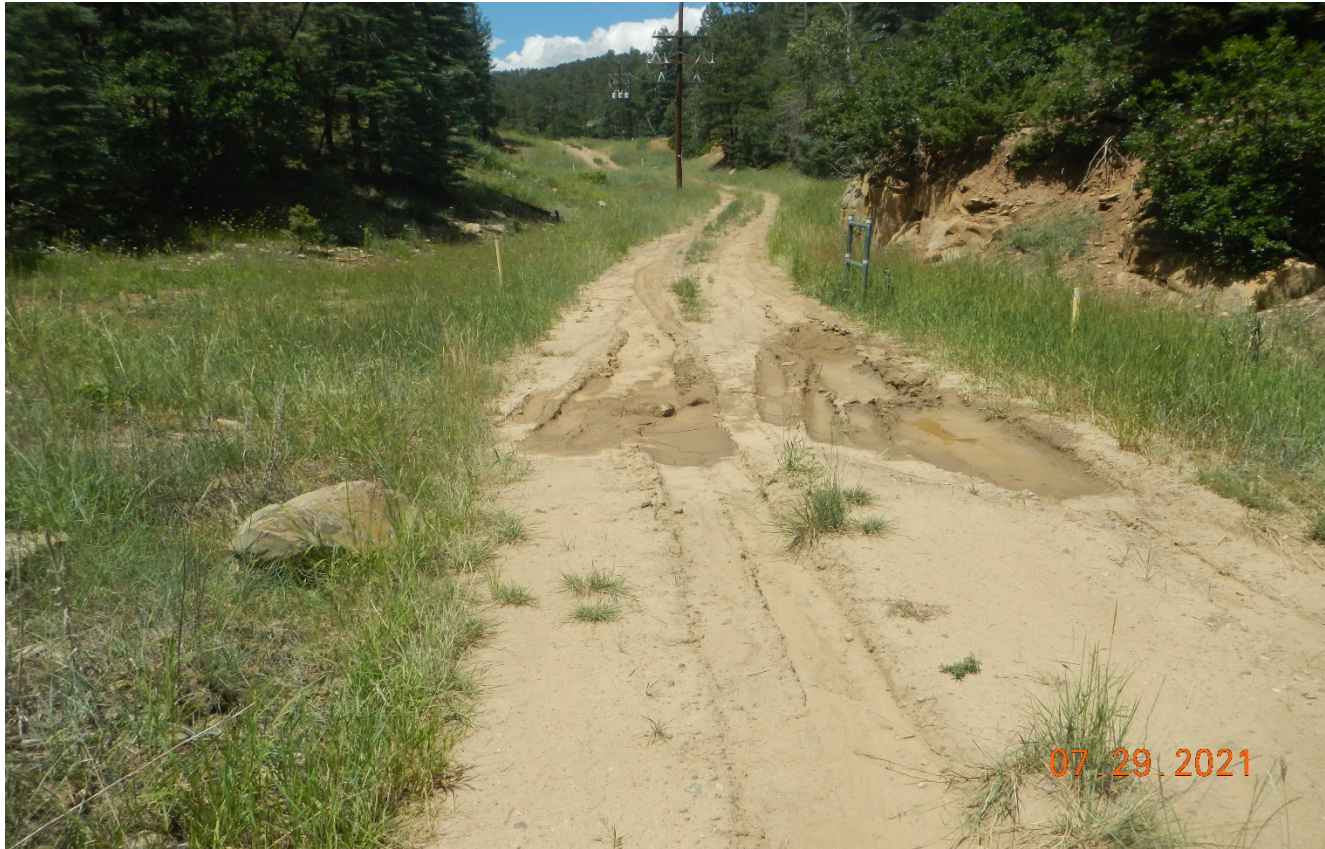
**Photo 4.** Stormwater accumulates on the road and is not diverted toward the culverts.

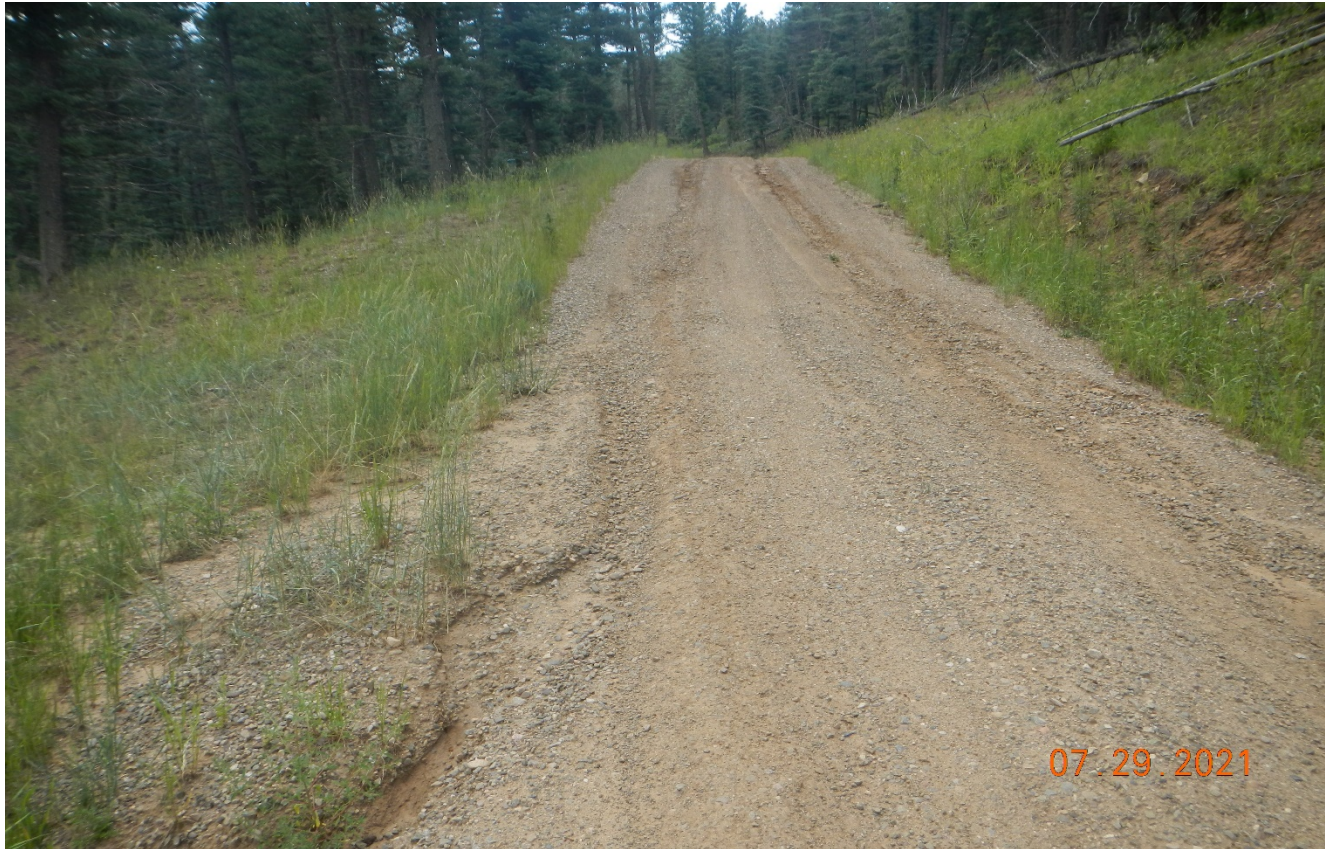
**Photo 5.** Facing toward the access road to the location.

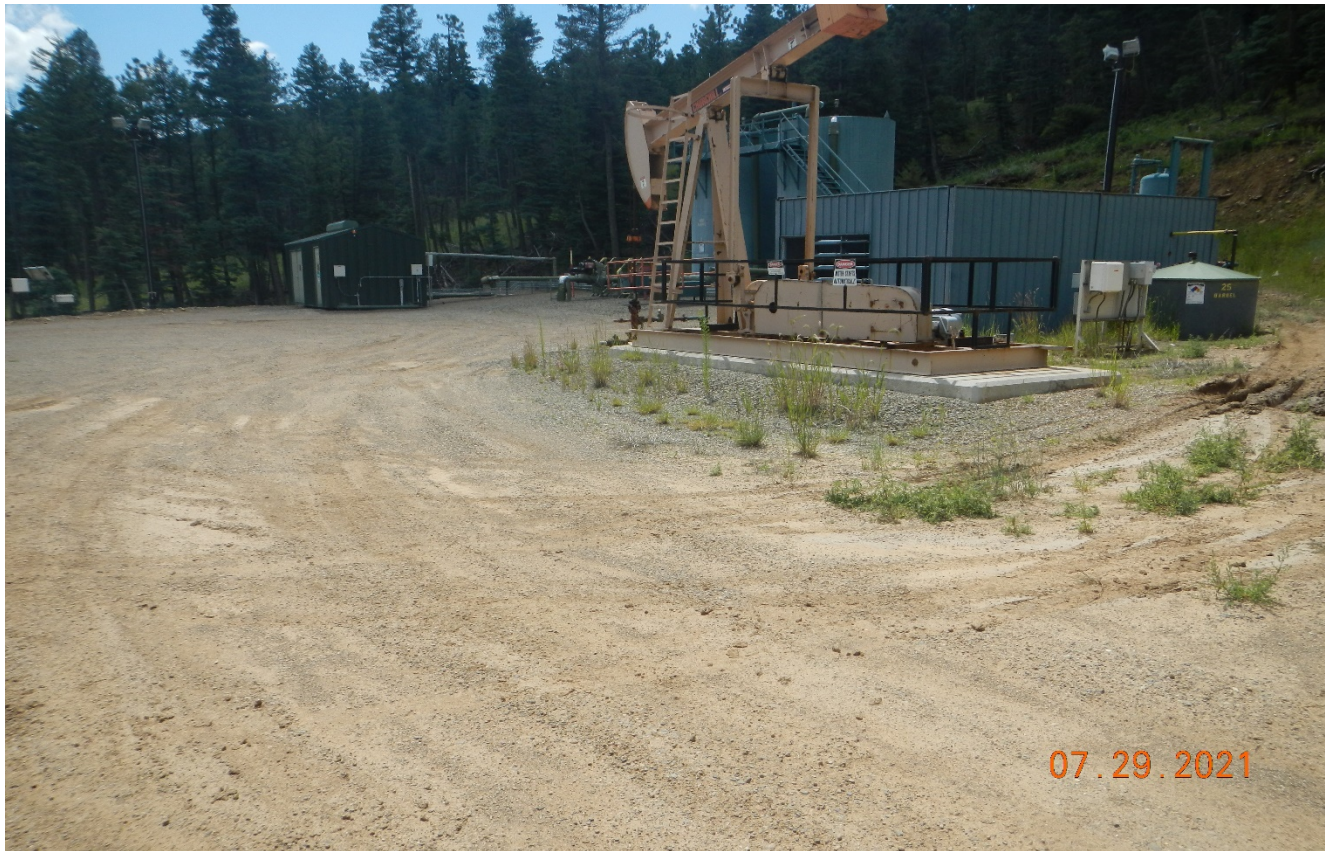
**Photo 6.** Facing toward the location.
