Inspection Photos

API: 071-08760

Operator: OGRIS OPERATING LLC

Inspection Date: 7/29/2021

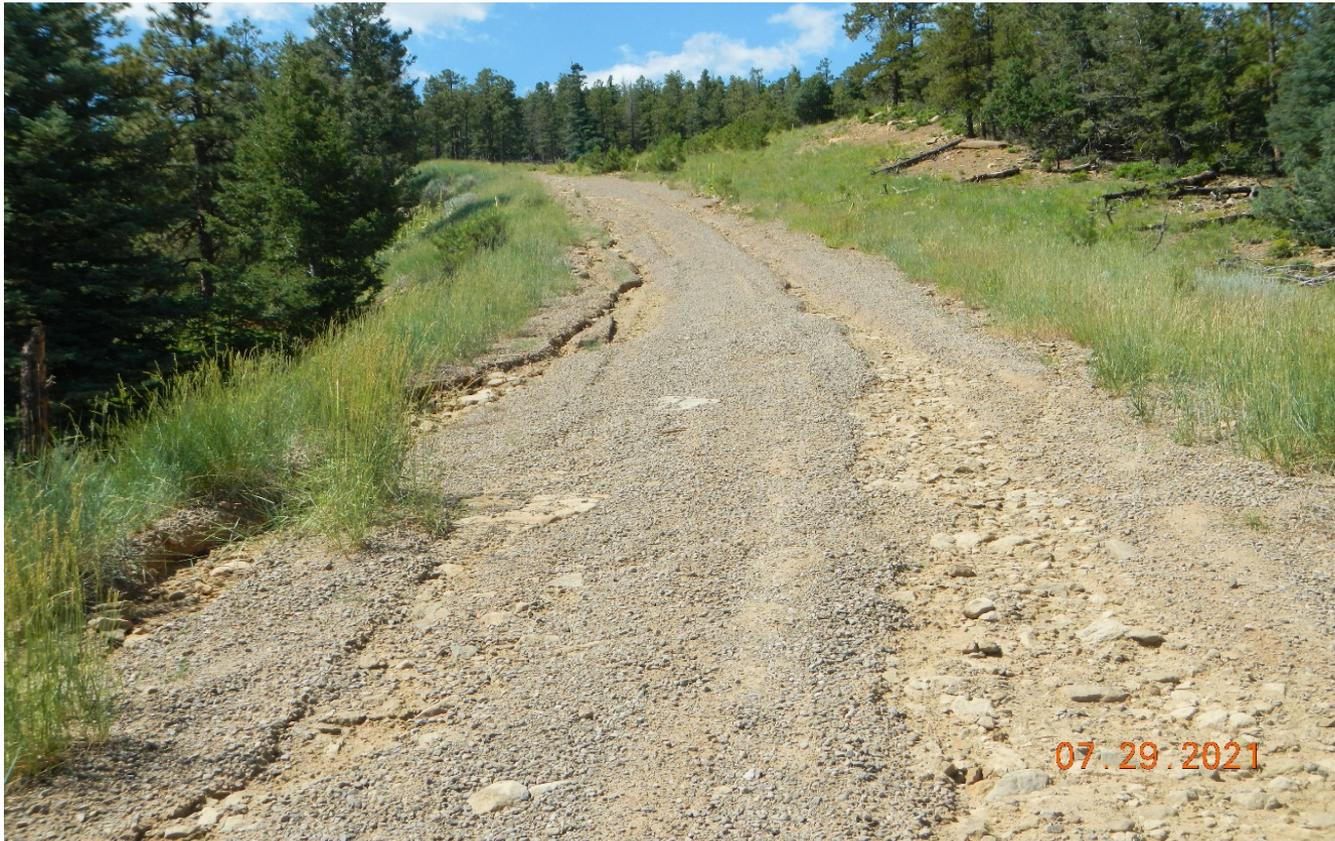
Photo 1. Facing southwest along the main road at Lat/Long:37.12487,-104.95788. There is erosion occurring down the road. Stormwater needs to be diverted off the road to prevent further erosion.

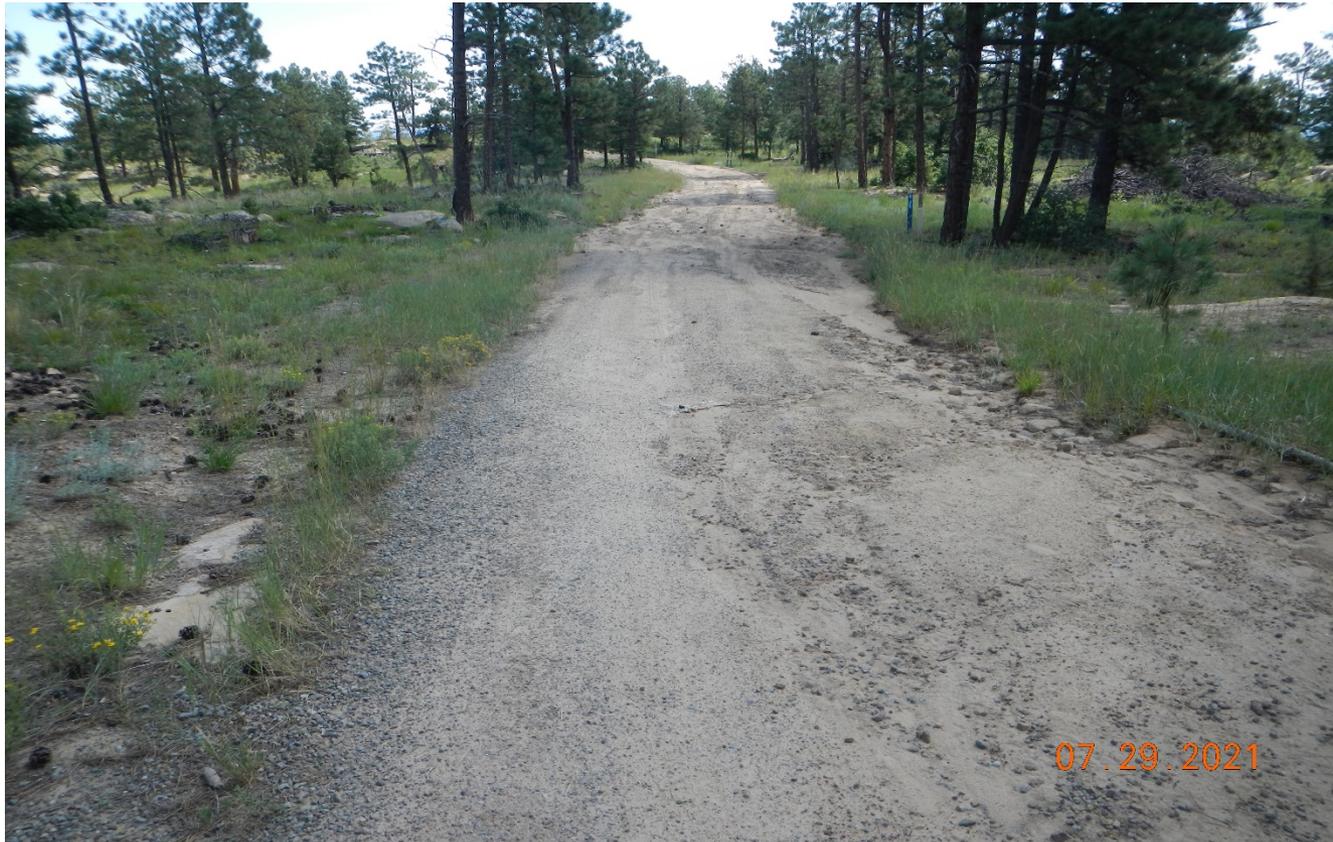
Photo 2. Facing northeast along the main road at Lat/Long:37.119485,-104.95374. There is erosion occurring down the road. Stormwater needs to be diverted off the road to prevent further erosion.

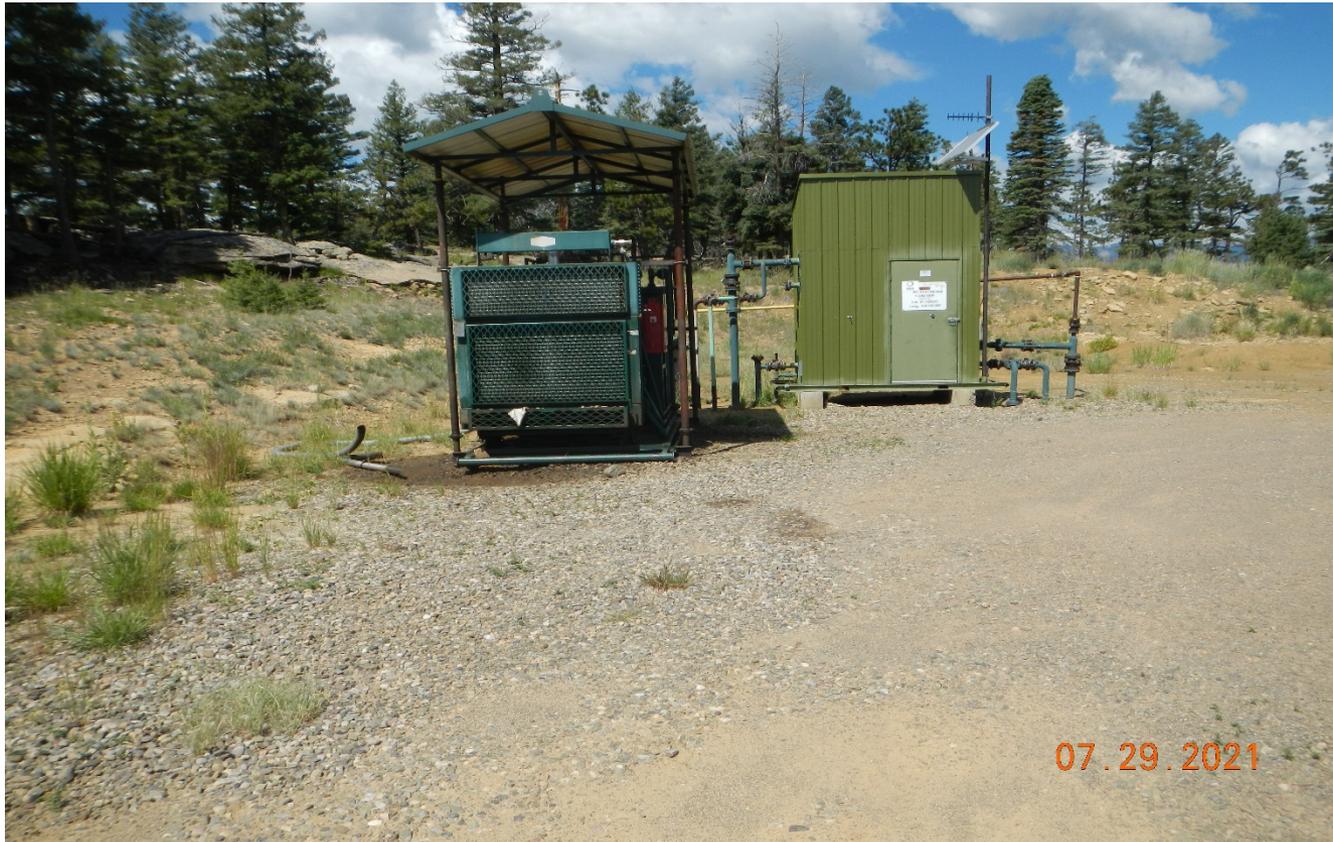
Photo 3. Facing west at the location.

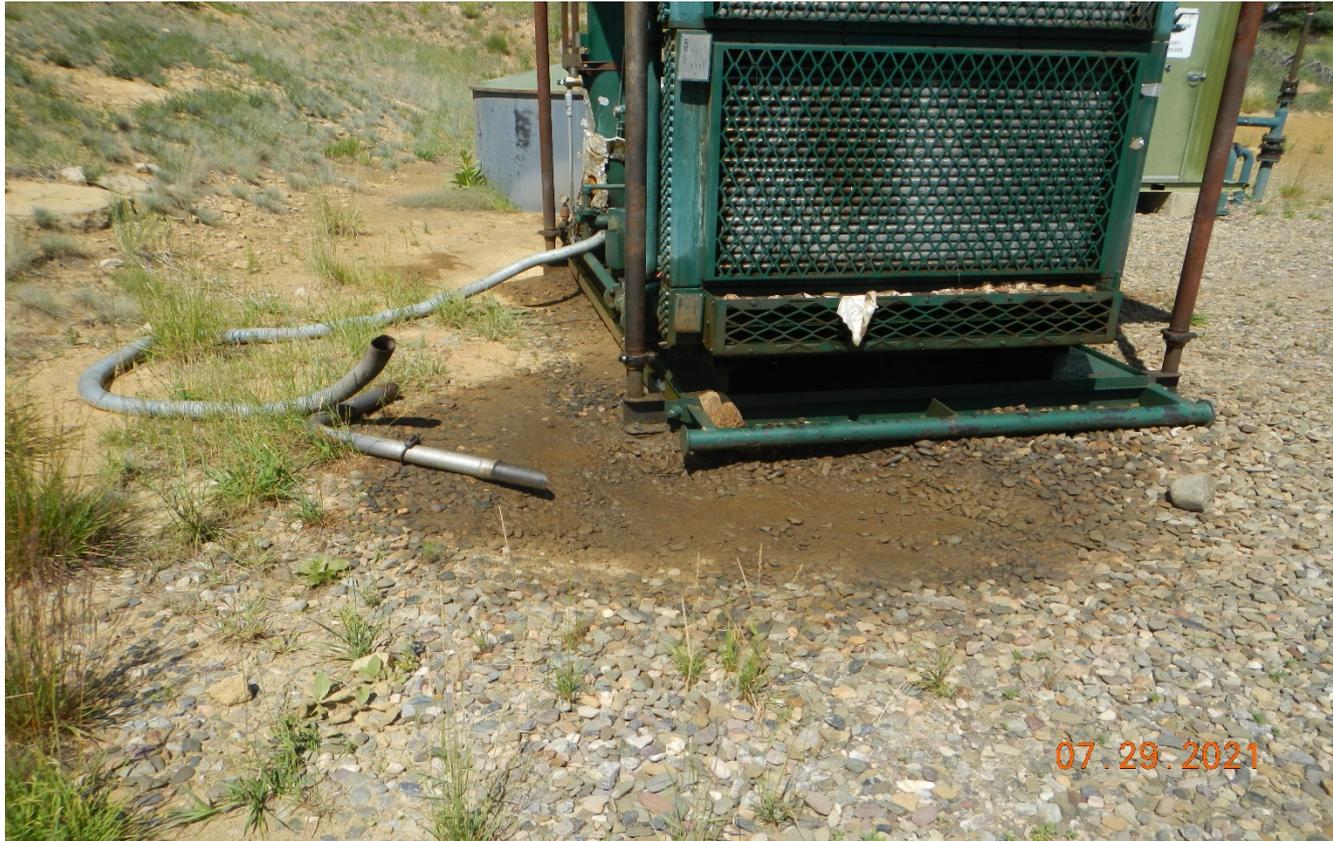
Photo 4. There is oil stained soils near the engine skid and oil inside the skid.

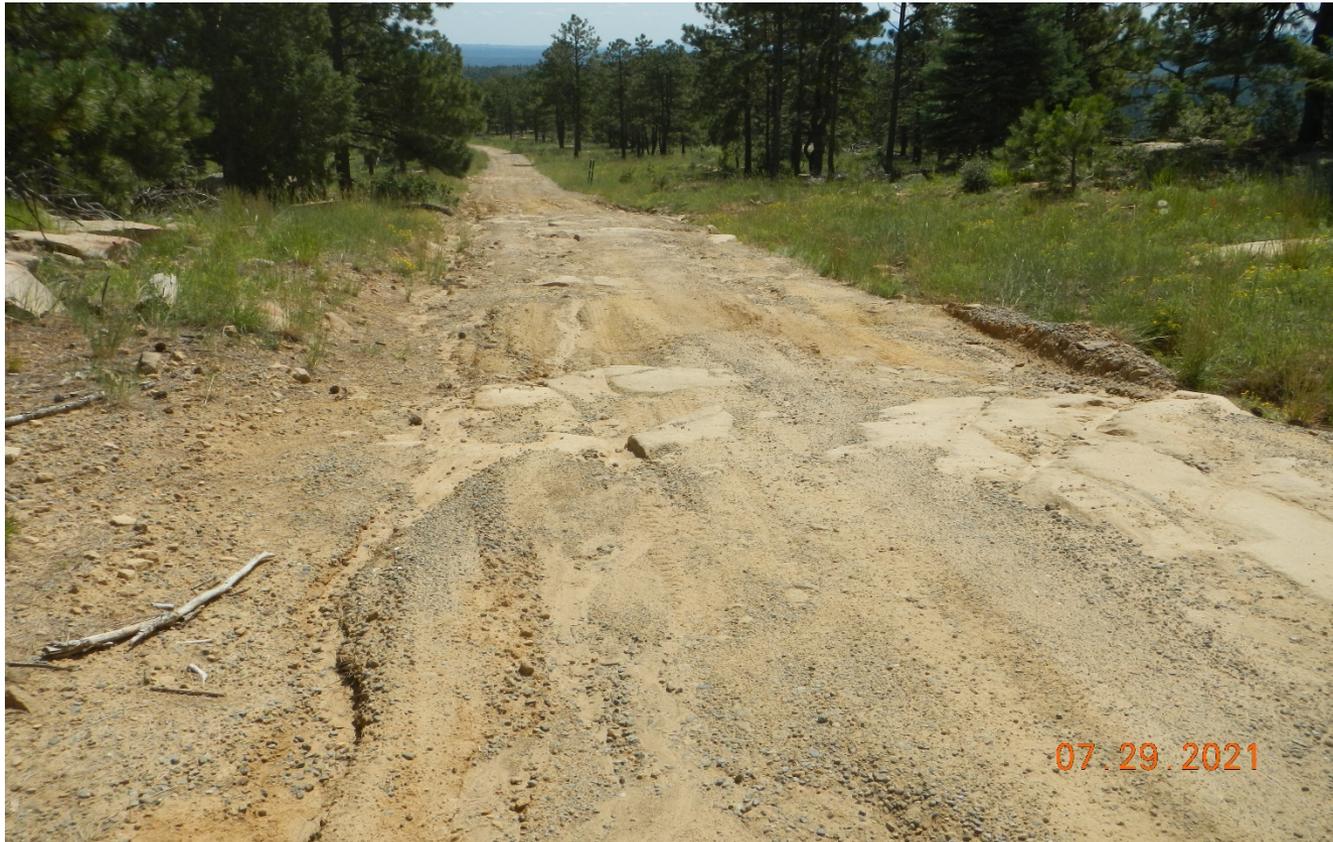
Photo 5. Traveling east along the main road near the location. This area has washed out and needs to be repaired.
