Inspection Photos
Operator: Simcoe
API: 067-08758
Date: 7/29/2021

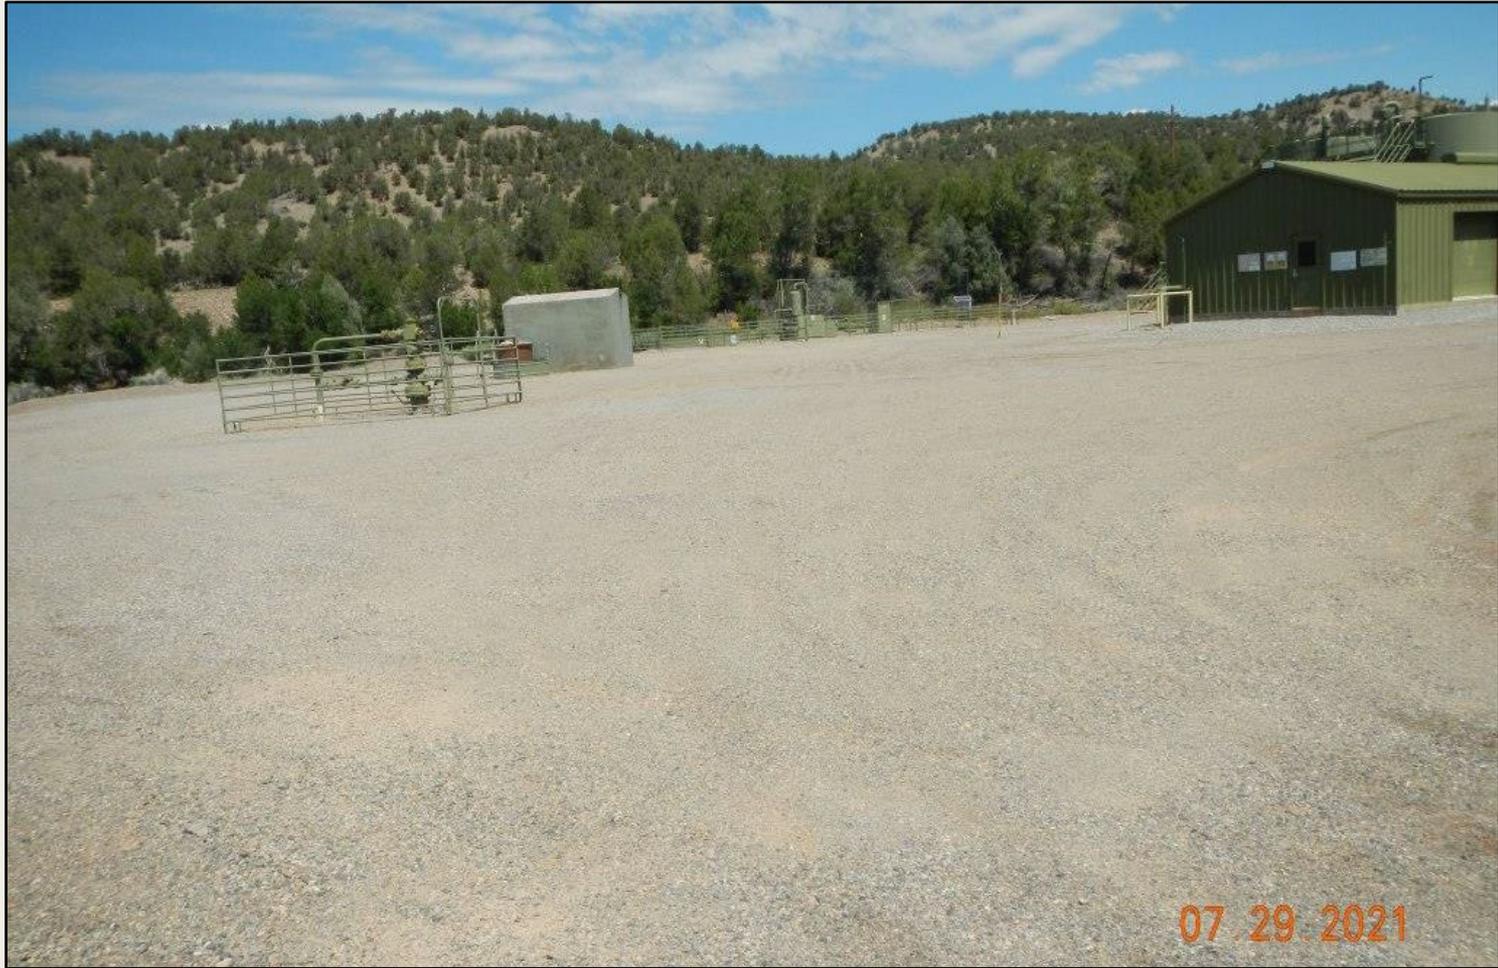
Photo 1. View of the project area from the well pad entrance facing center.

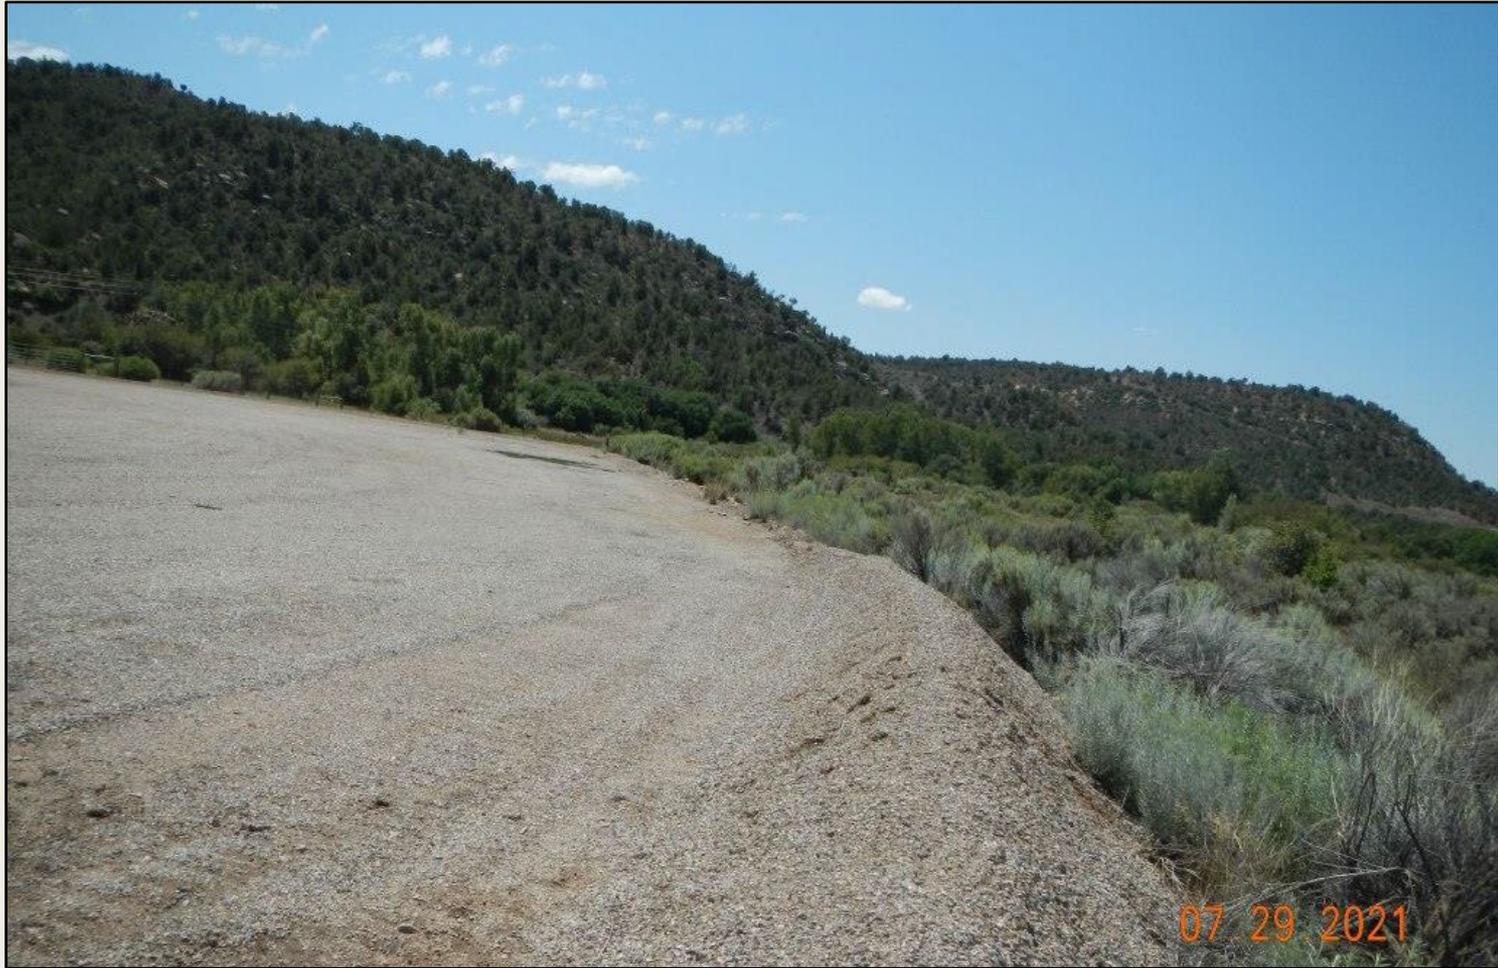
Photo 2. View of the western project area from the northwestern corner facing southward. Revegetation is progressing within the project area with crested wheatgrass, western wheatgrass, and rubber rabbitbrush.

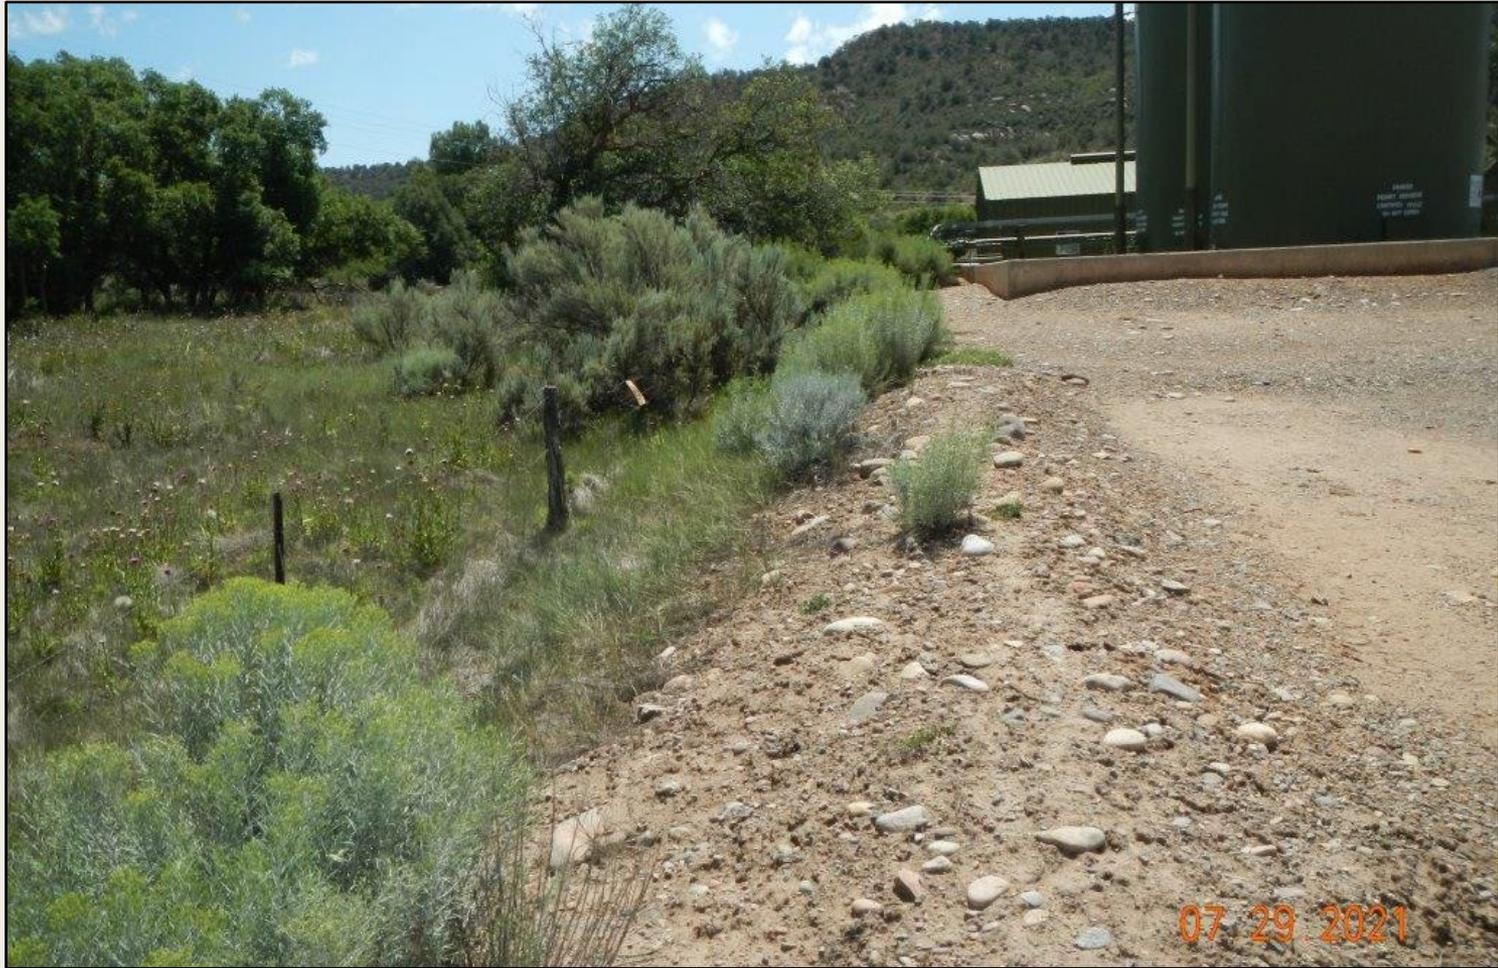
Photo 3. View of the eastern project area from the northeastern corner facing southward.

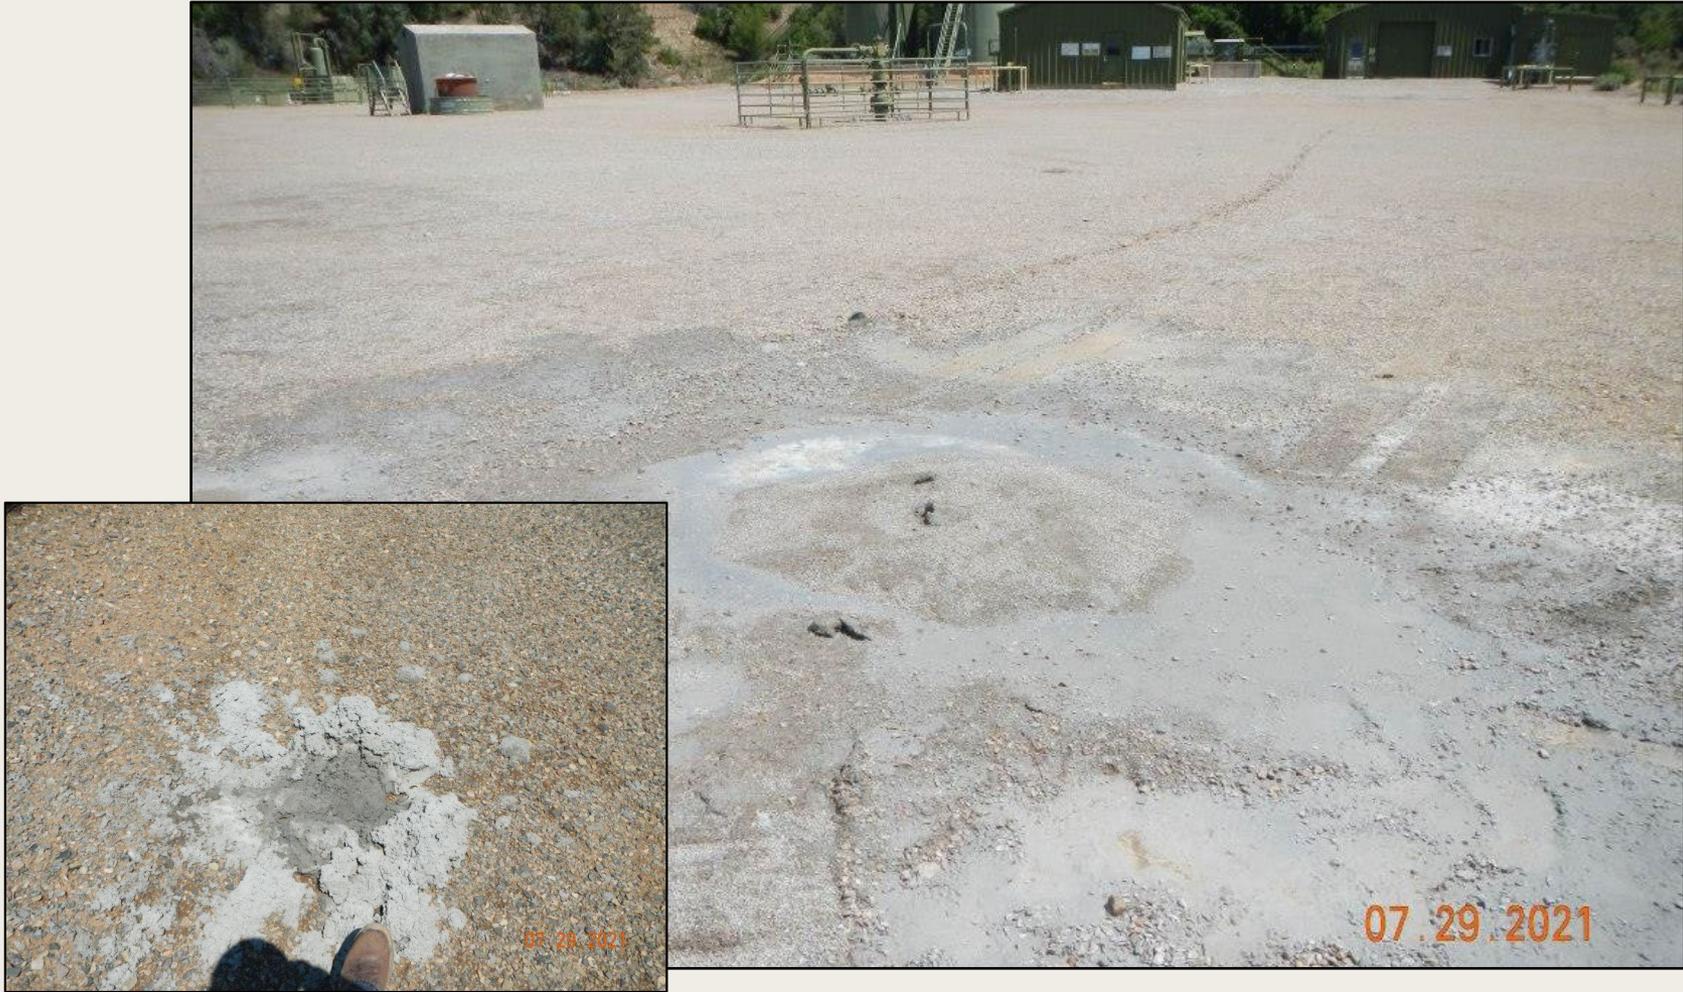
Photo 4. View of cement washout and debris in the southwestern well pad and in the southeastern well pad (inset). Needs to be removed and properly disposed of.

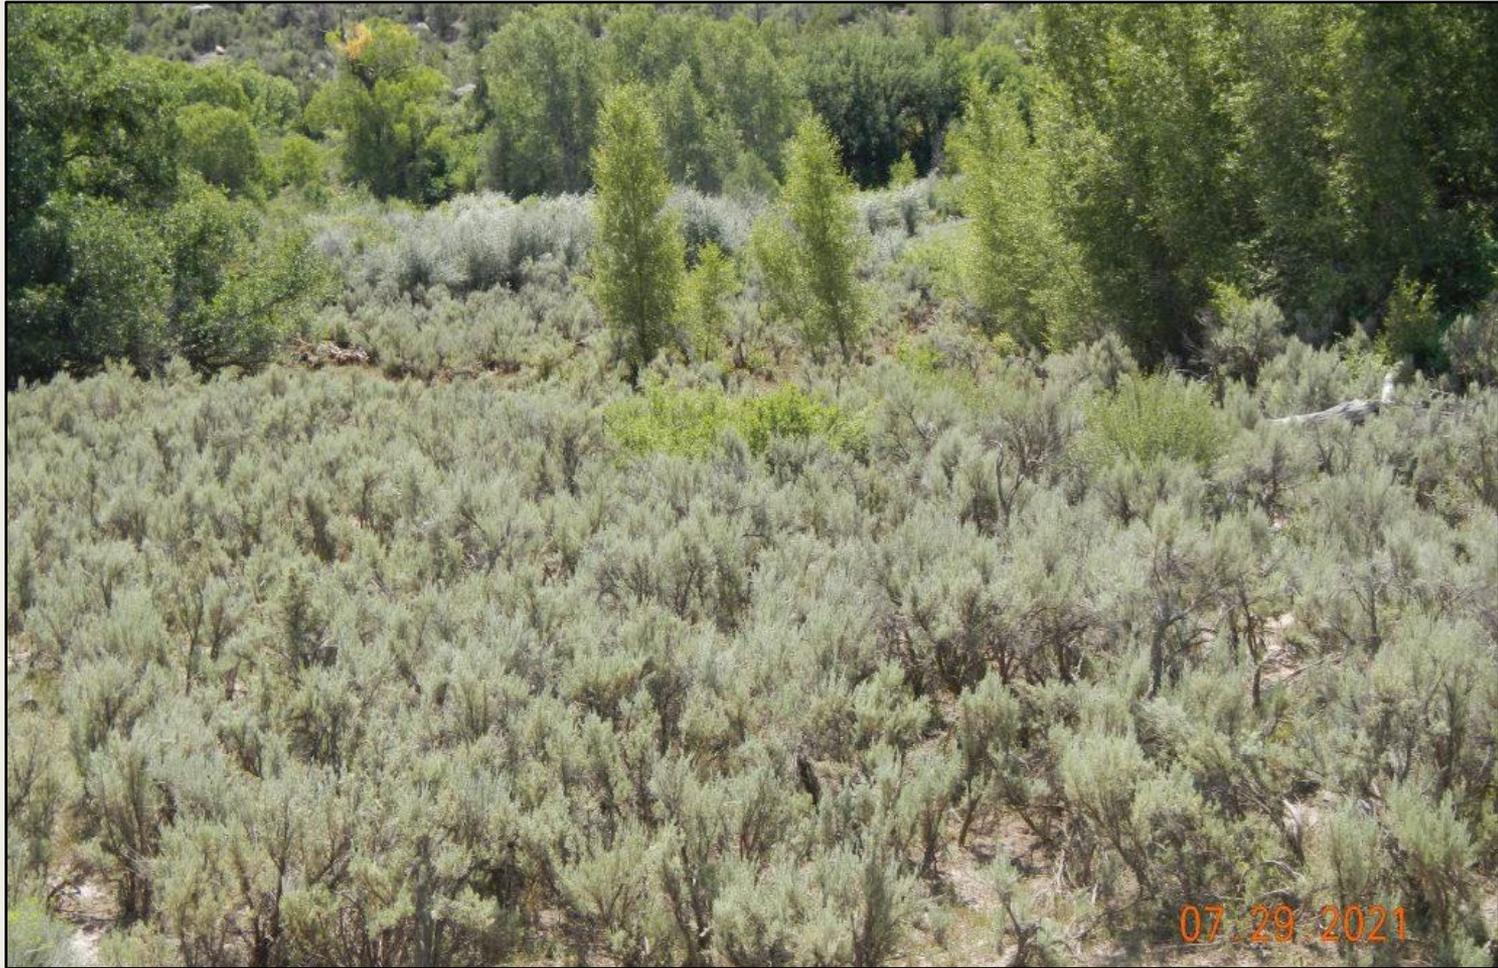
Photo 5. View of the reference area comprised of sagebrush shrubland, gambel oak, and cottonwood riparian mosaic in a cobble floodplain with western wheatgrass and goldenaster.
