Inspection Photos
Operator: Simcoe
API: 067-09683
Date: 7/29/2021

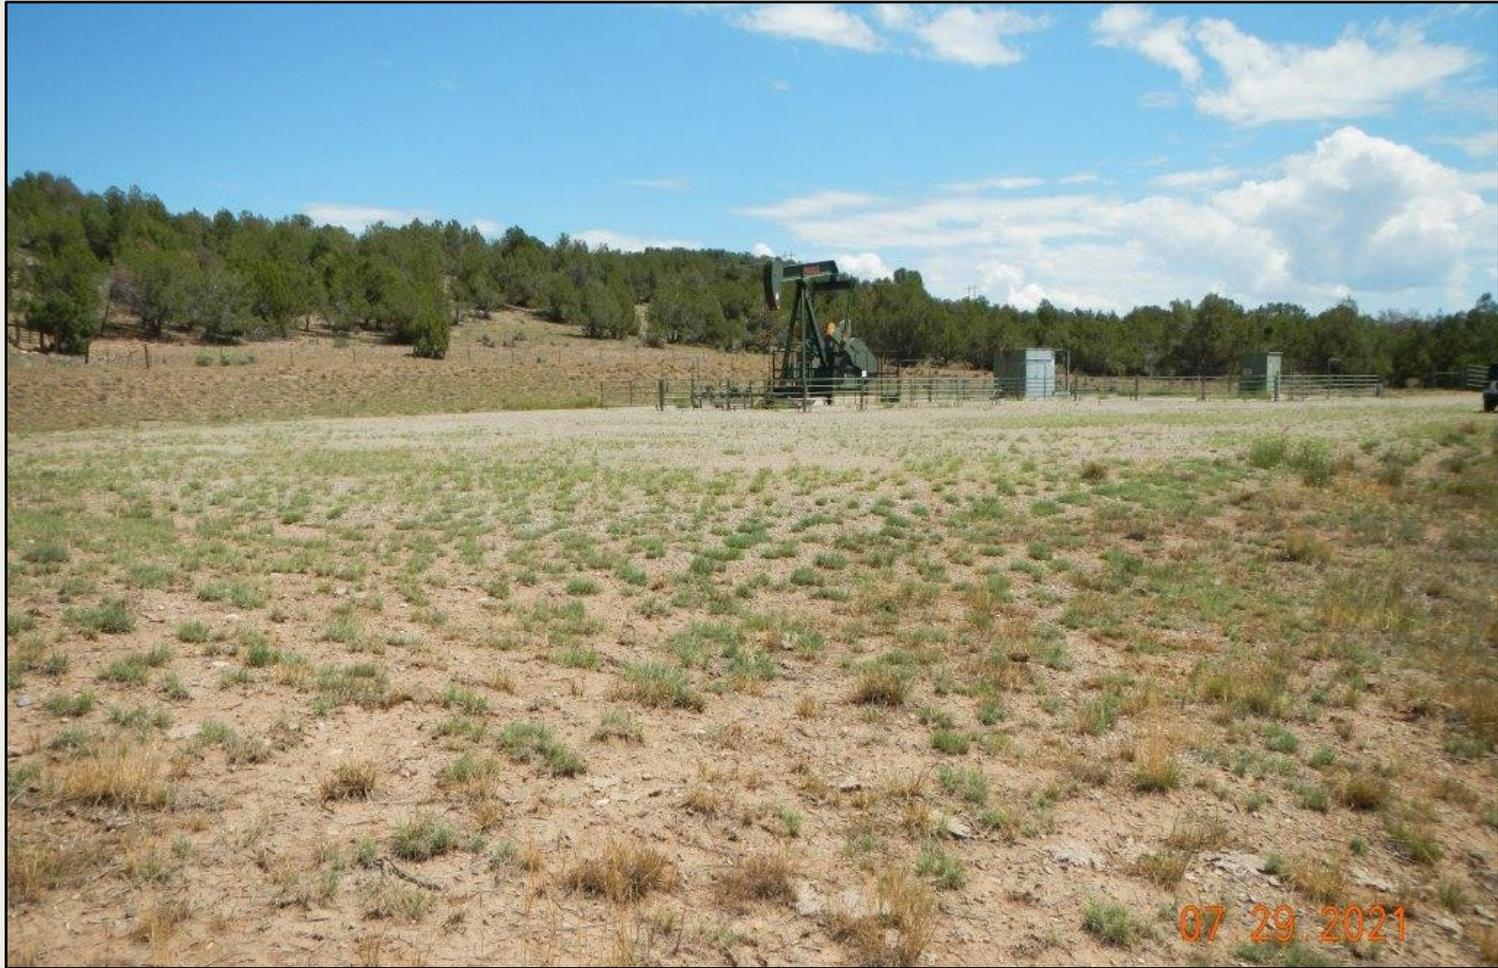
Photo 1. View of the project area from the southwestern corner facing center.

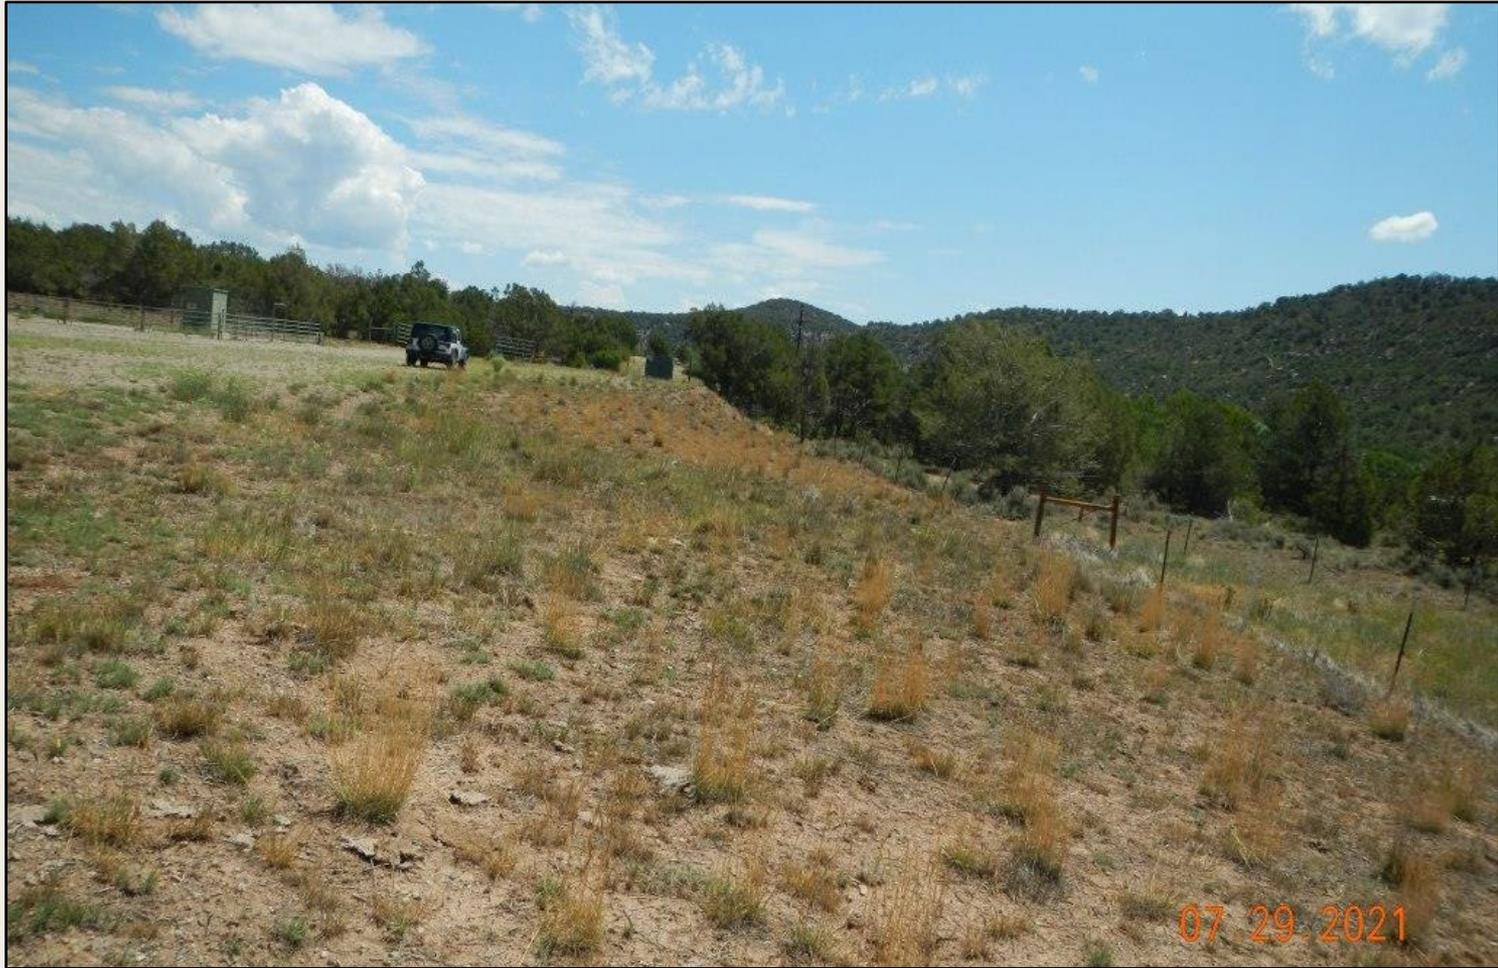
Photo 2. View of the southern project area from the southwestern corner facing eastward. Revegetation is progressing within the project area with crested wheatgrass, western wheatgrass, and James galleta.

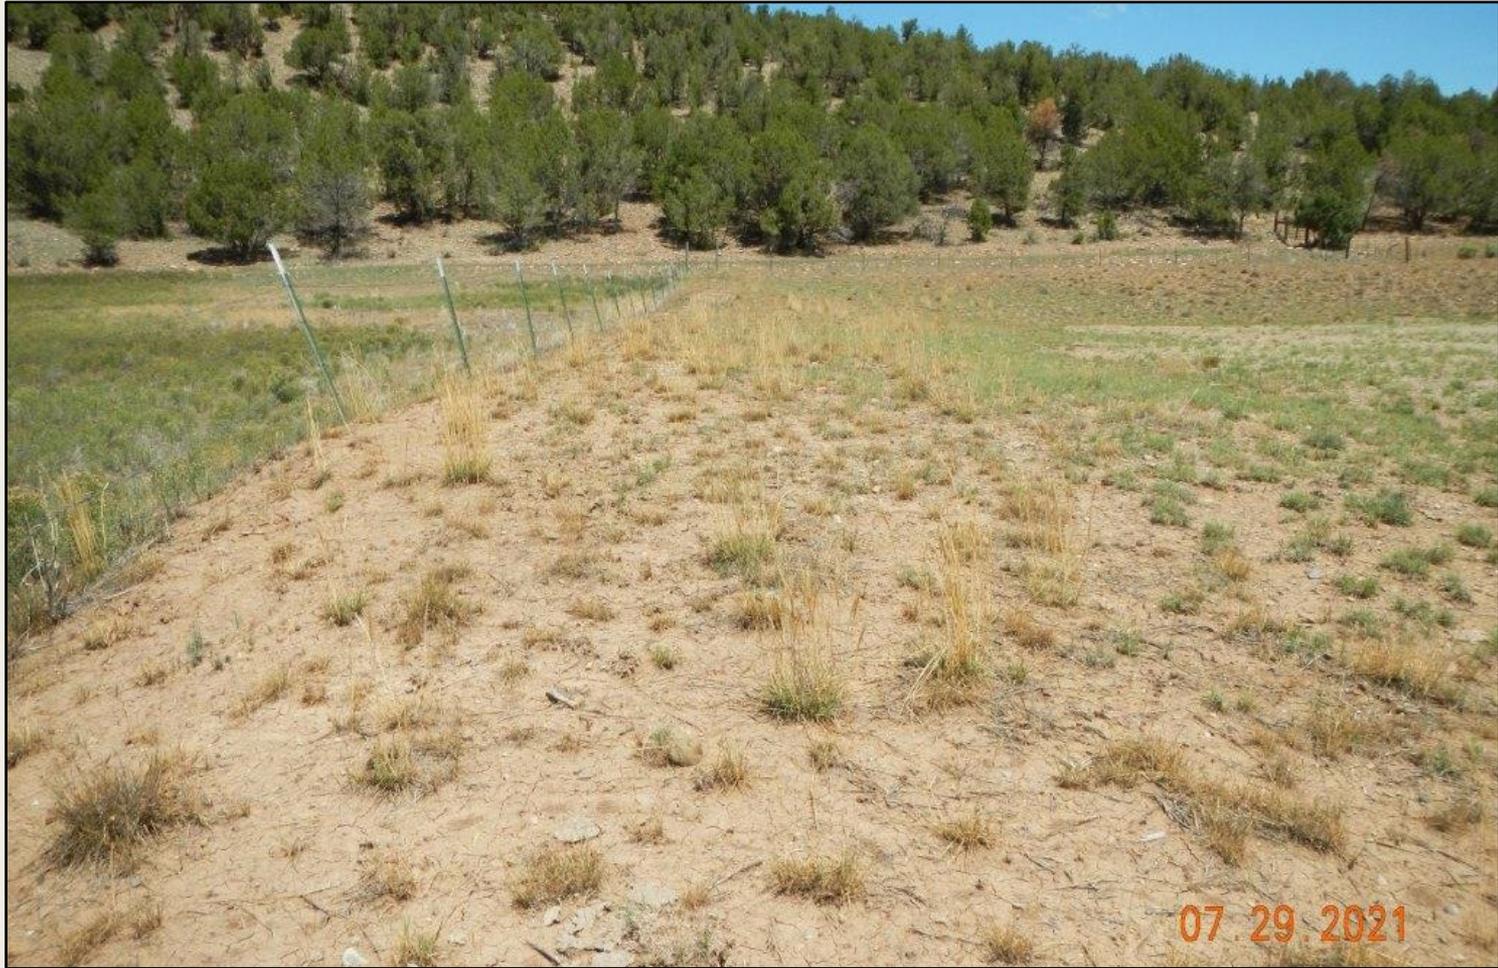
Photo 3. View of the eastern project area from the northeastern corner facing southward.

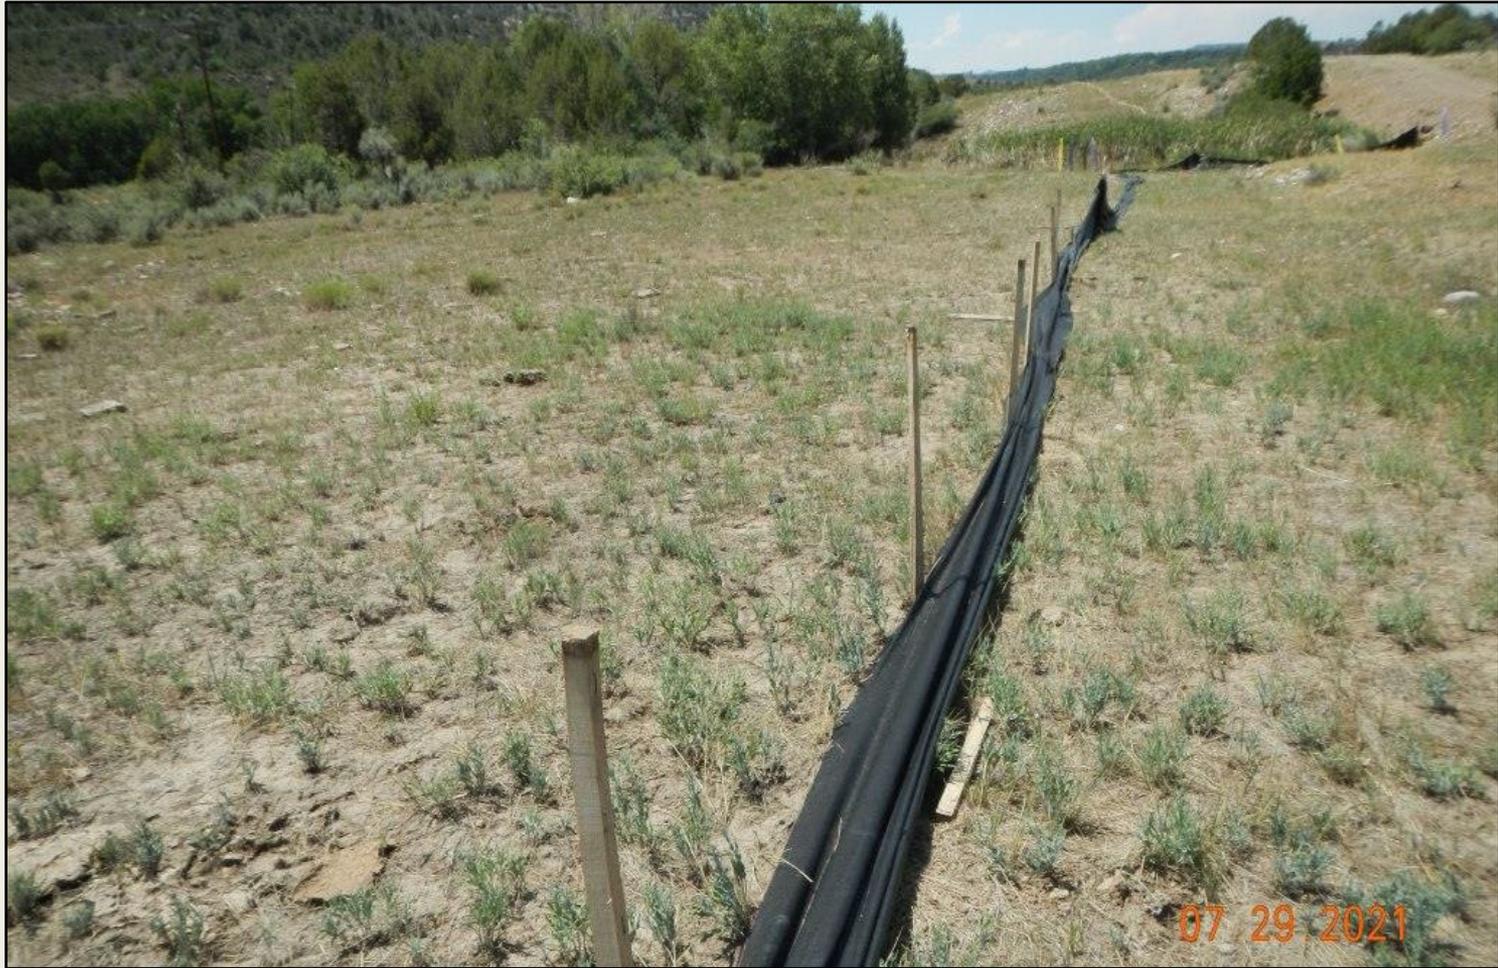
Photo 4. View of silt fence along the flowline right of way that is fallen, and no longer functioning.

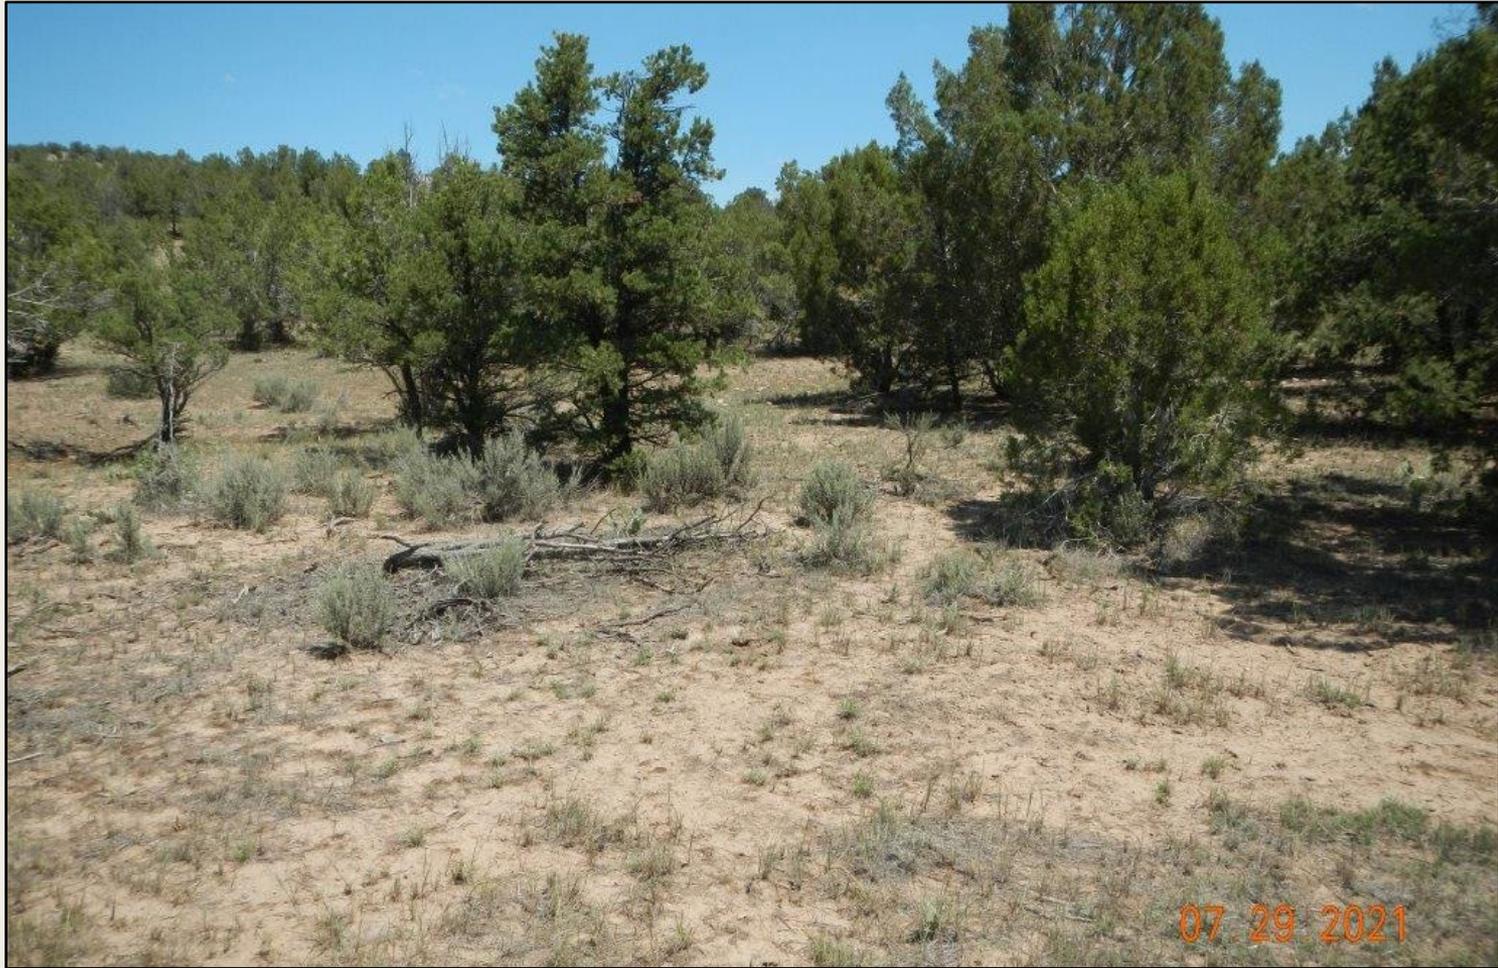
Photo 5. View of the reference area comprised of open pinyon and juniper woodland with understory of sagebrush, James galleta, penstemon, squirreltail and western wheatgrass.
