Inspection Photos
Operator: Logos
API: 067-05521
Date: 7/29/2021

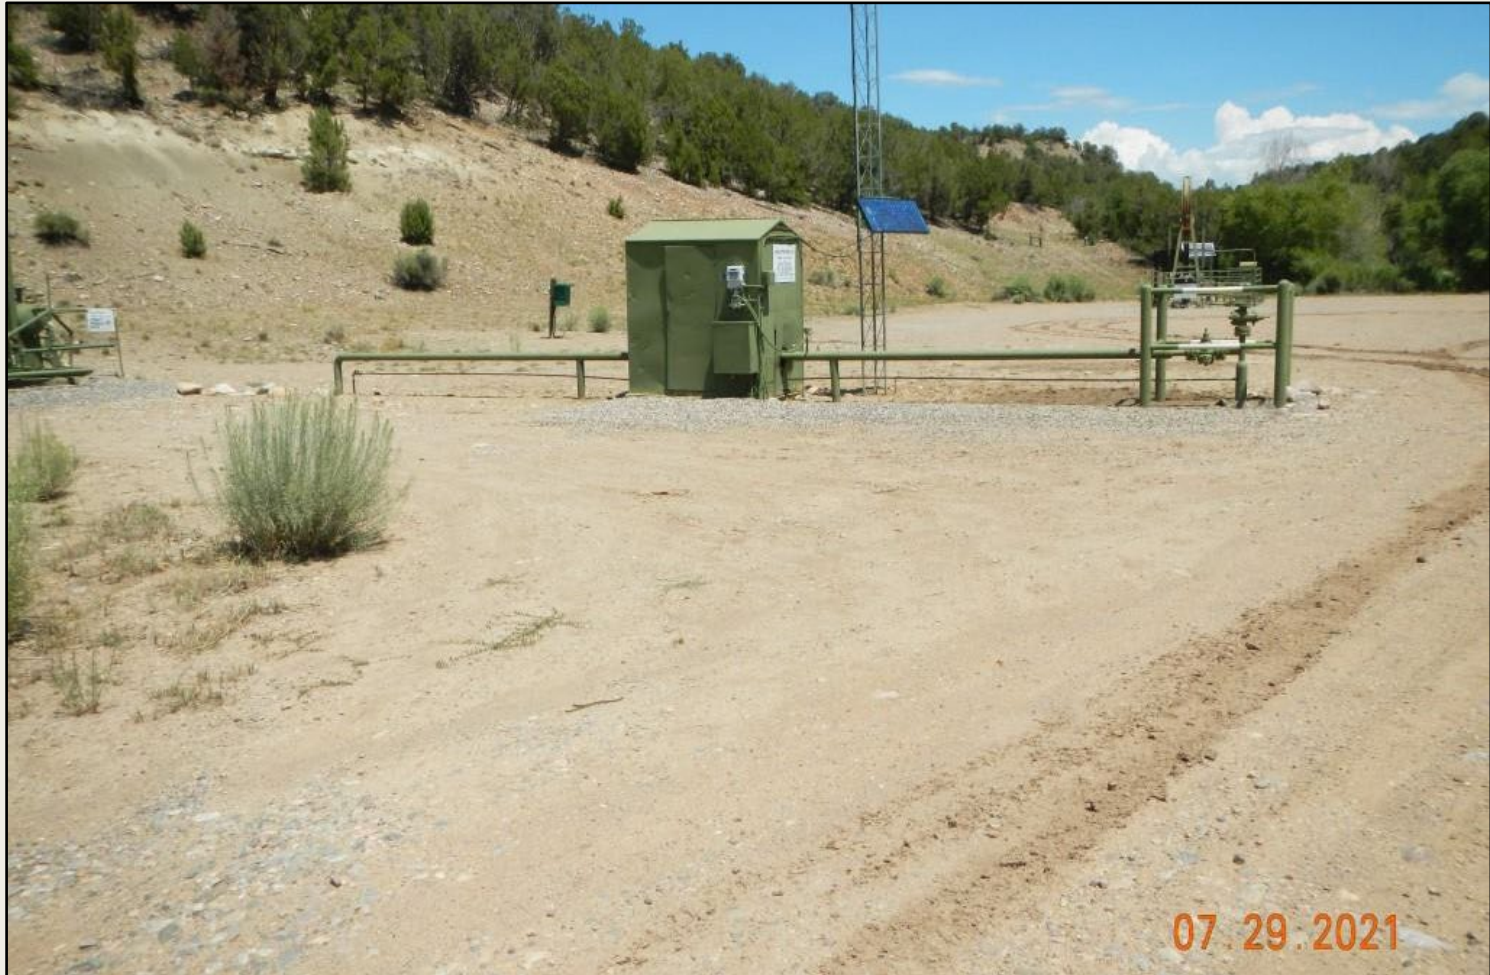
Photo 1. View of the project area from the well pad entrance facing center.

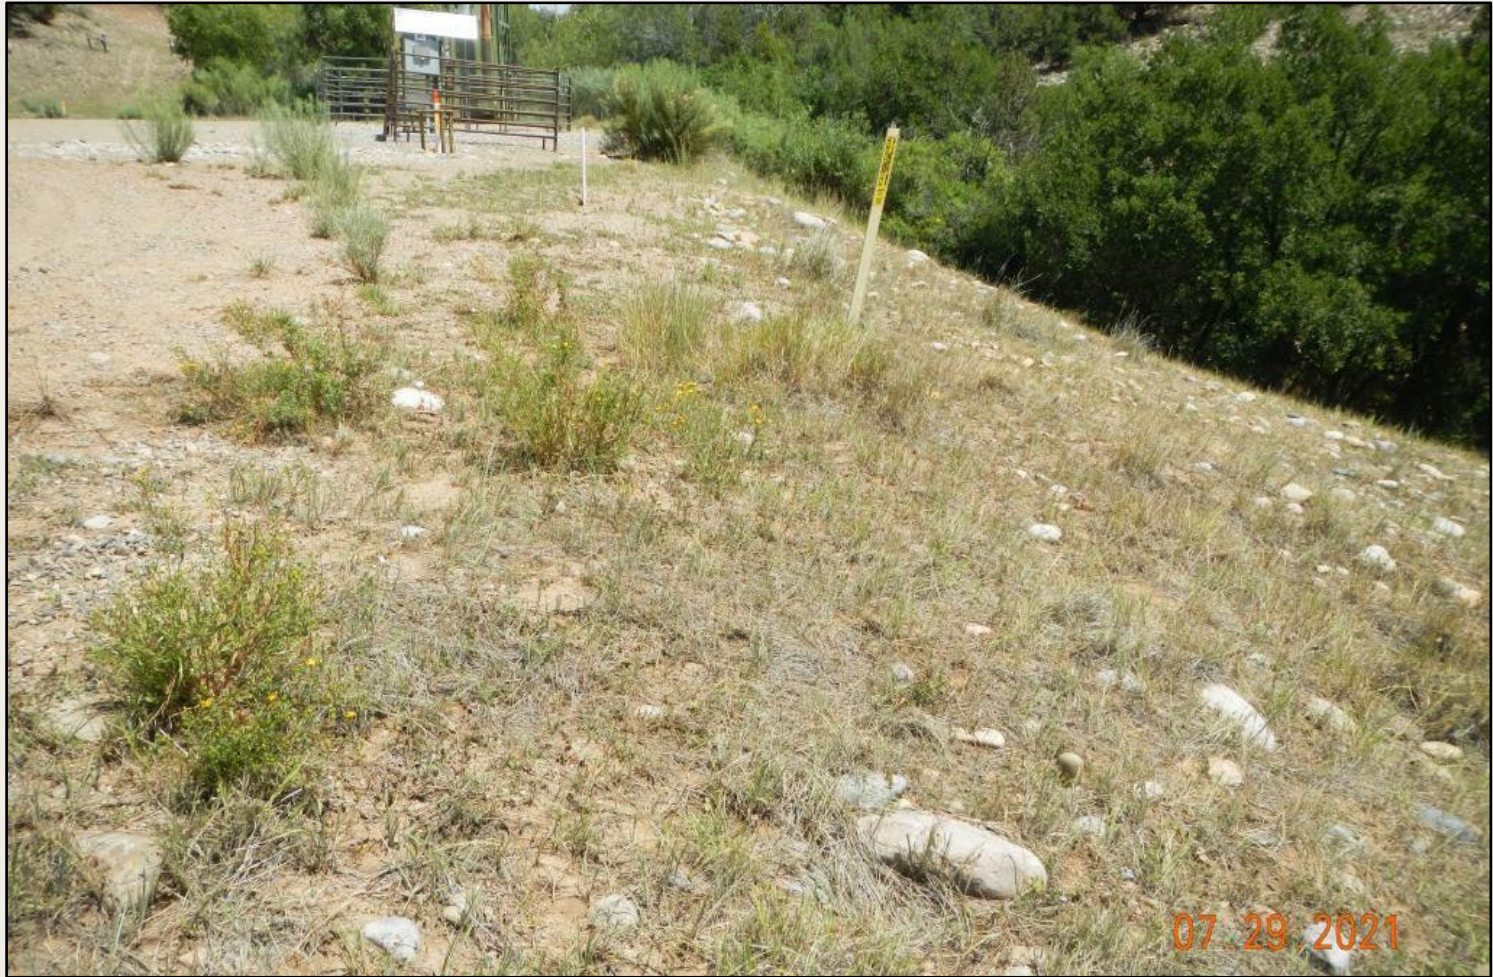
Photo 2. View of the southern project area from the southwestern corner facing eastward. Revegetation is progressing within the project area with crested wheatgrass, western wheatgrass, and Arizona gumweed.

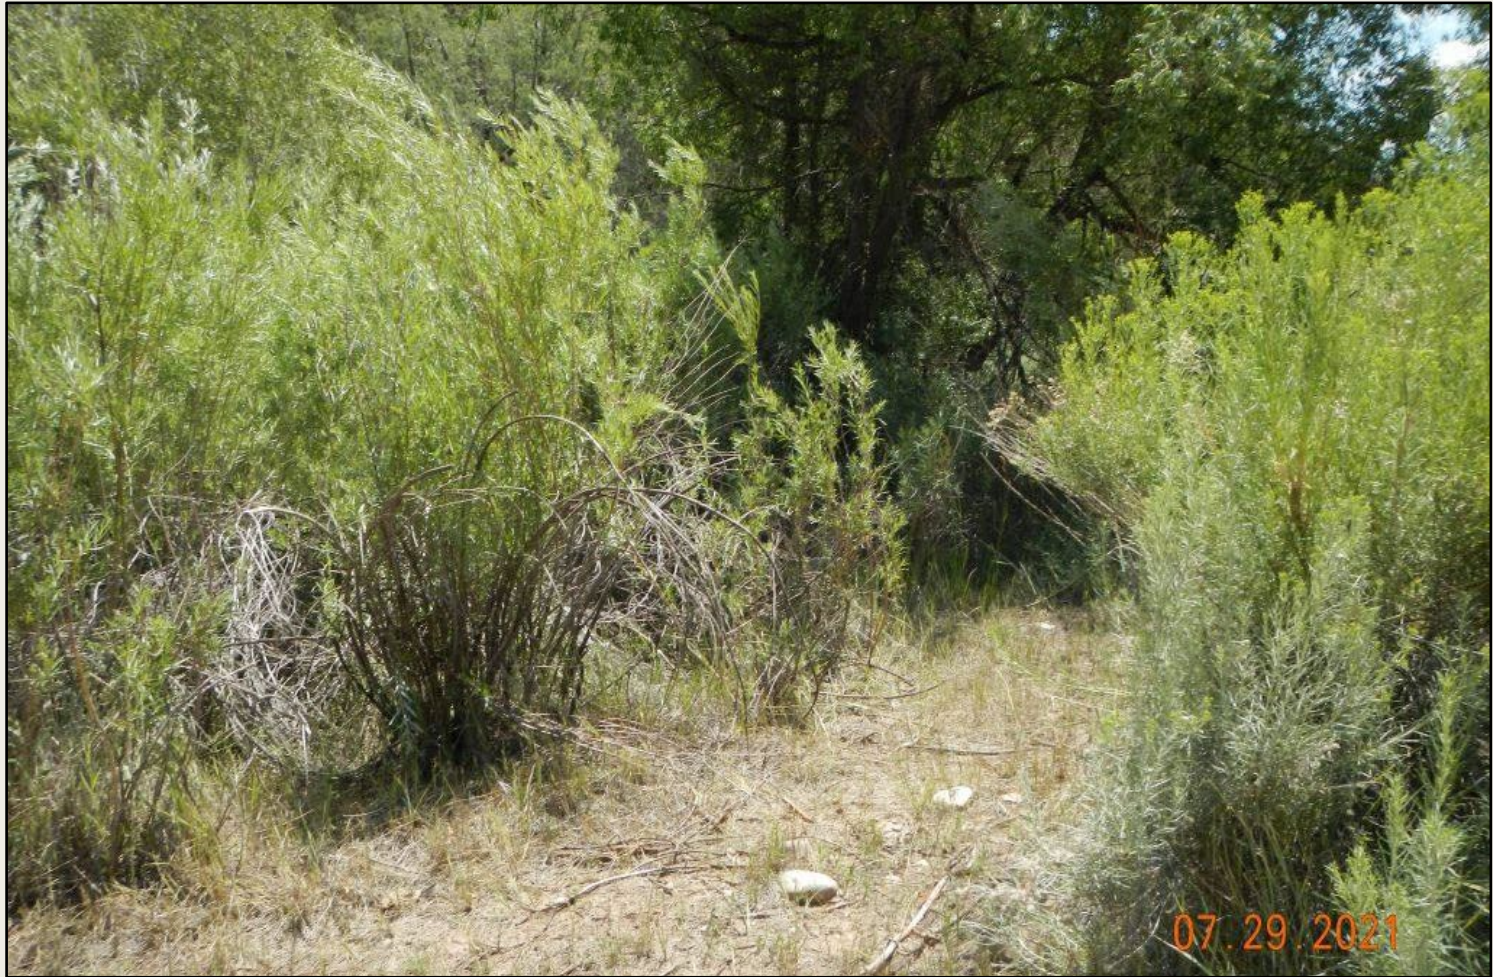
Photo 3. View of the eastern project area from the northeastern corner facing southward. Willows and cottonwoods are becoming established here.

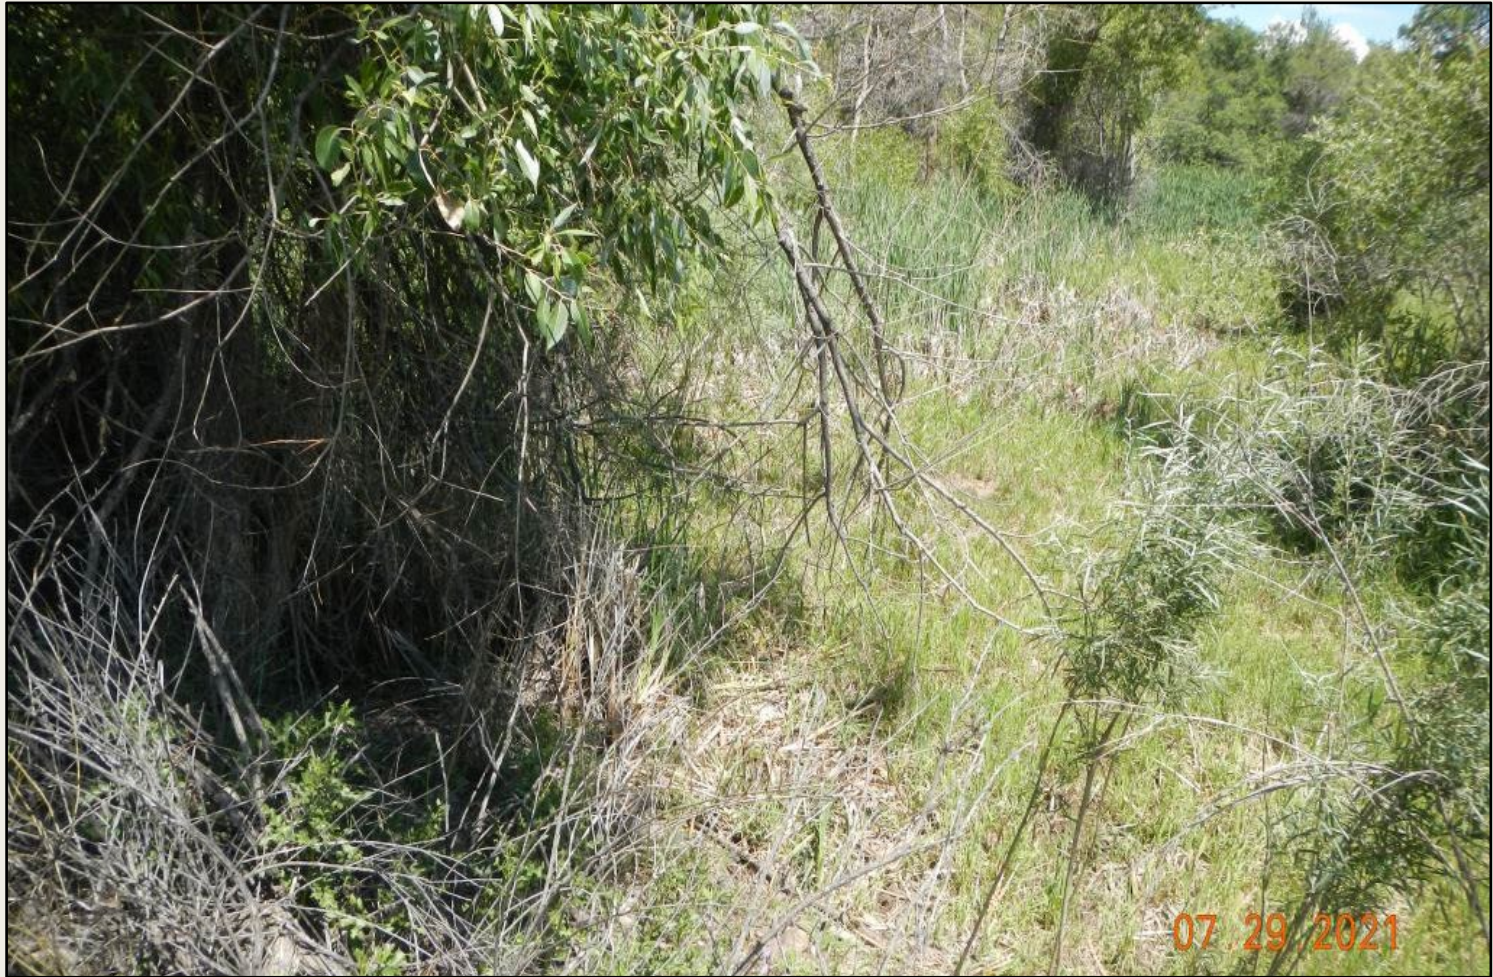
Photo 4. View of the reference area comprised of riparian and wetland vegetation with narrowleaf cottonwood, sandbar willows, cattails, smooth brome, and foxtail barley.

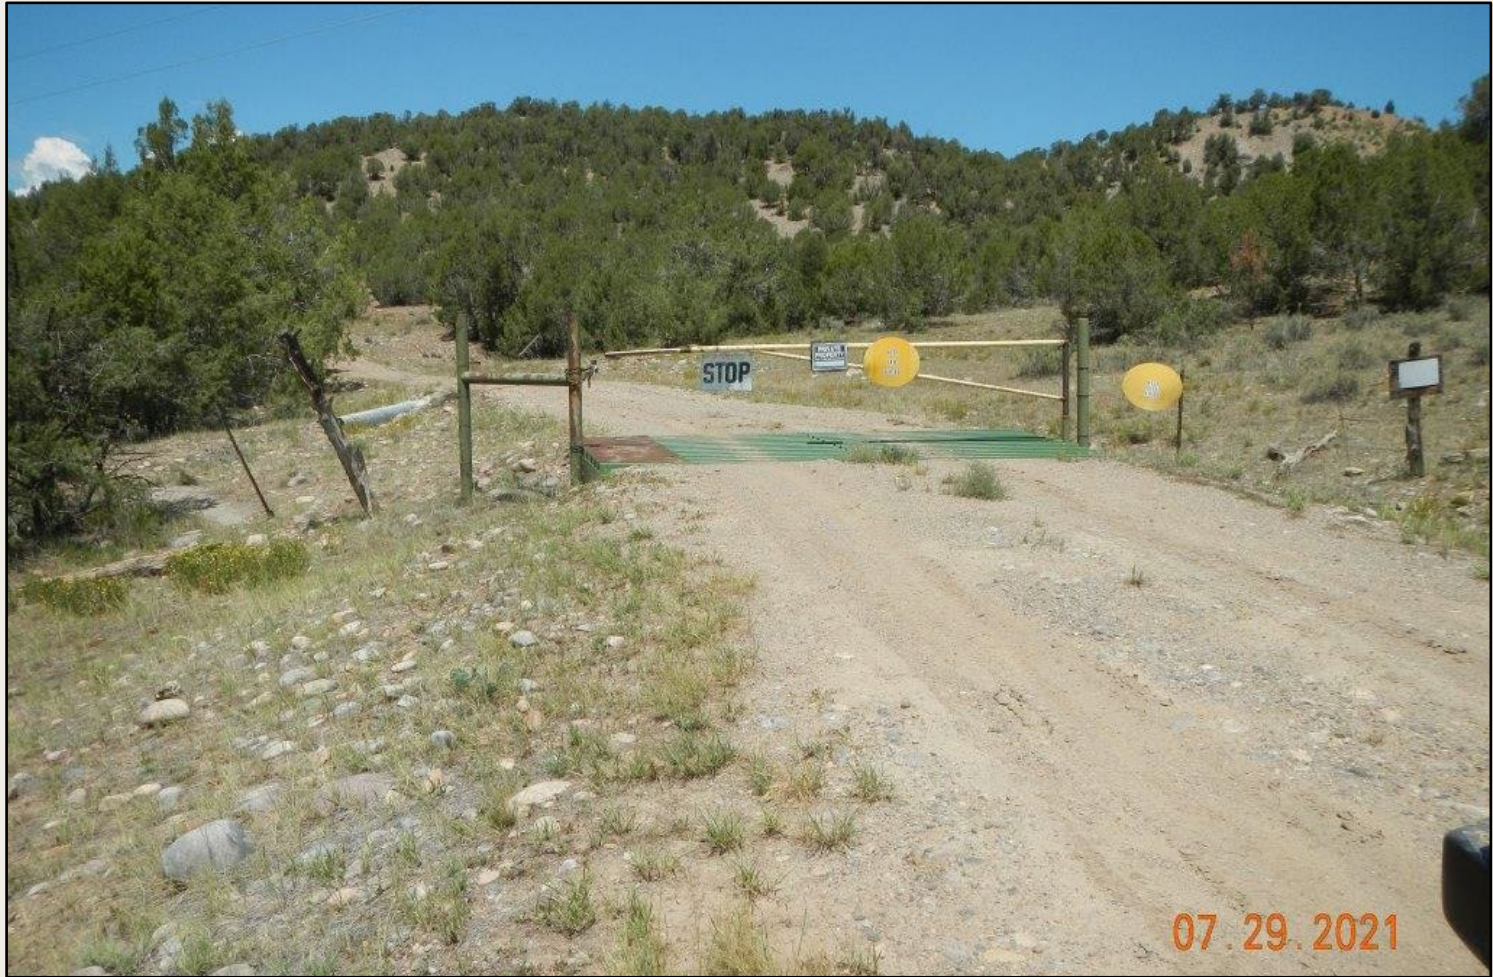
Photo 5. View of closed gate after leaving location.
