Inspection Photos
Operator: Simcoe
API: 067-07609
Date: 7/29/2021

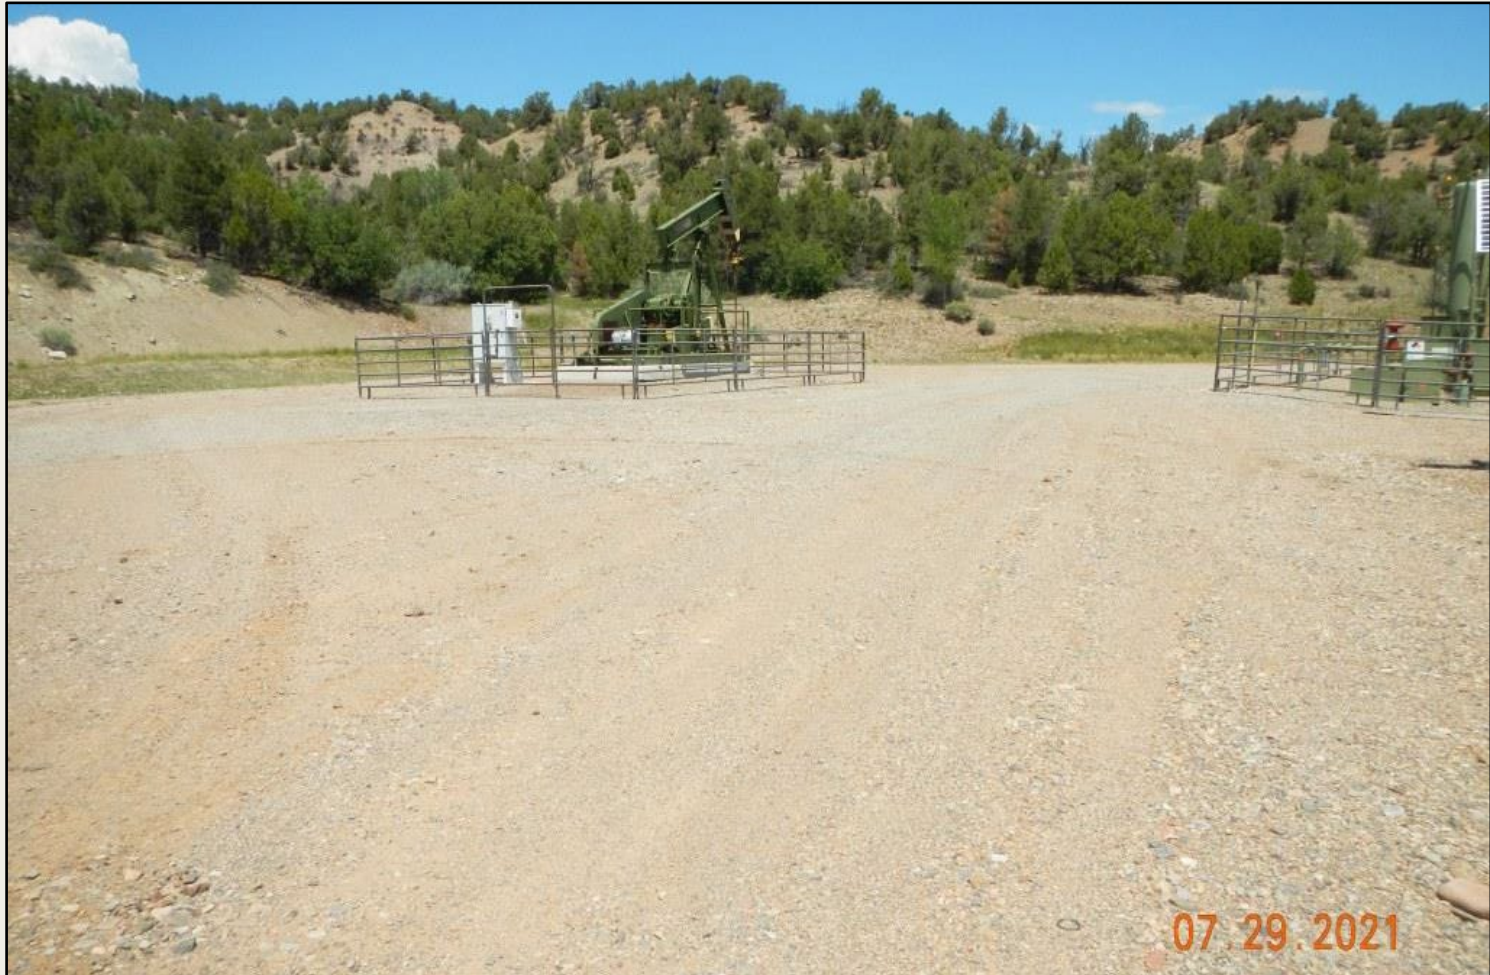
Photo 1. View of the project area from the well pad entrance facing center.

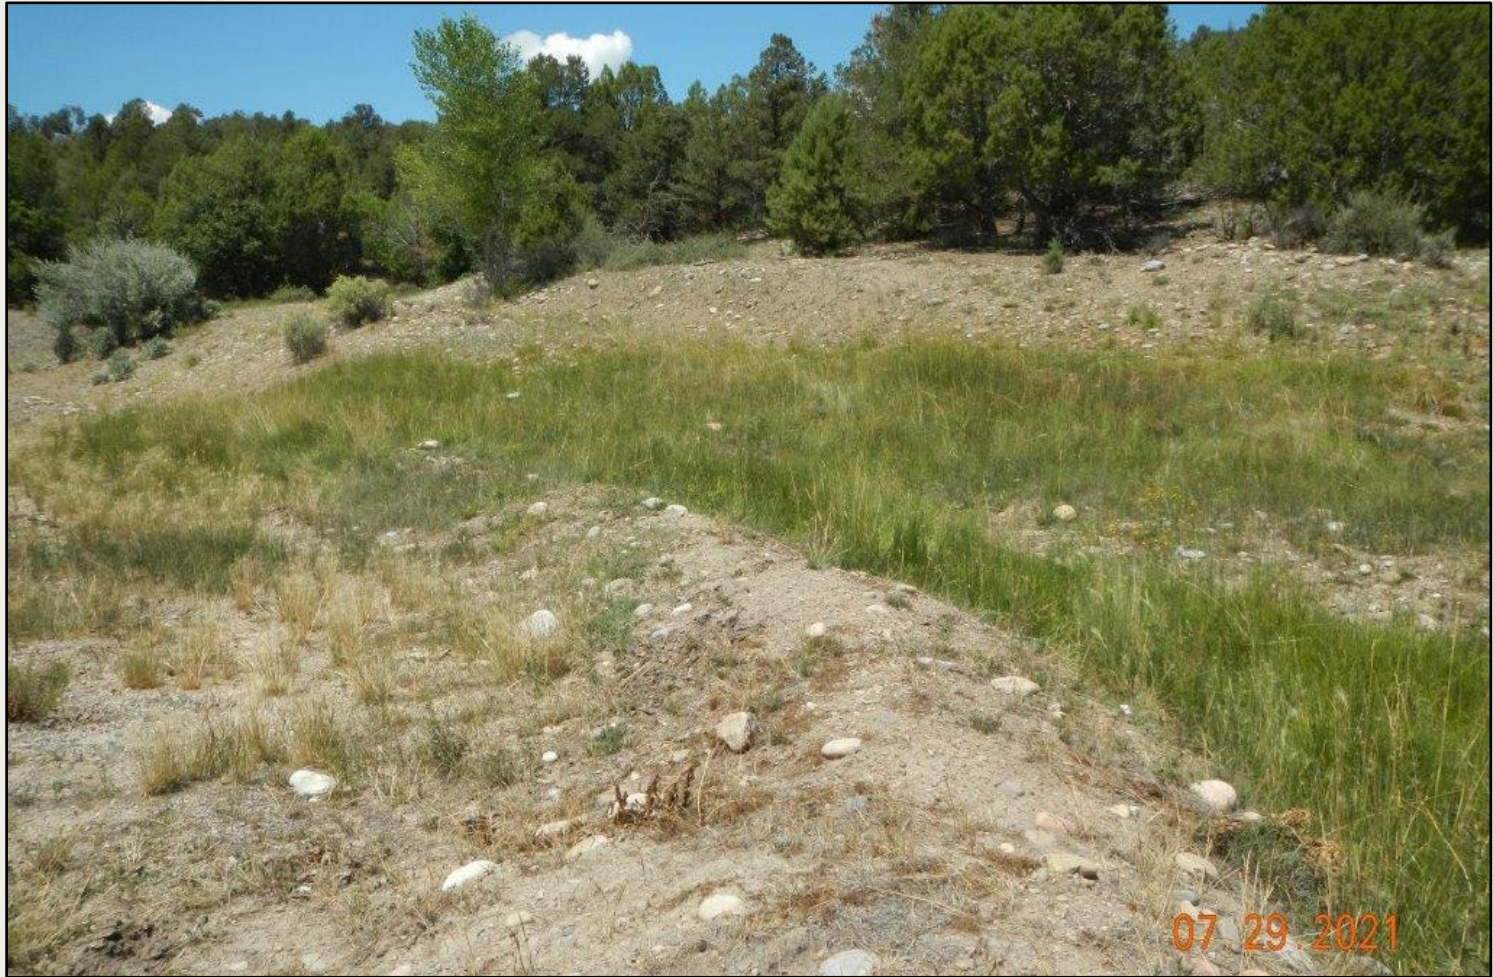
Photo 2. View of the eastern project area from the southeastern corner facing northward. Revegetation is progressing here with western wheatgrass, crested wheatgrass, and foxtail barley.

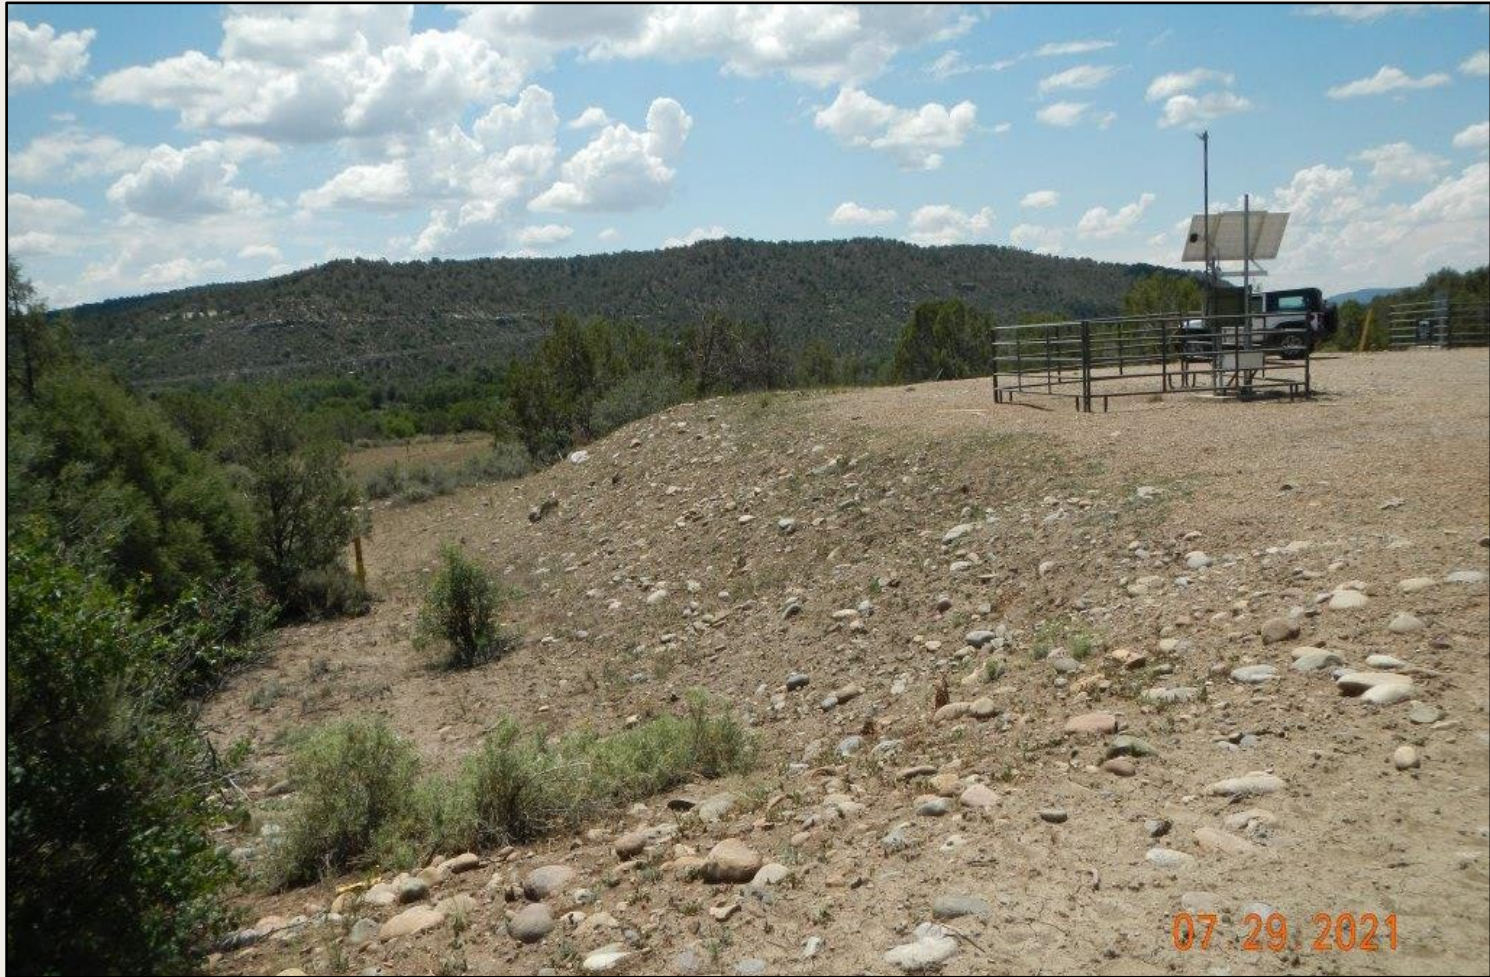
Photo 3. View of the southern project area from the southeastern corner facing southward. Vegetation here is grazed and sparse. Stormwater BMPs need to be installed and maintained until slope is stabilized.

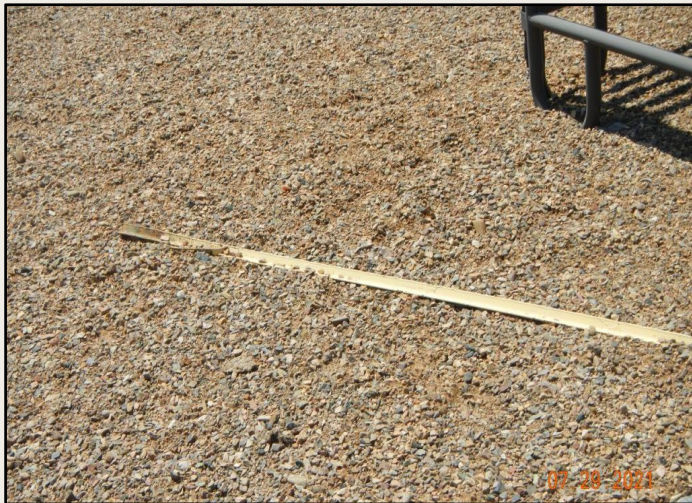
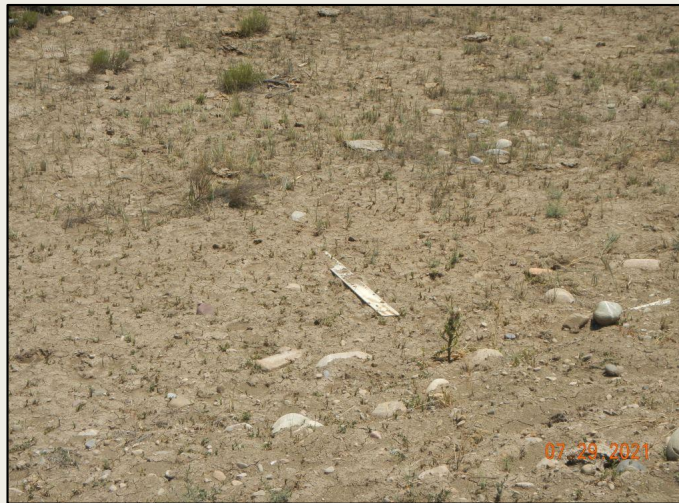
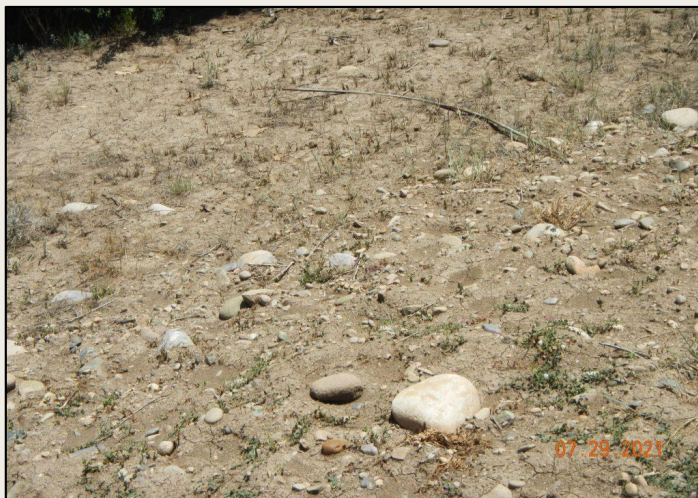
Photo 4. View of small pieces of marker debris a wires scattered around the well pad. At least 10 pieces were observed.

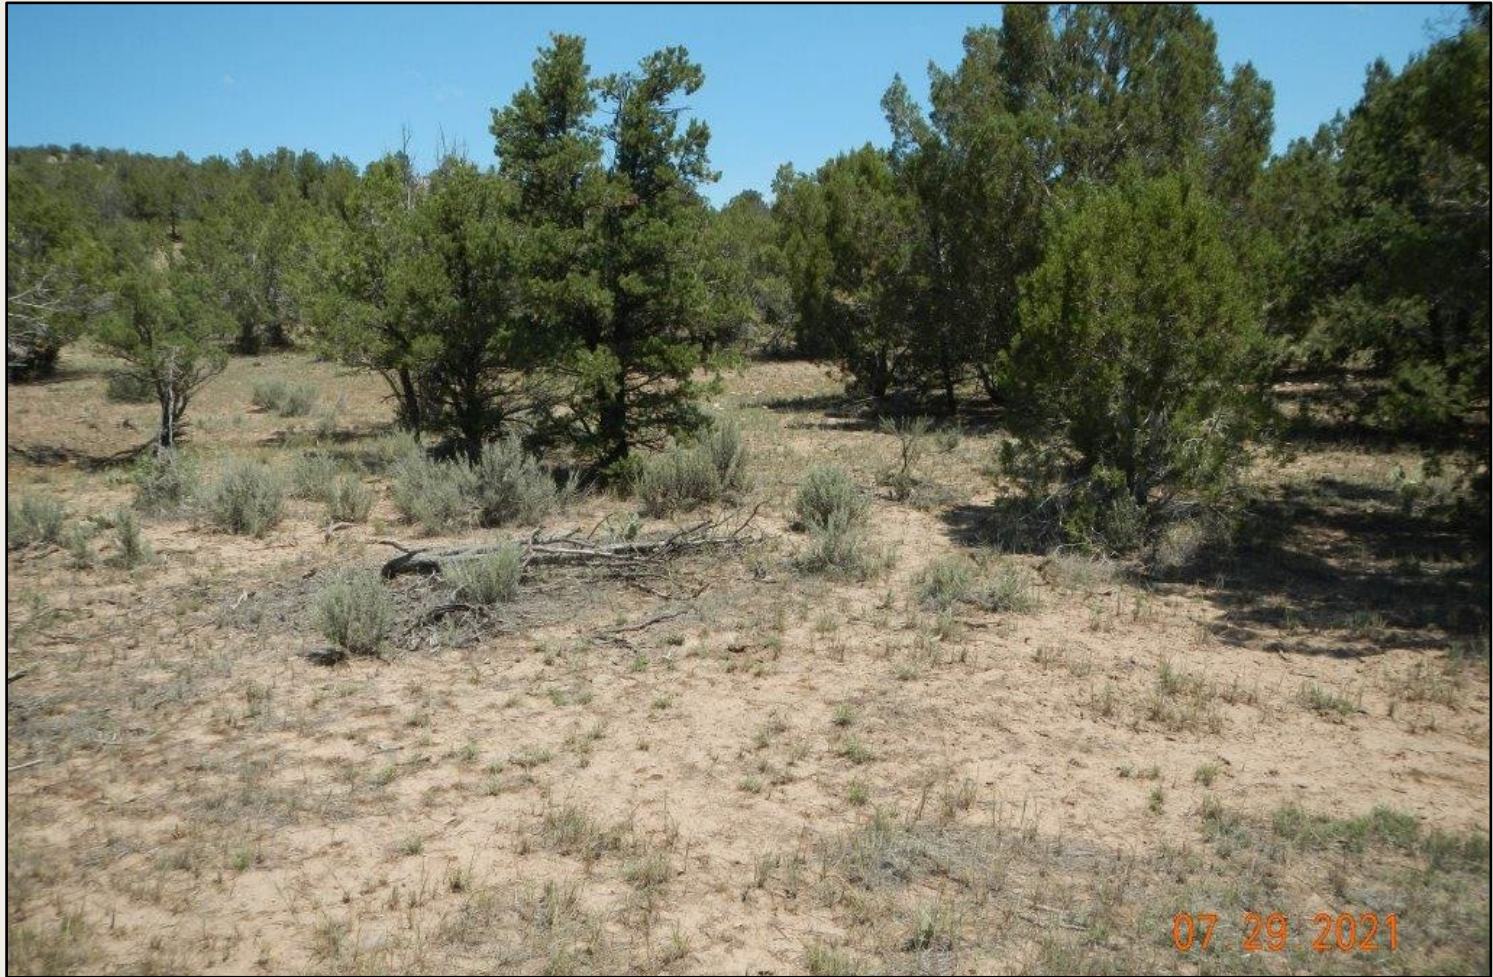
Photo 5.

View of the reference area comprised of open pinyon and juniper woodland with understory of sagebrush, James galleta, penstemon, squirreltail and western wheatgrass.
