**Inspection Photos**  
**Location Name: UPRR 43 Pan AM G12**  
**Location ID: 318381**

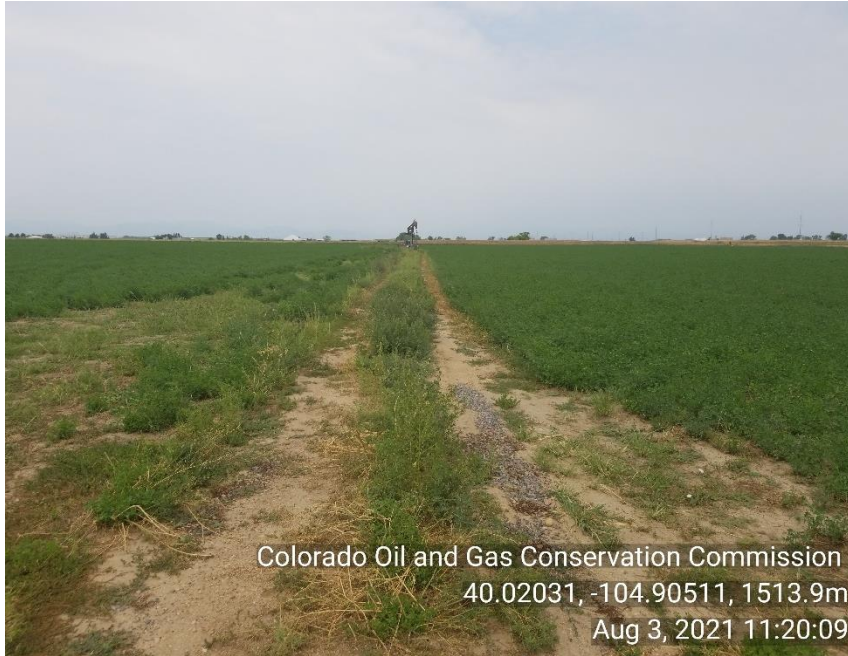
**Photo 1 Weeds not maintained on access road.**

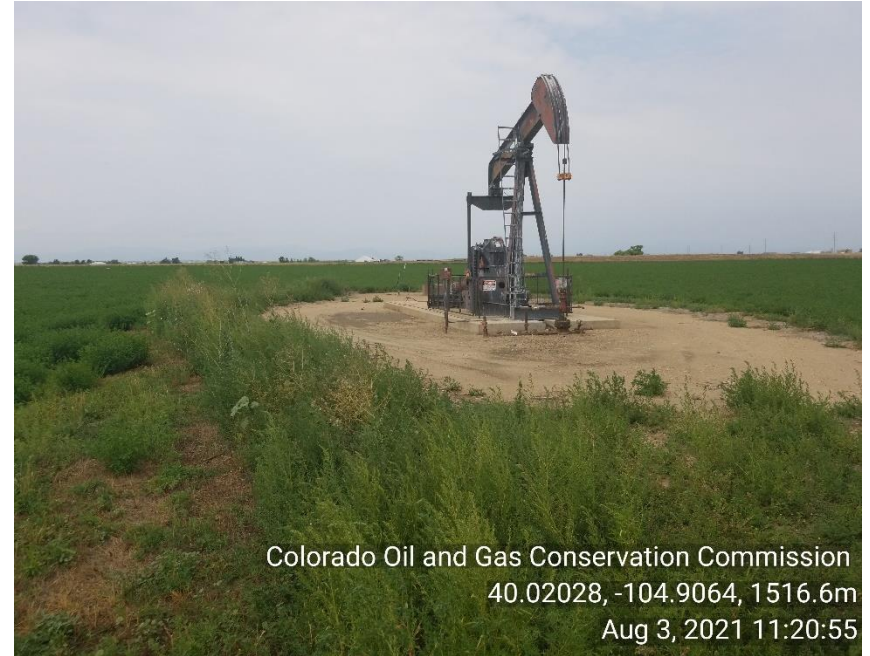
**Photo 2 Weeds not maintained on well site.**

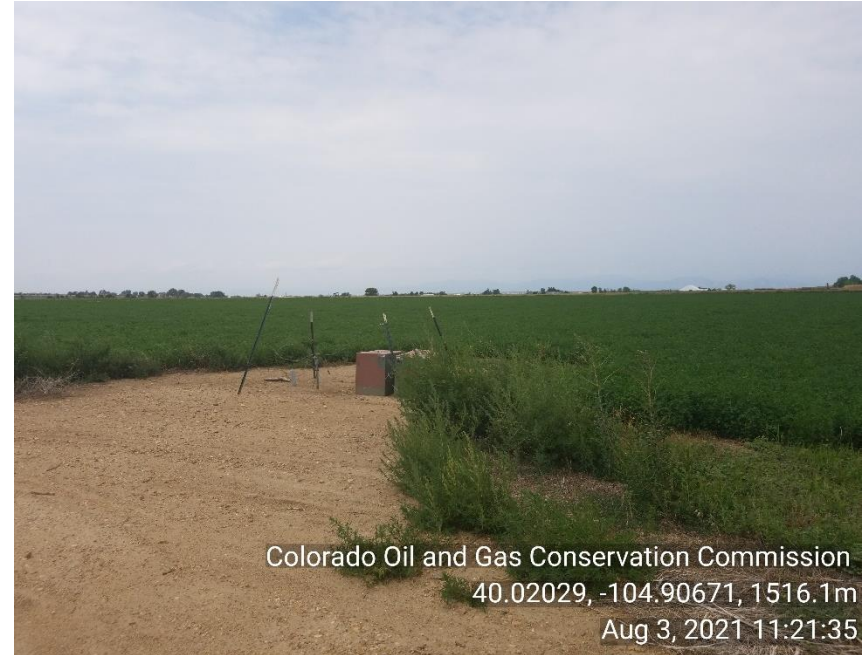
**Photo 4 Weeds on location.**

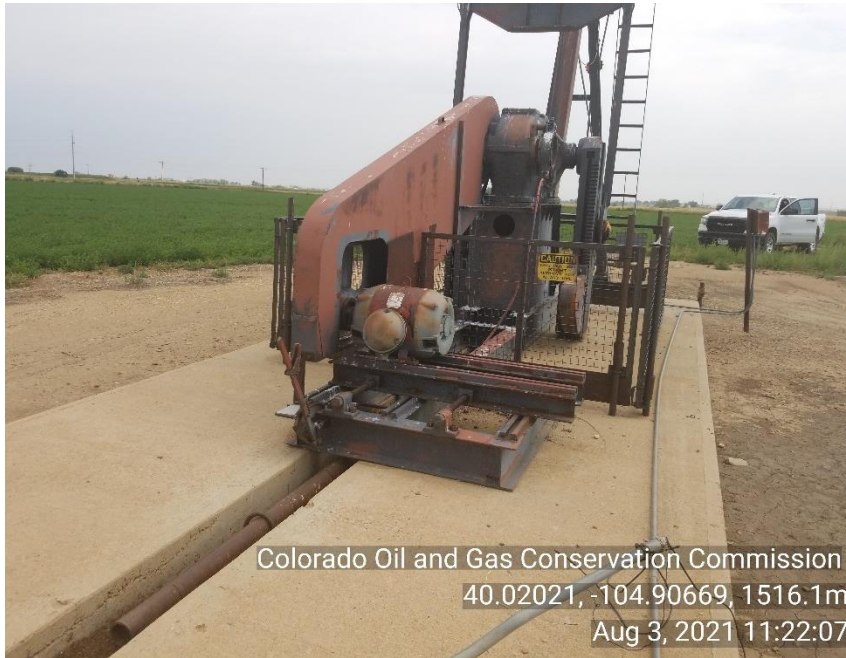
**Photo 5 Unused equipment: PU and associated equipment.  
Mechanical issue electric motor is not connected to power.**

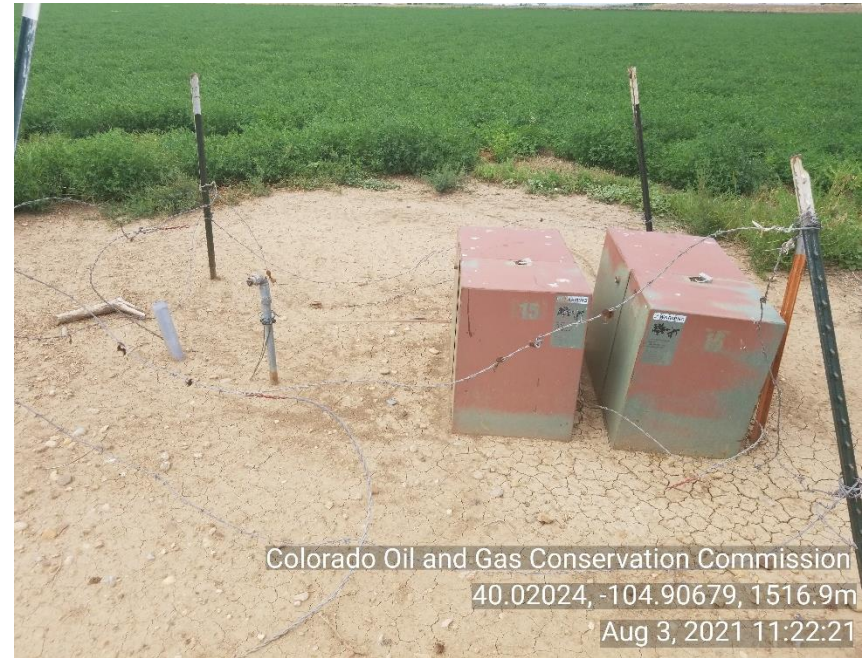
**Photo 6 Electric power meter appears to have been  
removed.**
