Inspection Photos
Location Name: Guildner #1
Location ID: 317889

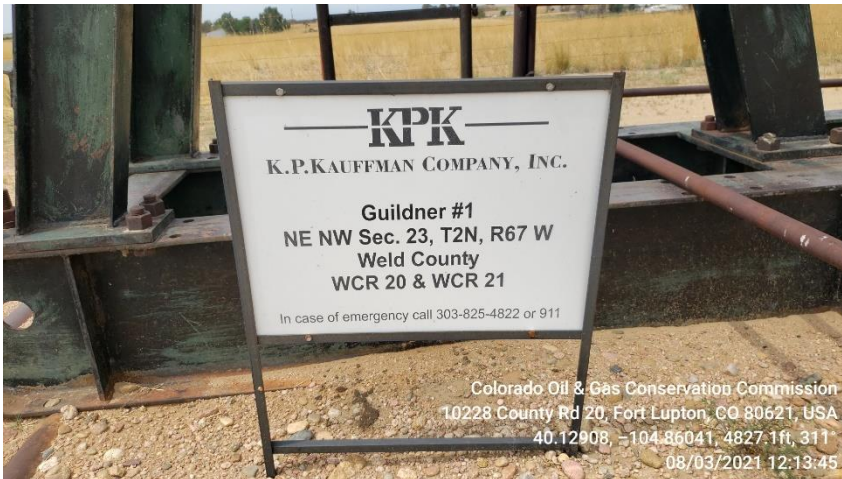
Photo 1 WH sign

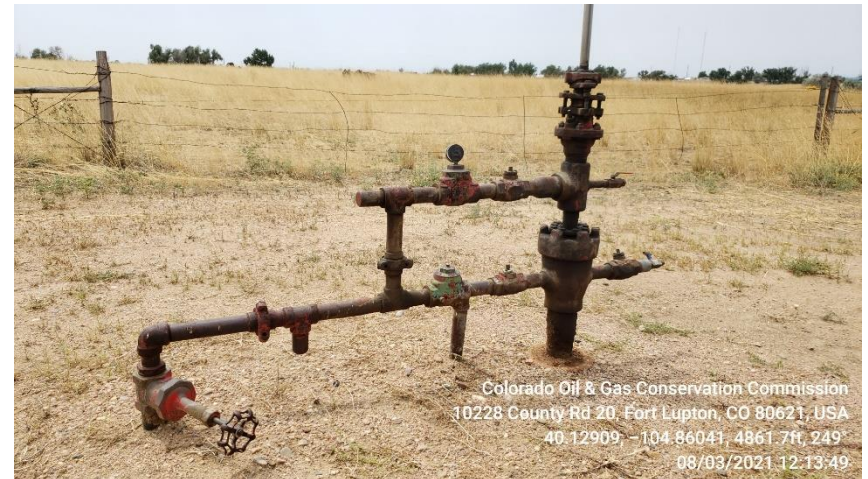
Photo 2 WH

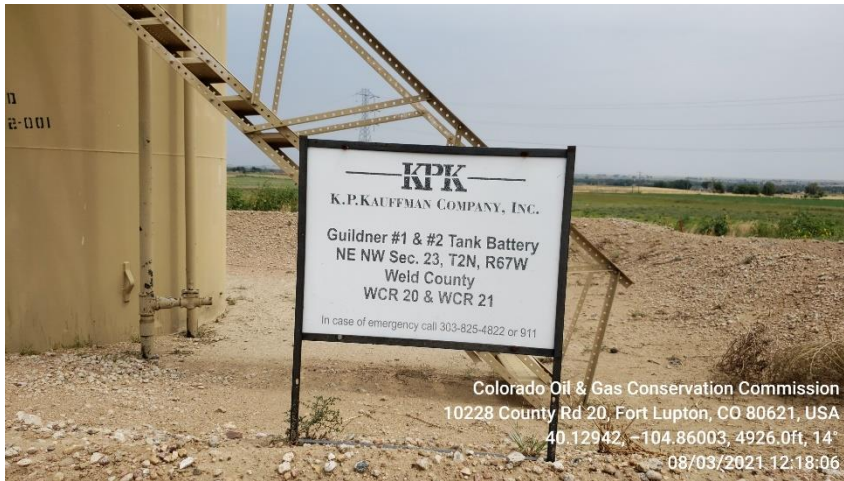
Photo 3 TB sign

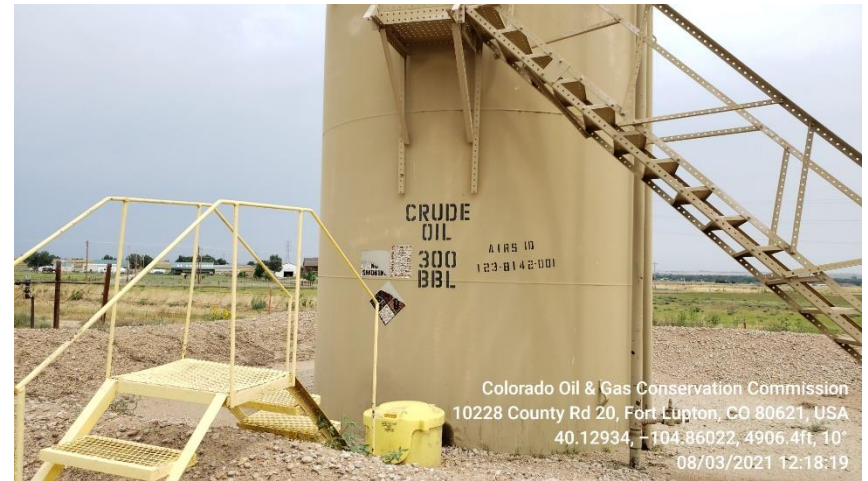
Photo 4 Placards on Crude tank peeling, faded and need replaced

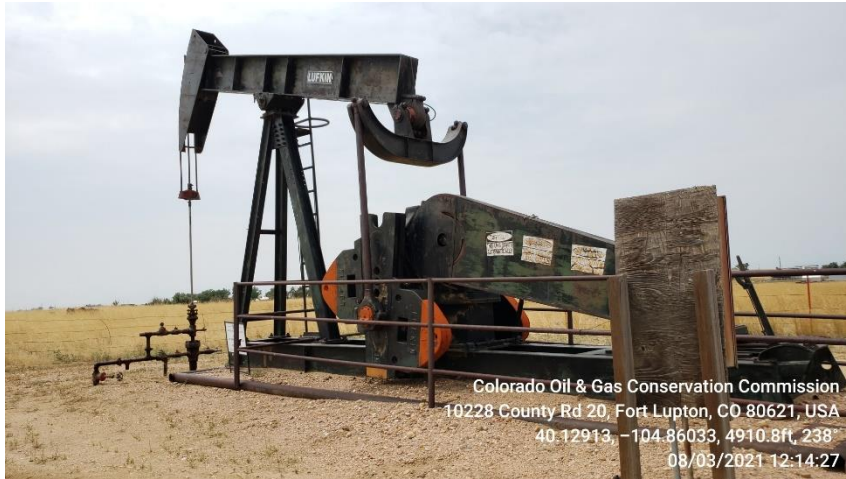
Photo 5 pump jack

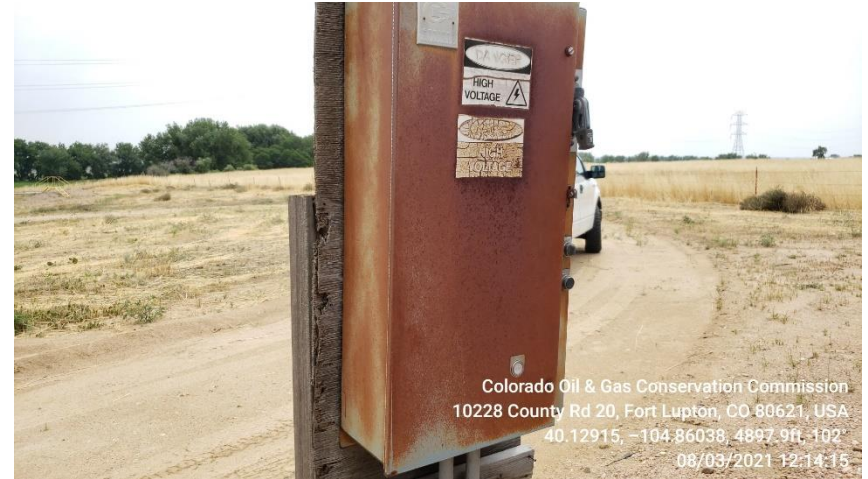
Photo 6 electric panel

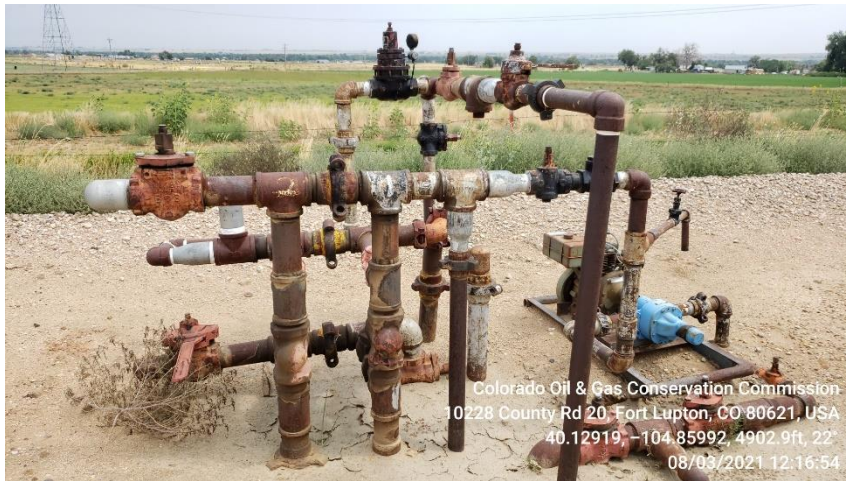
Photo 7 flow line manifold

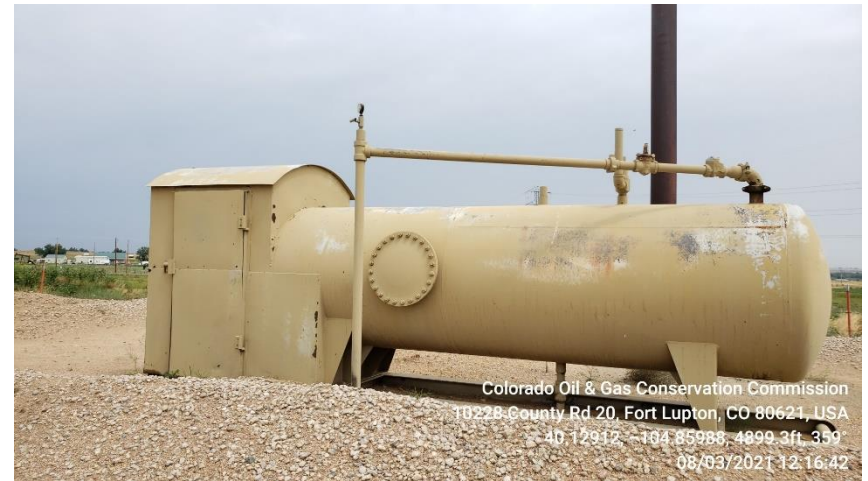
Photo 8 Horizontal Heated separator

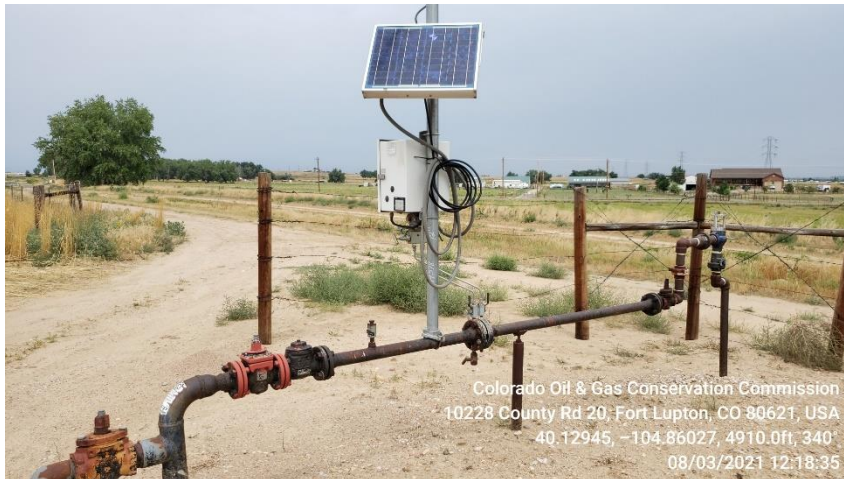
Photo 9 Gas Meter Run

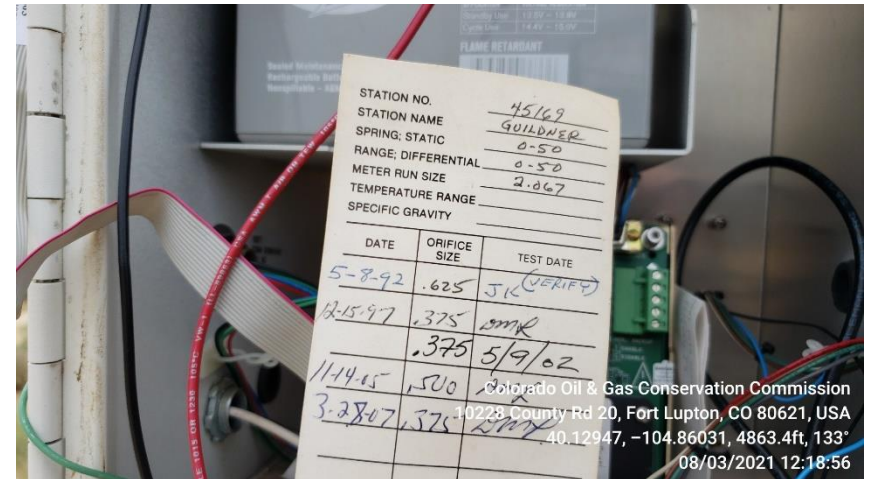
Photo 10 card in meter box indicates that calibration is not current

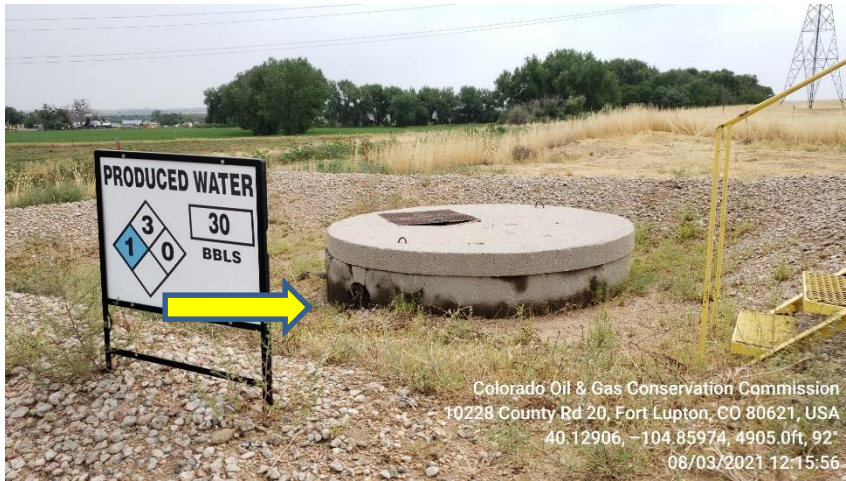
Photo 11 PW concrete vault, possible seepage

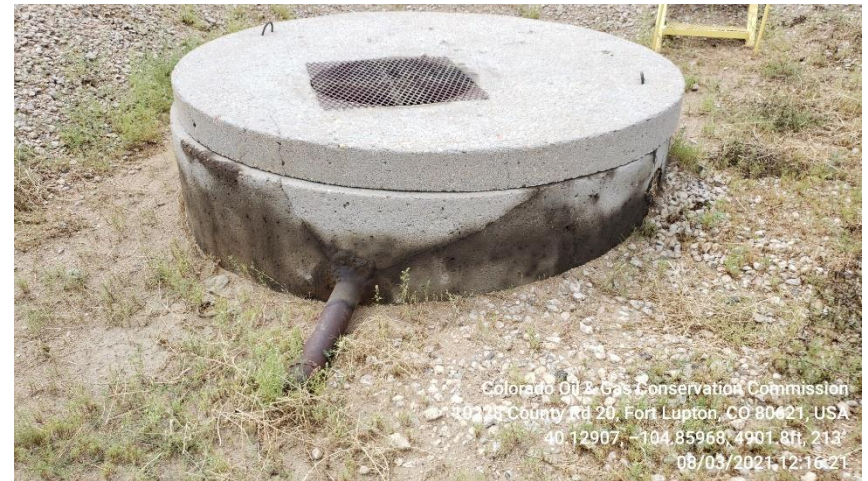
Photo 12 PW concrete vault, possible seepage

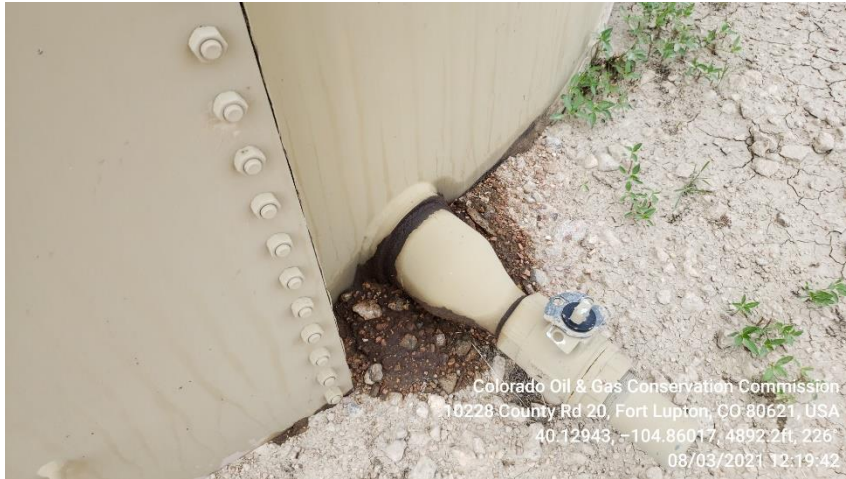
Photo 13 Stained soil, slow leak around threads

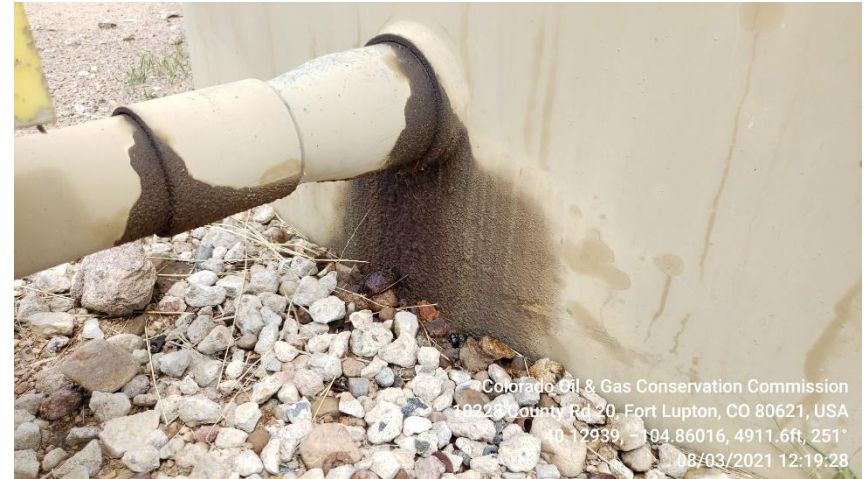
Photo 14 Stained soil, slow leak around threads
