Inspection Photos

Location Name: LARAMIE ENERGY LLC CC /0610-24-43 Pad,
Location ID: 324314

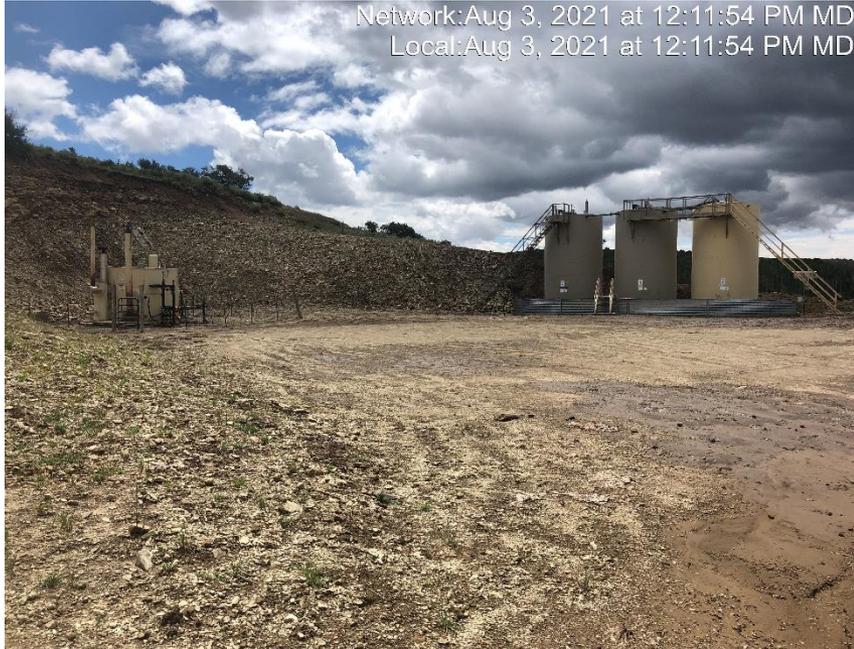
Photo #4654 from entrance to location.

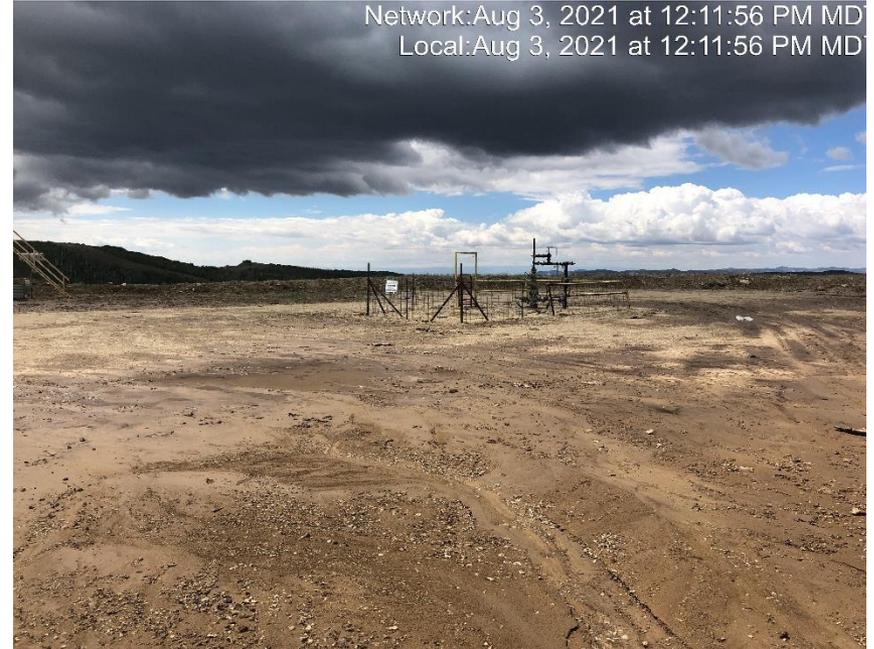
Photo #4655 from entrance to location.

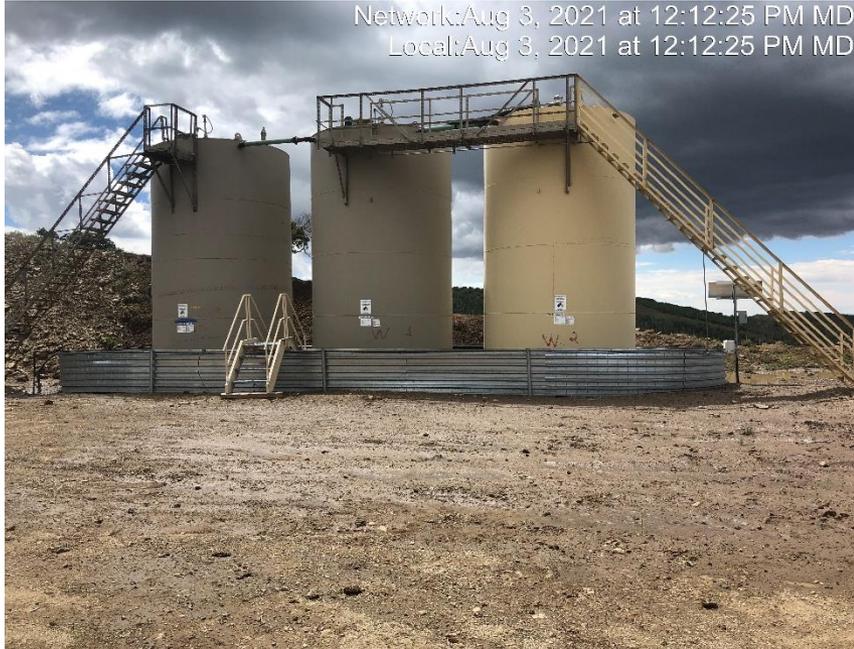
Photo #4656 No battery sign located at the tank battery.

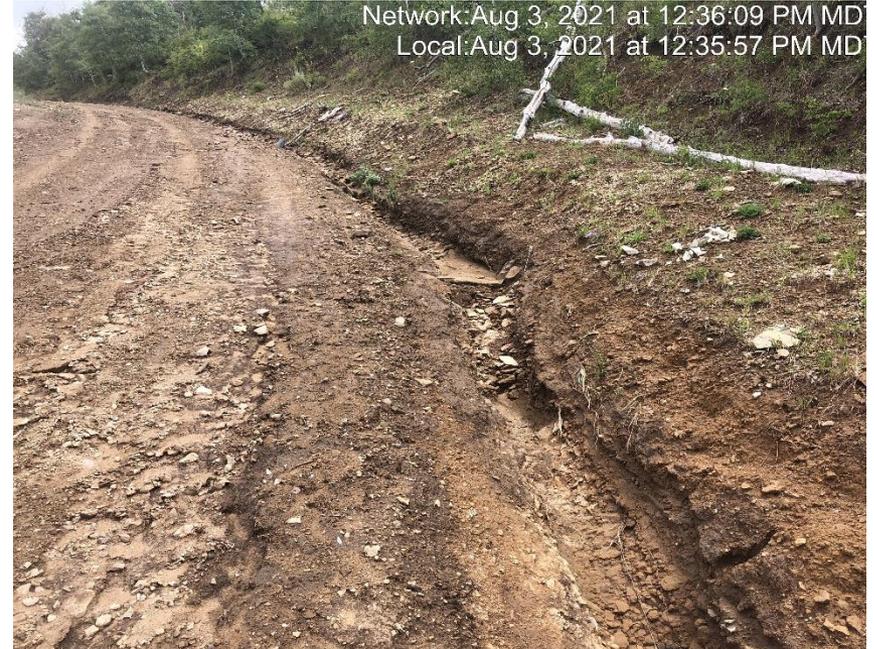
Photo #4657 Insufficient velocity checks in ditch.

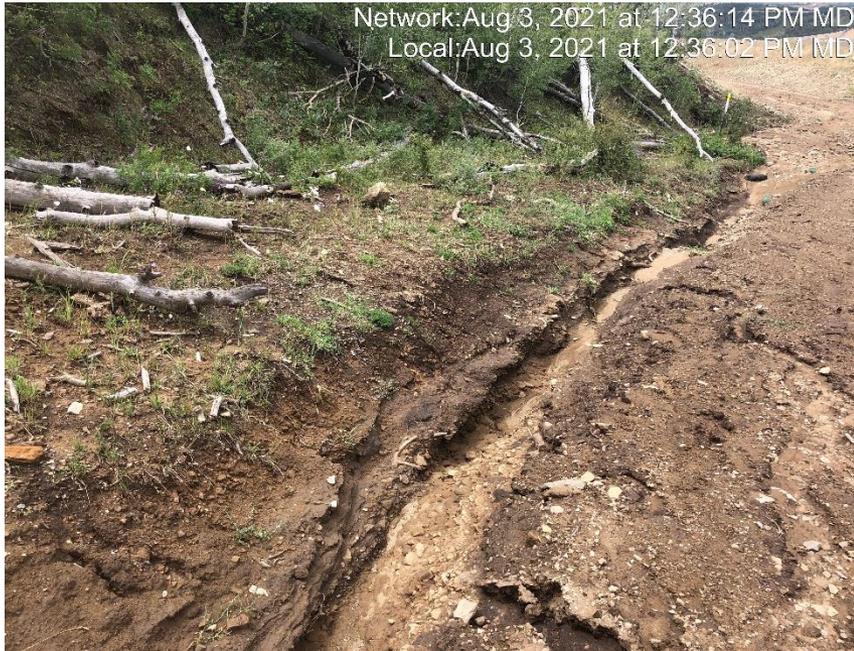
Photo #4658 Gully erosion occurring in ditch.

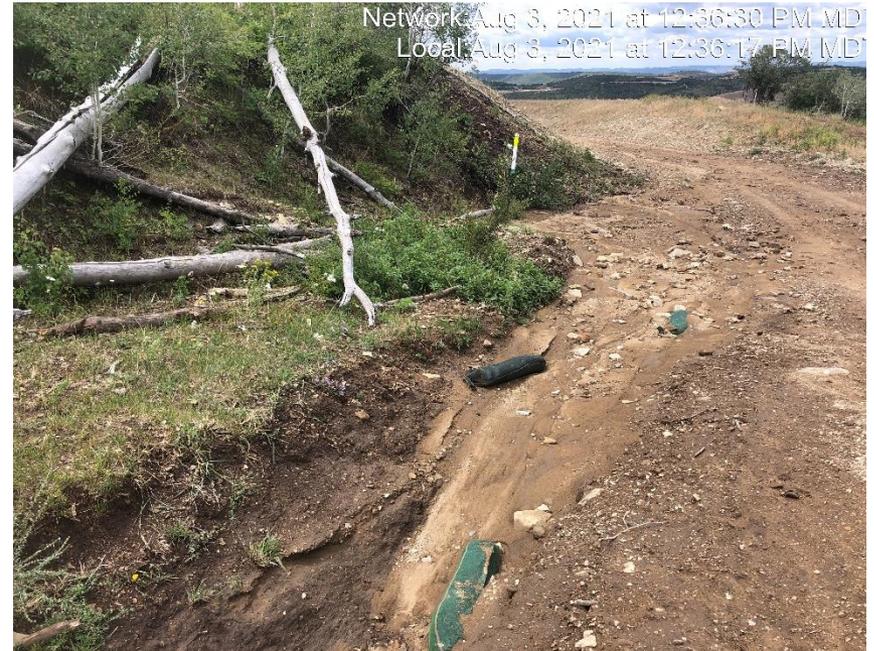
Photo #4659 Sediment has been transported onto access road.

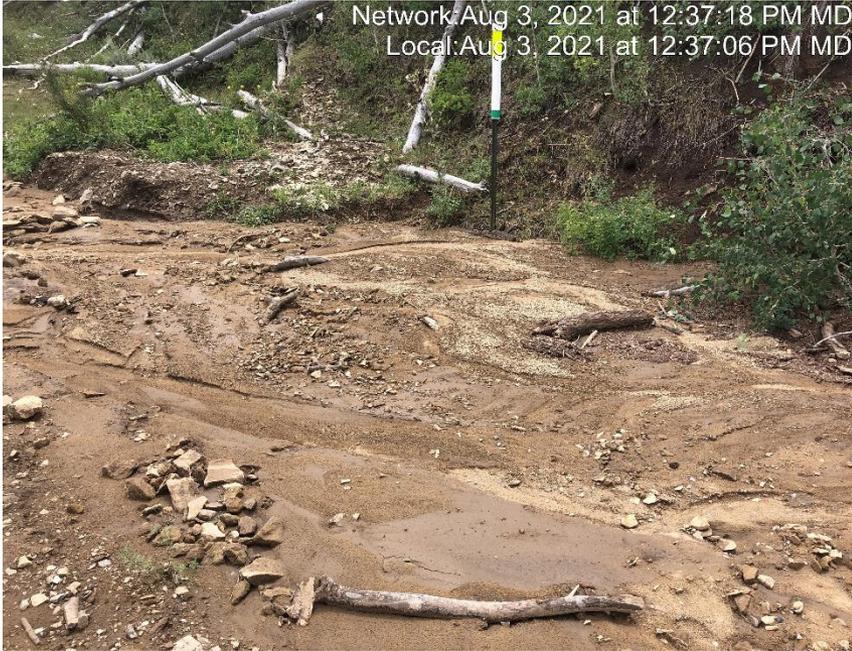
Photo #4660 Inlet of culvert.

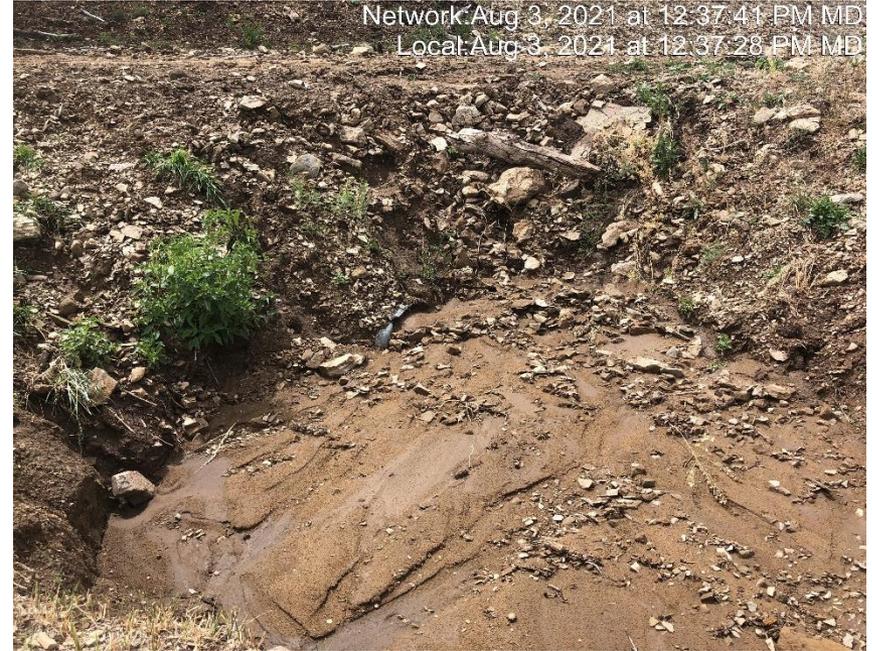
Photo #4661 Outlet of culvert.

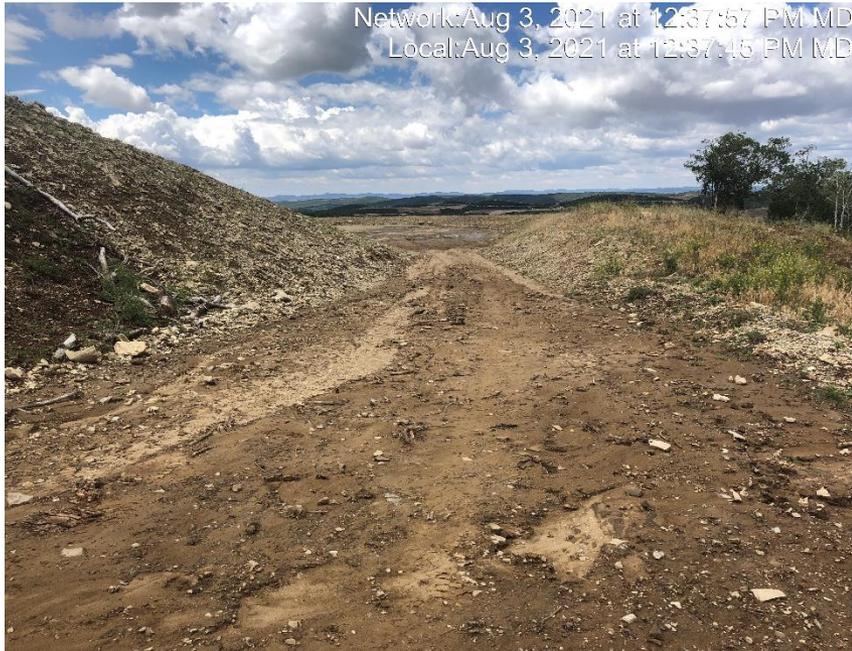
Photo #4662 Sediment has been transported down access road.
