## Inspection Photos

Location Name: LARAMIE ENERGY LLC Cascade Creek /697-15-01

Location ID: 335921

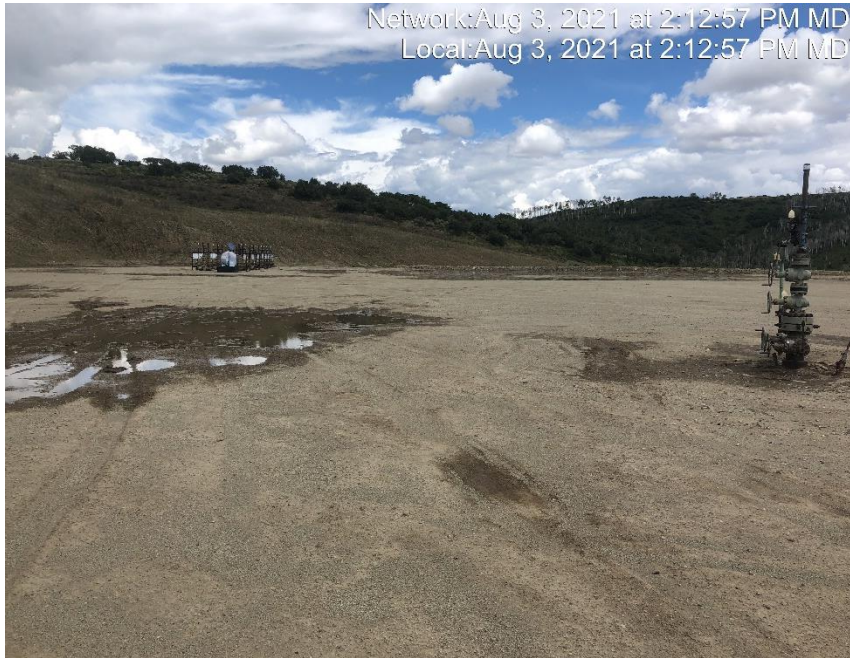
Photo #4674 from entrance to location.

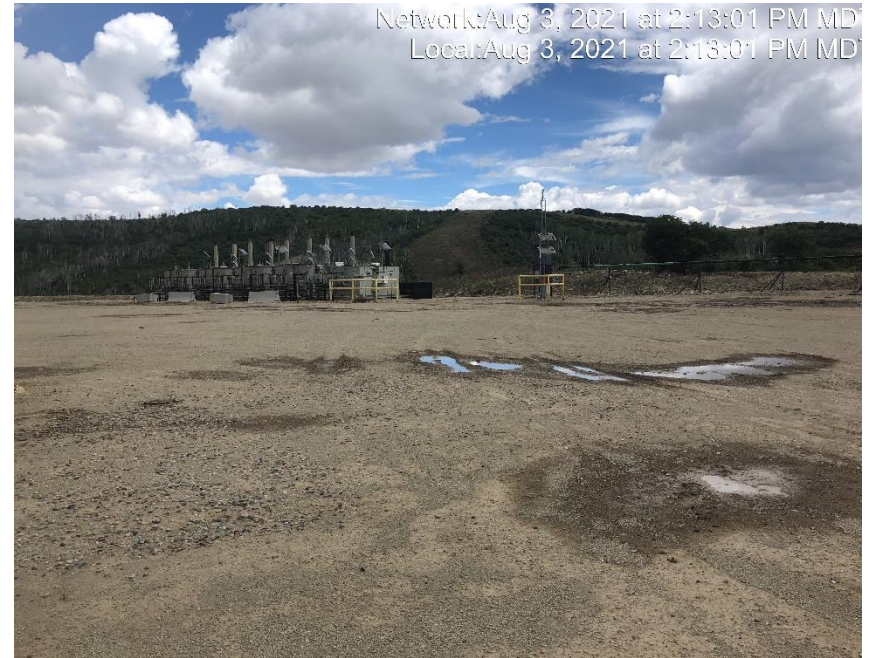
Photo #4675 from entrance to location.

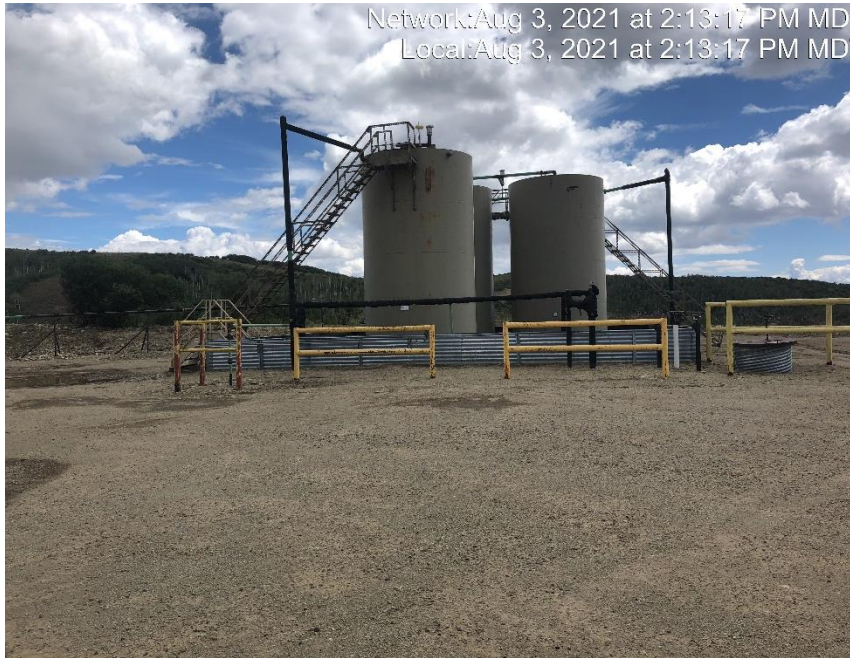
**Photo #4676 No battery sign located at the tank battery.**

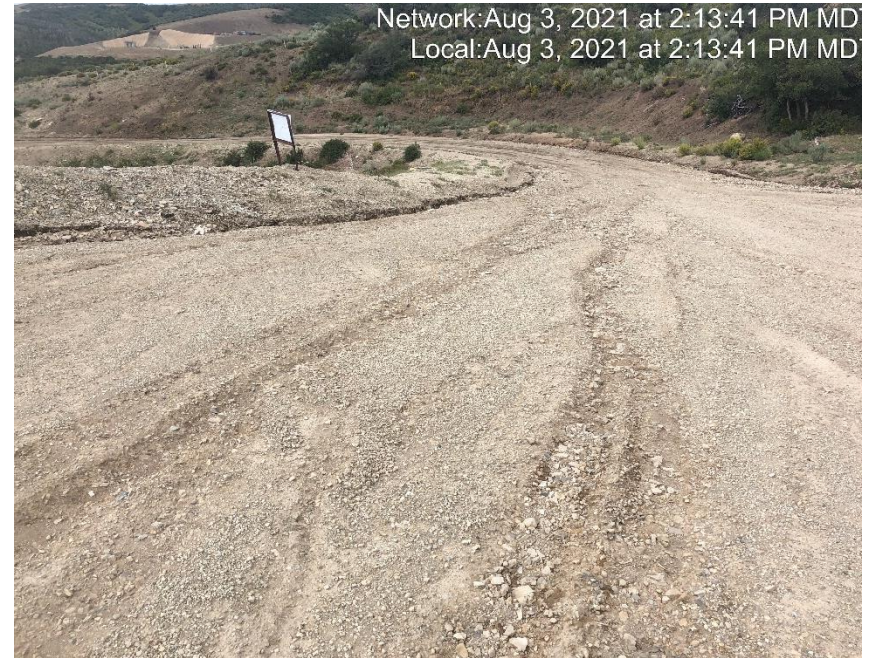
**Photo #4677 Access road lacks stabilization.**

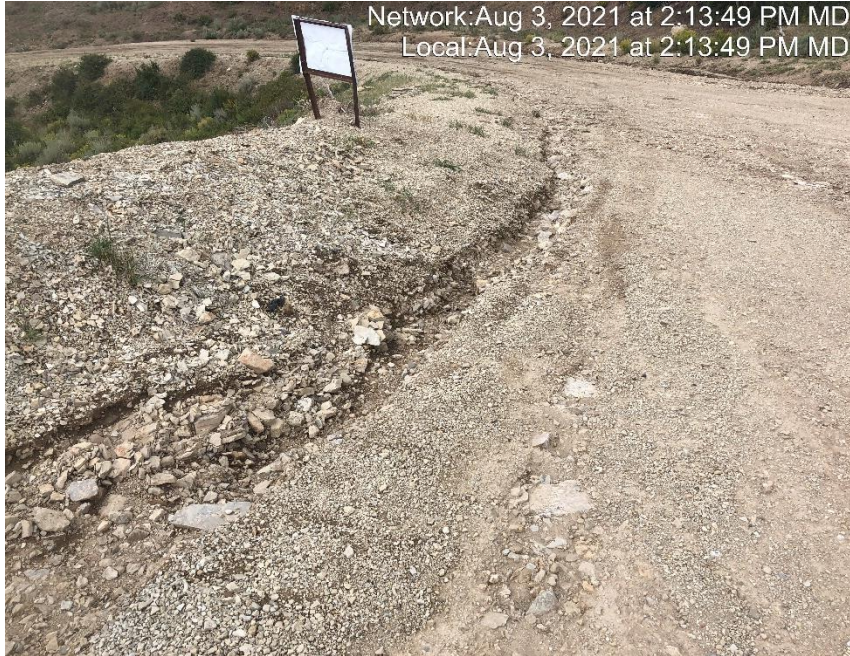
**Photo #4678 Rill erosion occurring in ditch.**

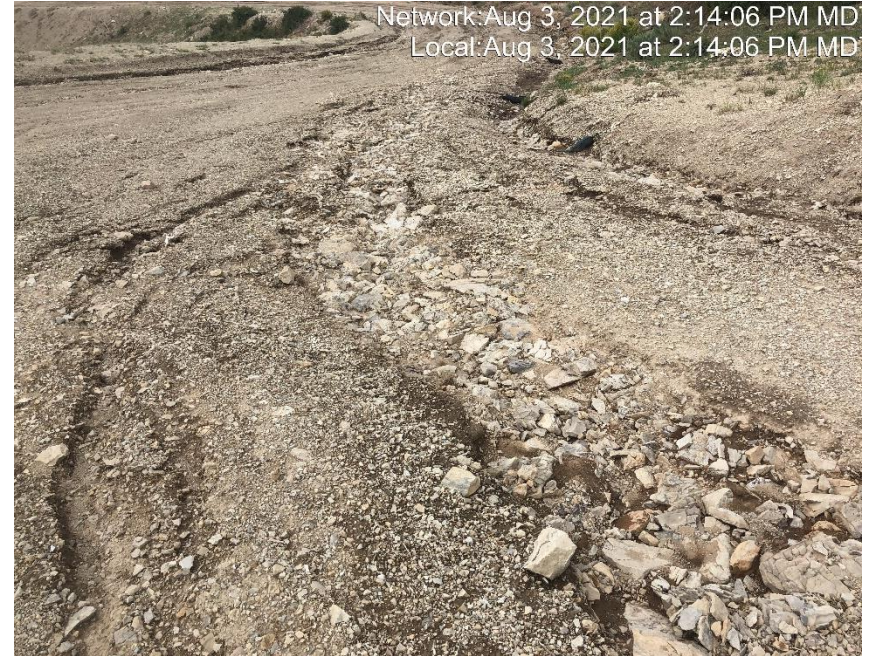
**Photo #4679 Rill erosion occurring in ditch and access road.**

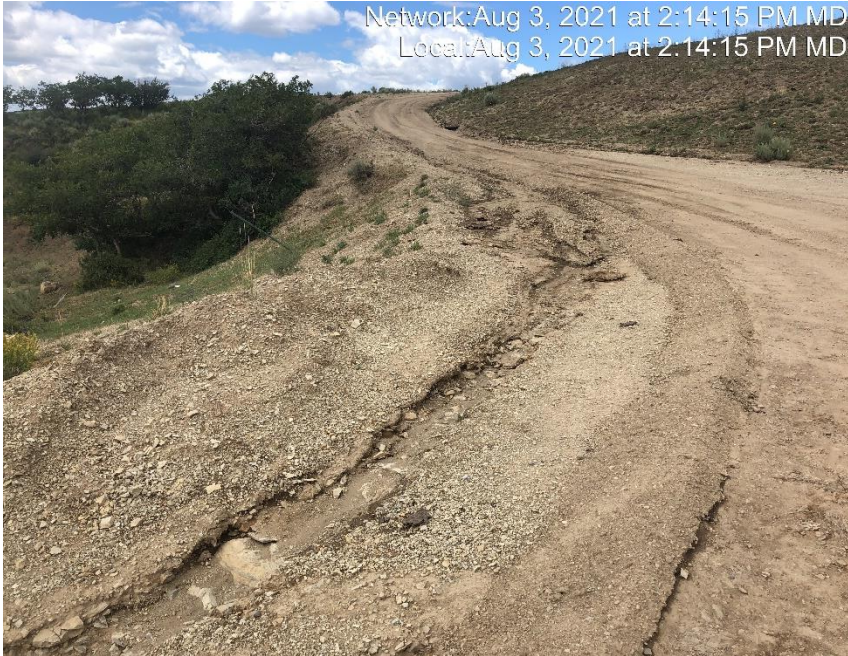
**Photo #4680 Insufficient velocity checks.**

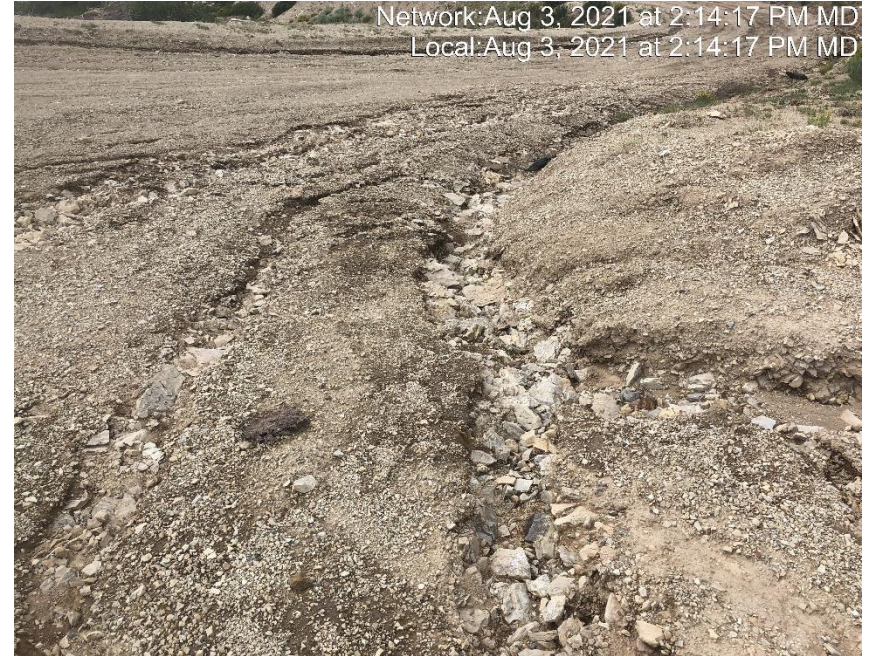
**Photo #4681 Insufficient velocity check.**
