Inspection Photos

API: 071-09004

Operator: EVERGREEN NATURAL RESOURCES

Inspection Date: 8/4/2021

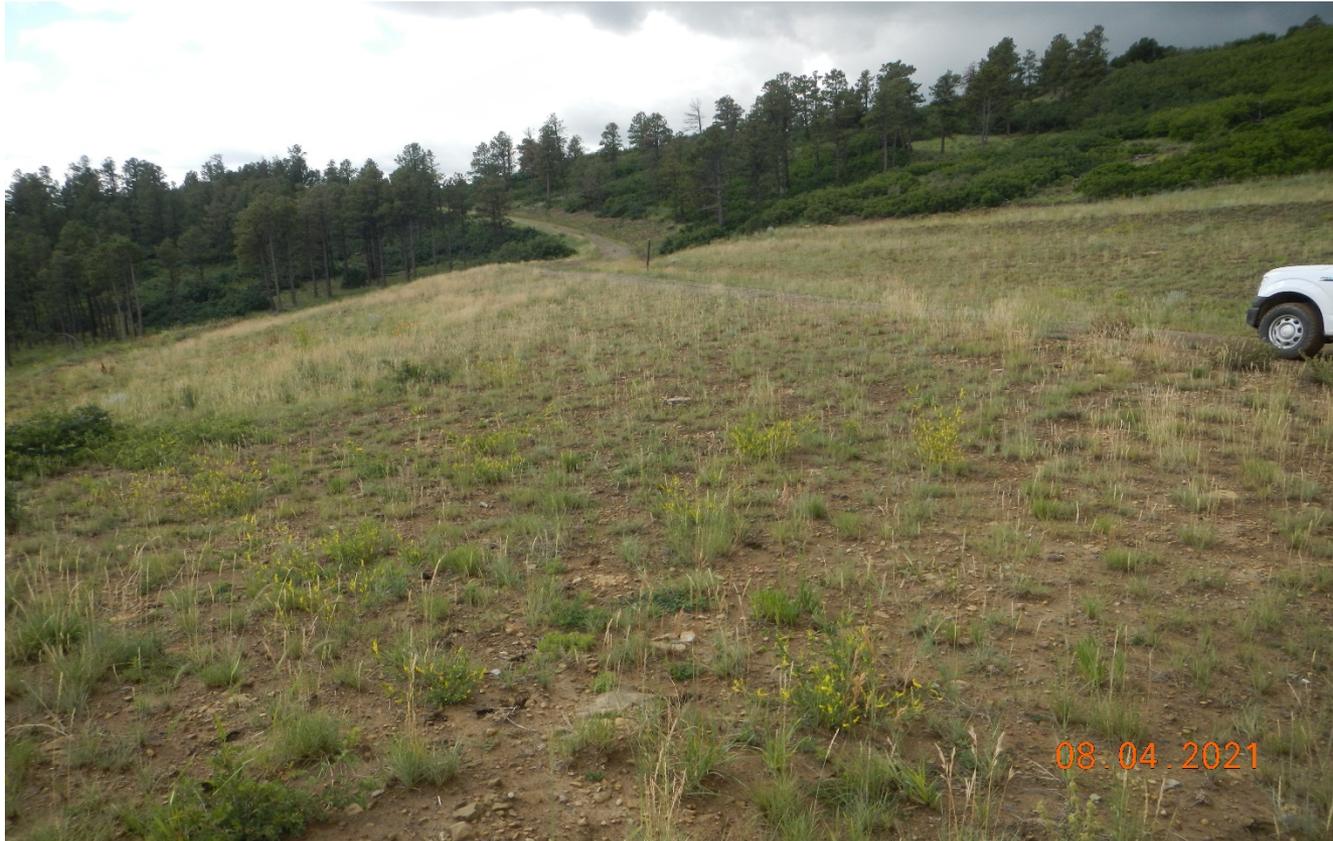
Photo 1. Facing south toward the location. The road continues thru the location.

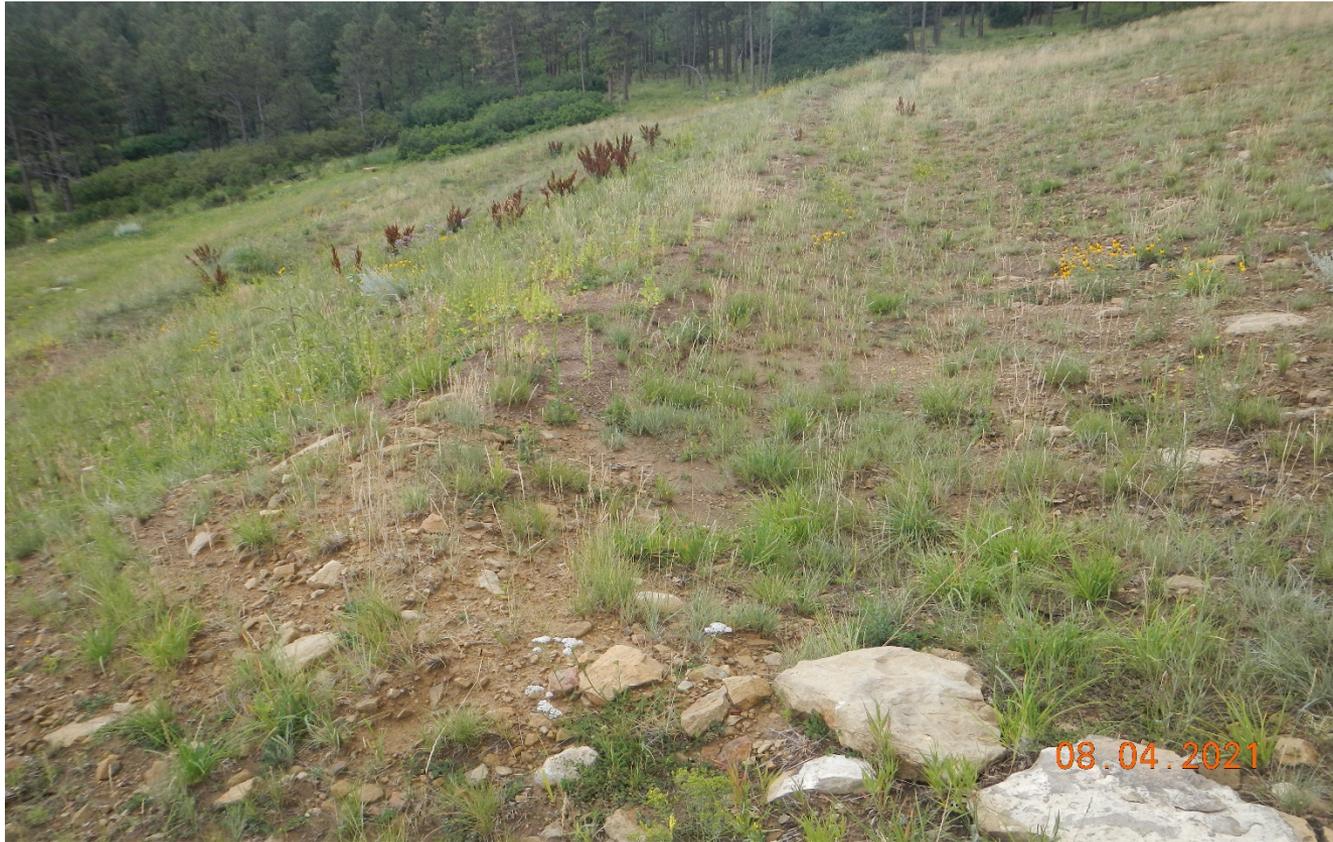
Photo 2. Facing south toward the lower portion of the location.

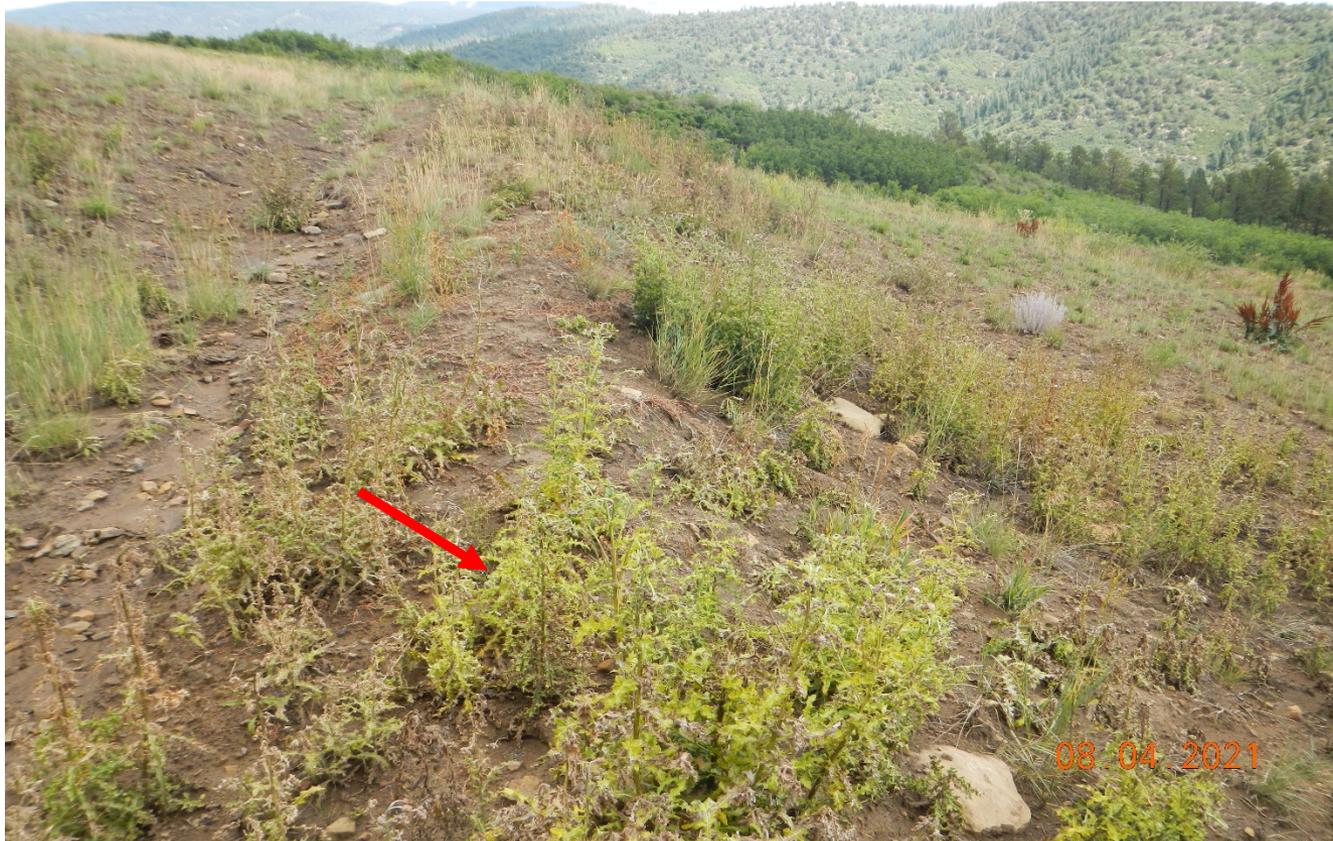
Photo 3. There was numerous noxious weeds observed at the location. Red arrow points to Canada thistle. Most of the weeds observed were wilted from recent weed control.

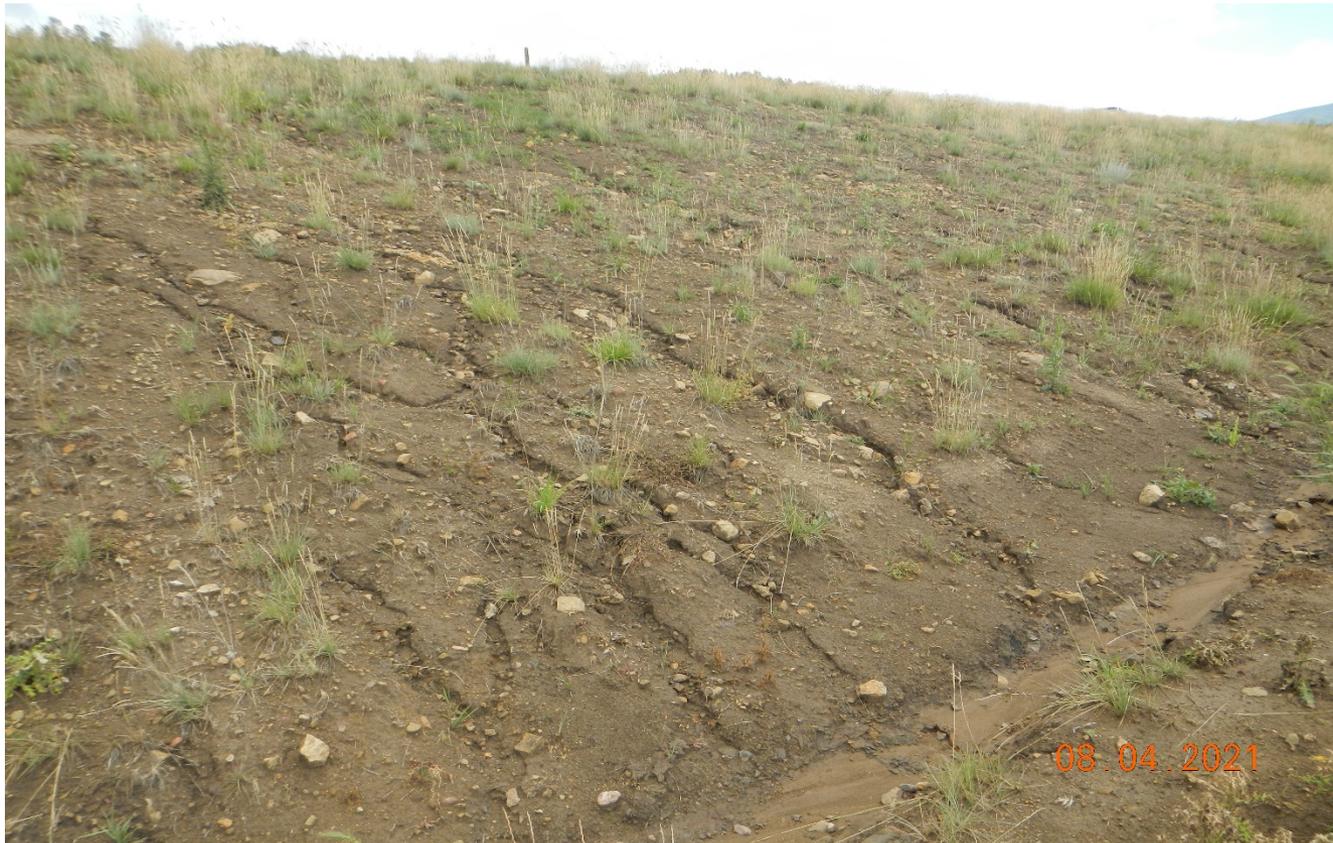
Photo 4. Facing northwest at the location. This area needs additional seeding to help establish vegetation.

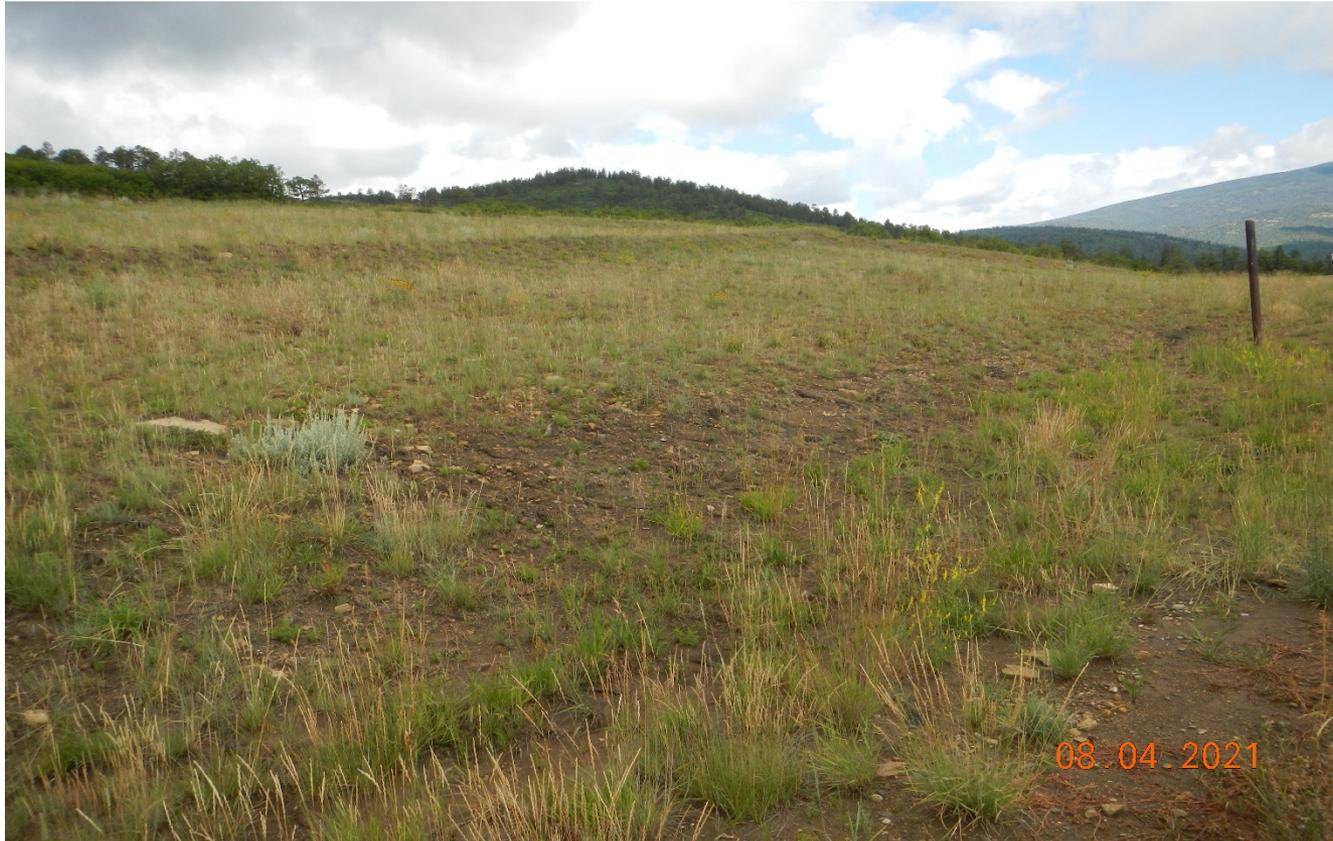
Photo 5. Facing northwest toward the upper portion of the location.

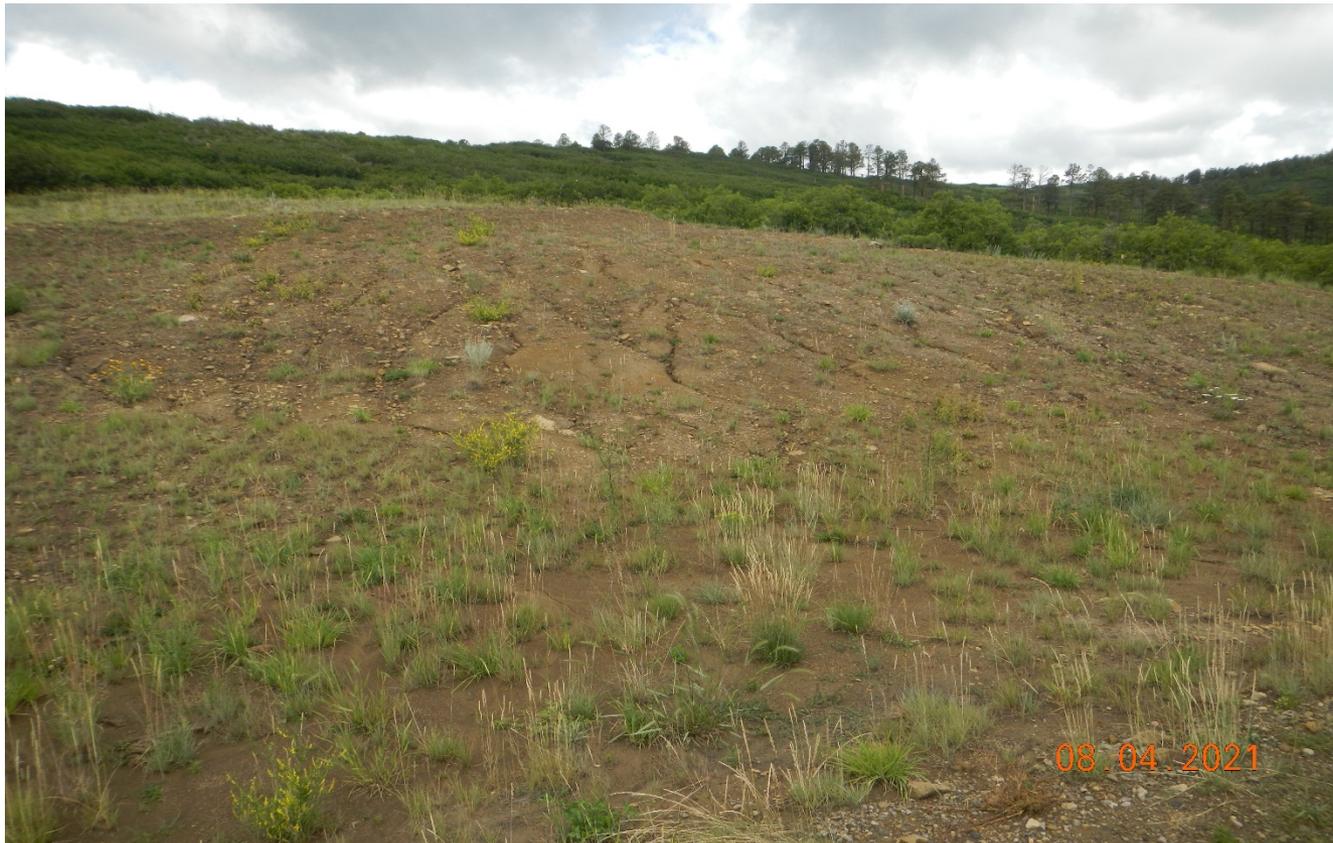
Photo 6. North side of the location facing west. There is signs of erosion along the slope. This area needs additional seeding to help establish vegetation.

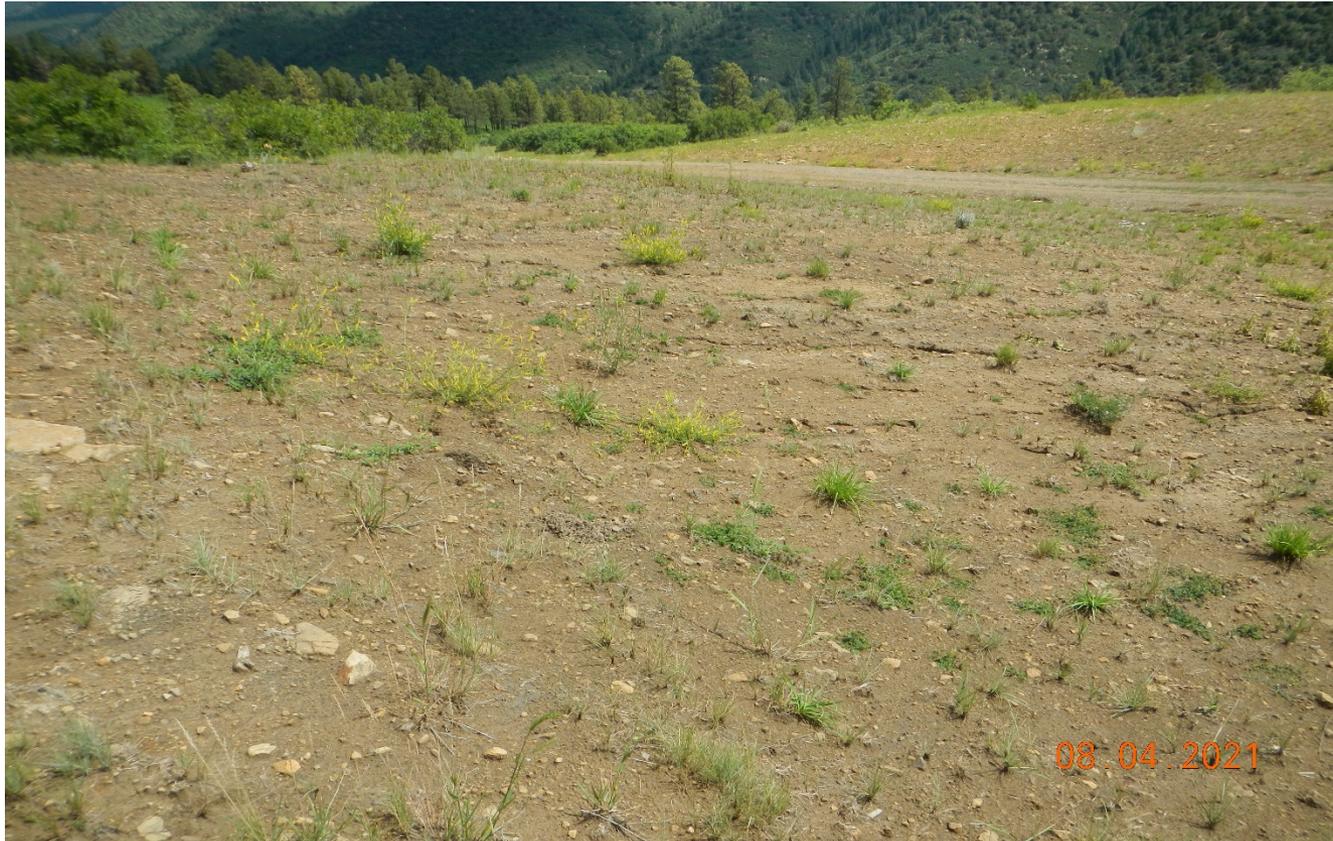
Photo 7. Facing northeast toward the area shown in previous photo.

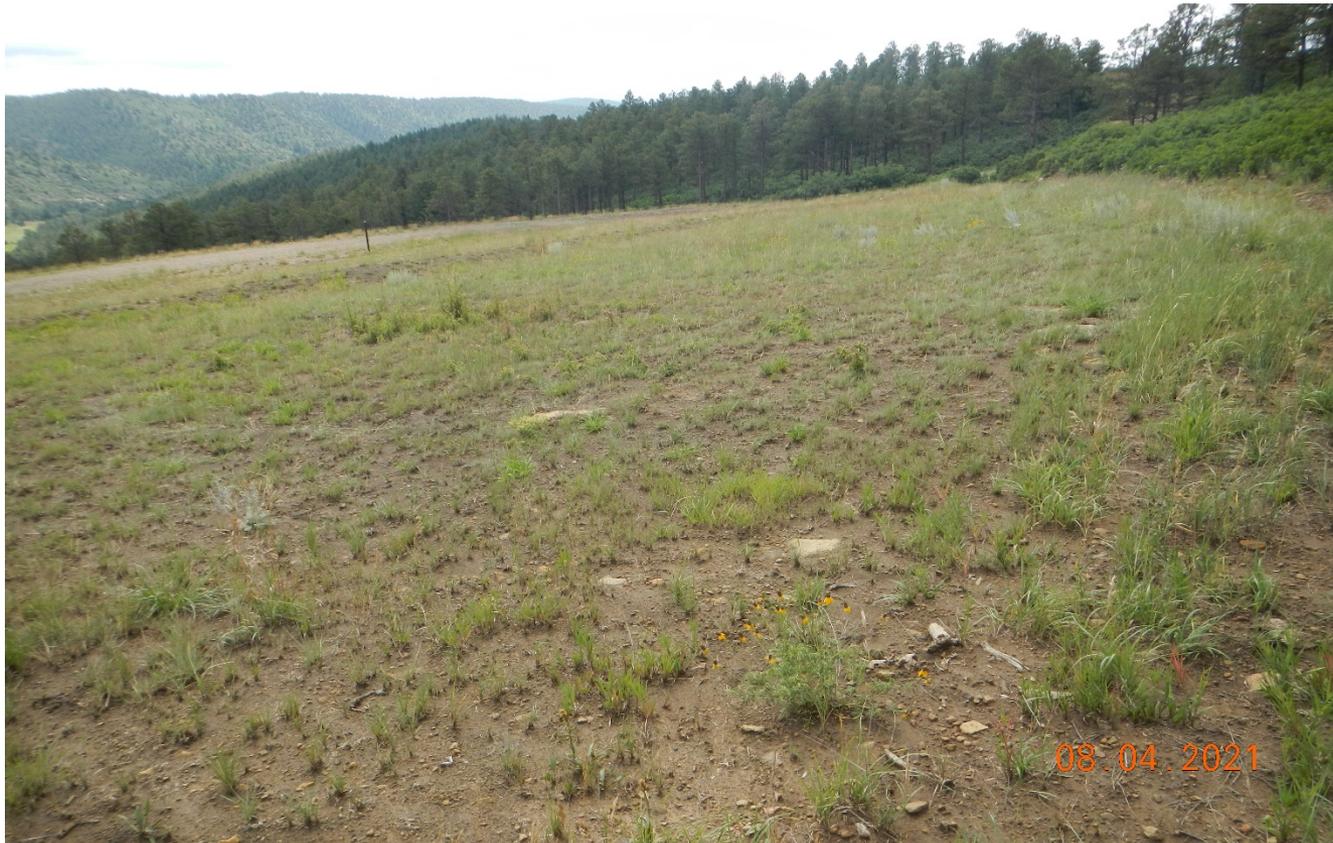
Photo 8. Facing southeast toward the location.
