Inspection Photos

API: 071-09549

Operator: EVERGREEN NATURAL RESOURCES

Inspection Date: 8/4/2021

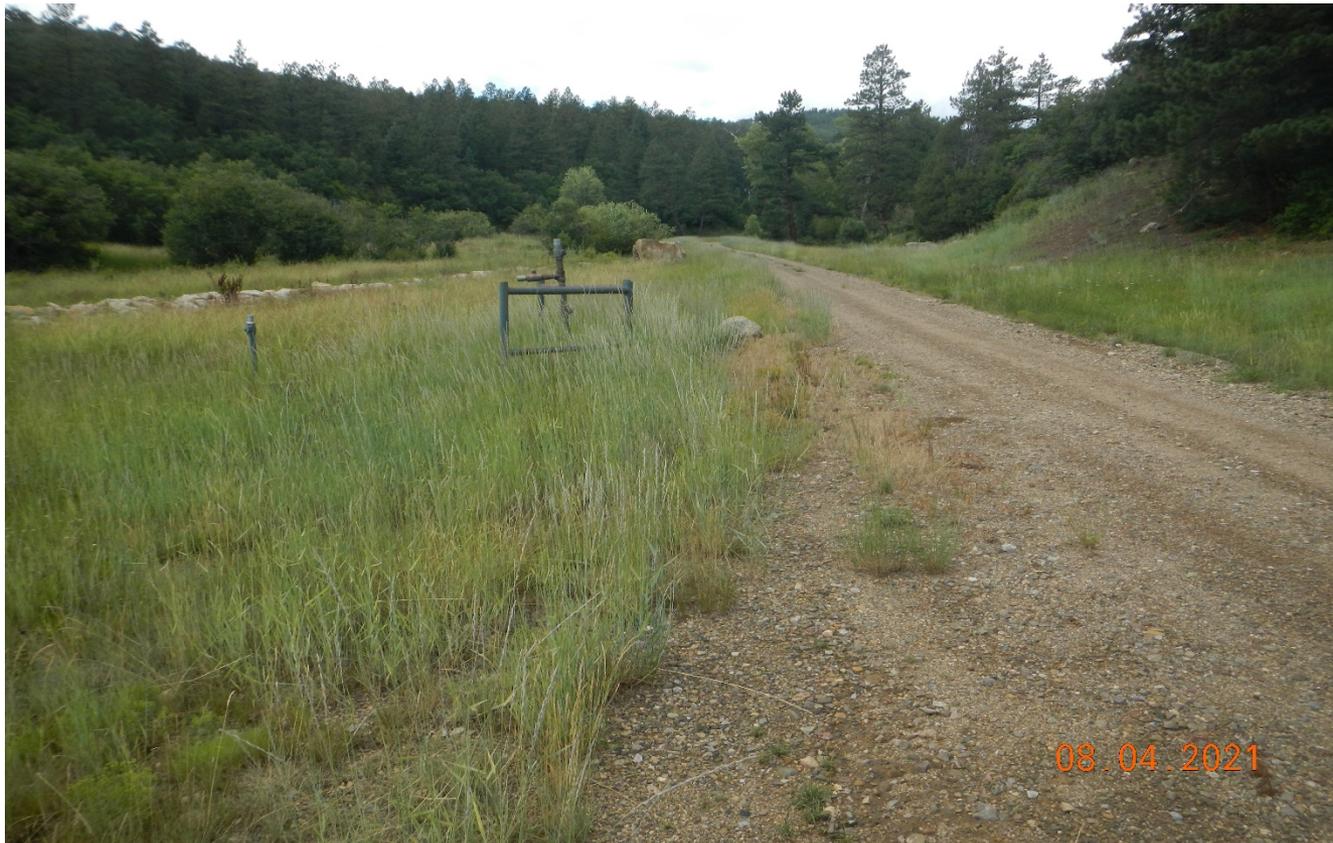
Photo 1. Facing northwest along the preexisting road traveling to the location. There are pipe risers that remain that need to be removed as there are no active sites beyond this point.

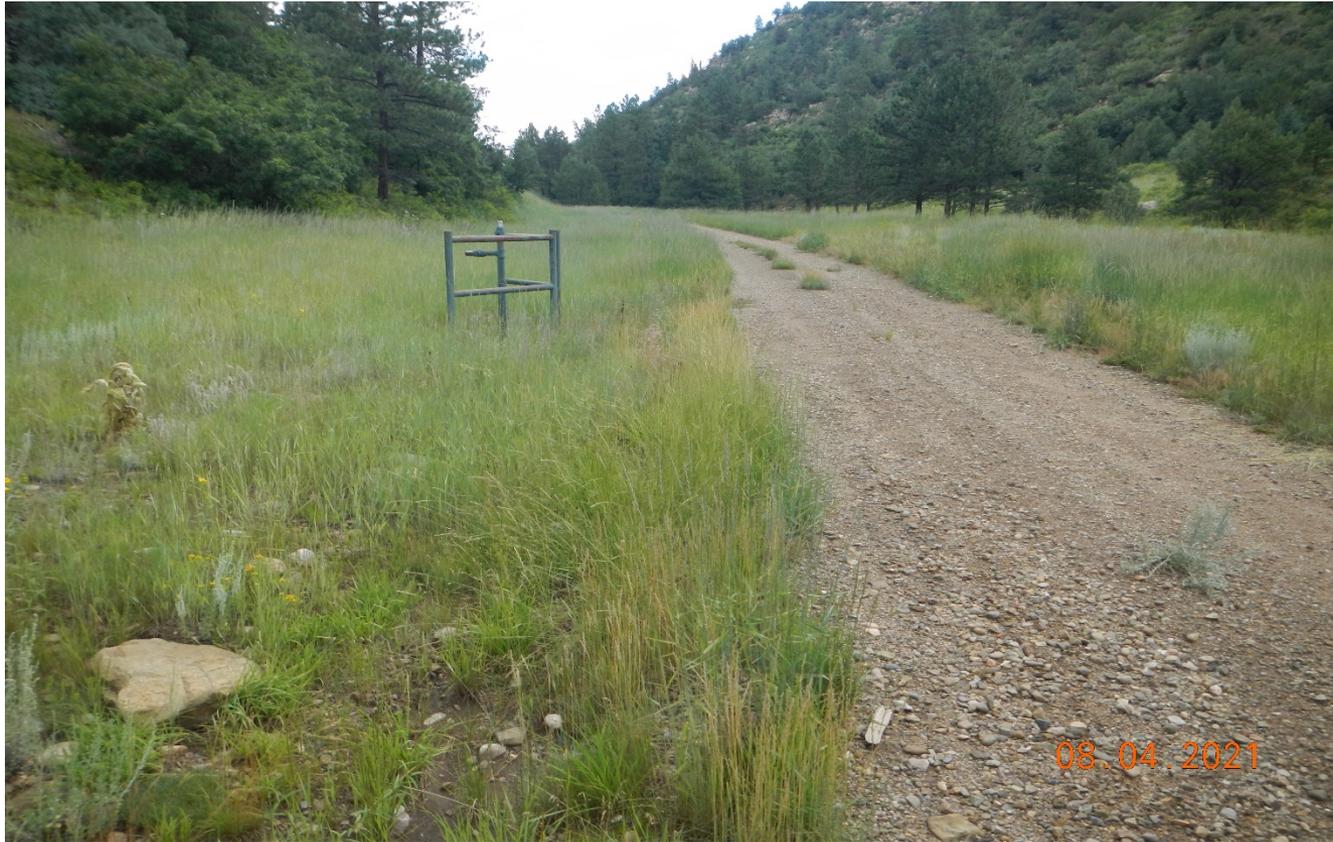
Photo 2. There is a second pipe riser that remains further along the road.

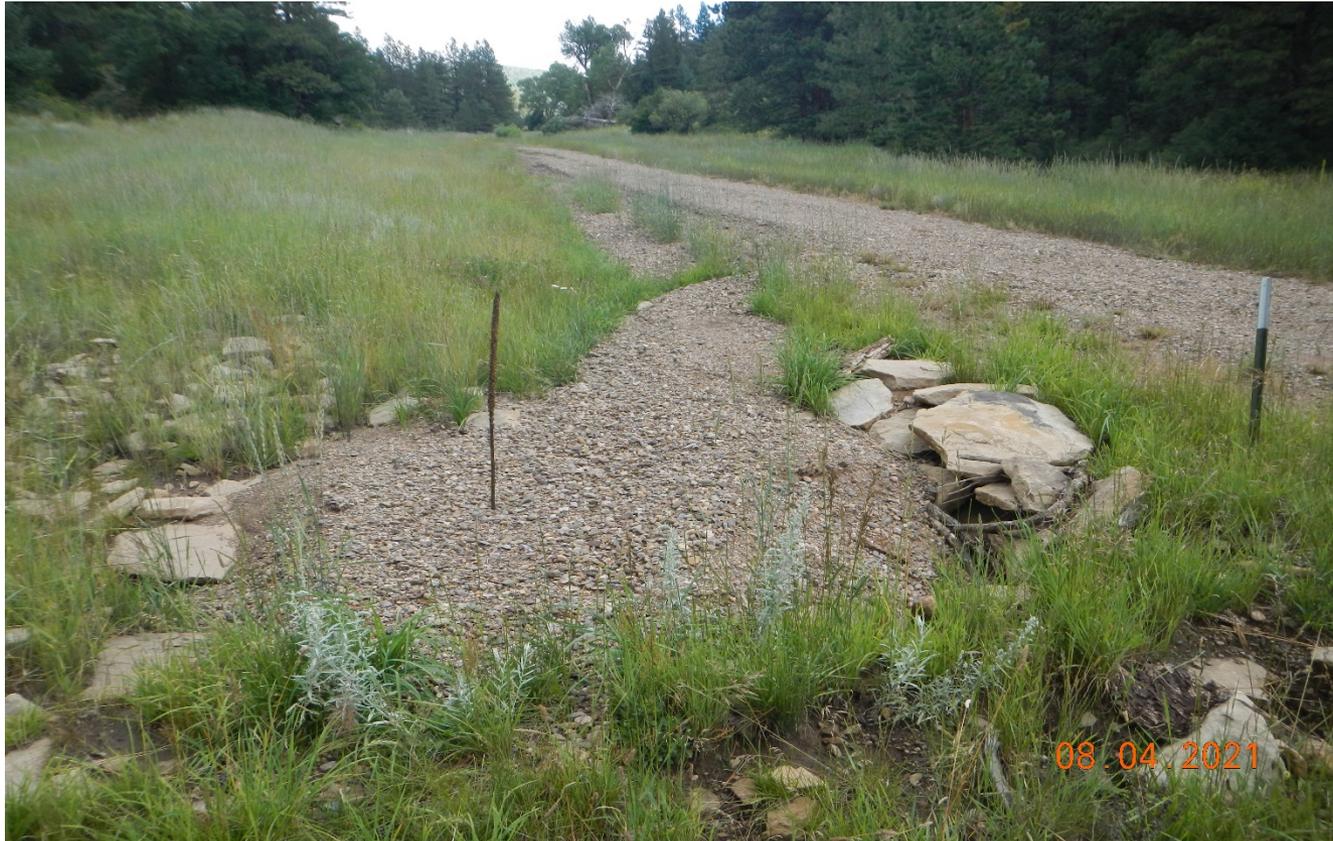
Photo 3. There is a culvert along the main road that has filled in with gravel and sediment which needs to be cleaned out.

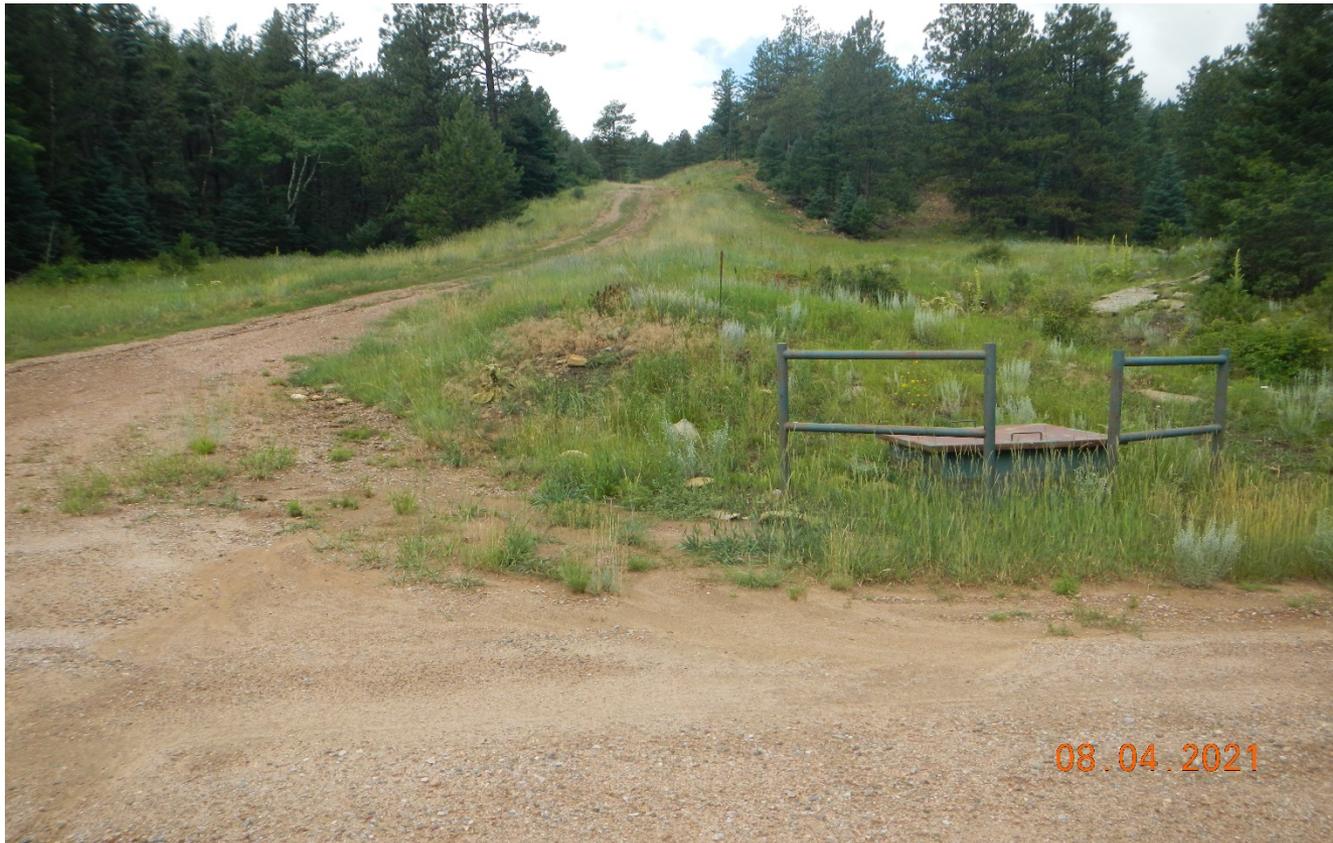
Photo 4. Facing west along the preexisting road traveling to the location. There is a metal valve box that needs to be removed.

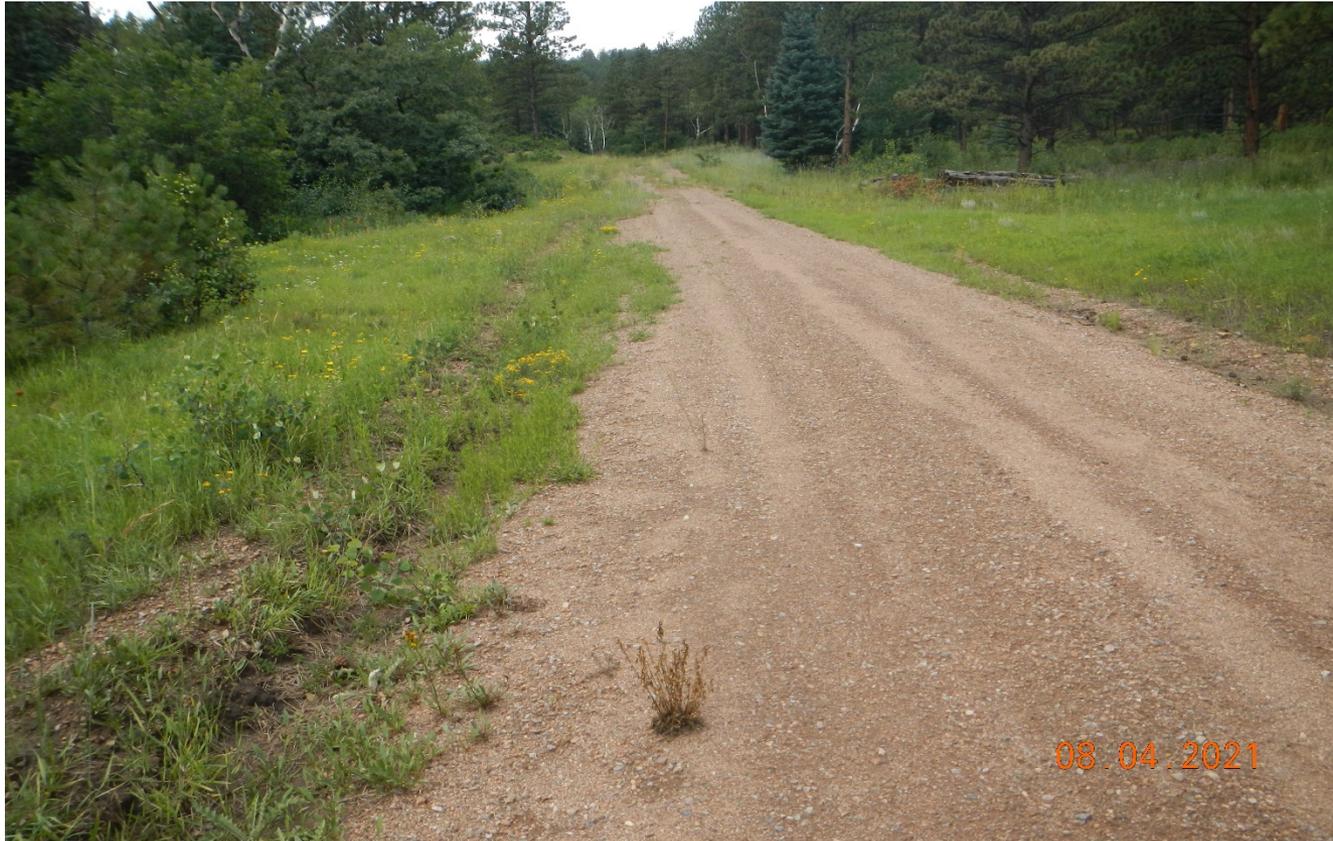
Photo 5. Facing west along the preexisting road traveling to the location.

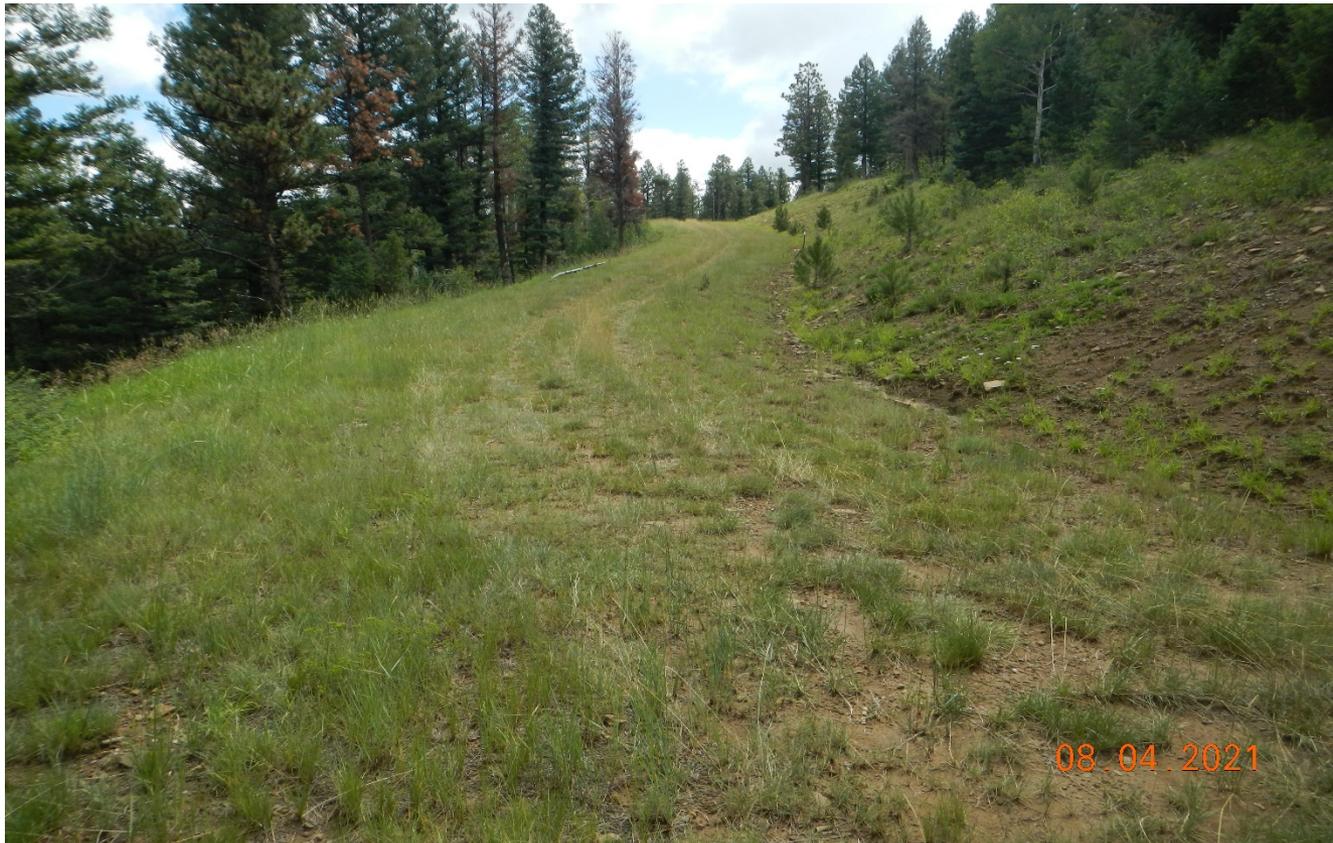
Photo 6. Facing south along the preexisting road traveling to the location. The road is stabilized with vegetation along with other BMP's.

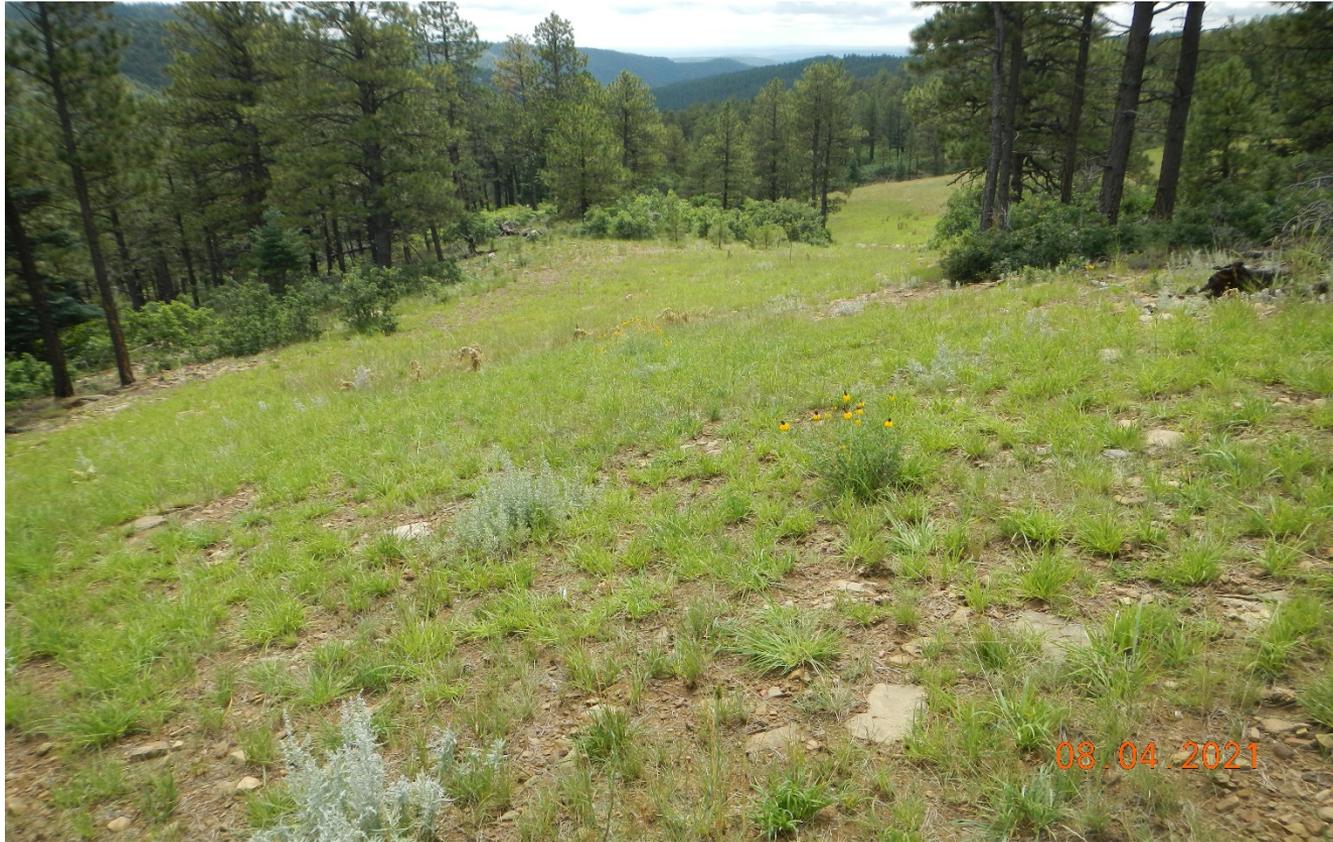
Photo 7. Facing southeast toward the access road which was recontoured and reclaimed.

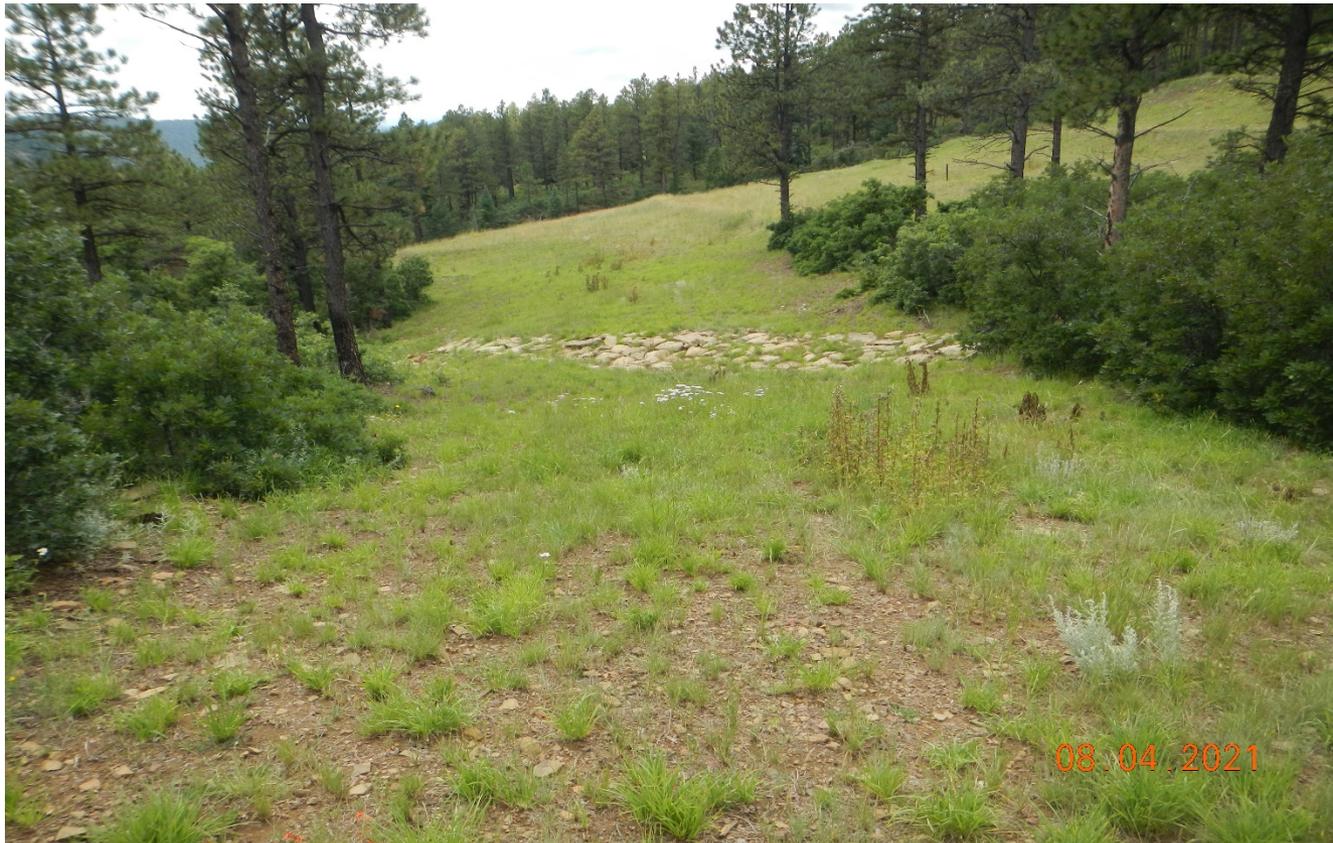
Photo 8. Facing southeast along the access road toward the location.

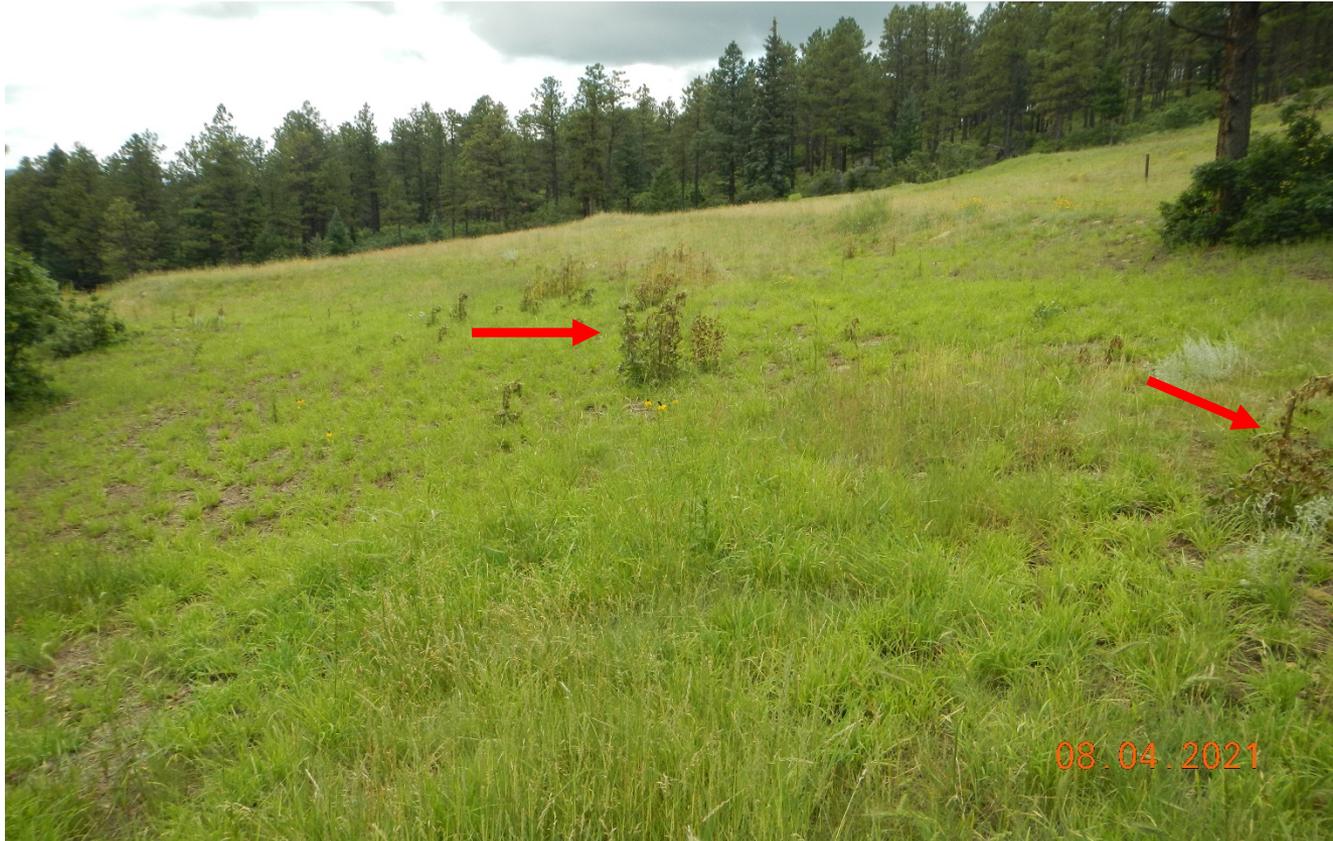
Photo 9. Facing southeast toward the location. There are noxious weeds shown at the red arrow which are wilted from recent weed control.

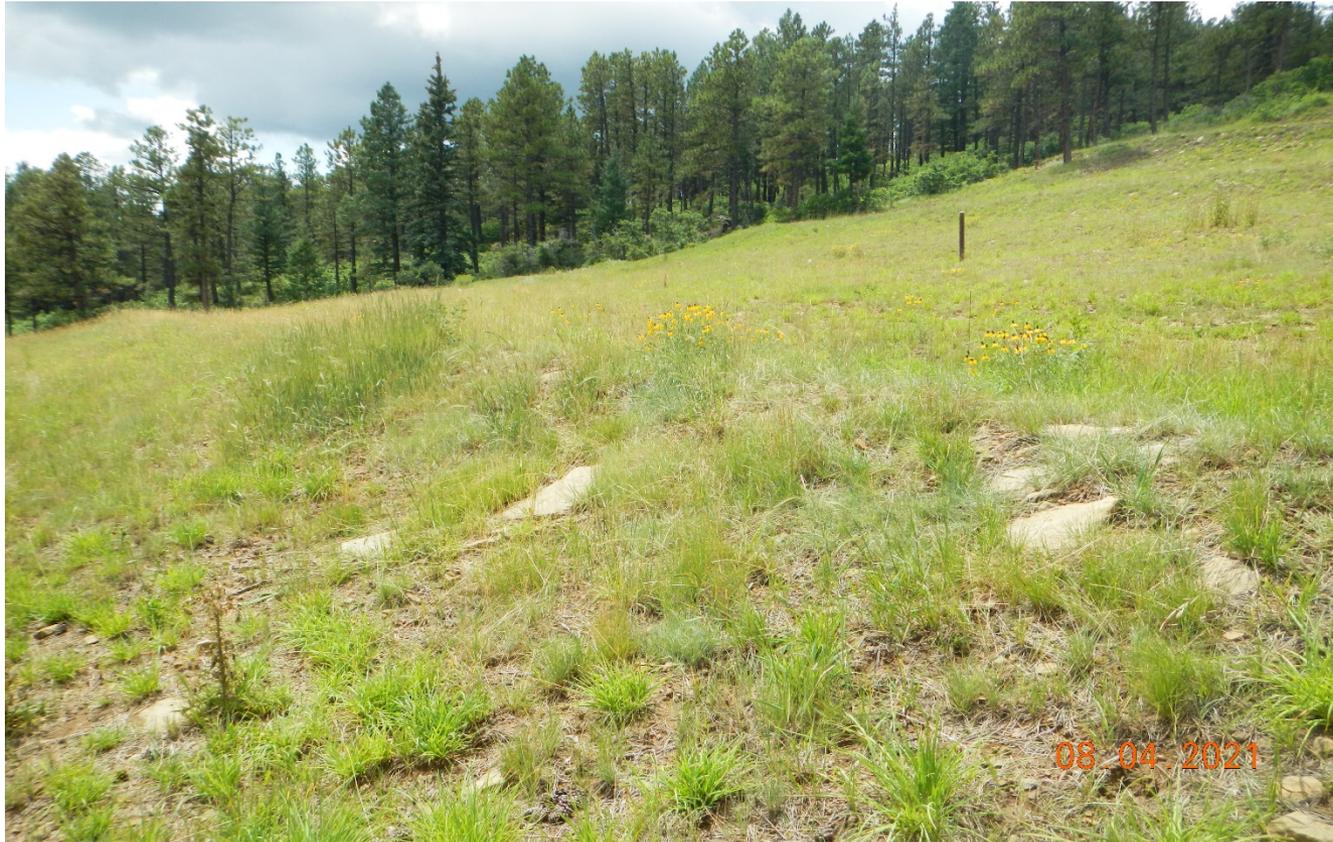
Photo 10. Facing southwest toward the location. The perennial vegetation is well established throughout the location.

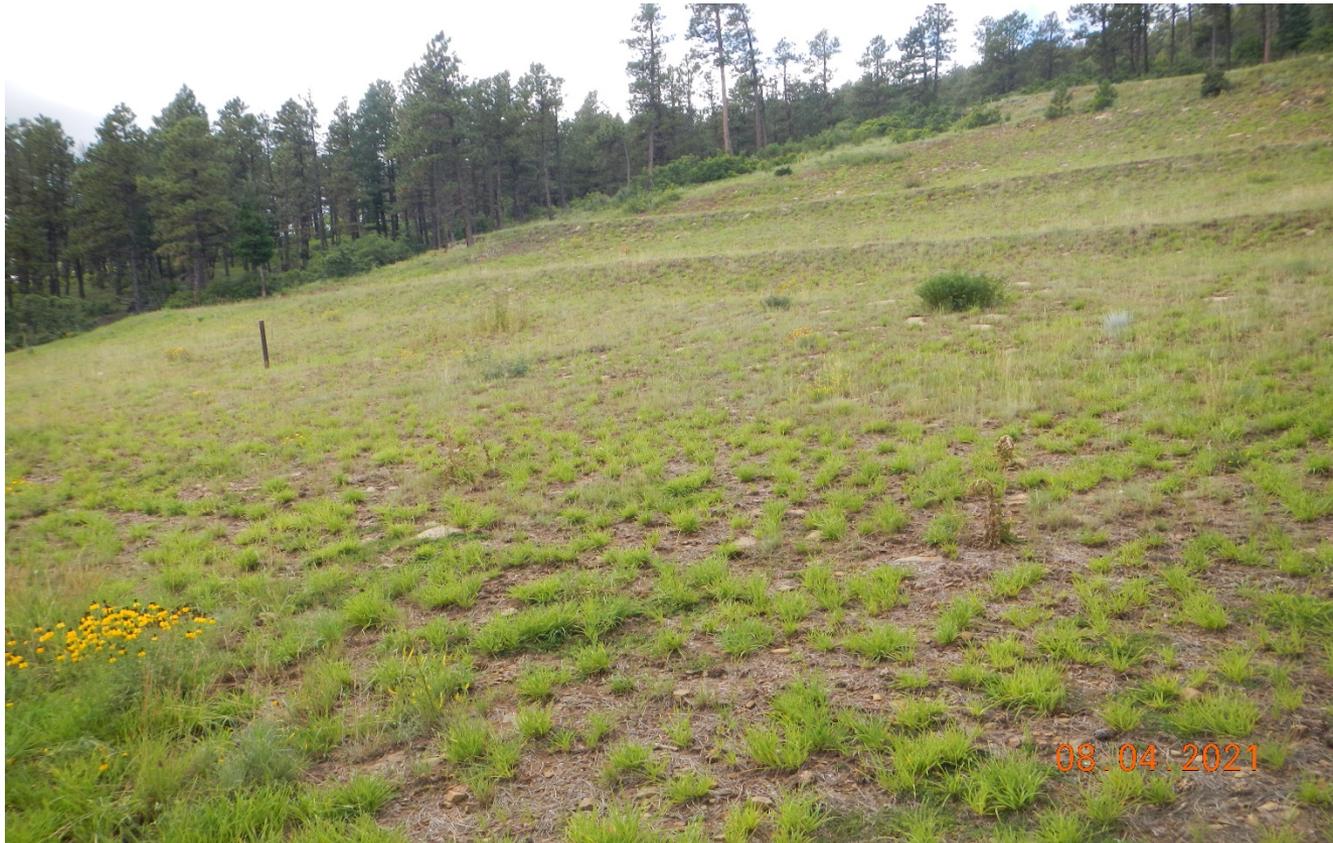
Photo 11. Facing southwest toward the upper portion of the reclaimed location.
