Inspection Photos

API: 071-09540

Operator: EVERGREEN NATURAL RESOURCES

Inspection Date: 8/4/2021

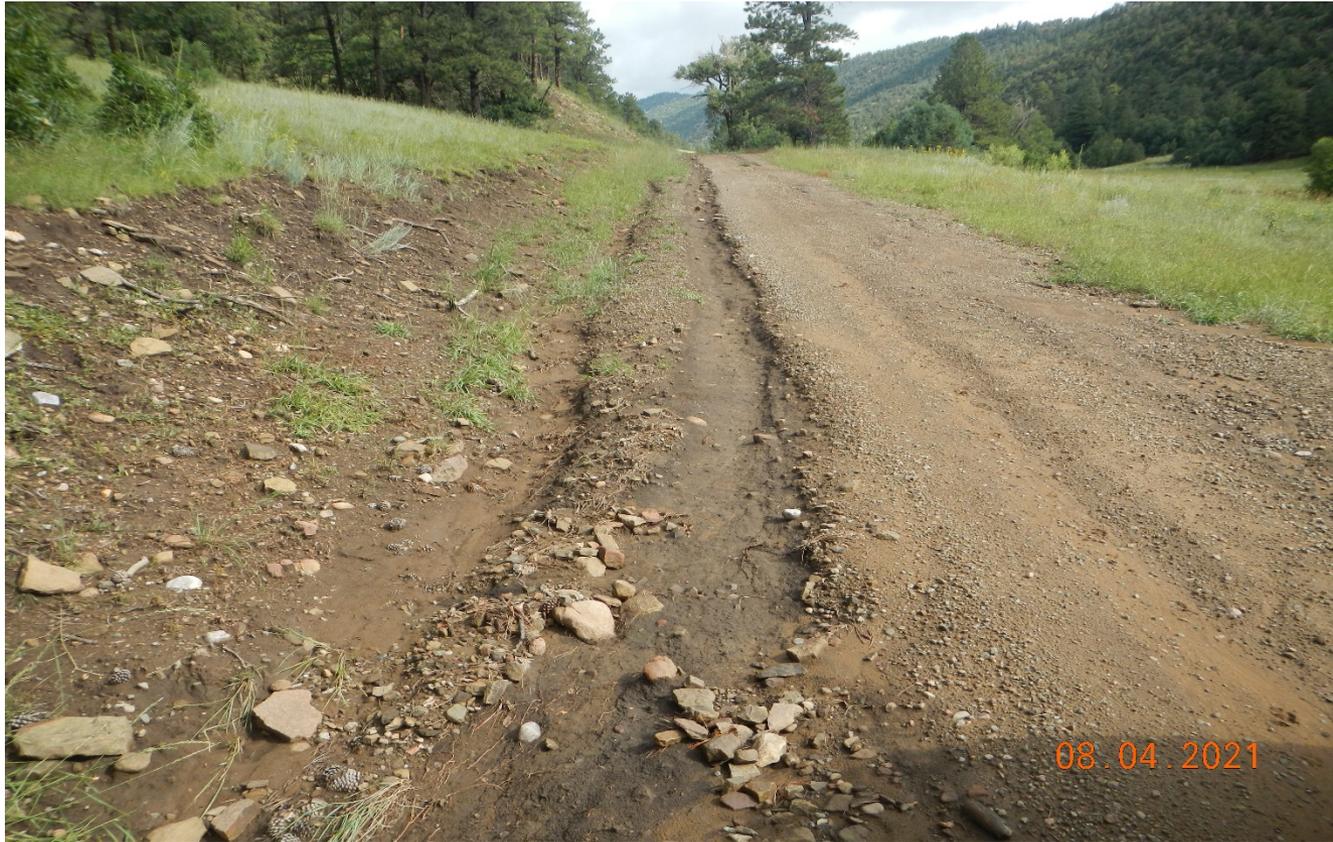
Photo 1. Facing northwest along the road traveling to the location. There A culvert further up is filled in with sediment causing erosion down the road in this area.

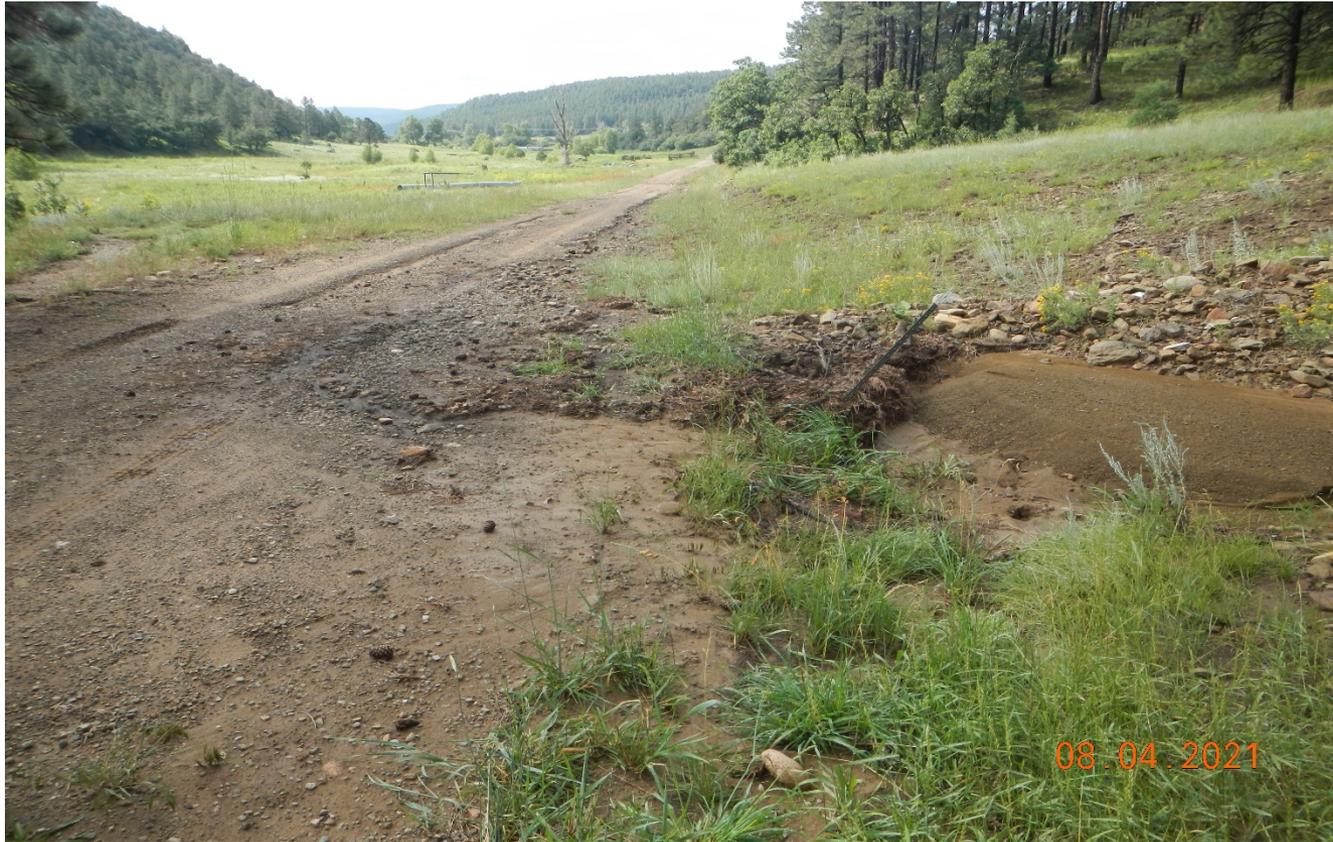
Photo 2. Facing back to the southeast at the culvert filled in with sediment.

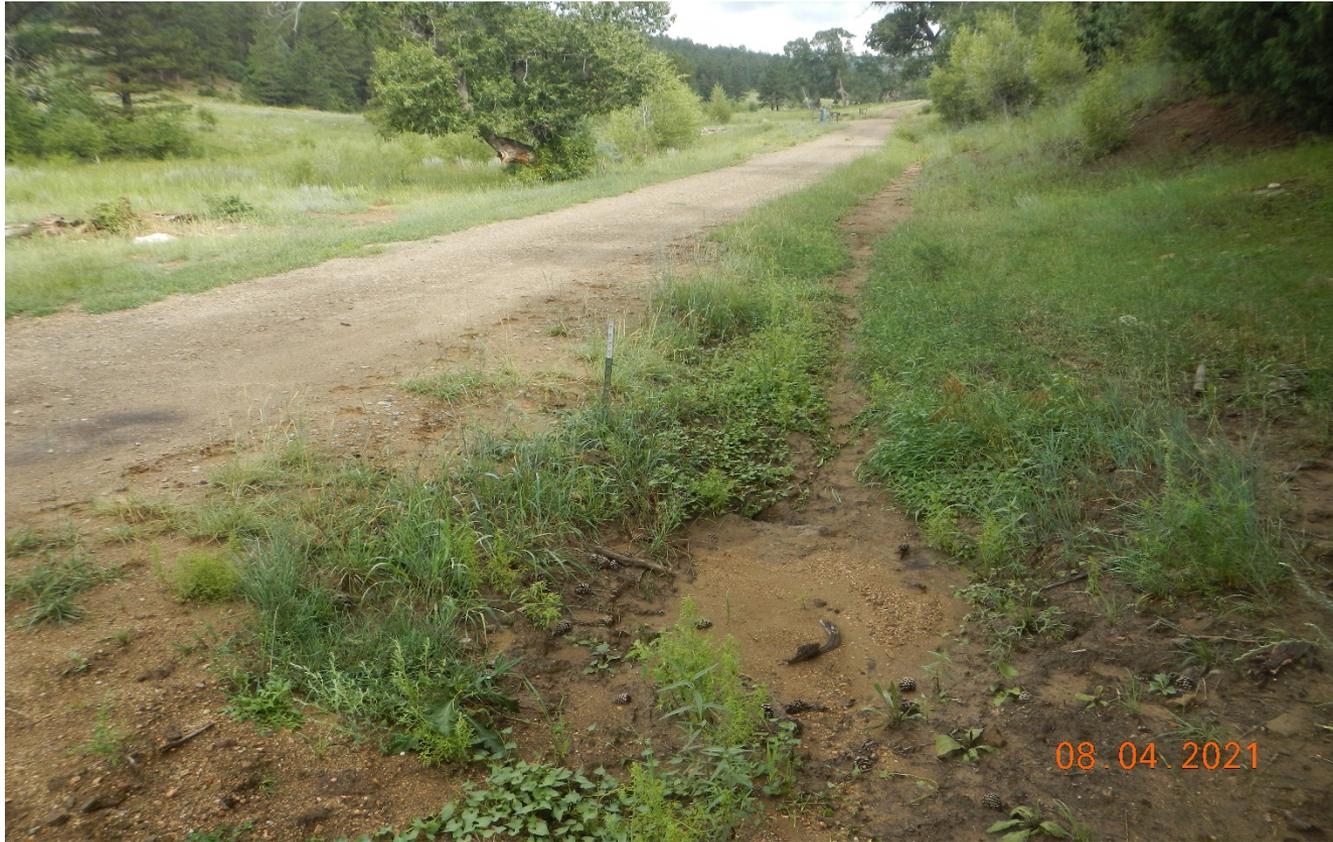
Photo 3. Further up the road in the canyon is another culvert filled in with sediment.

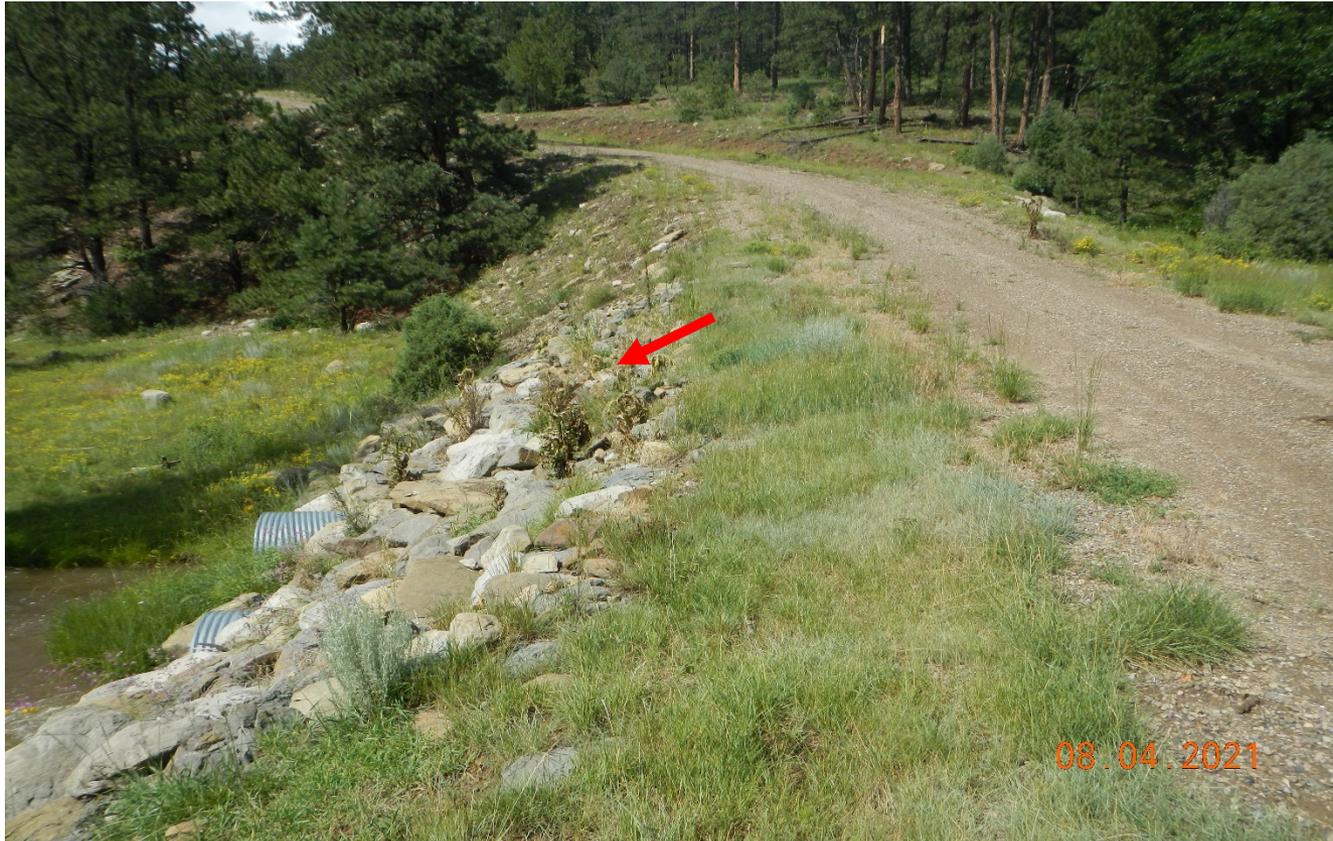
Photo 4. Facing southwest toward the access road. There are wilted noxious weeds from weed control observed along the road shown at red arrow.

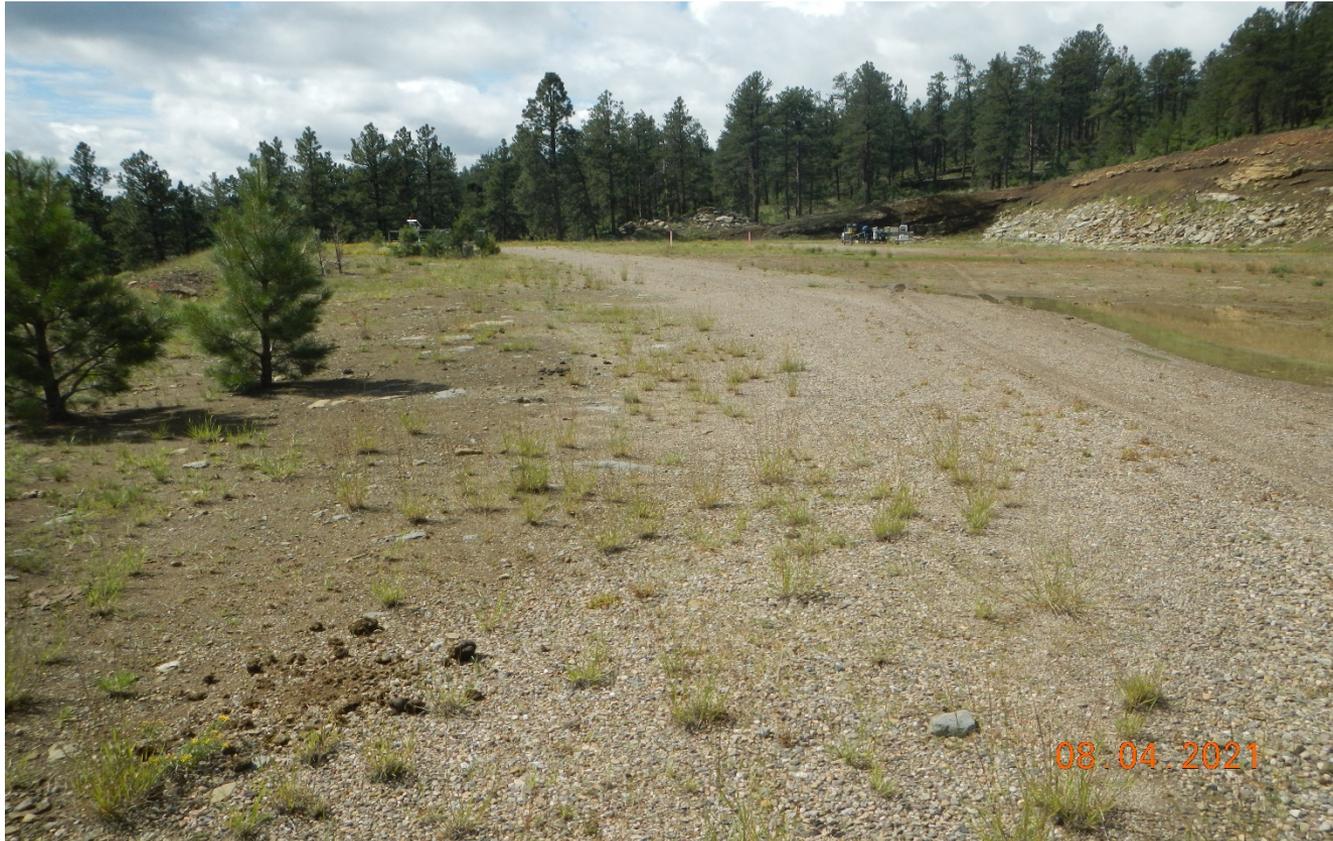
Photo 5. Facing southwest toward the location.

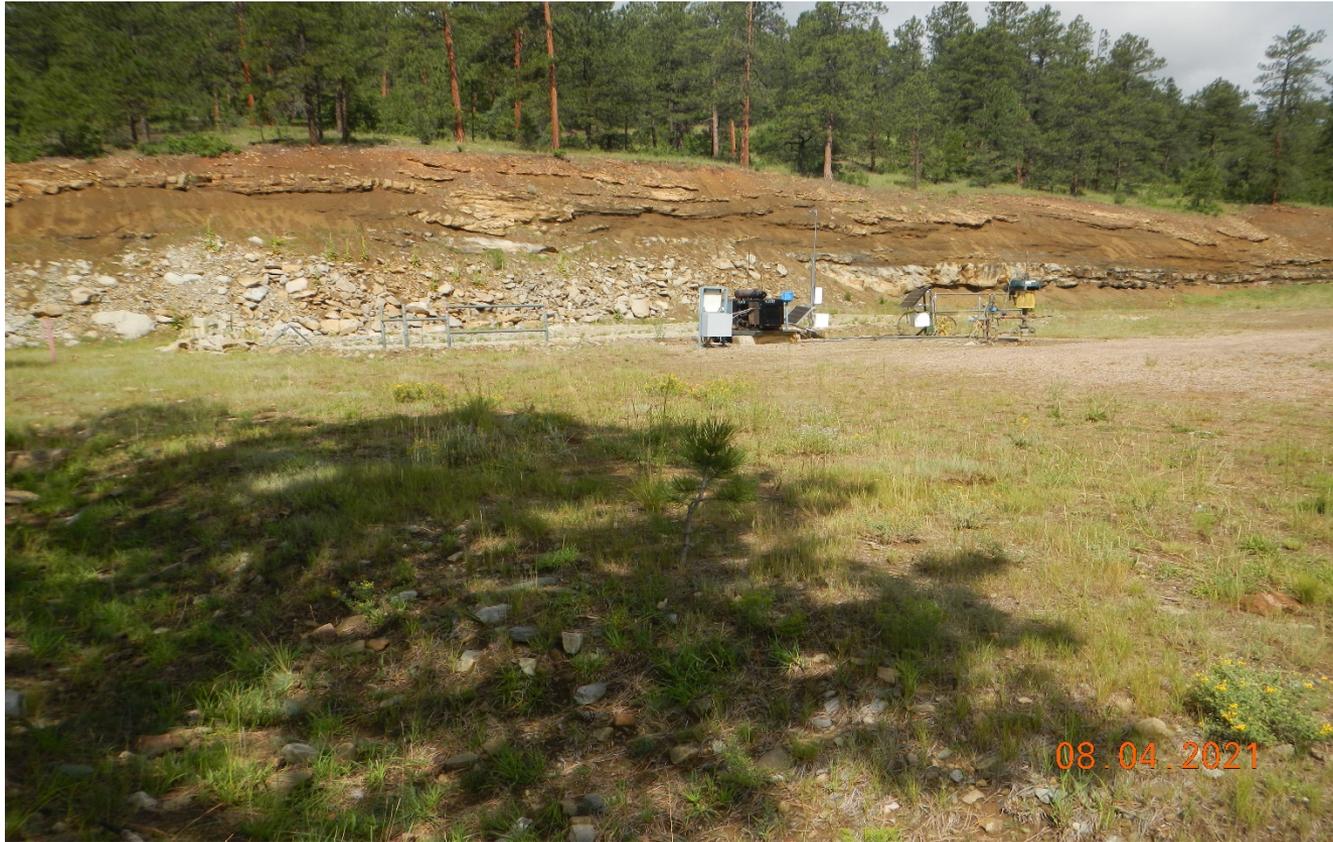
Photo 6. Facing west toward the well site.
