Inspection Photos

Location Name: TEP ROCKY MOUNTAIN LLC UNOCAL-66S96W /34NWNW

Location ID: 335408

COLORADO
Oil & Gas Conservation
Commission
Department of Natural Resources

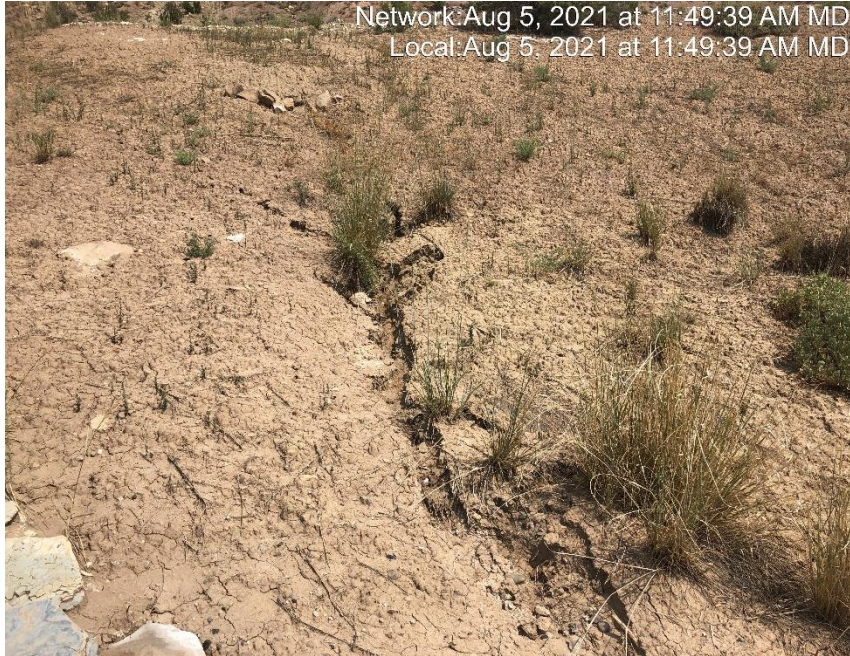
Photo #4715 Rill erosion occurring on cut slope.

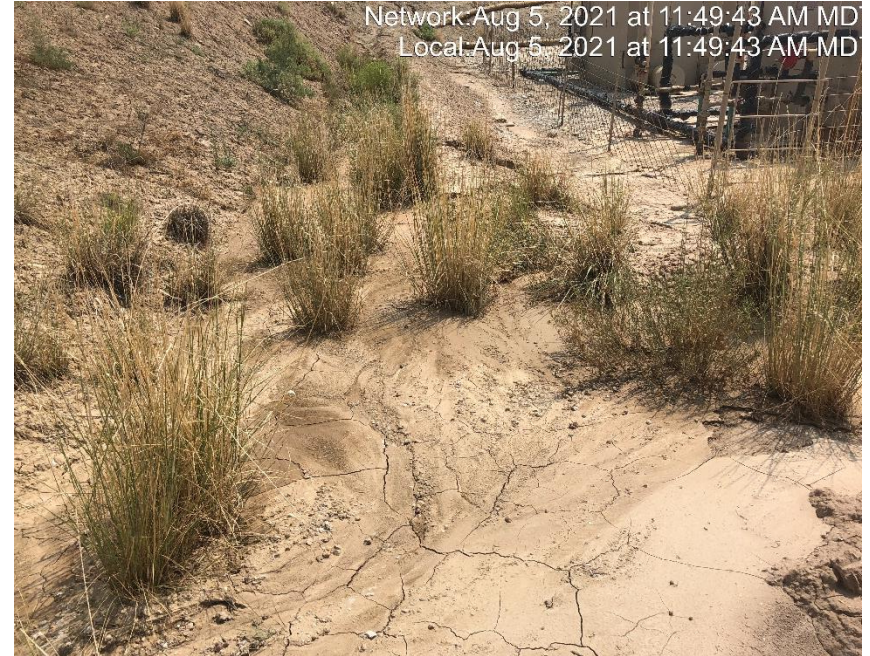
Photo #4716 Ditch is filled with sediment.

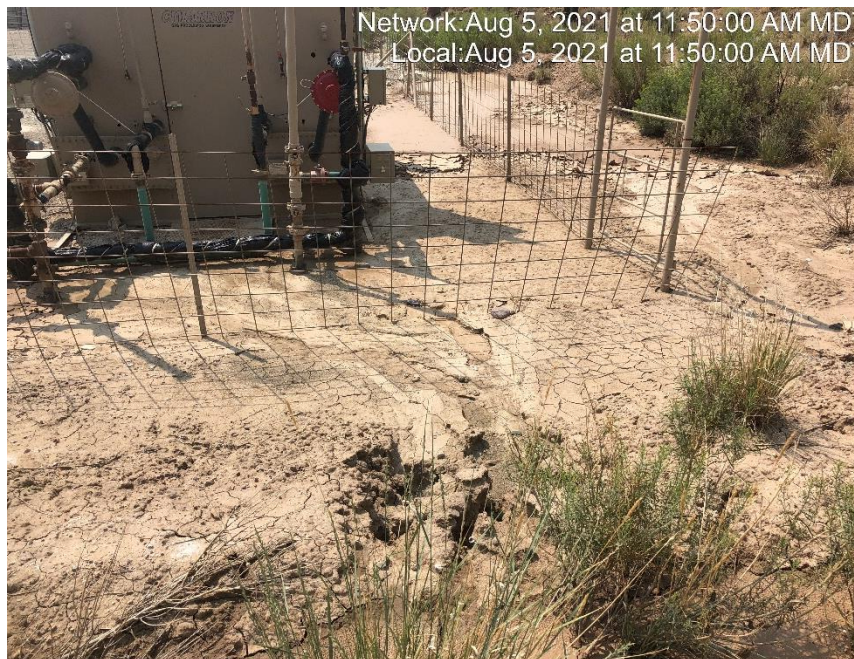
Photo #4717 Sediment is encroaching on production equipment.

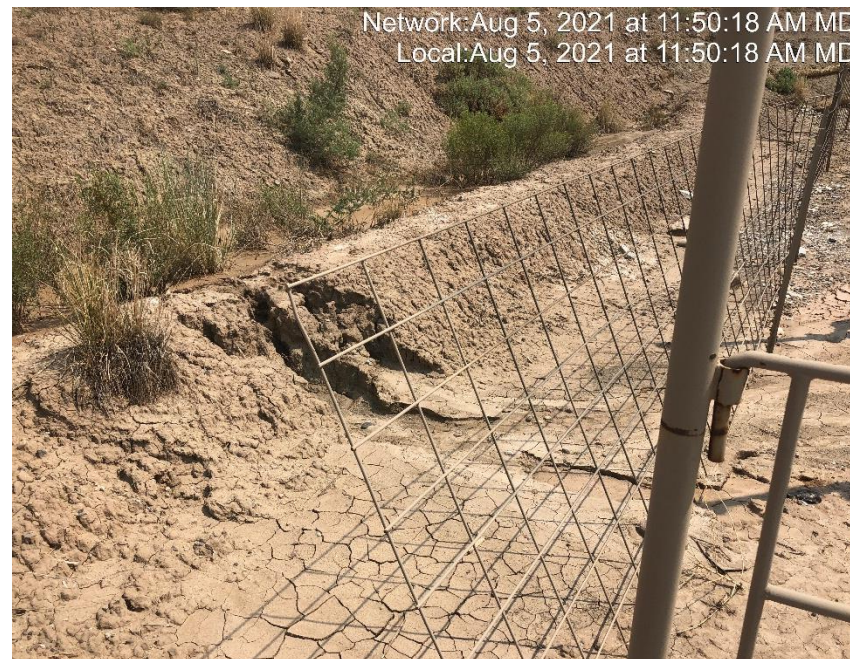
Photo #4718 Ditch is no longer controlling run on to location.

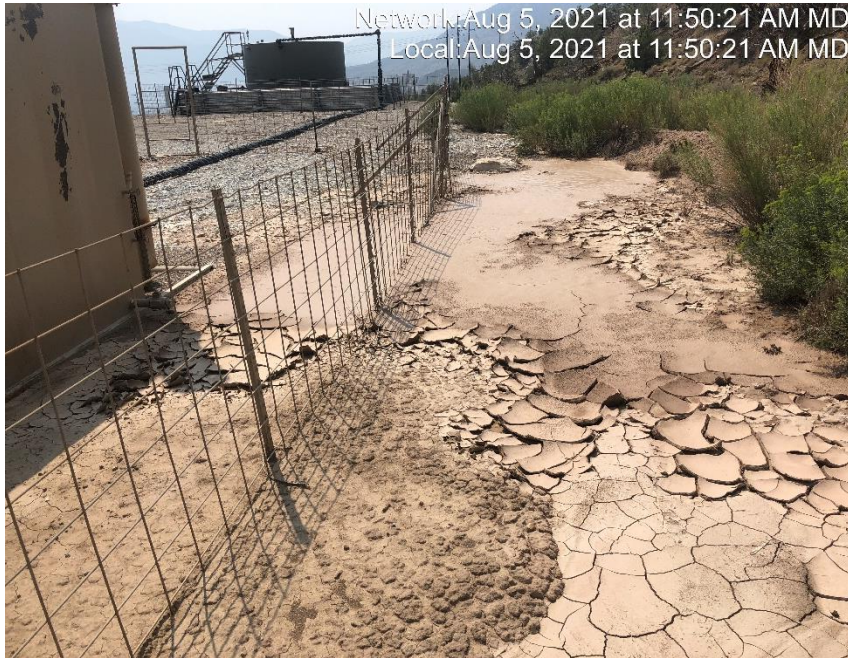
Photo #4719 Sediment is encroaching on production equipment.

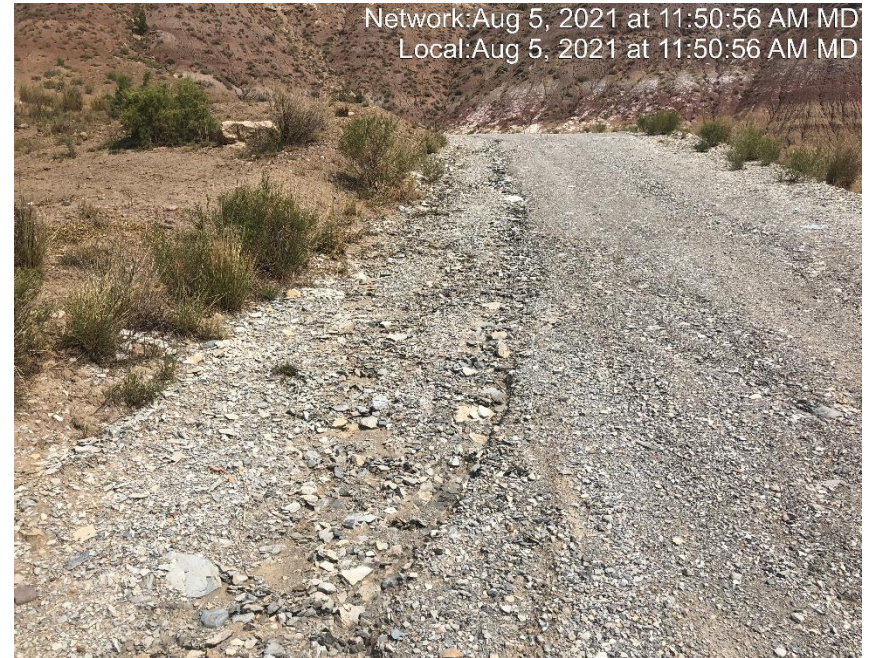
Photo #4720 Access road lacks stabilization.

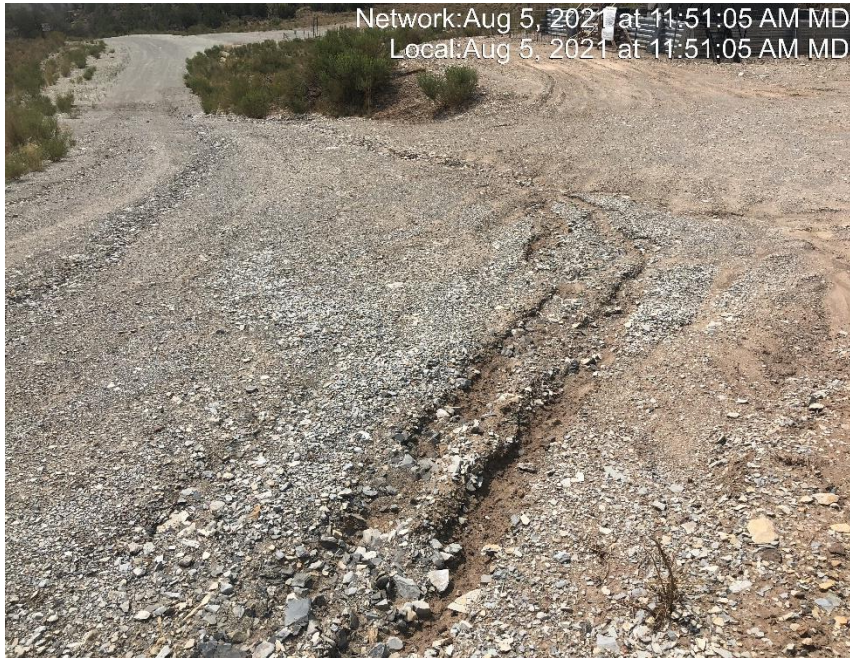
Photo #4721 Access road lacks stabilization.
