Inspection Photos

API: 071-06141

Operator: OGRIS OPERATING LLC

Inspection Date: 8/6/2021

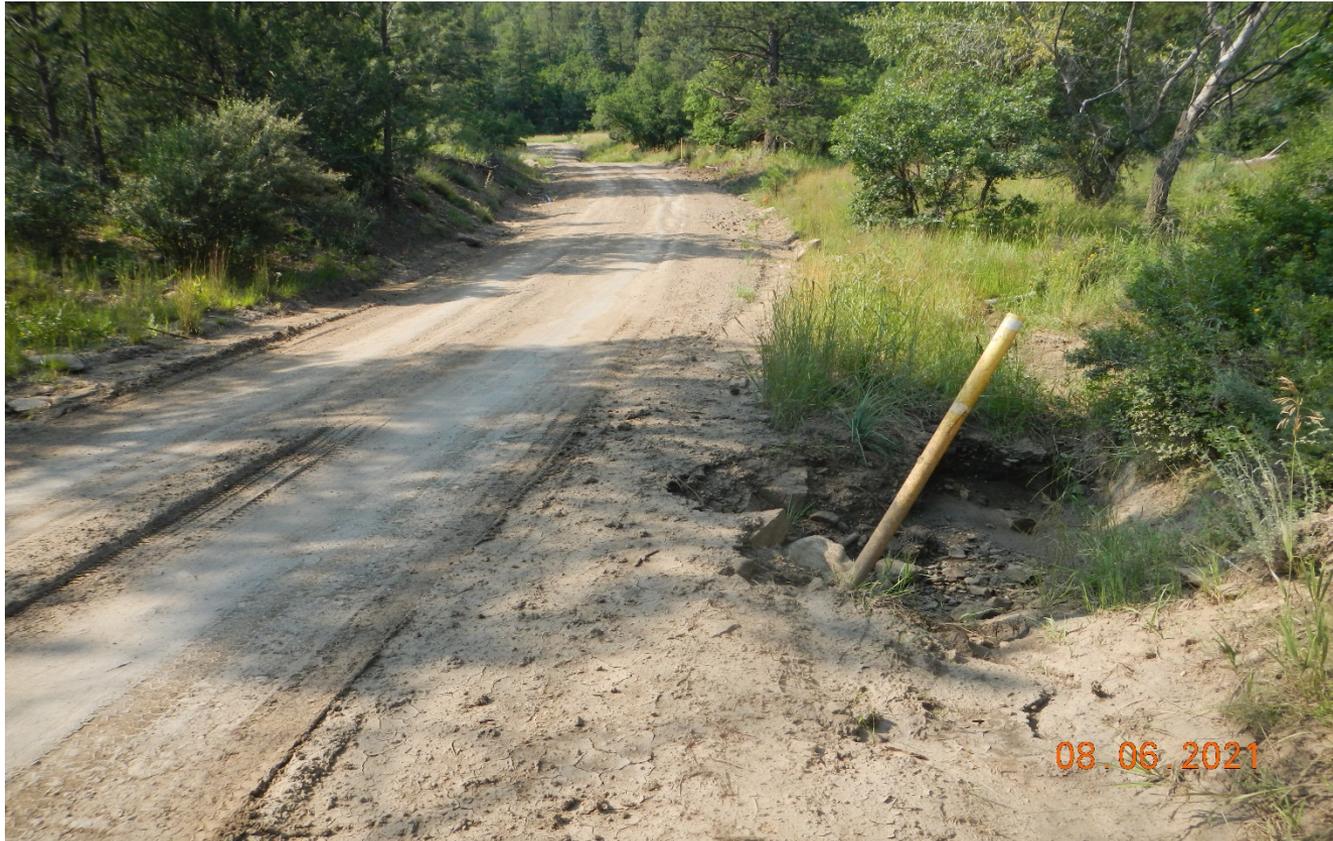
Photo 1. There has been maintenance performed on culverts along the road in the canyon.

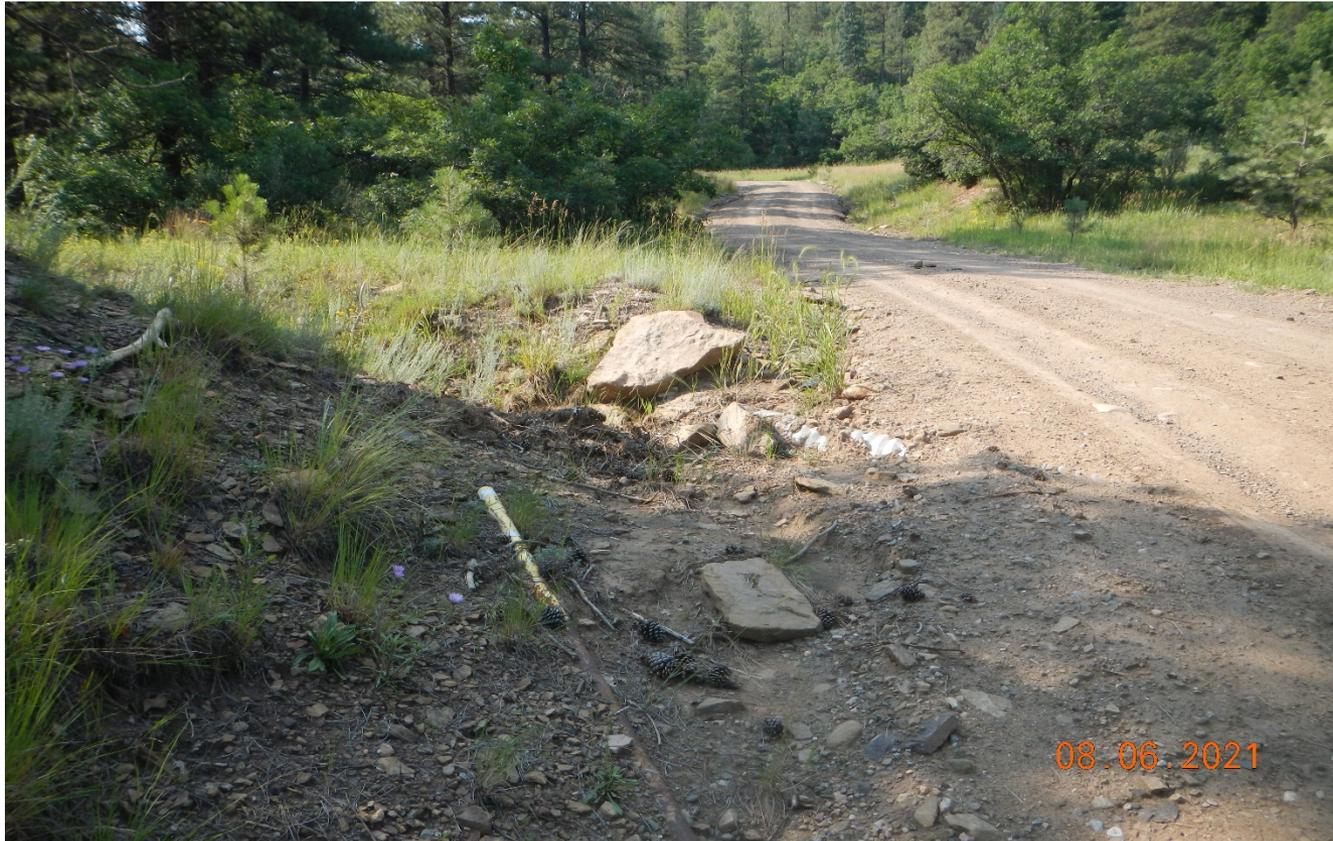
Photo 2. There is metal pipe markers laying on the ground near the culverts. The pipe needs to be removed or reinstalled.

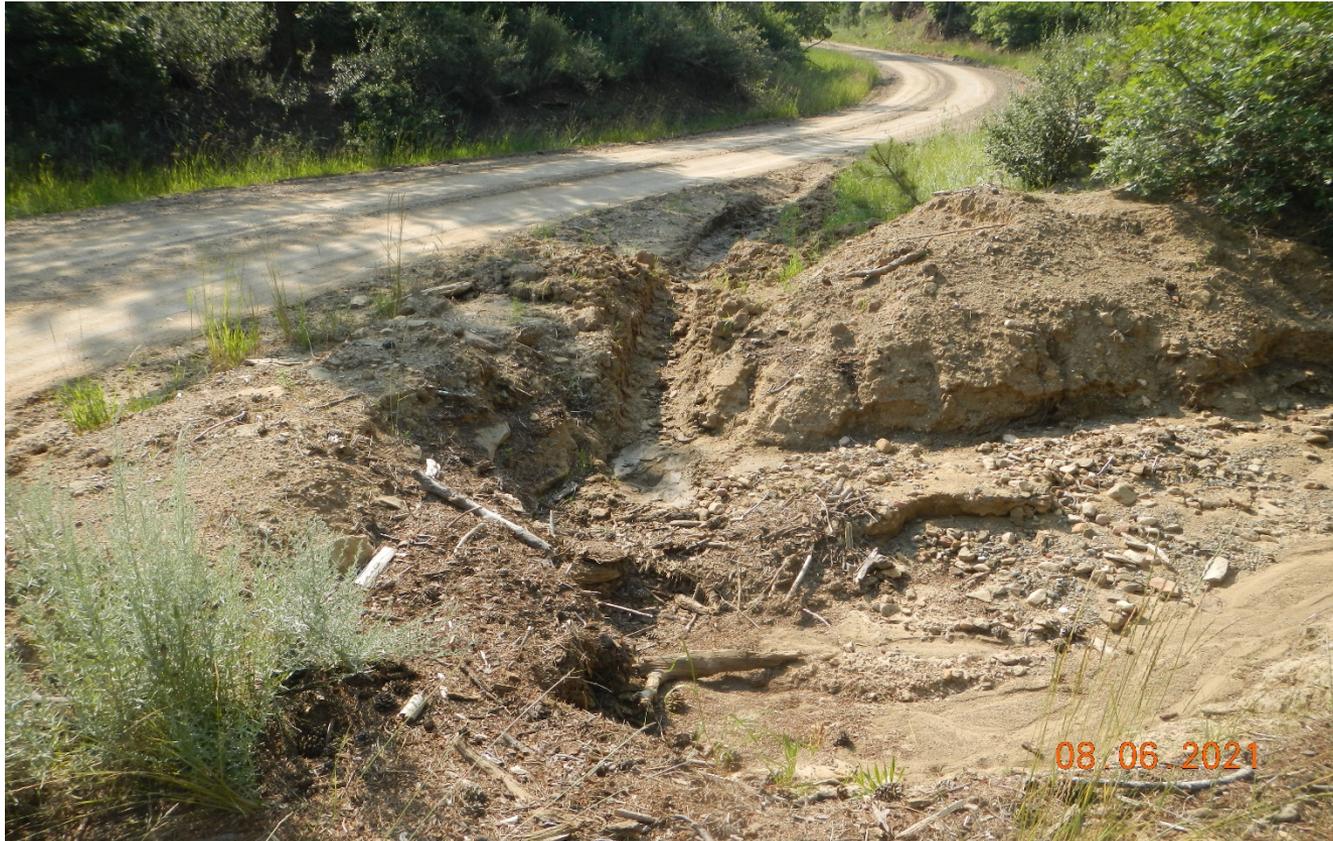
Photo 3. It appears this culvert was cleaned out in the canyon and has since filled back in with debris. Ongoing maintenance is required.

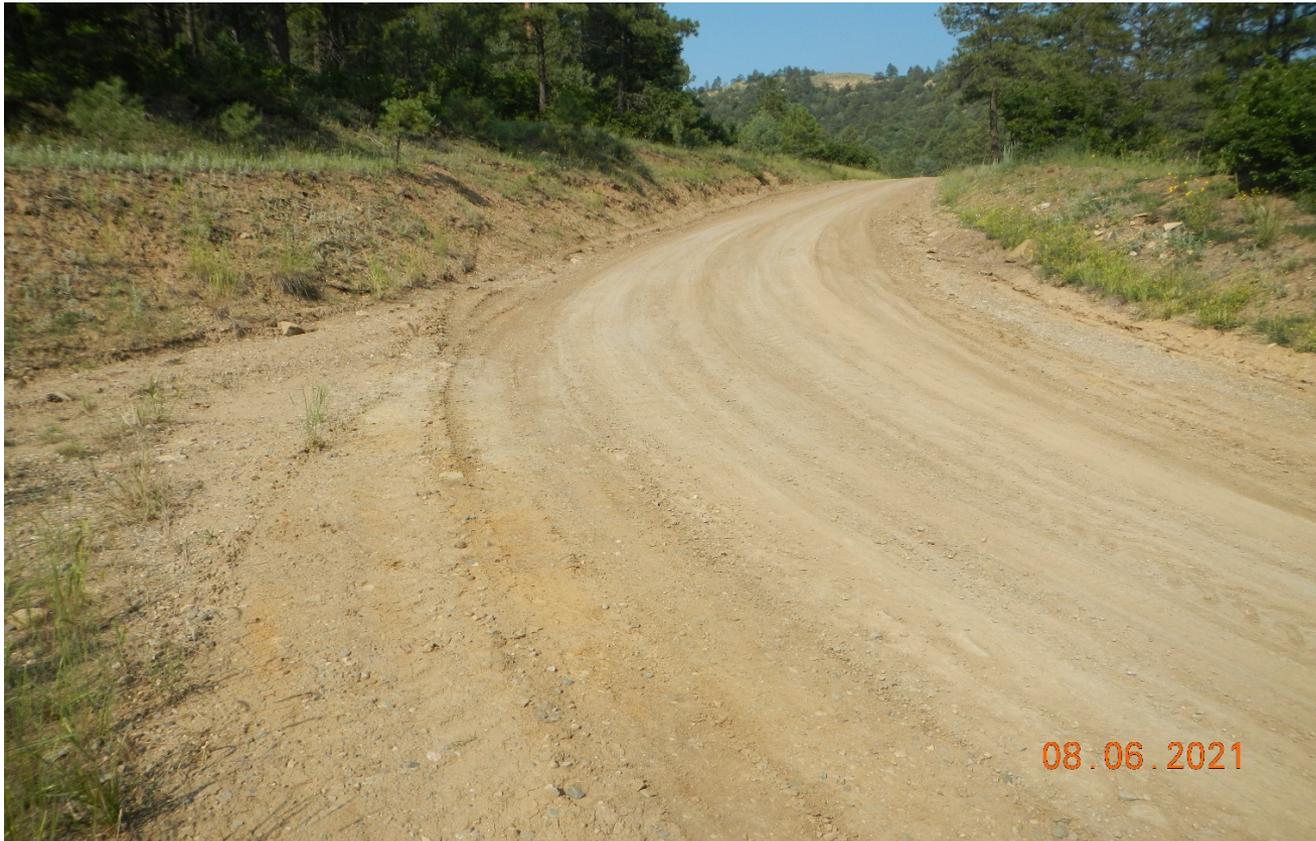
Photo 4. Facing west at the switch back of the road where there was vehicle rutting. The road was graded however, the road was not stabilized and vehicle rutting may occur during wet winter condition.

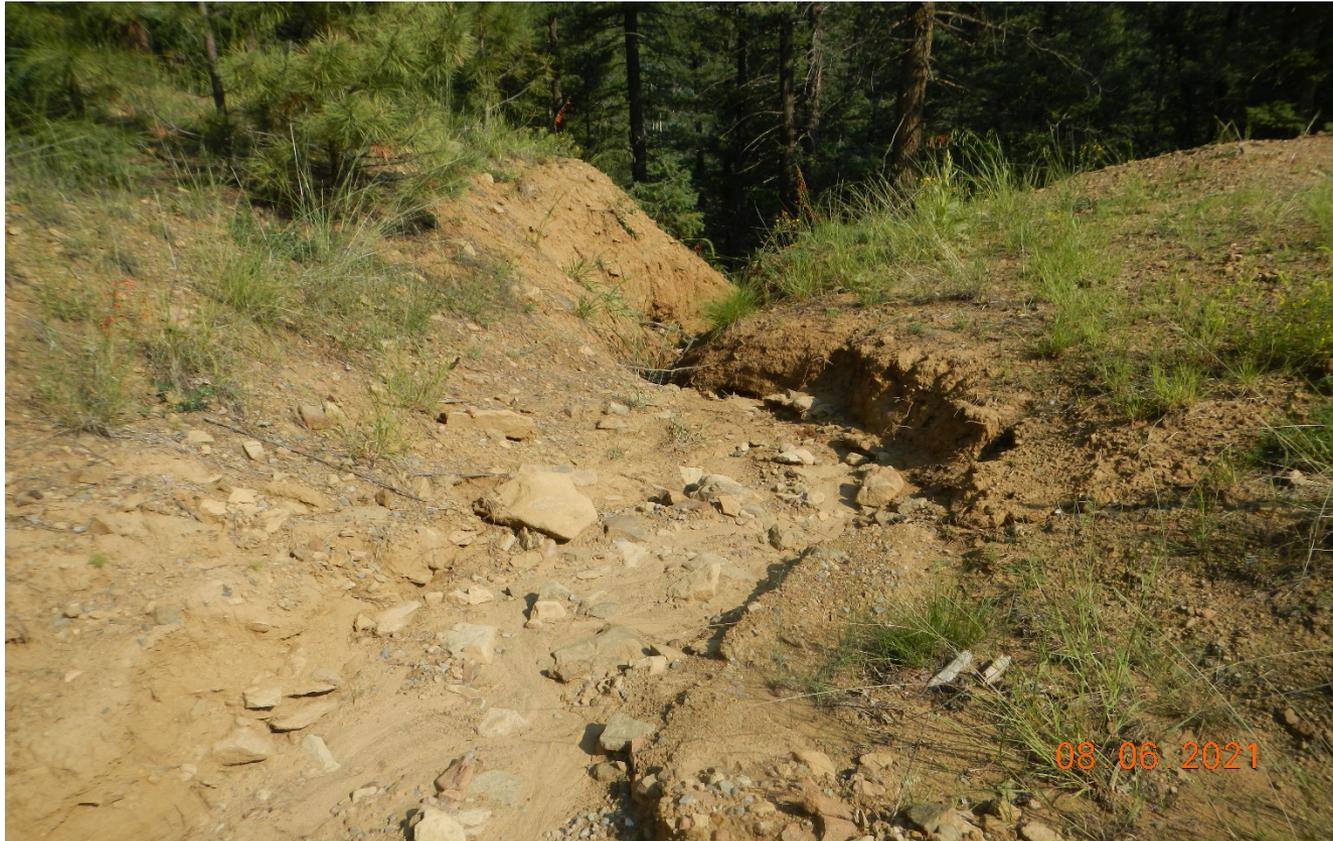
Photo 5. The erosion gully at the second switchback of the road was not repaired/stabilized.

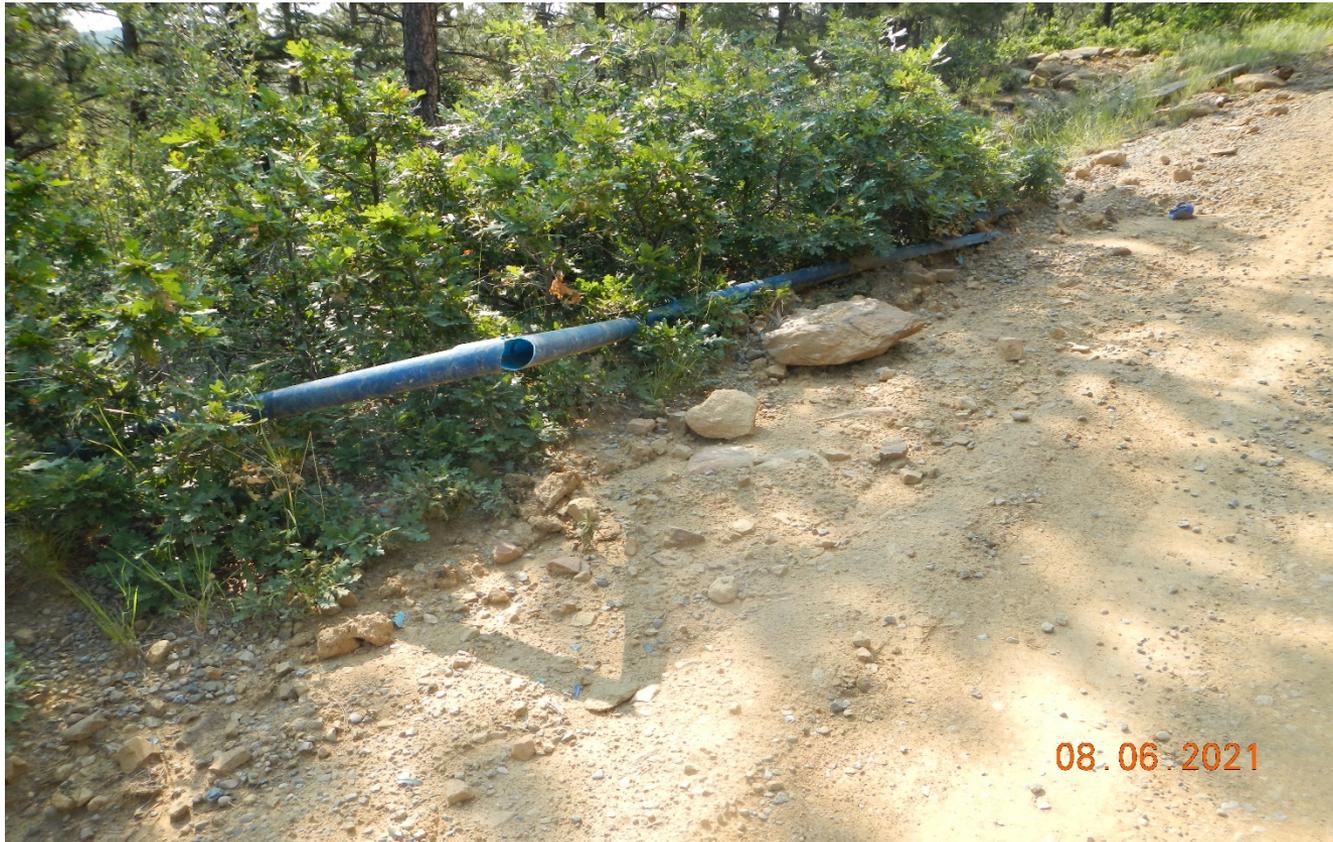
Photo 6. There is blue fiberglass pipe along area of the road that is broke apart and is trash. The pipe debris needs to be removed.

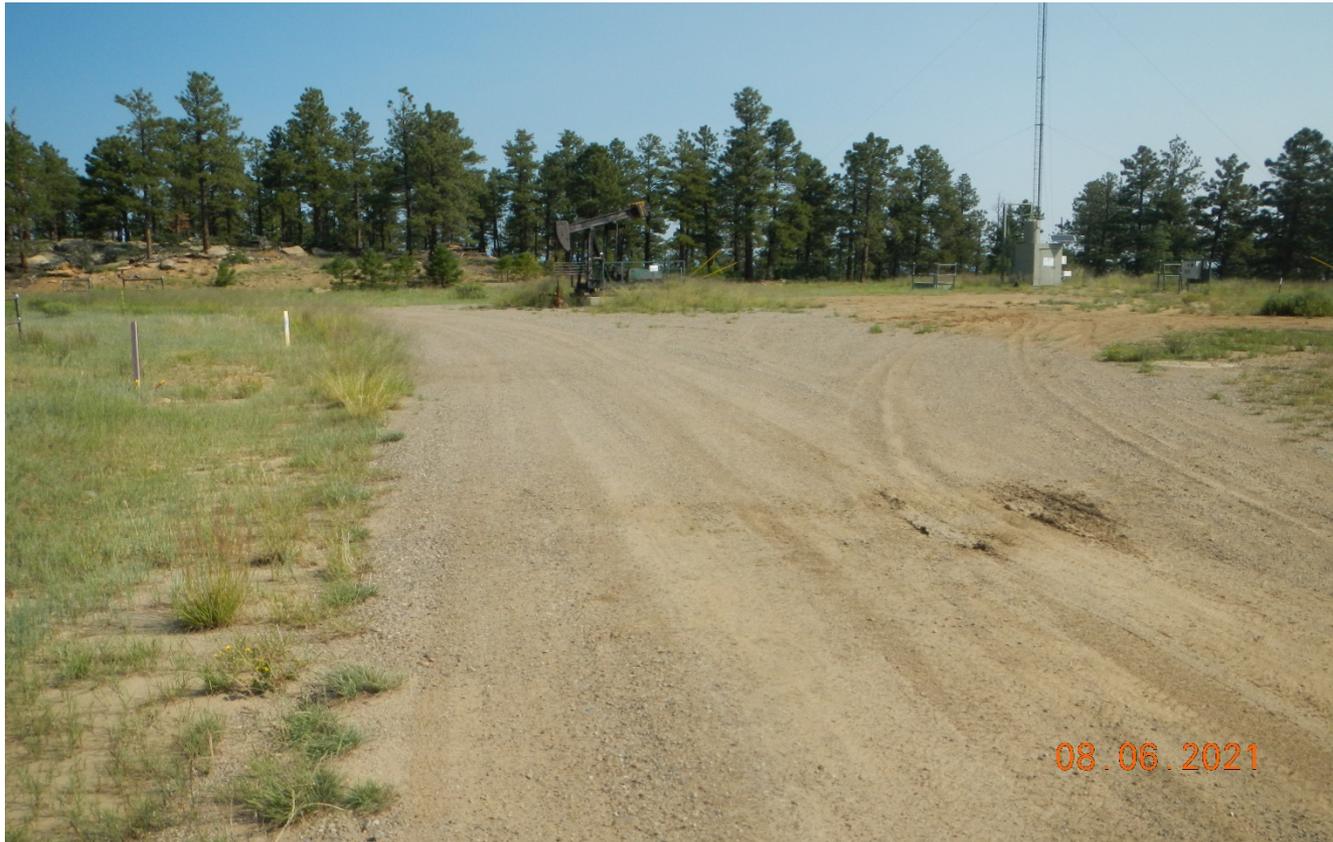
Photo 7. Facing toward the location.
