Inspection Photos

8/3/2021

Operator: GUNNISON ENERGY LLC #10515

Location ID: 453805

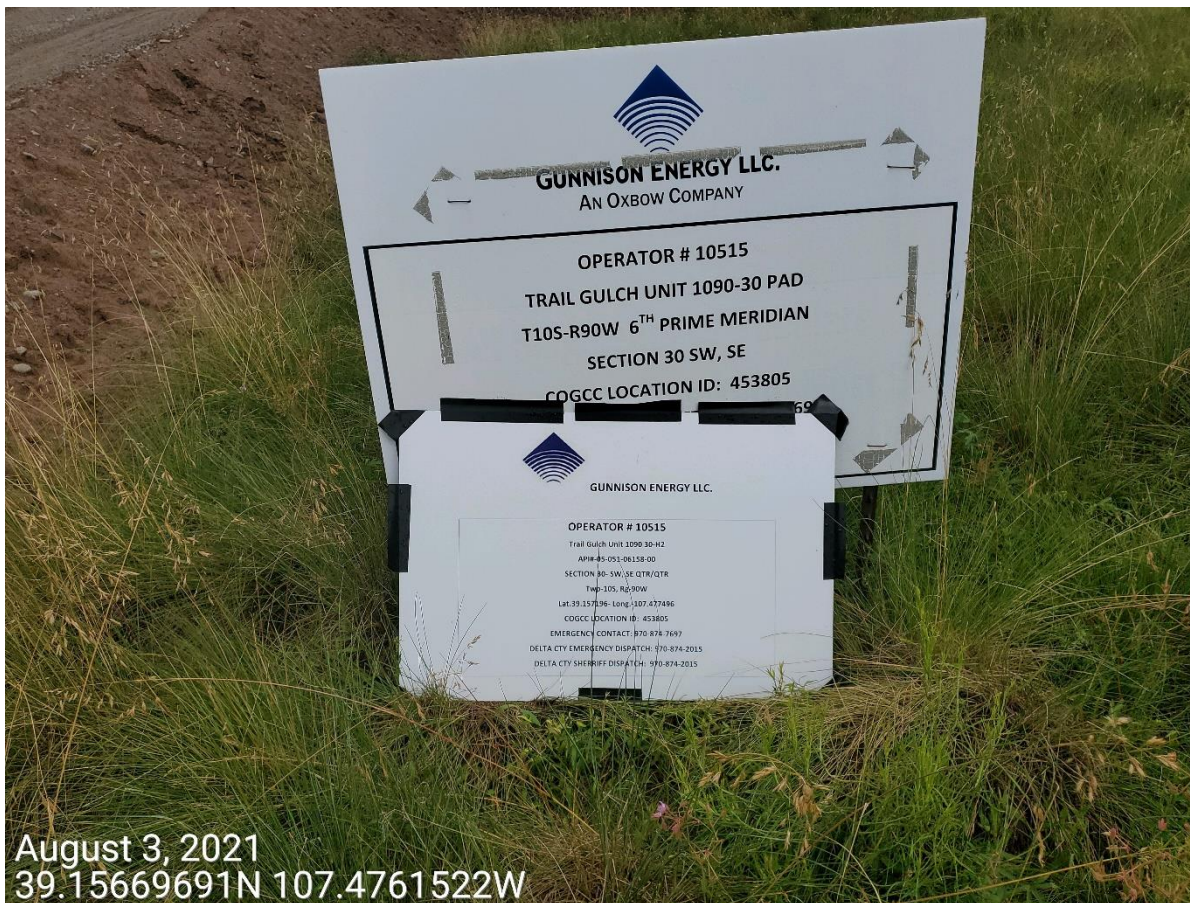
Photo 1: Photo of signage at Location entrance

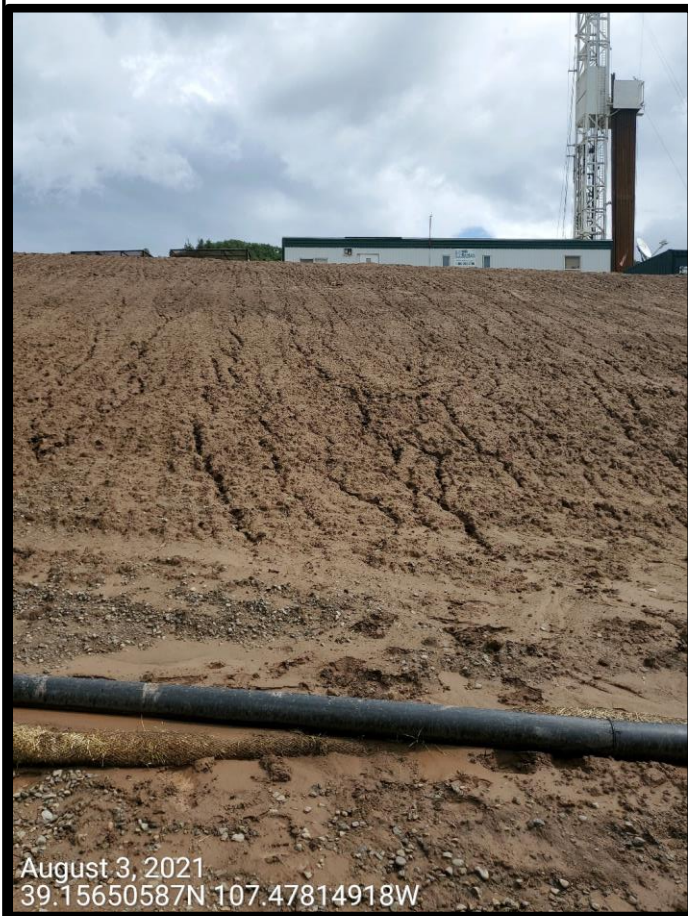
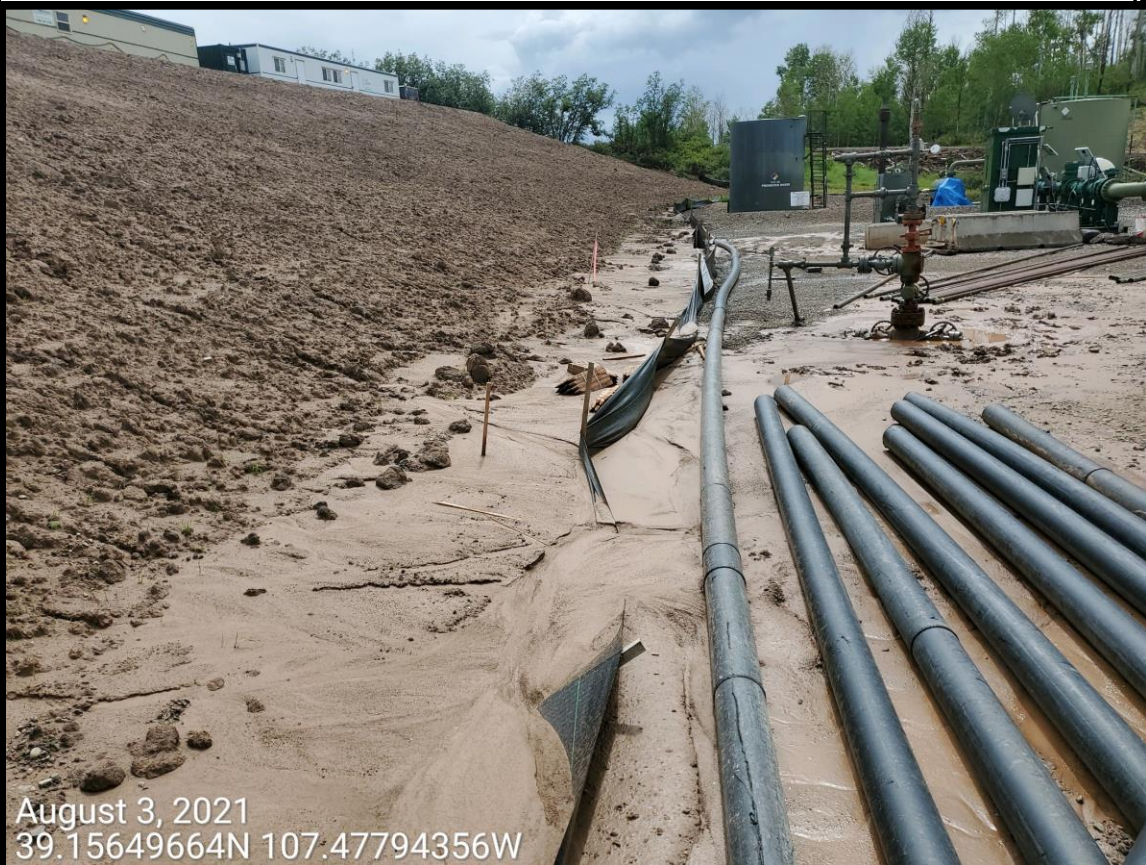
Photo 2: Photo taken from the fill slopes on the west end of the Location. Photo shows stormwater and erosion control measures to protect/stabilize the slopes of the Location, and to properly manage discharge remains missing or inadequate.

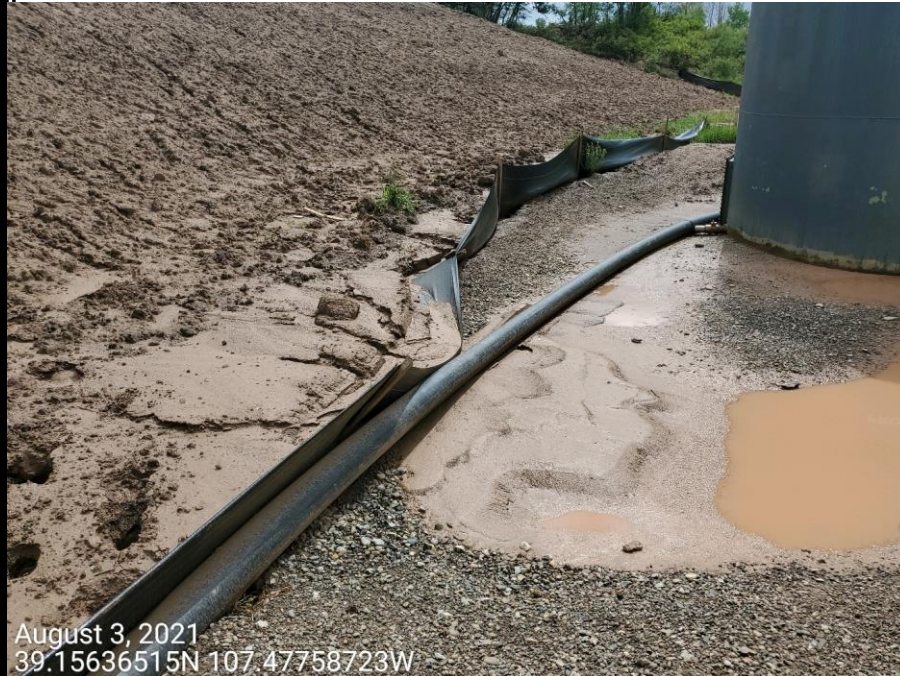
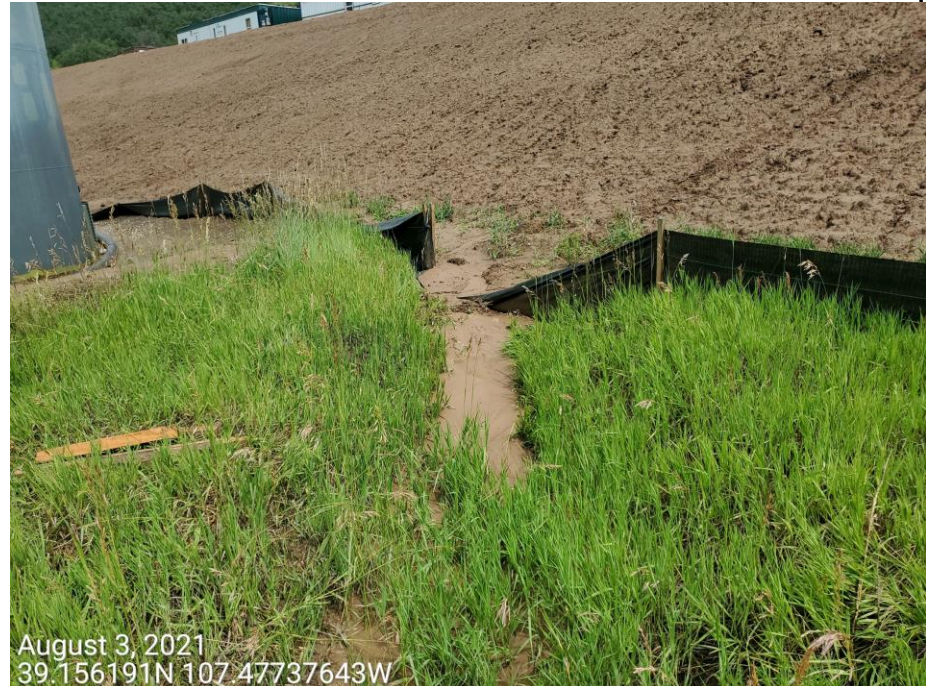
Photo 3: Photo taken from the fill slopes on the west end of the Location. Photo shows stormwater and erosion control measures to protect/stabilize the slopes of the Location, and to properly manage discharge remains missing or inadequate.

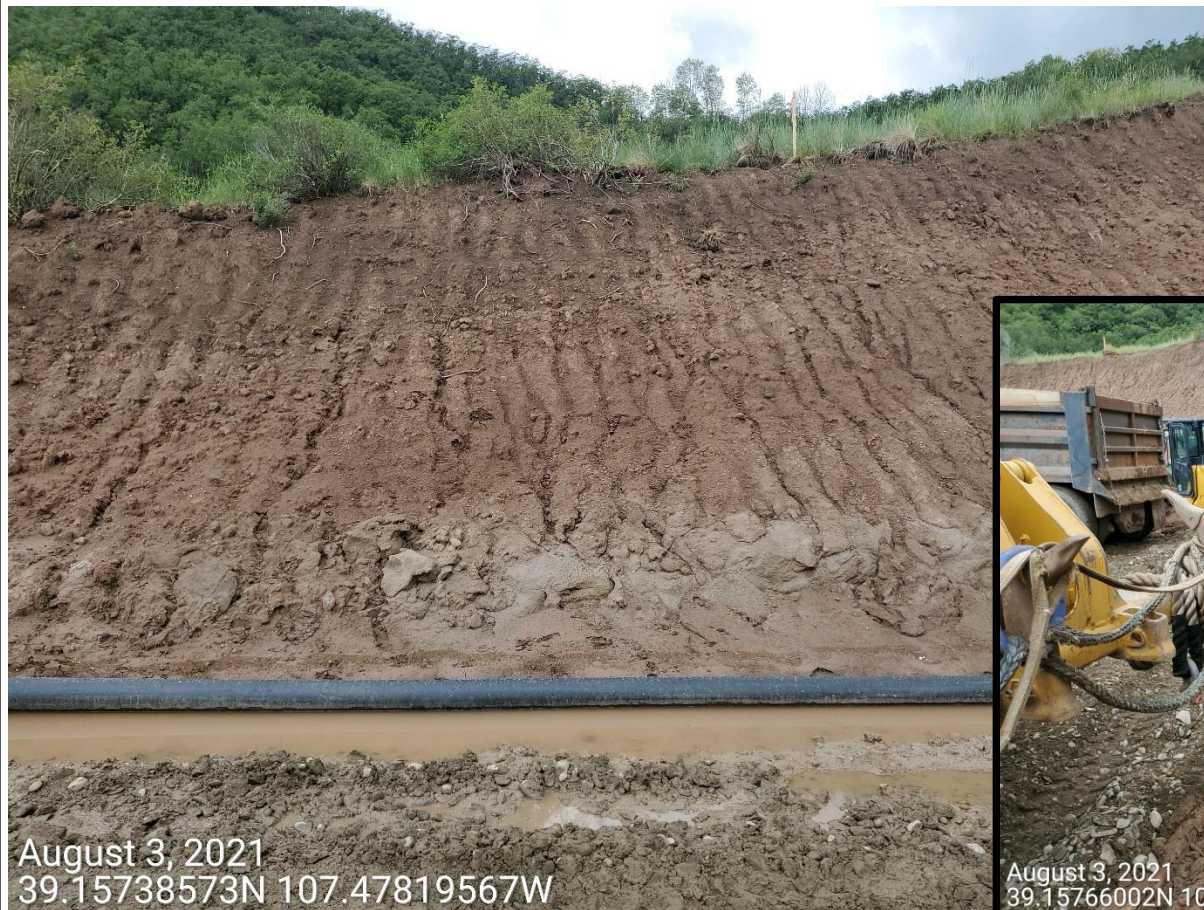
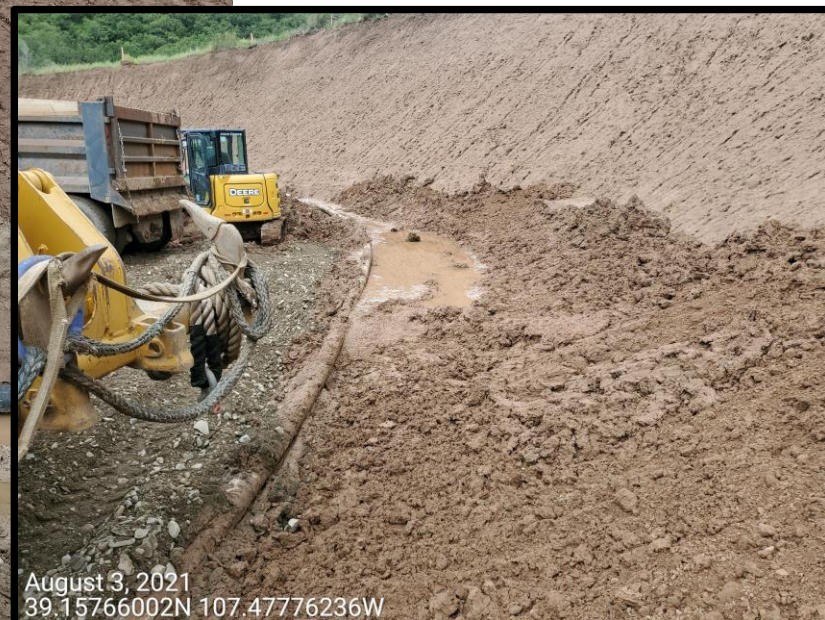
Photo 4: Photo taken from the cut slopes on the east end of the Location. Photo shows stormwater and erosion control measures to protect/stabilize the slopes of the Location remain missing or inadequate.

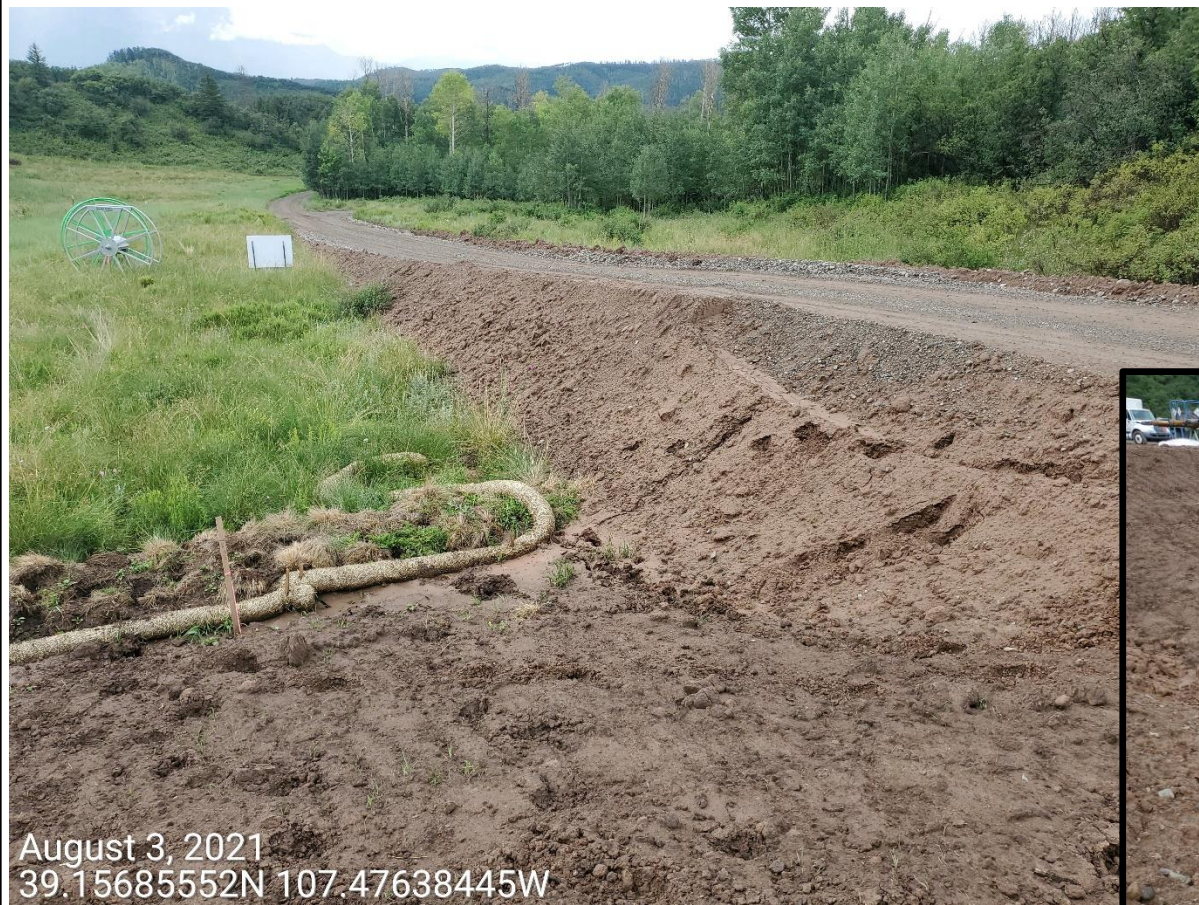
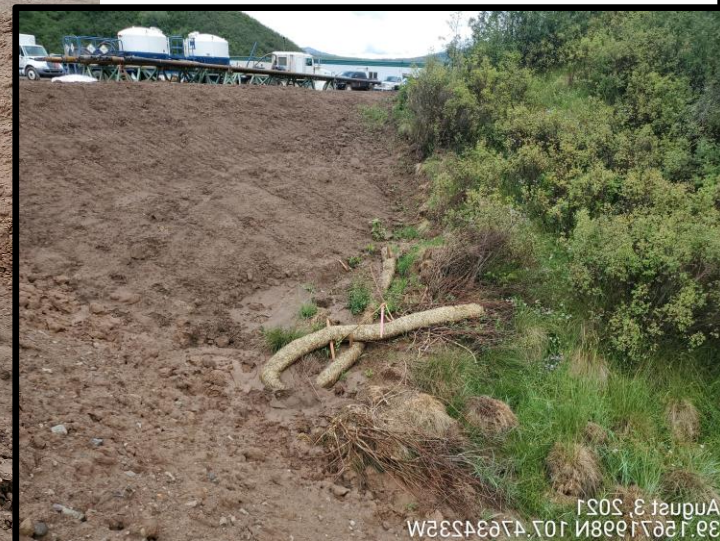
Photo 5: Photo taken from the North end of the Location, facing south. Photo shows vegetation establishment is predominantly undesirable weedy plant species. Little to no desirable plant germination observed.

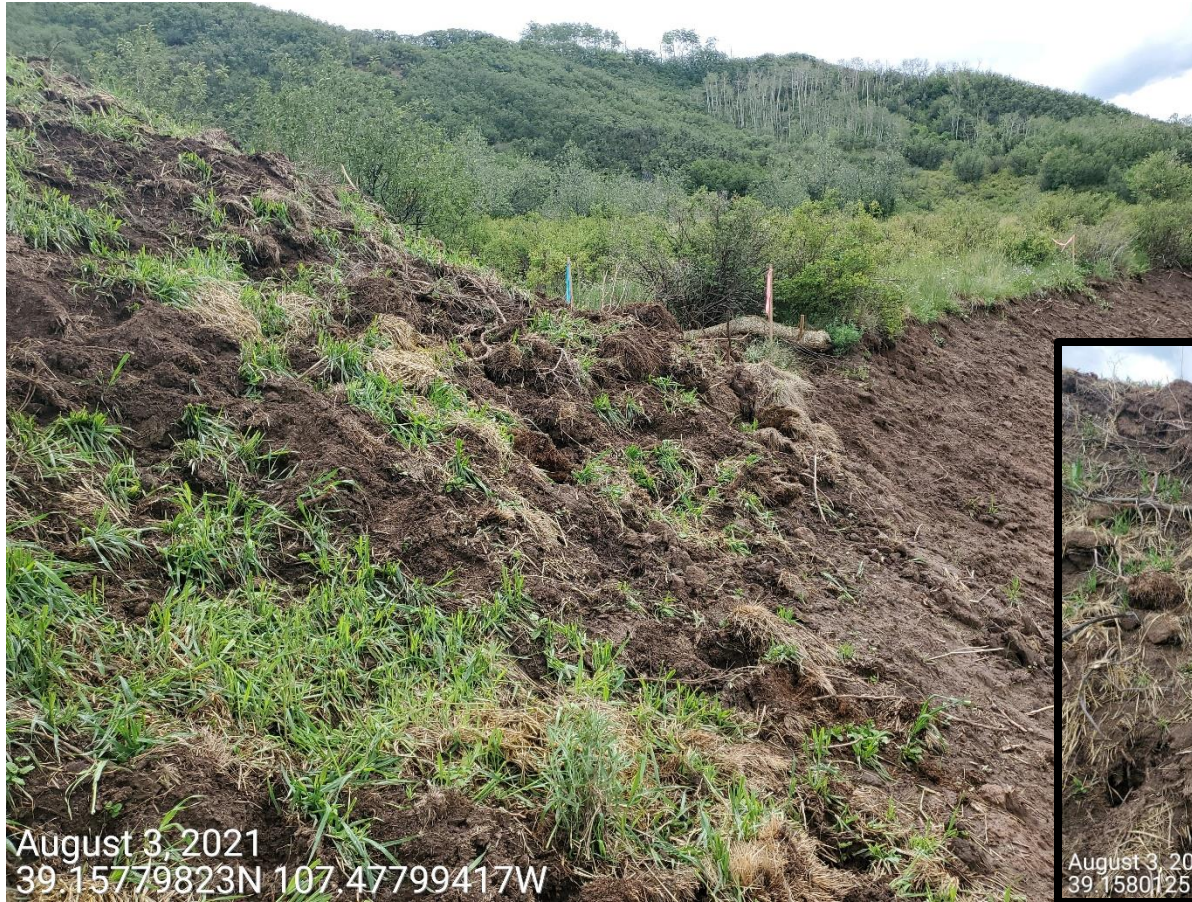
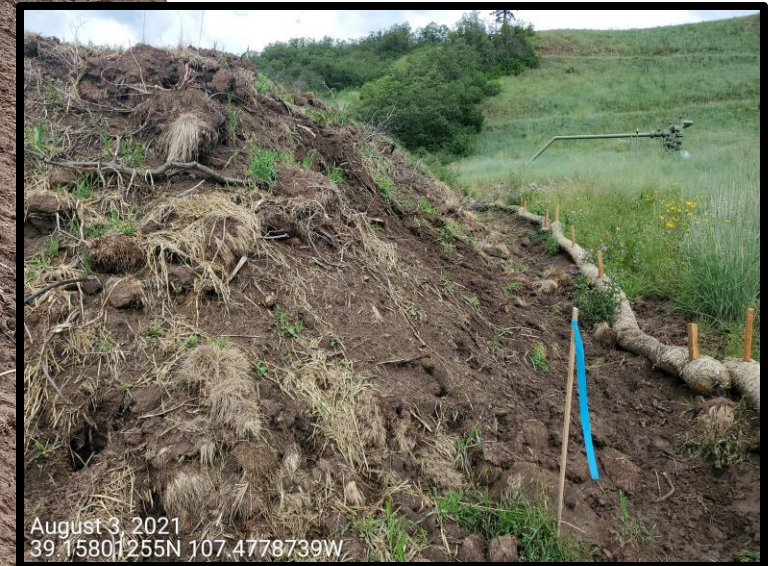
Photo 6: Photo taken from the south end of the Location, facing east. Photo shows vegetation establishment is predominantly undesirable weedy plant species. Little to no desirable plant germination observed.

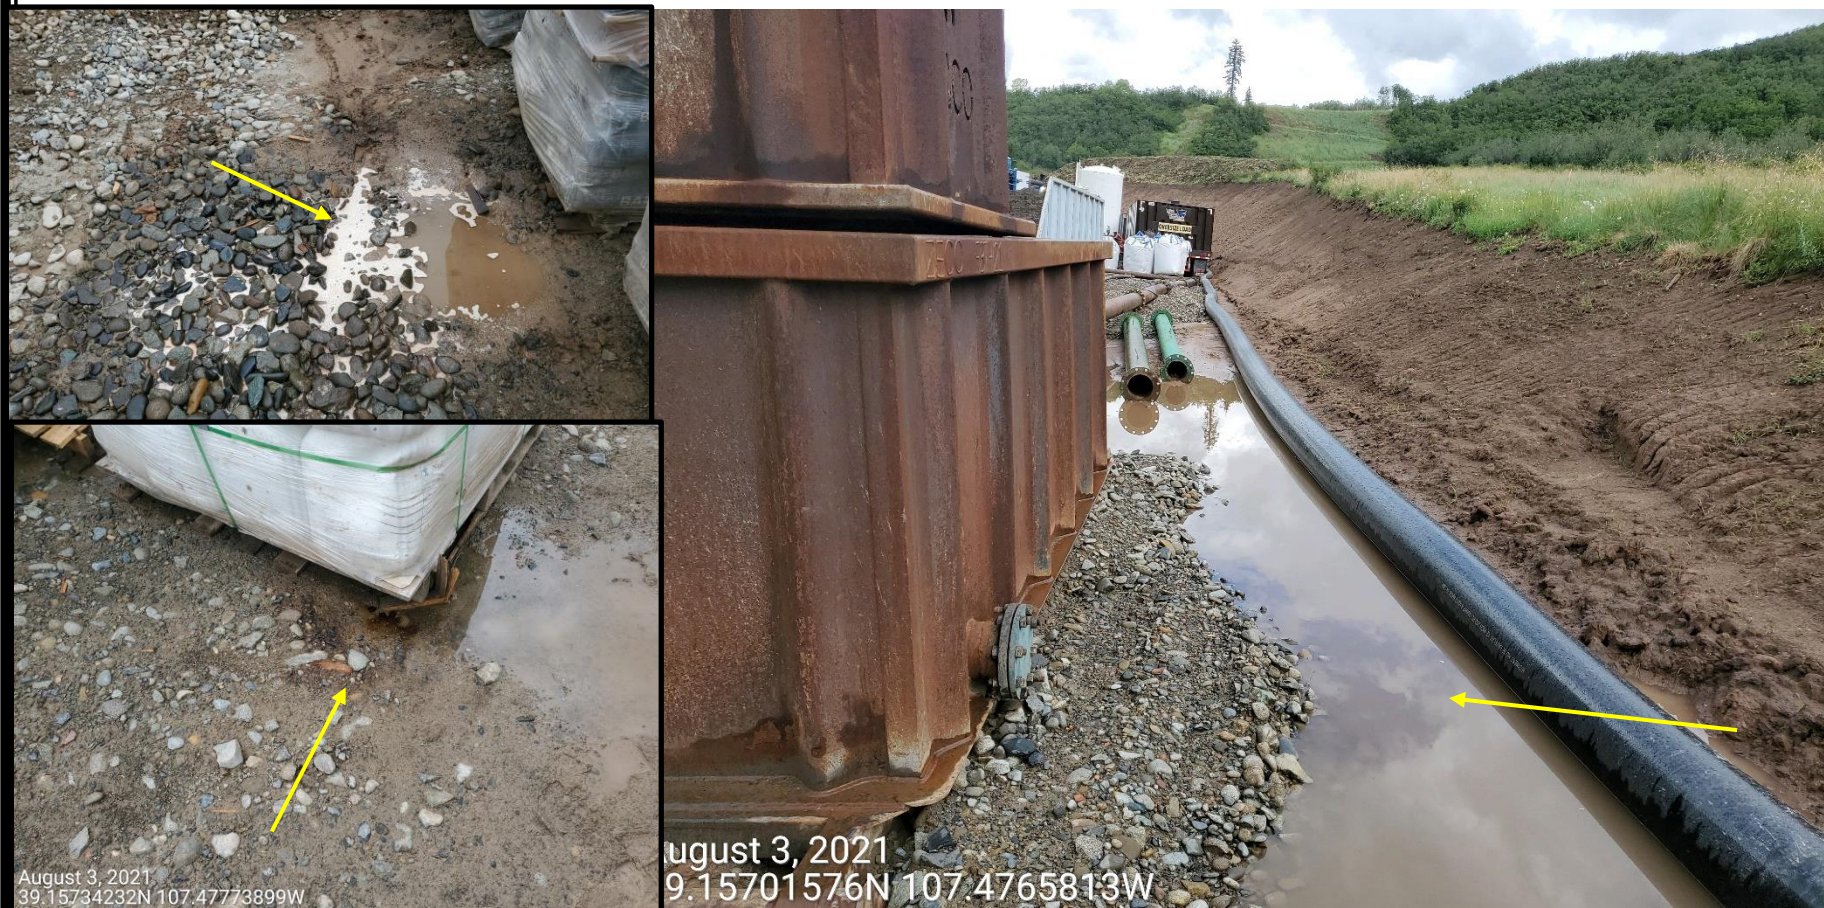
Photo 7: Photo shows example of impacted stormwater issues observed on the Location due to various spills.

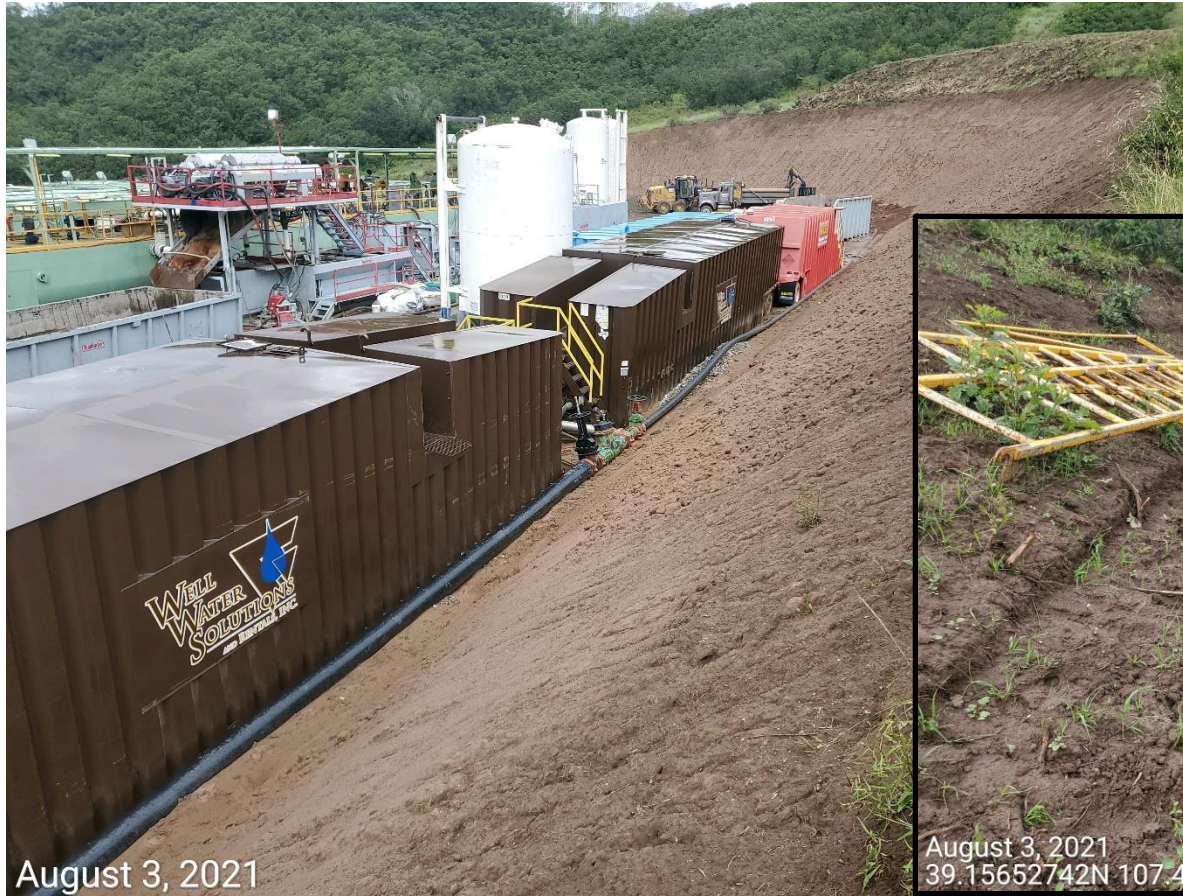
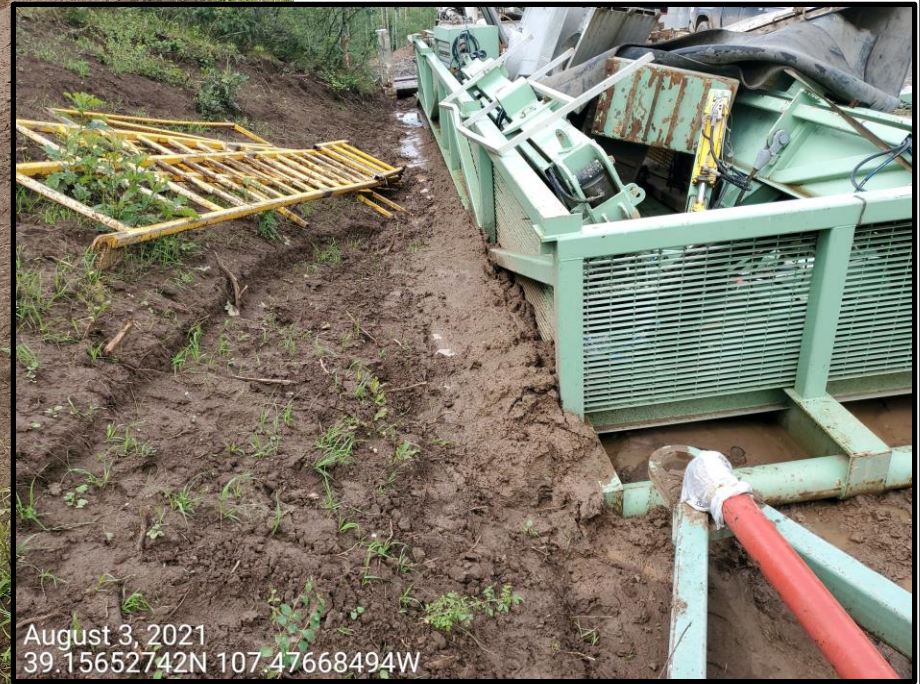
Photo 8: Photo shows equipment remains improperly stored/placed within the stormwater diversion ditch on the eastern and southern perimeter of the pad.

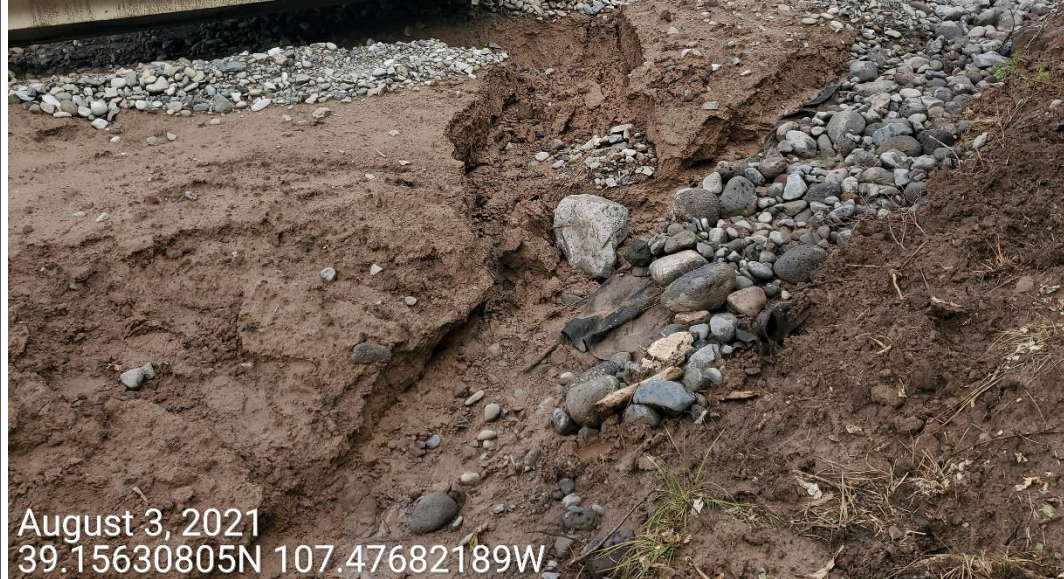
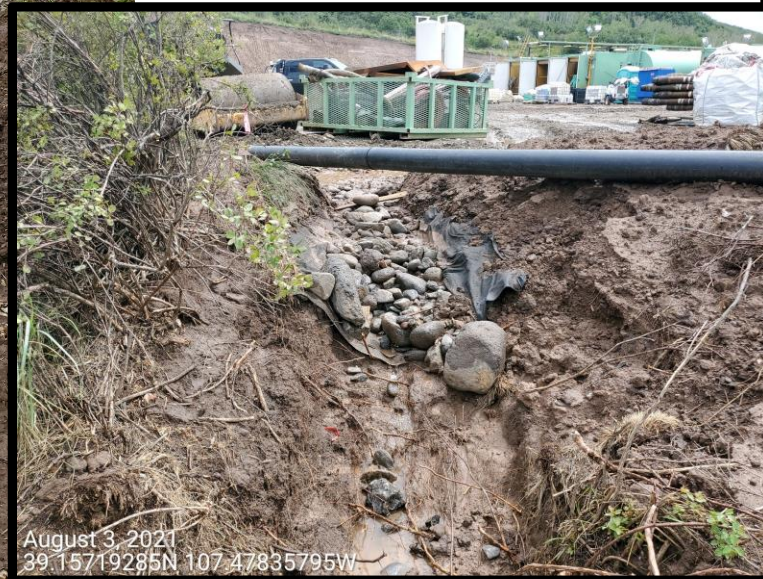
Photo 9: Photo taken from the southwest (left photo) and northwest (right photo) of the pad. Photo shows the stormwater outlets leading from the pad; erosion degradation remains evident at the outlets; BMPs has not been installed in accordance with good engineering practices, or maintained in proper functioning condition.

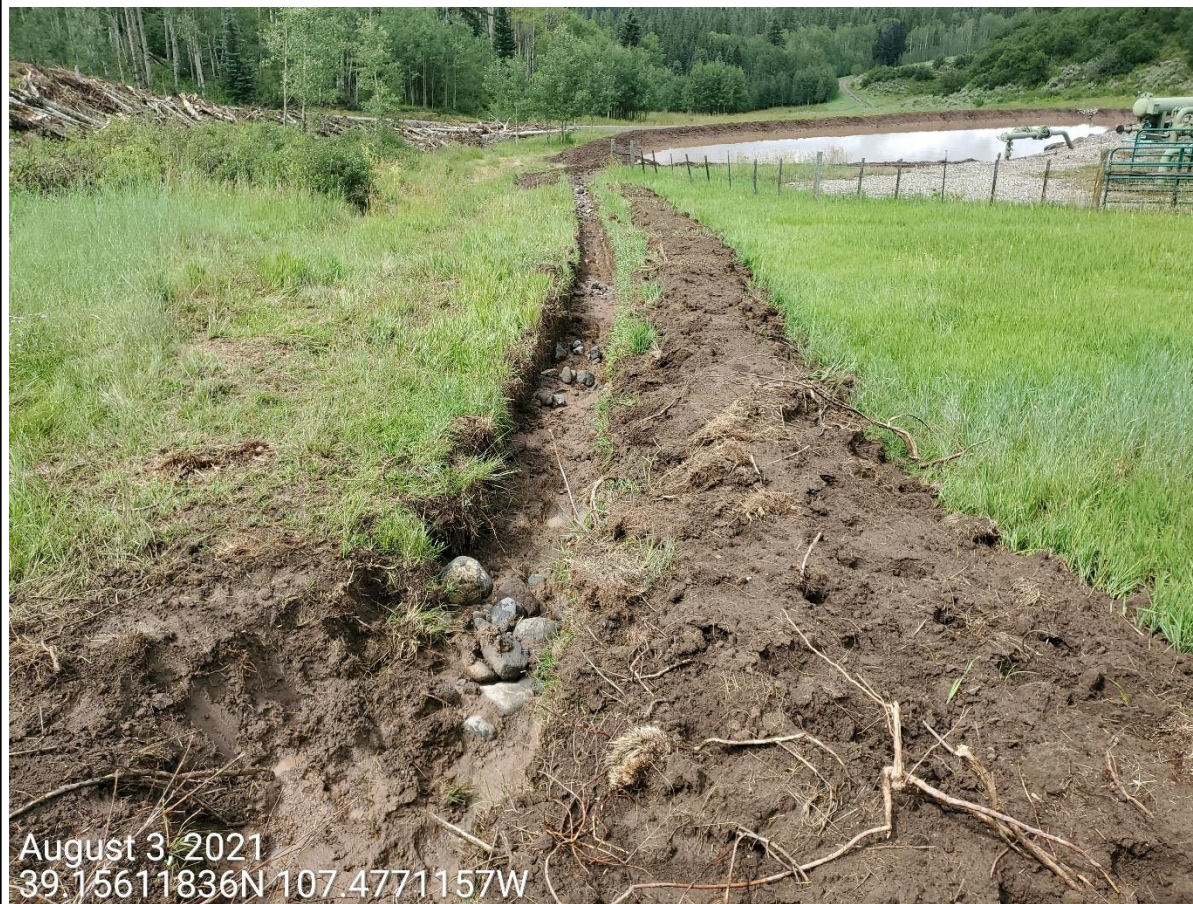
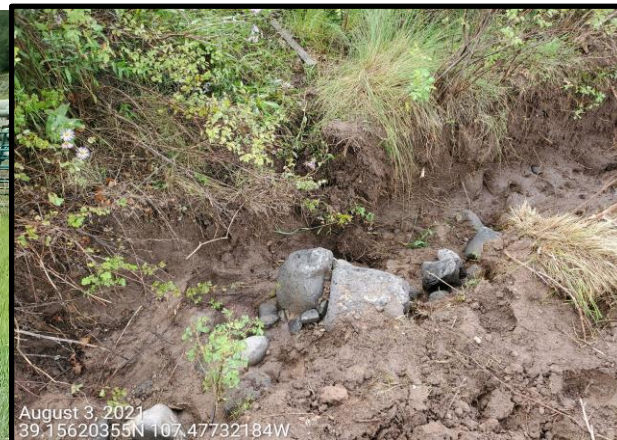
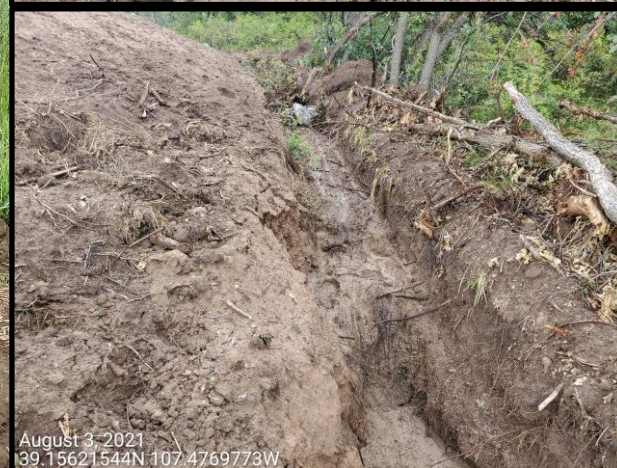
Photo 10: Photo taken from the stormwater “ditch” leading from the Location. Photos show BMPs remain improperly constructed with vertical slopes and extracted soils left along channel remain unconsolidated and a pollutant source .

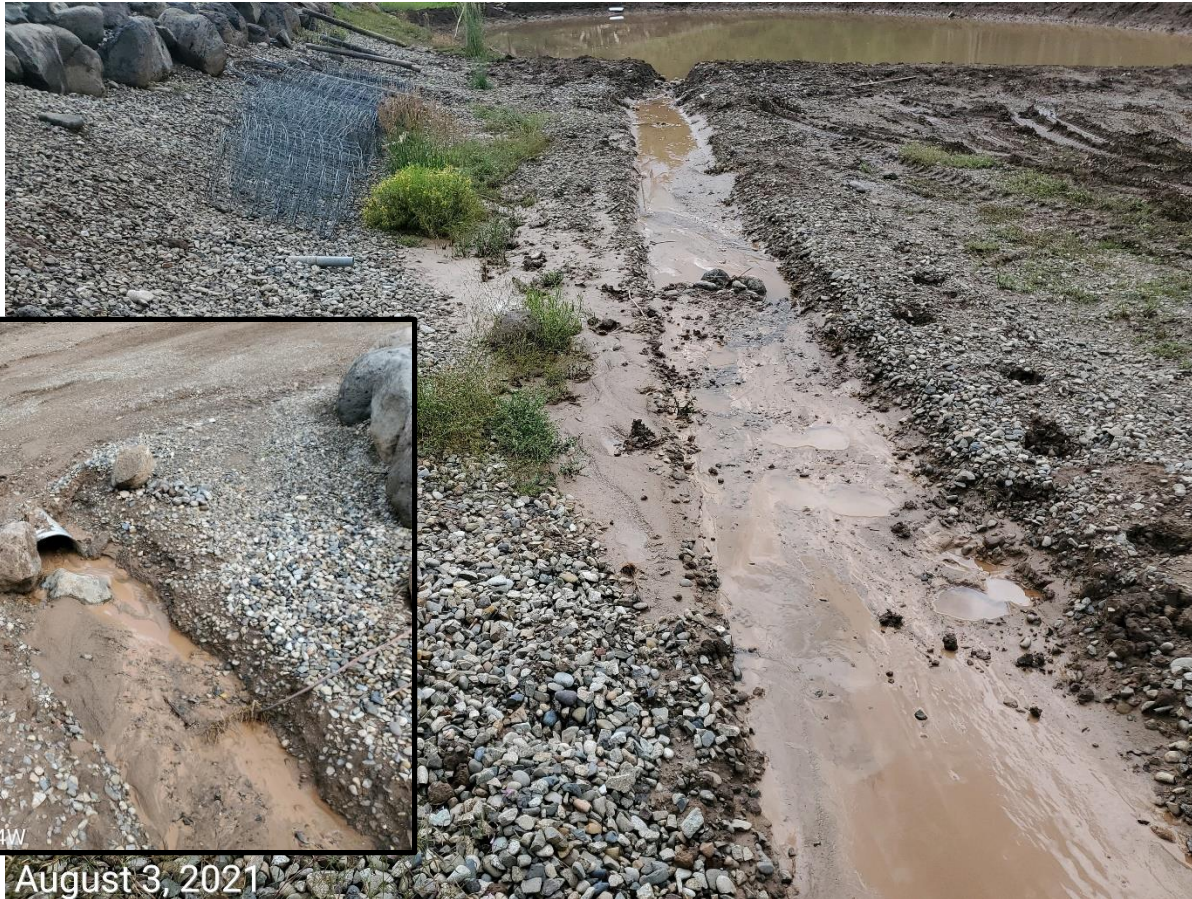
Photo 11: Photo shows stormwater and sediment discharge from the Location has filled the stormwater ditches and culvert.

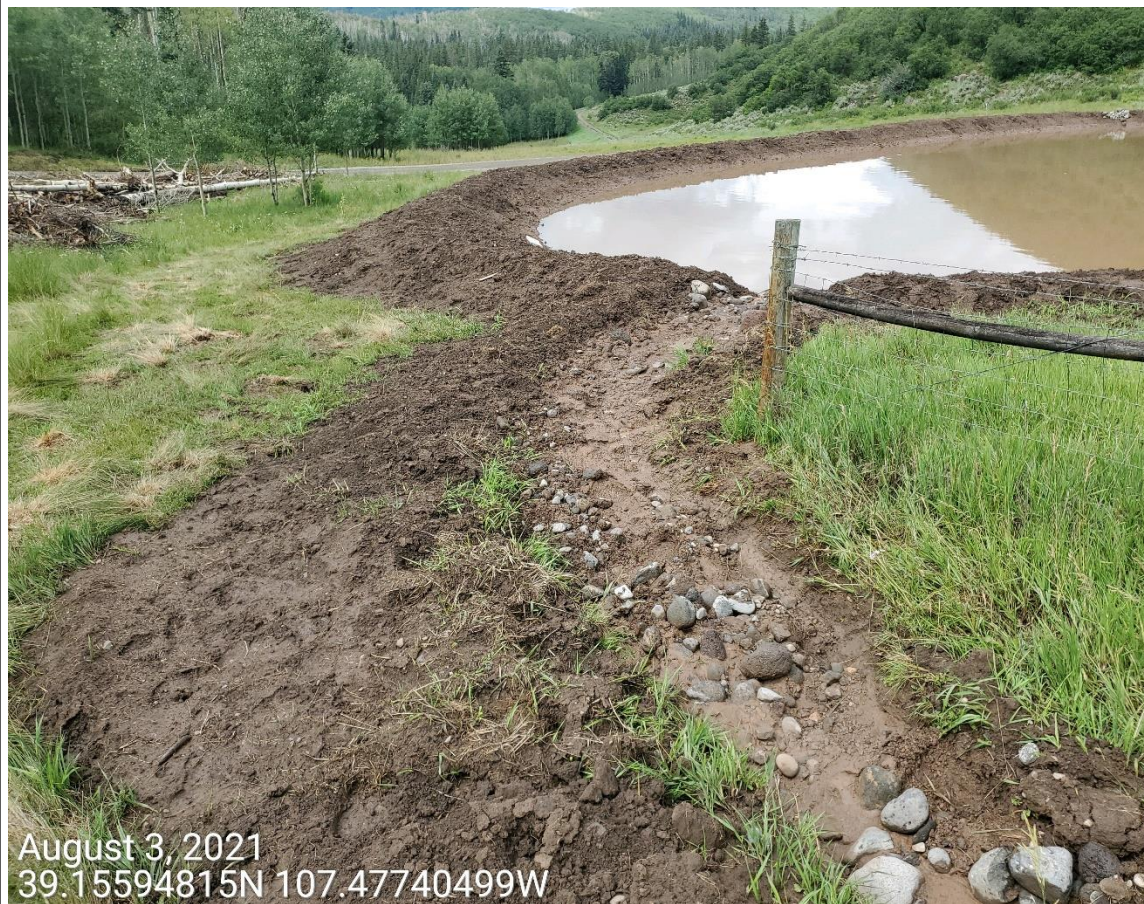
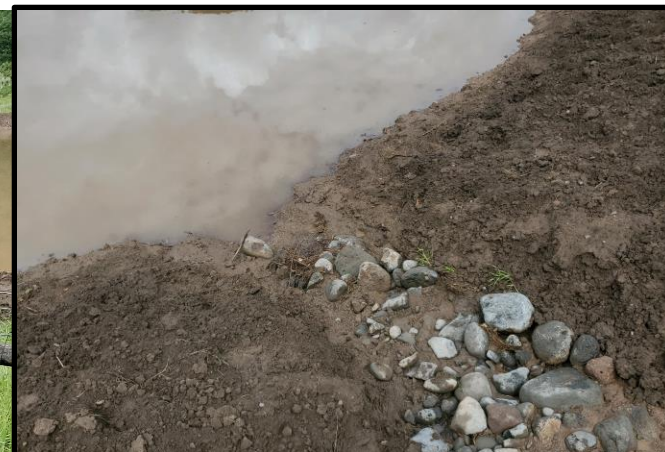
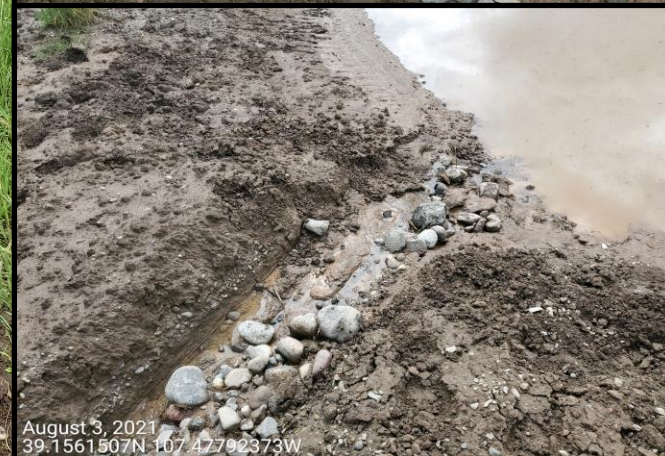
Photo 12: Photo taken from the sediment trap/pond west of the Location. Previous inspection documented that the inlets were inadequate. Photos show inlets remain inadequate.

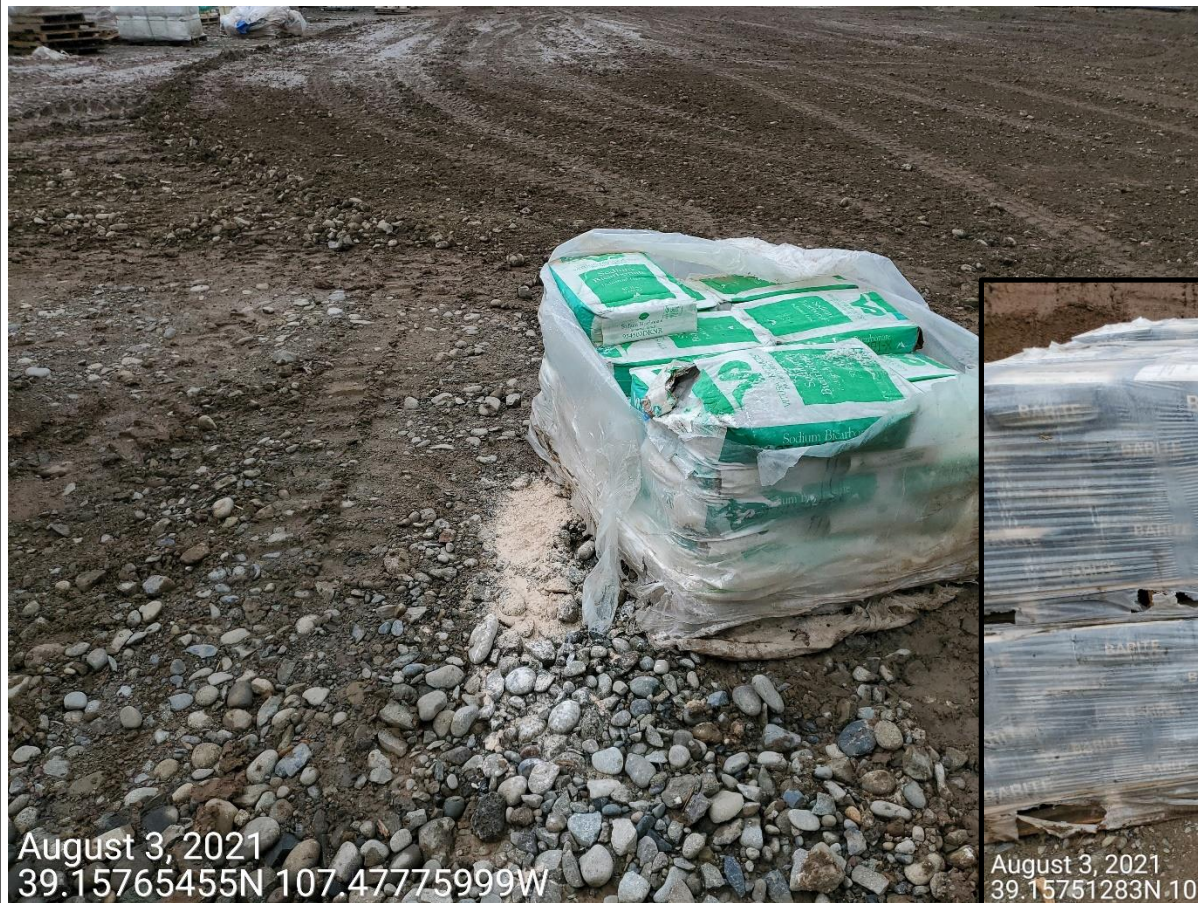
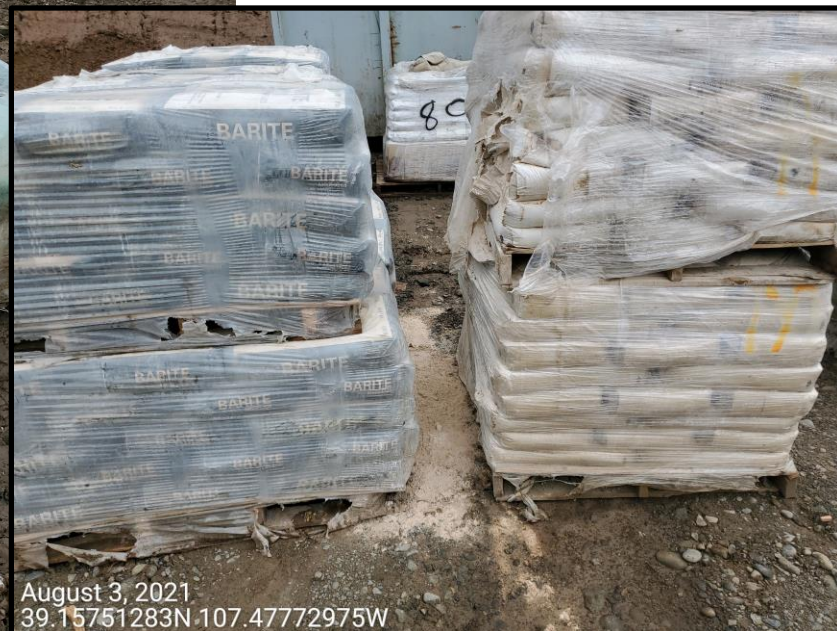
Photo 13: Photo shows example of improper materials management that has resulted in spills throughout the Location. This issues was documented in the previous inspection; proper materials management, covering and spill prevention on the Location remains insufficient.

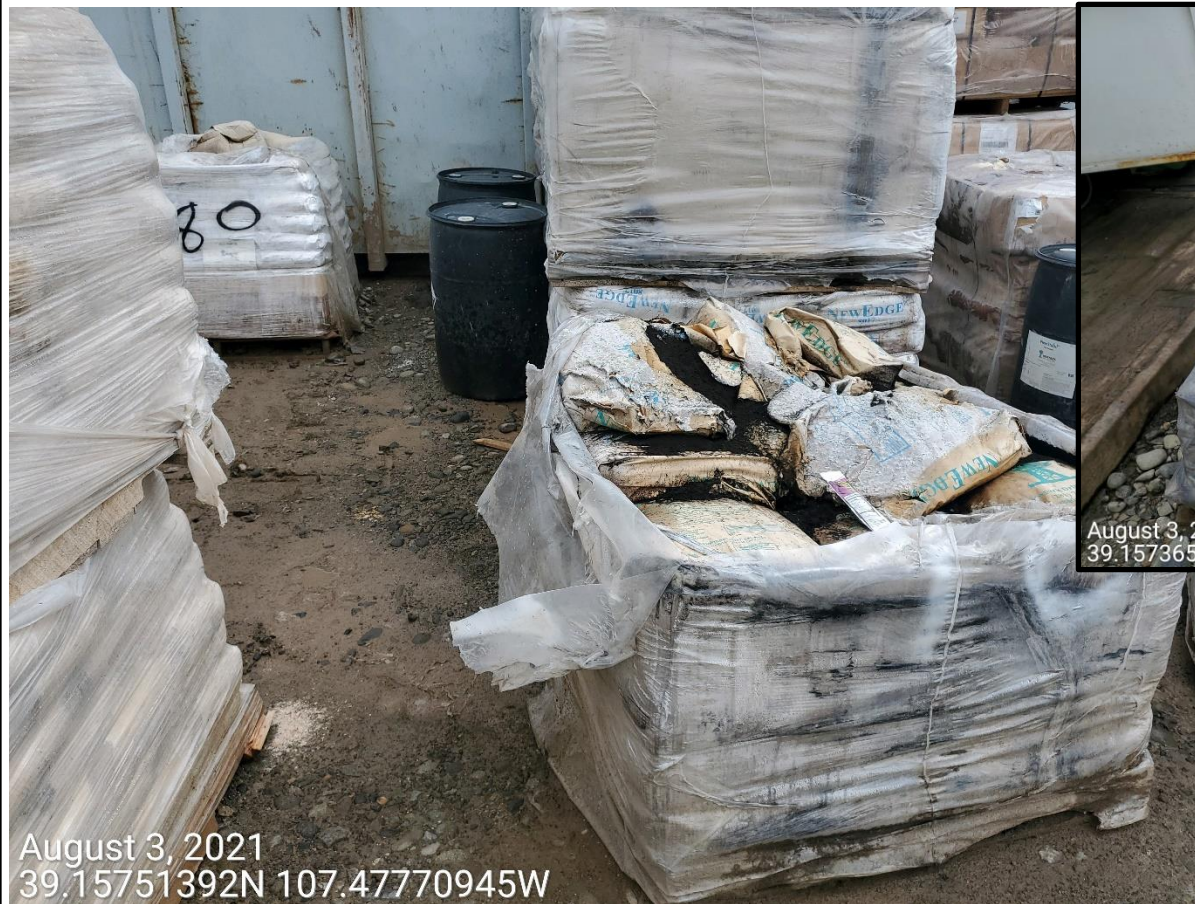
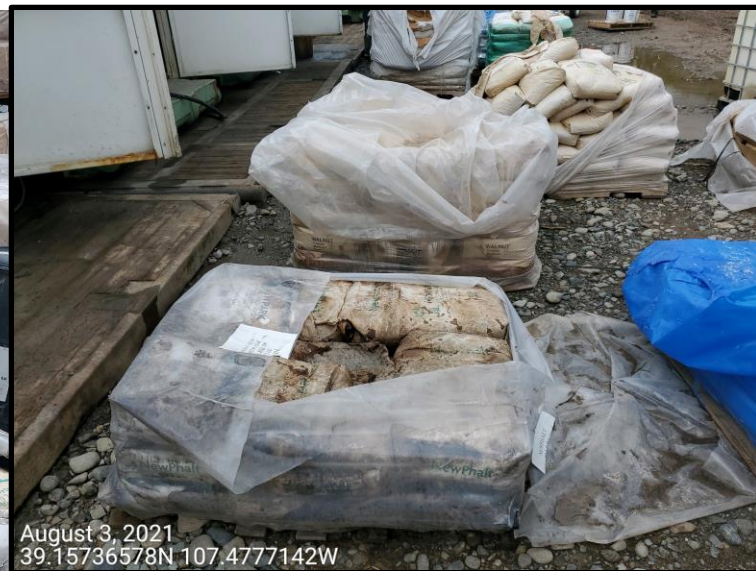
Photo 14: Photo shows example of stored materials onsite without proper covering to minimize contact of precipitation and stormwater runoff with materials, wastes, equipment, and activities with potential to result in discharges causing pollution of surface waters. This issue was documented in the previous inspection; proper materials management on the Location remains insufficient.

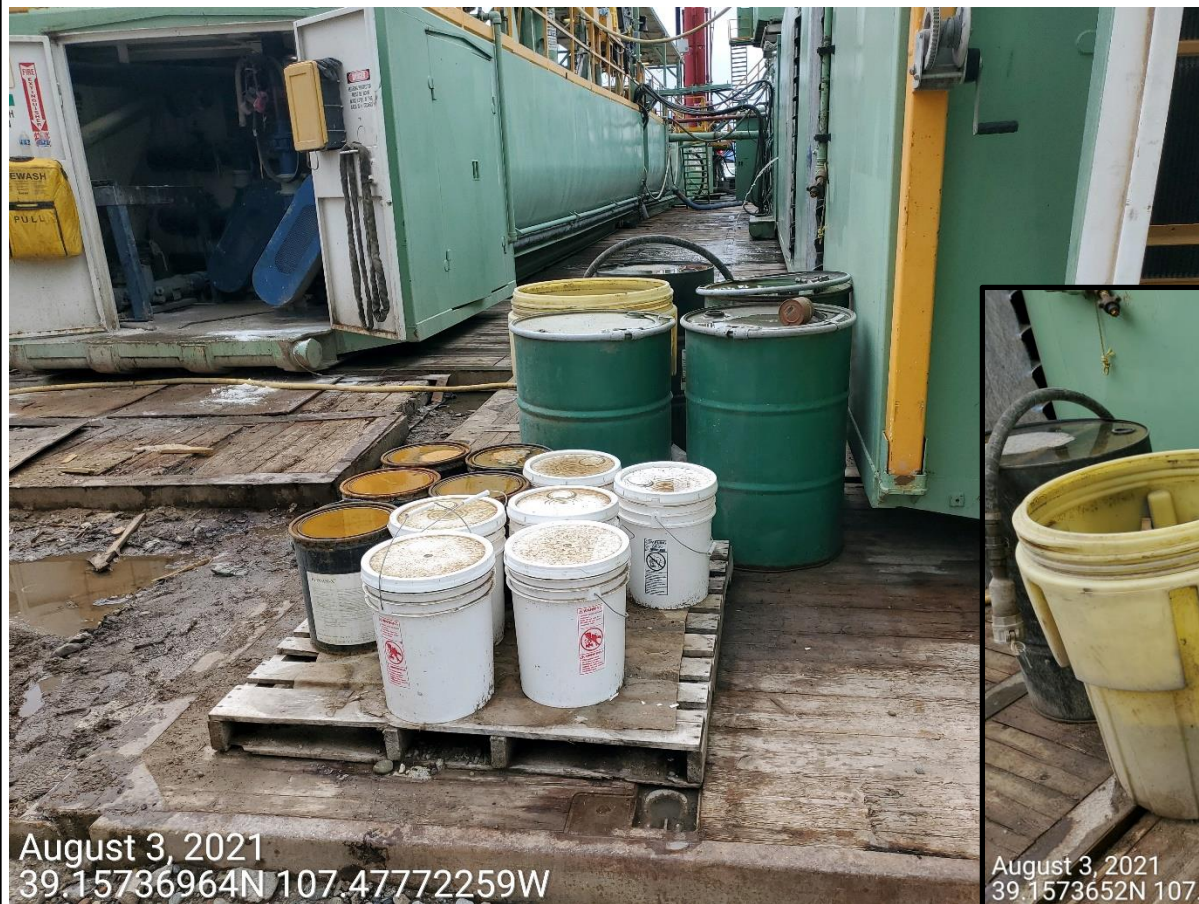
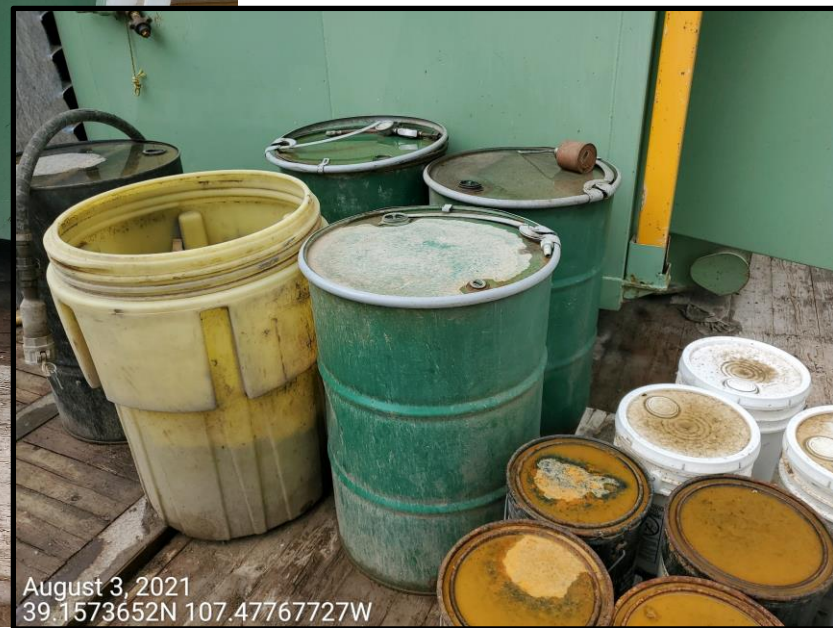
Photo 15: Photo shows green barrels with unknown contents; photo shows example of barrels, and containers where labeling information remains missing. This issue was documented in the previous inspection.
