Inspection Photos

8/3/2021

Operator: GUNNISON ENERGY LLC #10515

Location ID: 453805

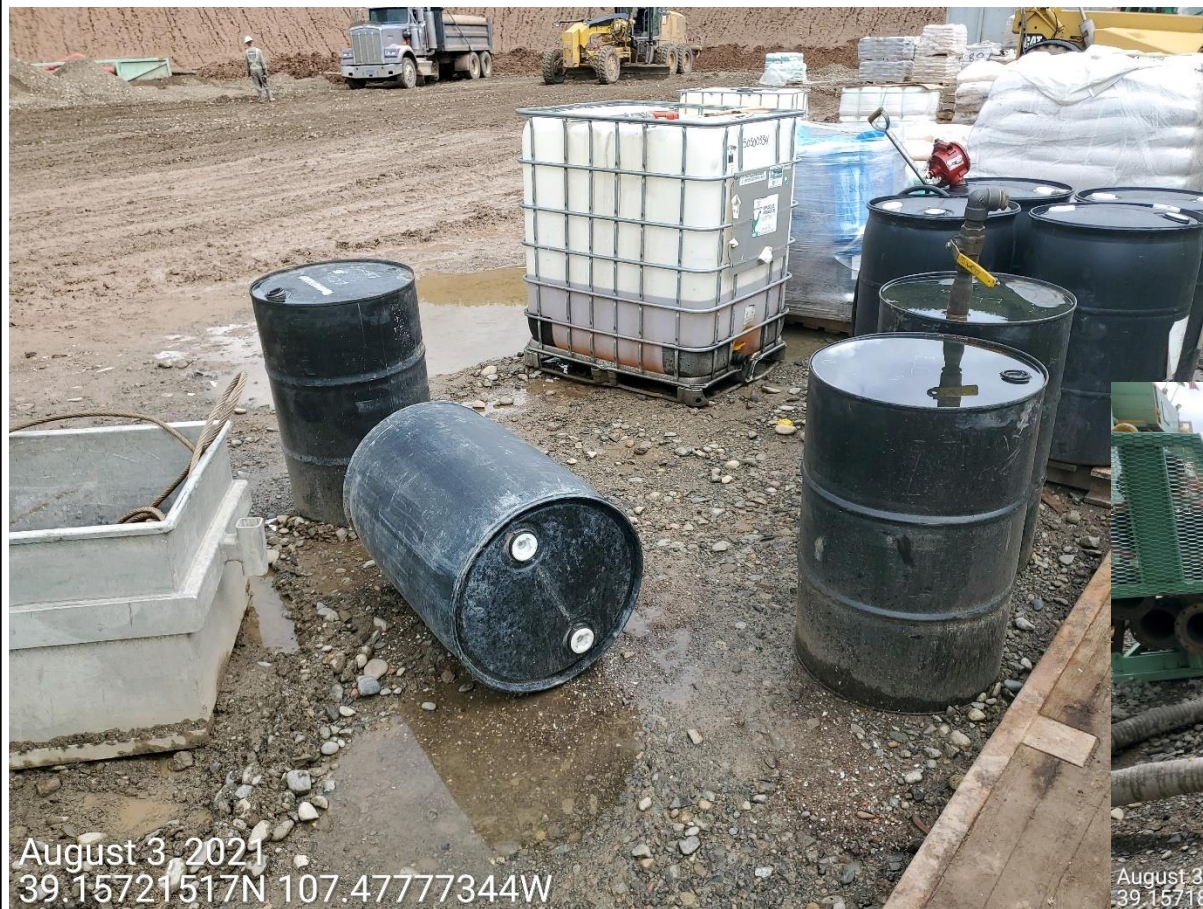
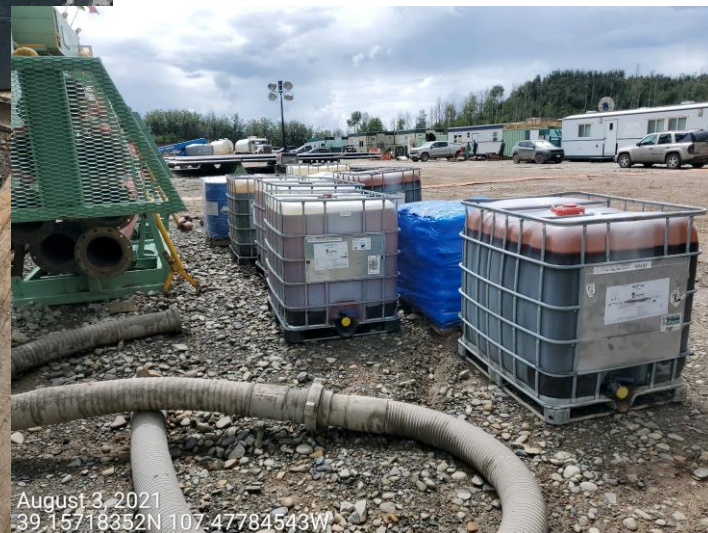
Photo 16: Photo shows example of barrels/tanks/containers observed stored on the Location without proper secondary containment. This issue was documented in the previous inspection; BMPs remain missing or insufficient to contain a spill.

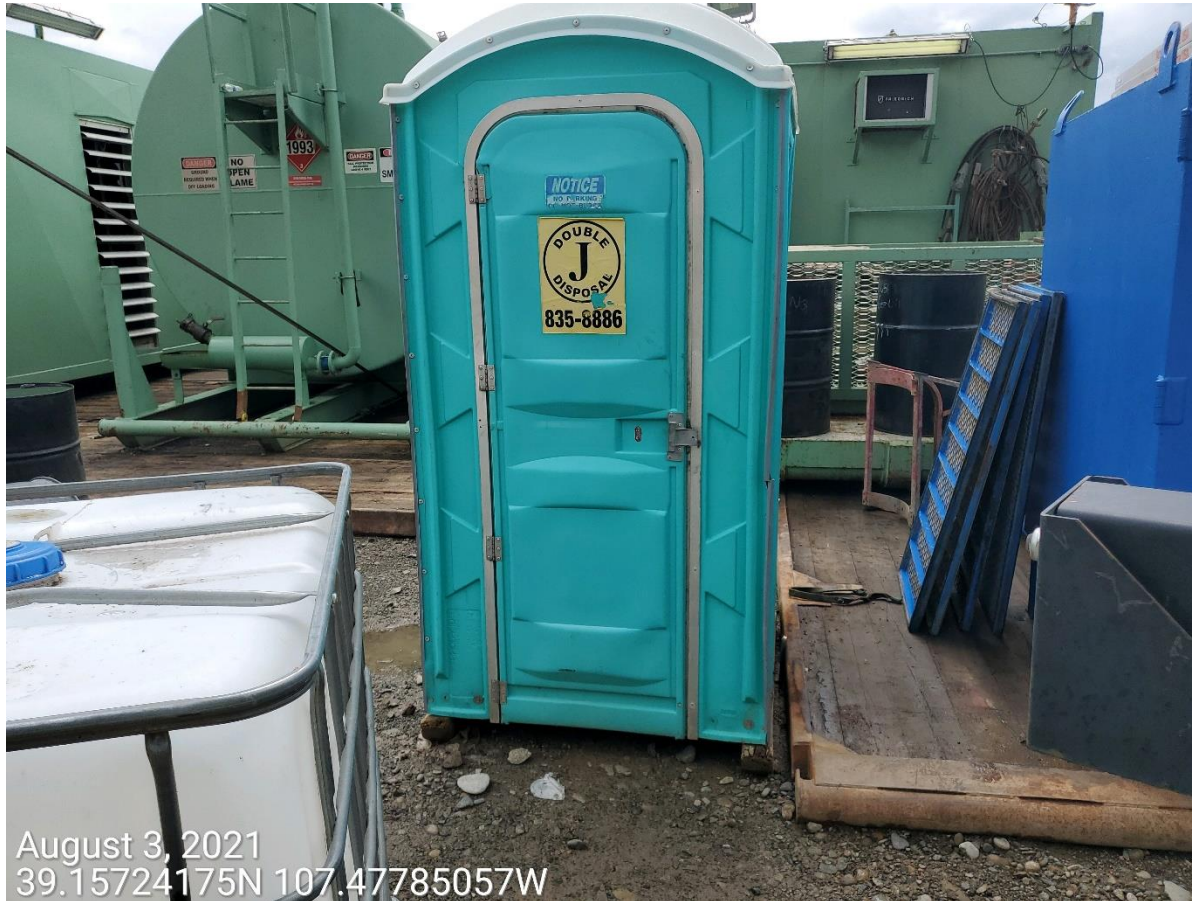
Photo 18: Operator has placed 2 porta-johns on the Location. Porta-john on the south end of the Location has been properly secured. Photo shows porta-john on the north end of the Location that has not been properly secured in place
