Inspection Photos

Operator: Black Resources
API: 083-06680
Date: 8/4/2021

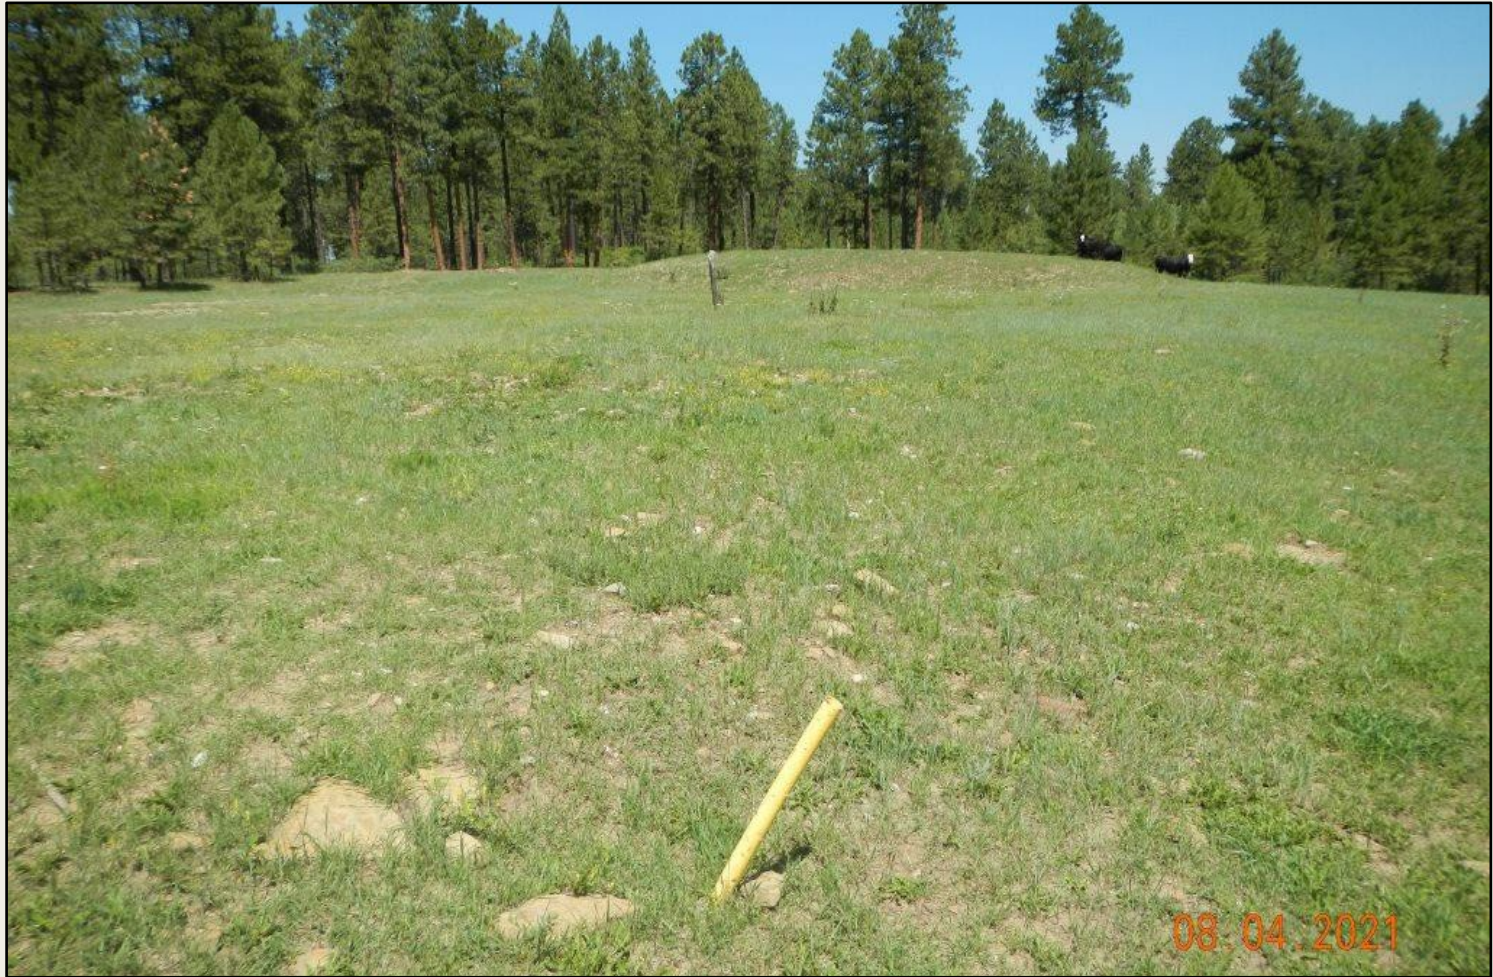
Photo 1. View of the project area from the southeastern corner facing center.

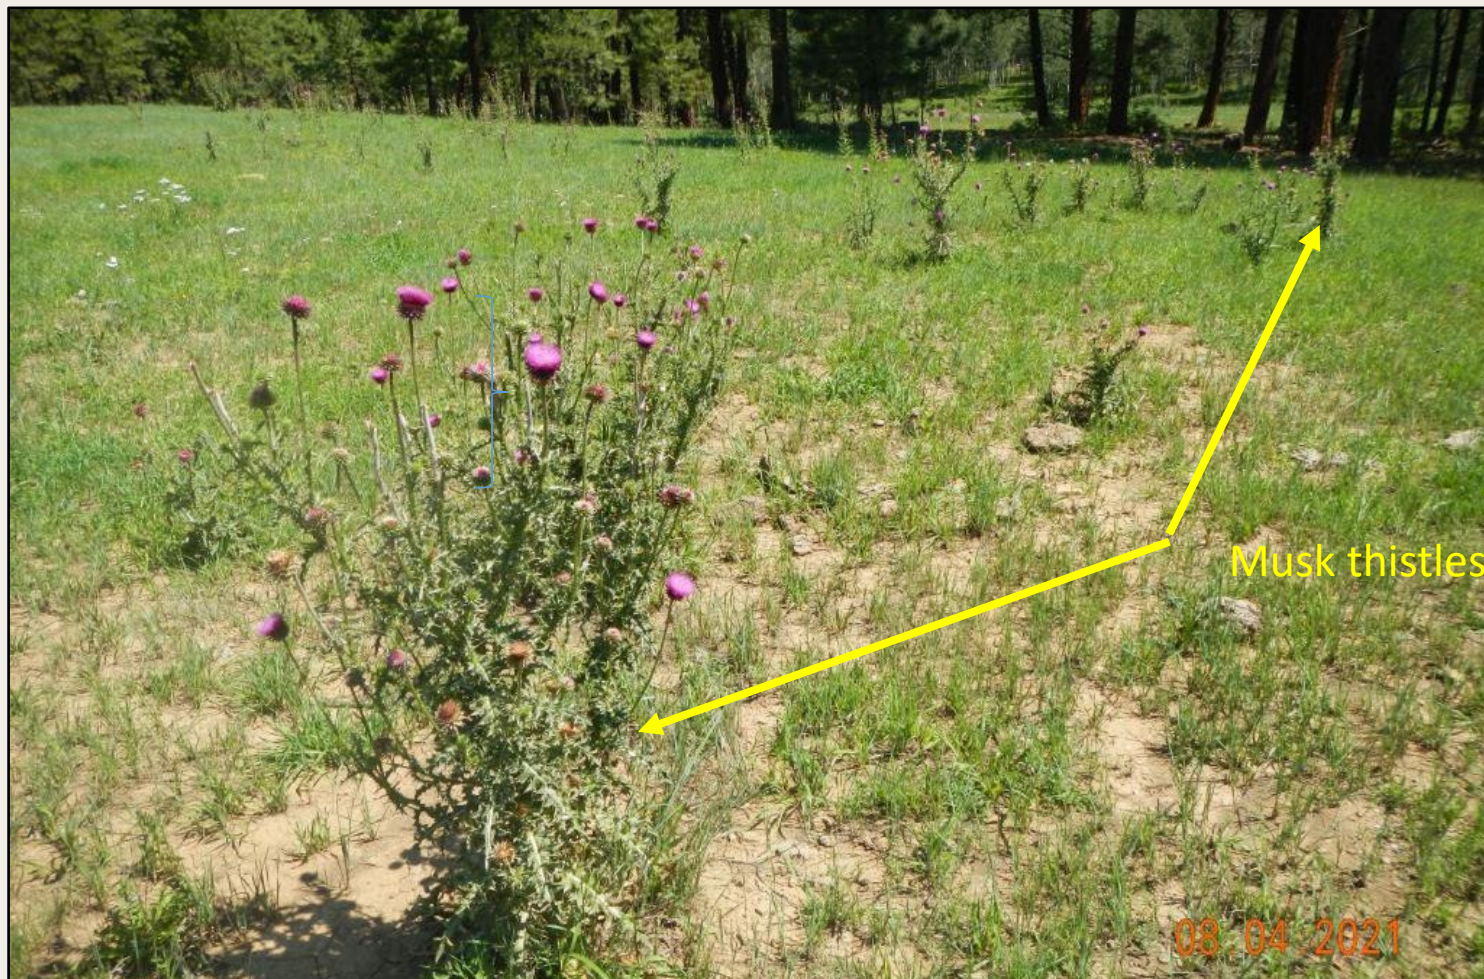
Photo 2. View of musk thistles within the project area. Approximately 150 flowering individuals observed.

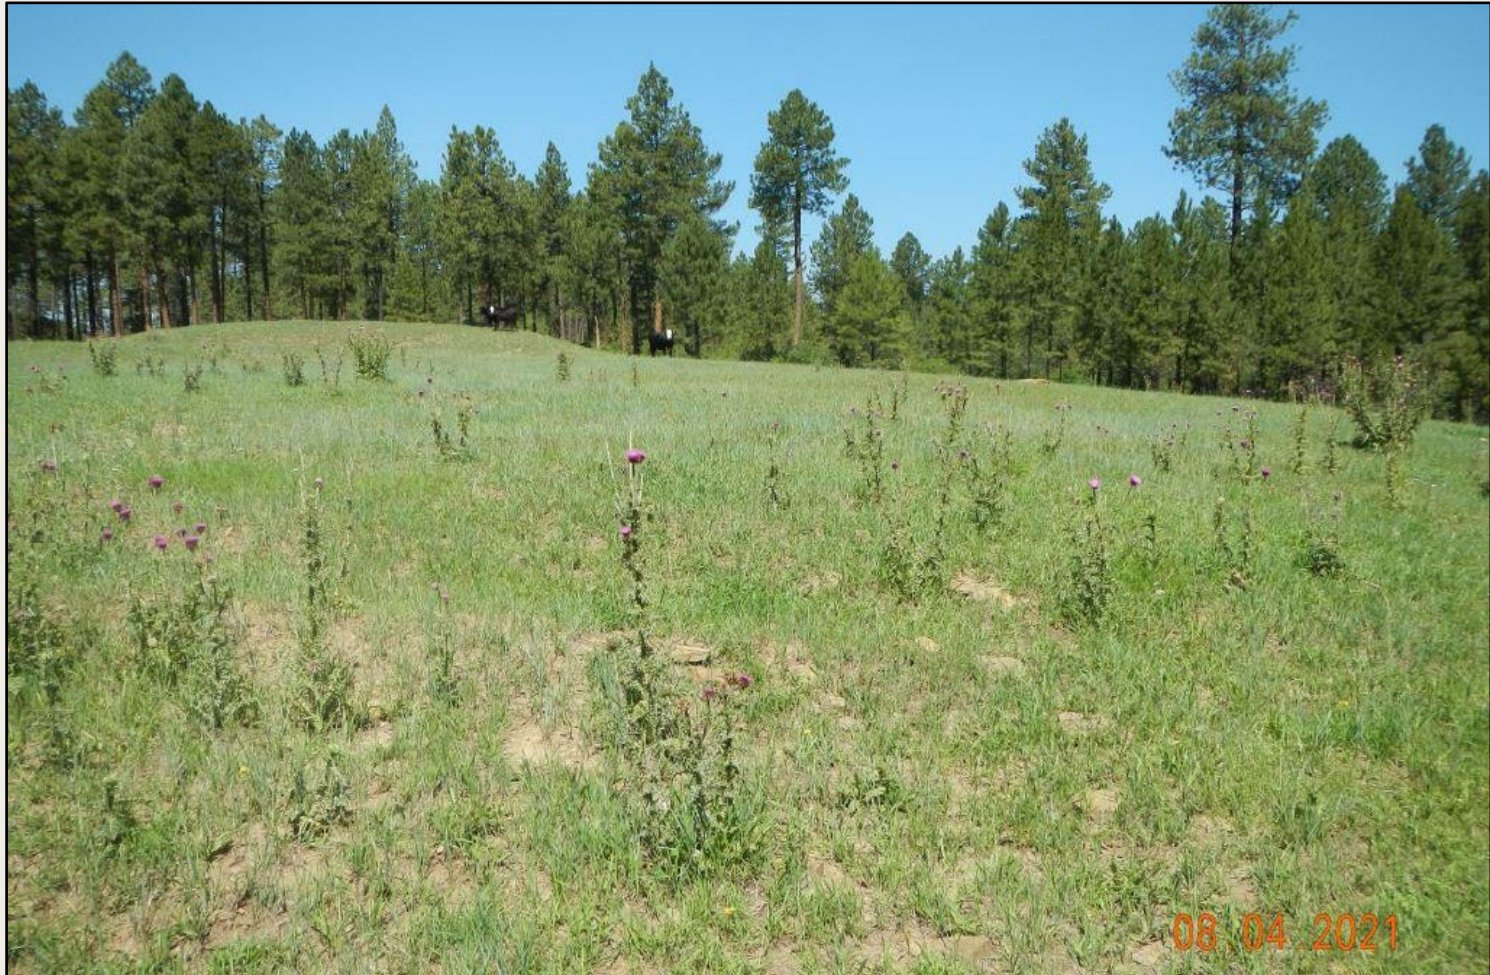
Photo 3. View of the eastern project area from the southeastern corner facing northward. Revegetation is progressing within the reclamation areas with western wheatgrass, smooth brome, and yarrow observable.

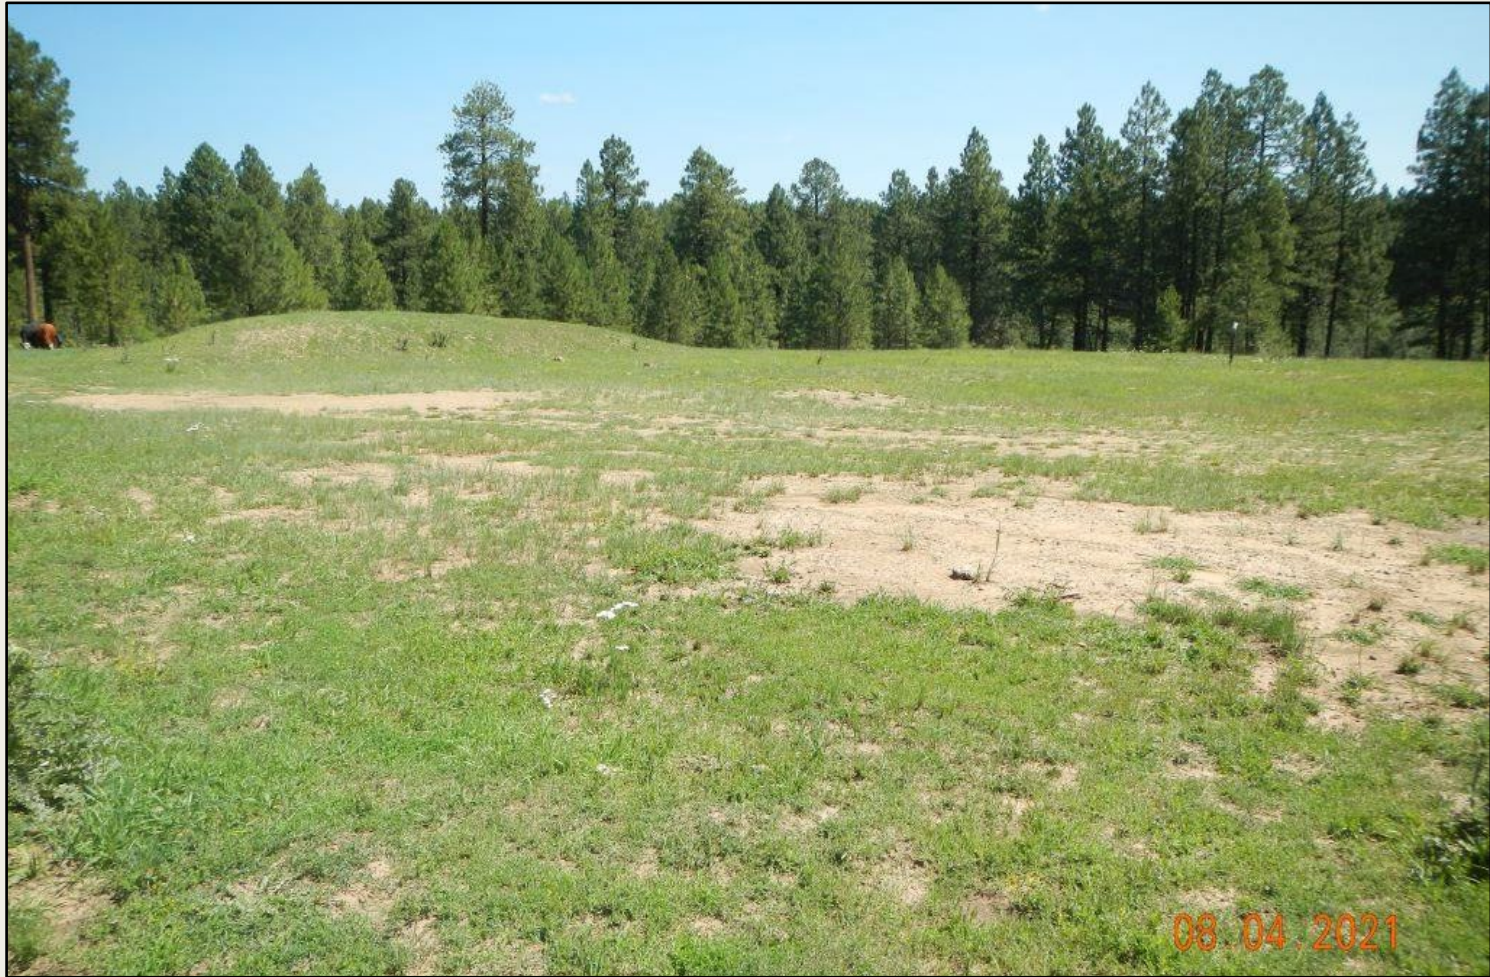
Photo 4. View of areas on the well pad where little vegetation is present. These areas are likely not revegetating due to soil compaction or contamination issues.

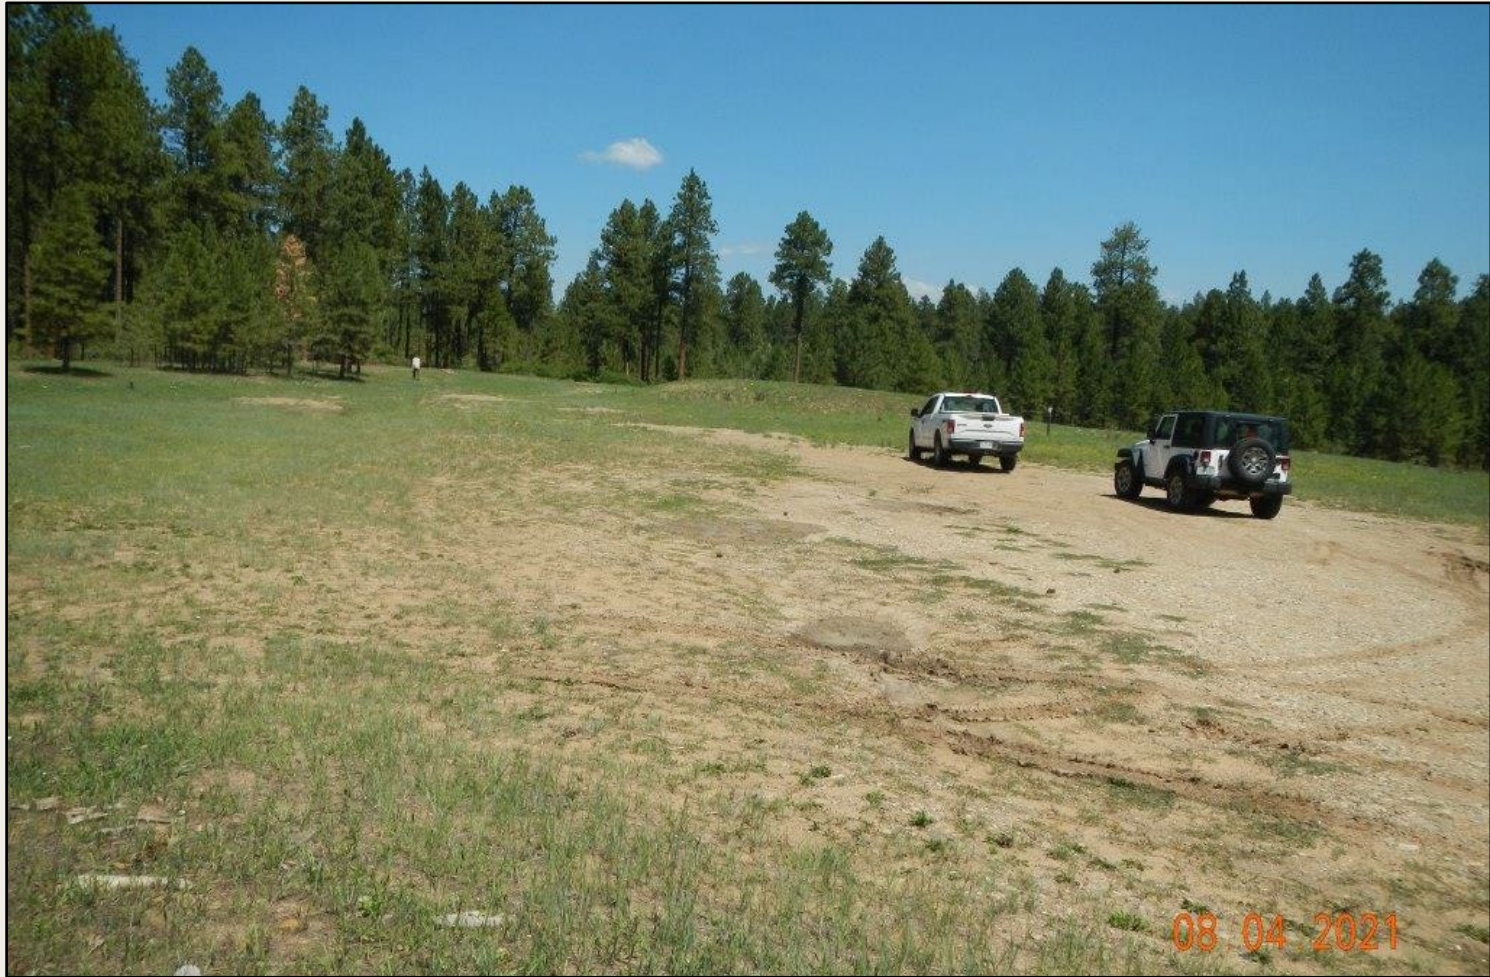
Photo 5. View of area near the well pad entrance that is not reclaimed.

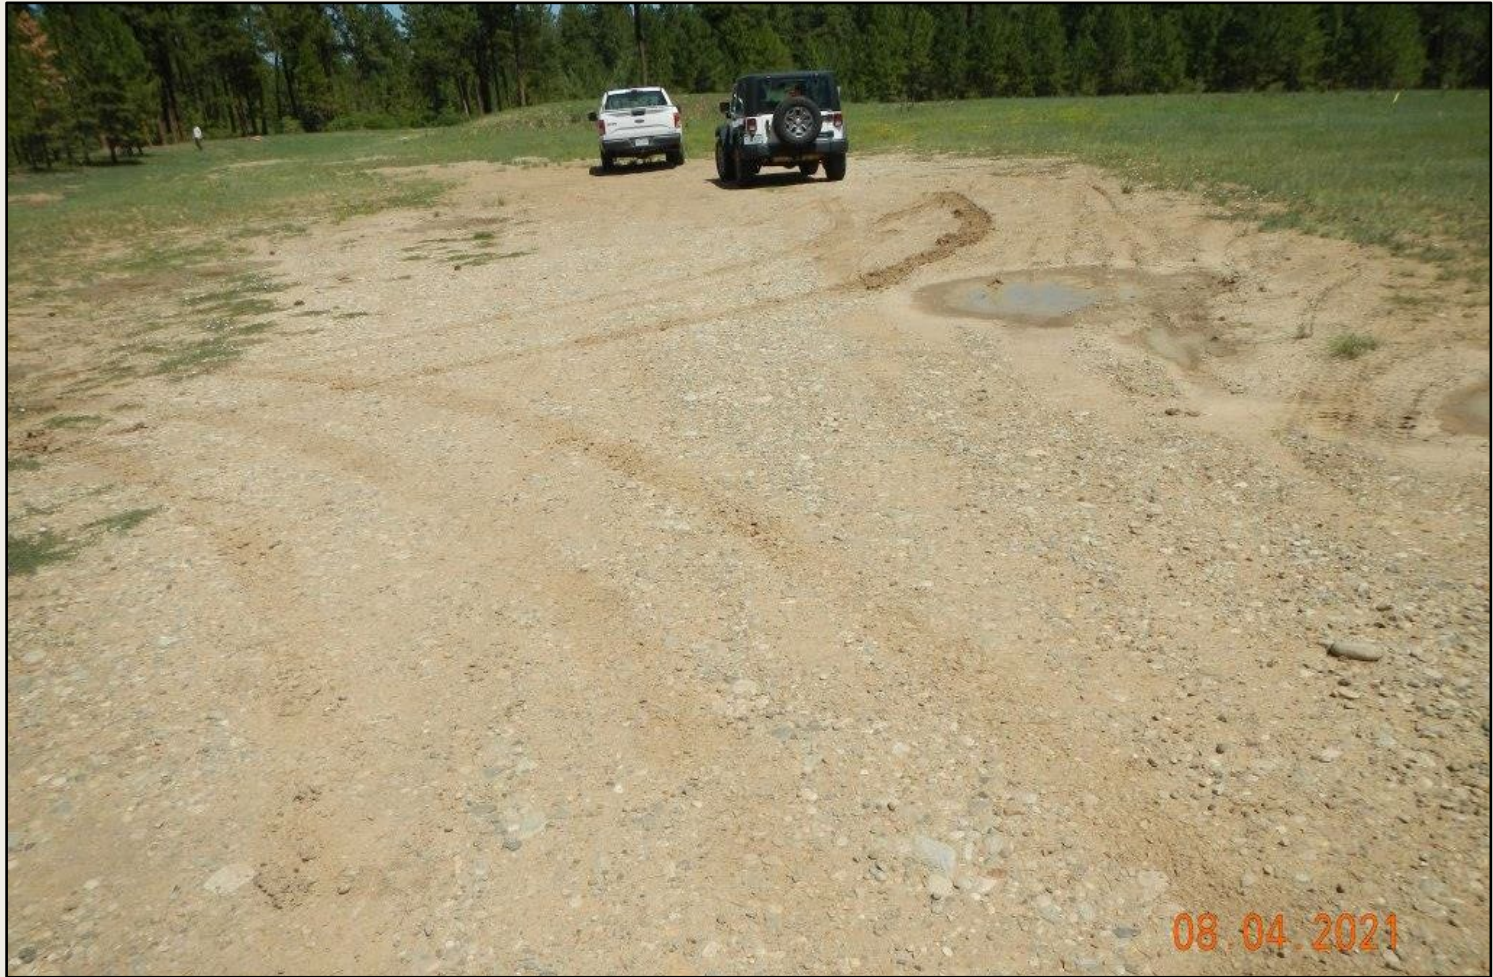
Photo 6. Another view of unreclaimed area at the entrance to the well pad.

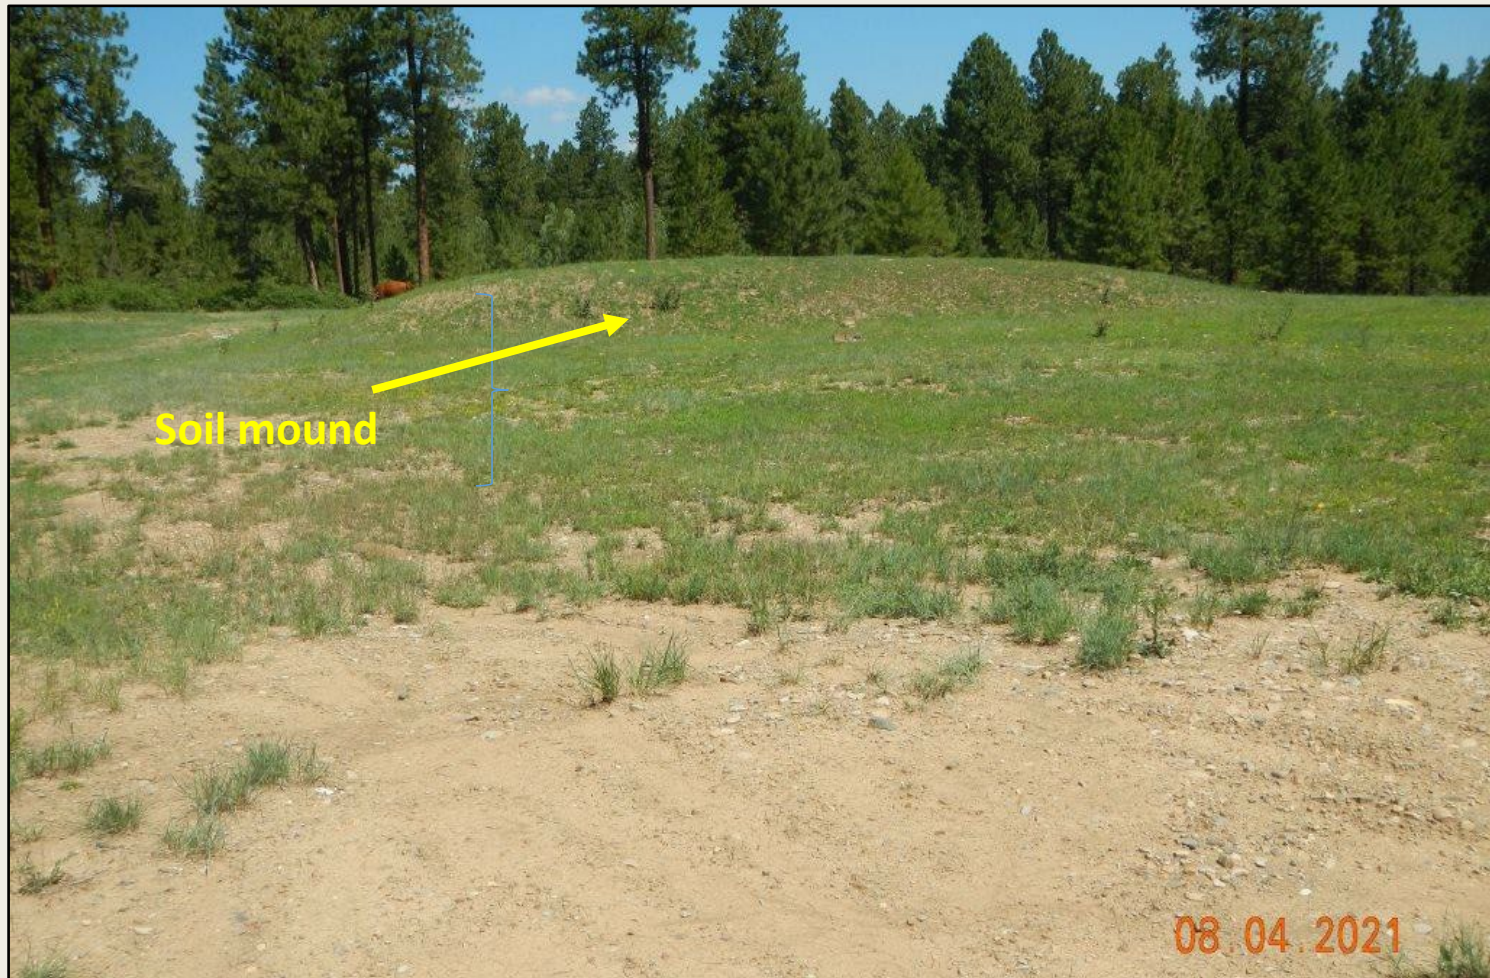
Photo 7. View of soil mound in the northern project area, approximately 7ft high and 40ft long.

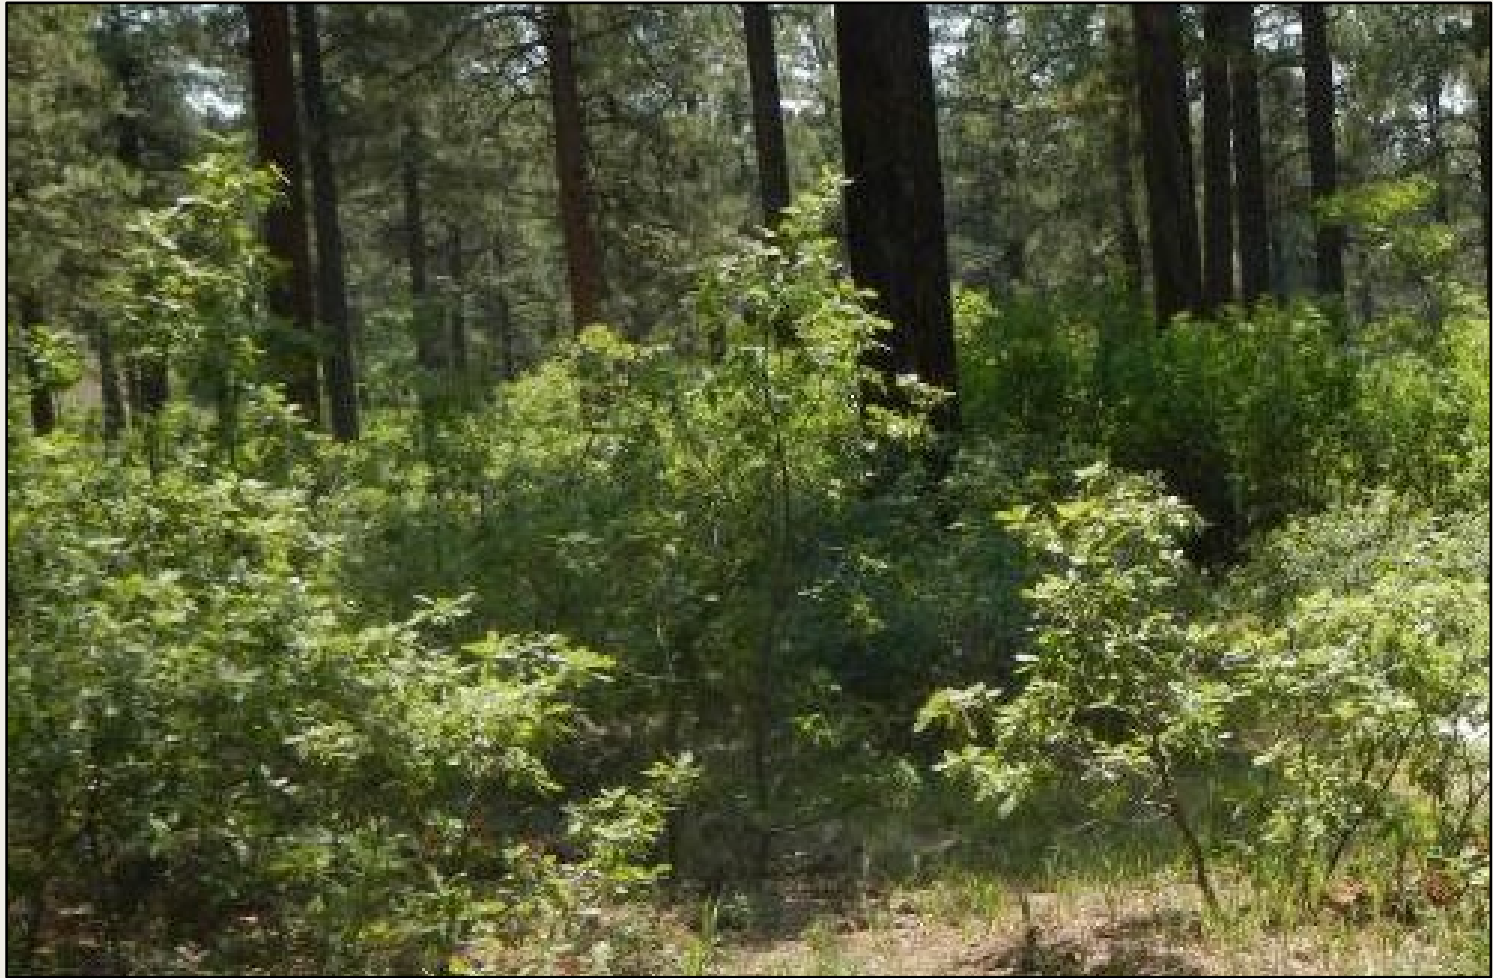
Photo 8. View of the reference area comprised of ponderosa pine and gambel oak woodland with understory of sandberg bluegrass, junegrass, yarrow, Oregon grape, and sugarbowl clematis.
