Inspection Photos

Operator: Black Resources
API: 083-06519
Date: 8/4/2021

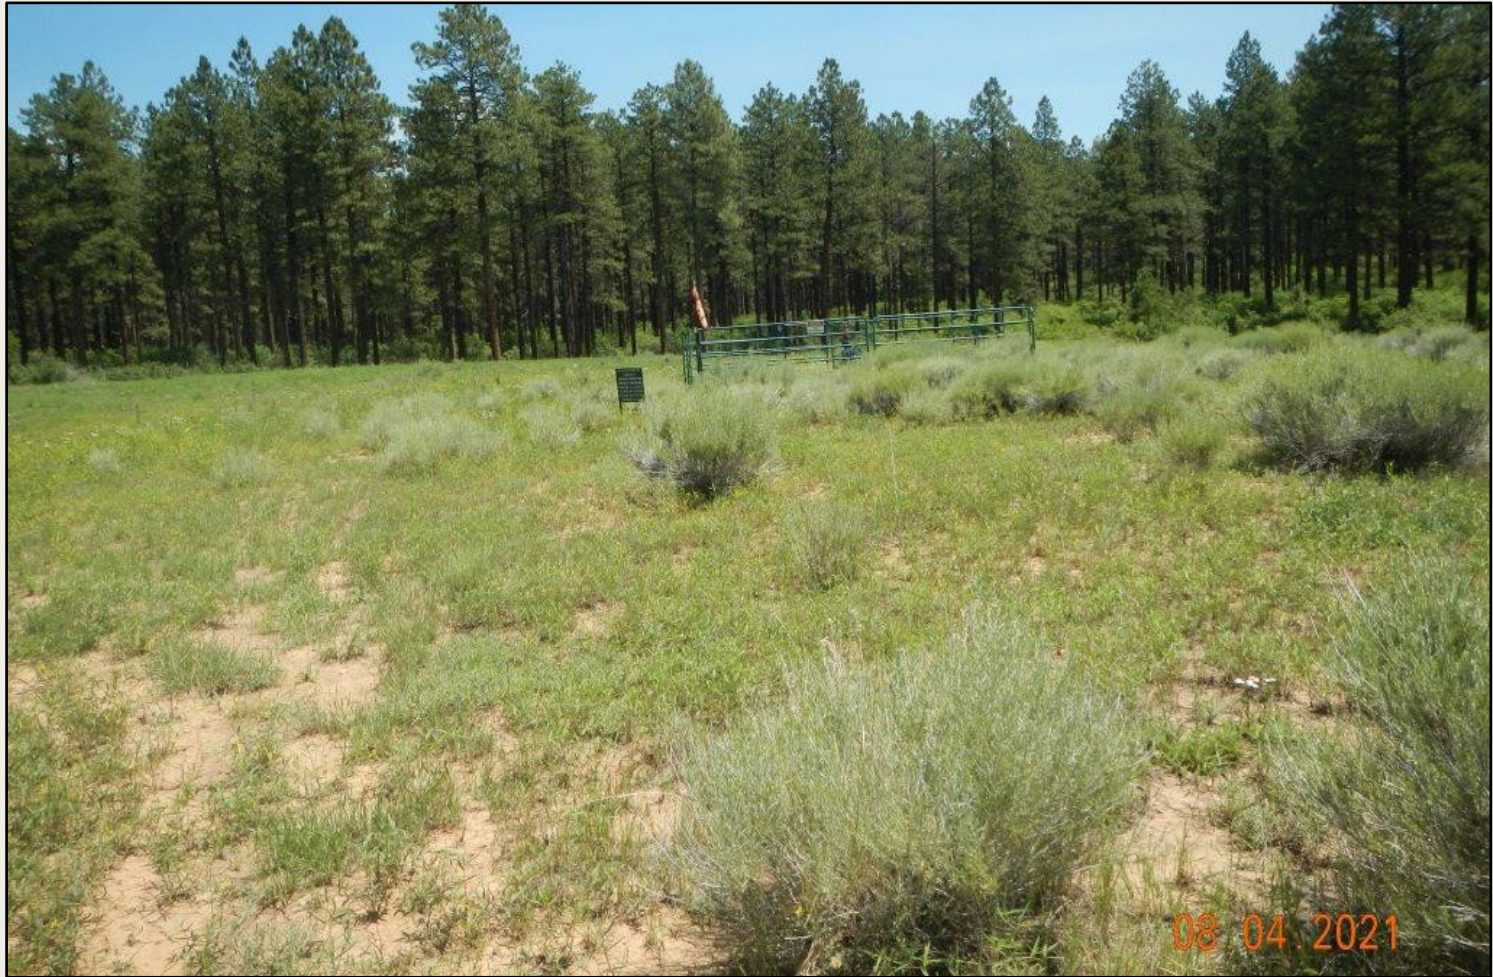
Photo 1. View of the project area from the well pad entrance facing center.

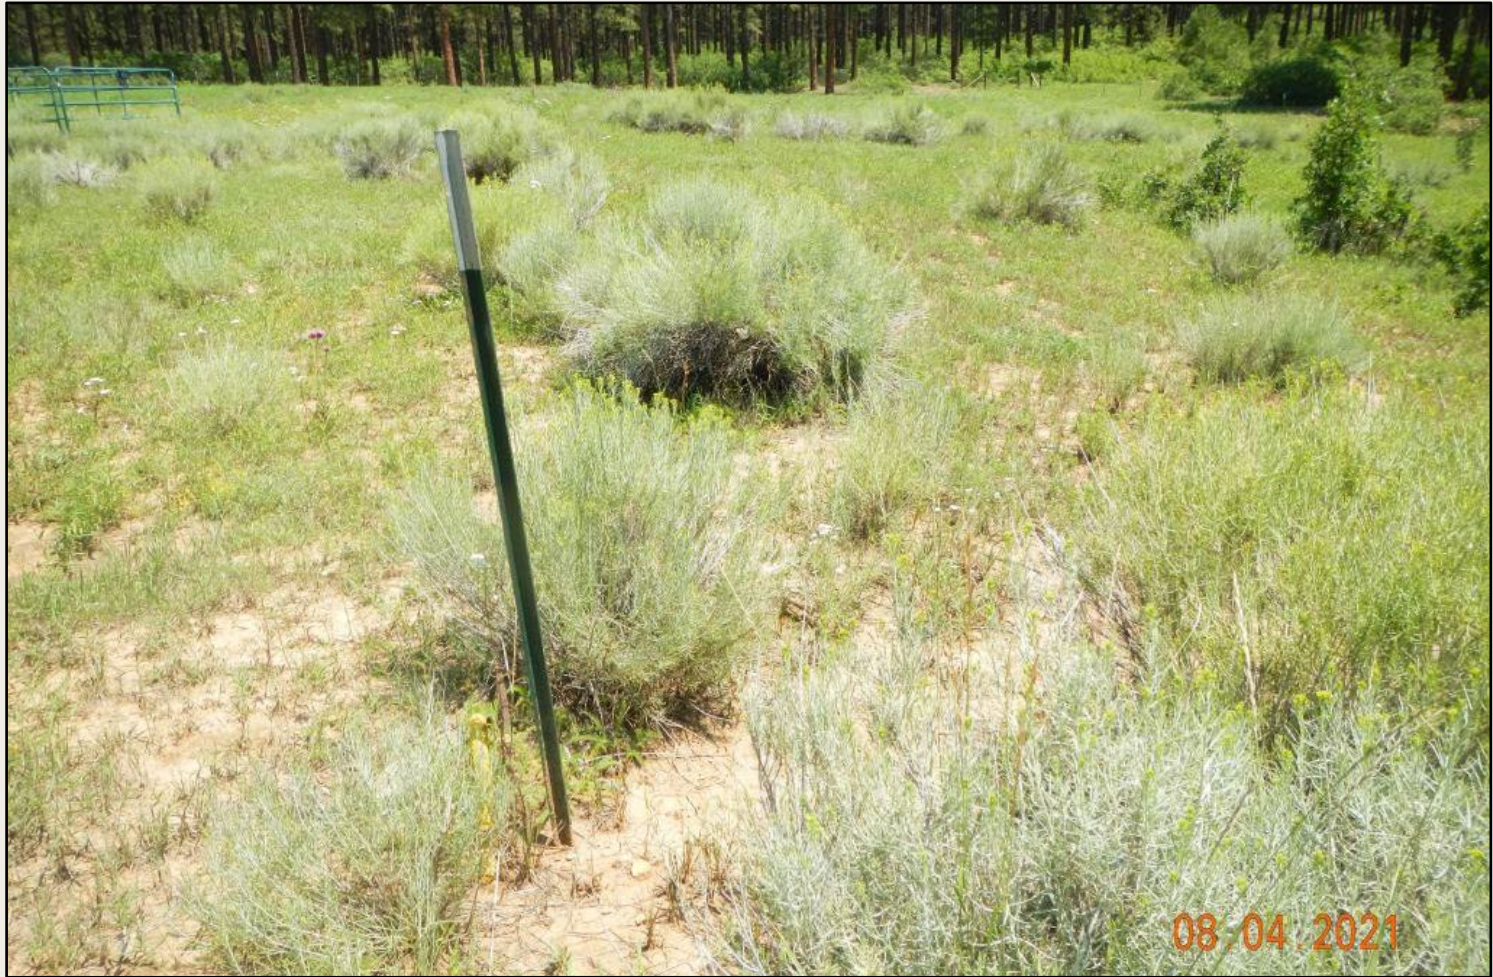
Photo 2. View of the southern project area from the southwestern corner facing eastward. Revegetation is progressing here with western wheatgrass, smooth brome, rubber rabbitbrush, and yarrow.

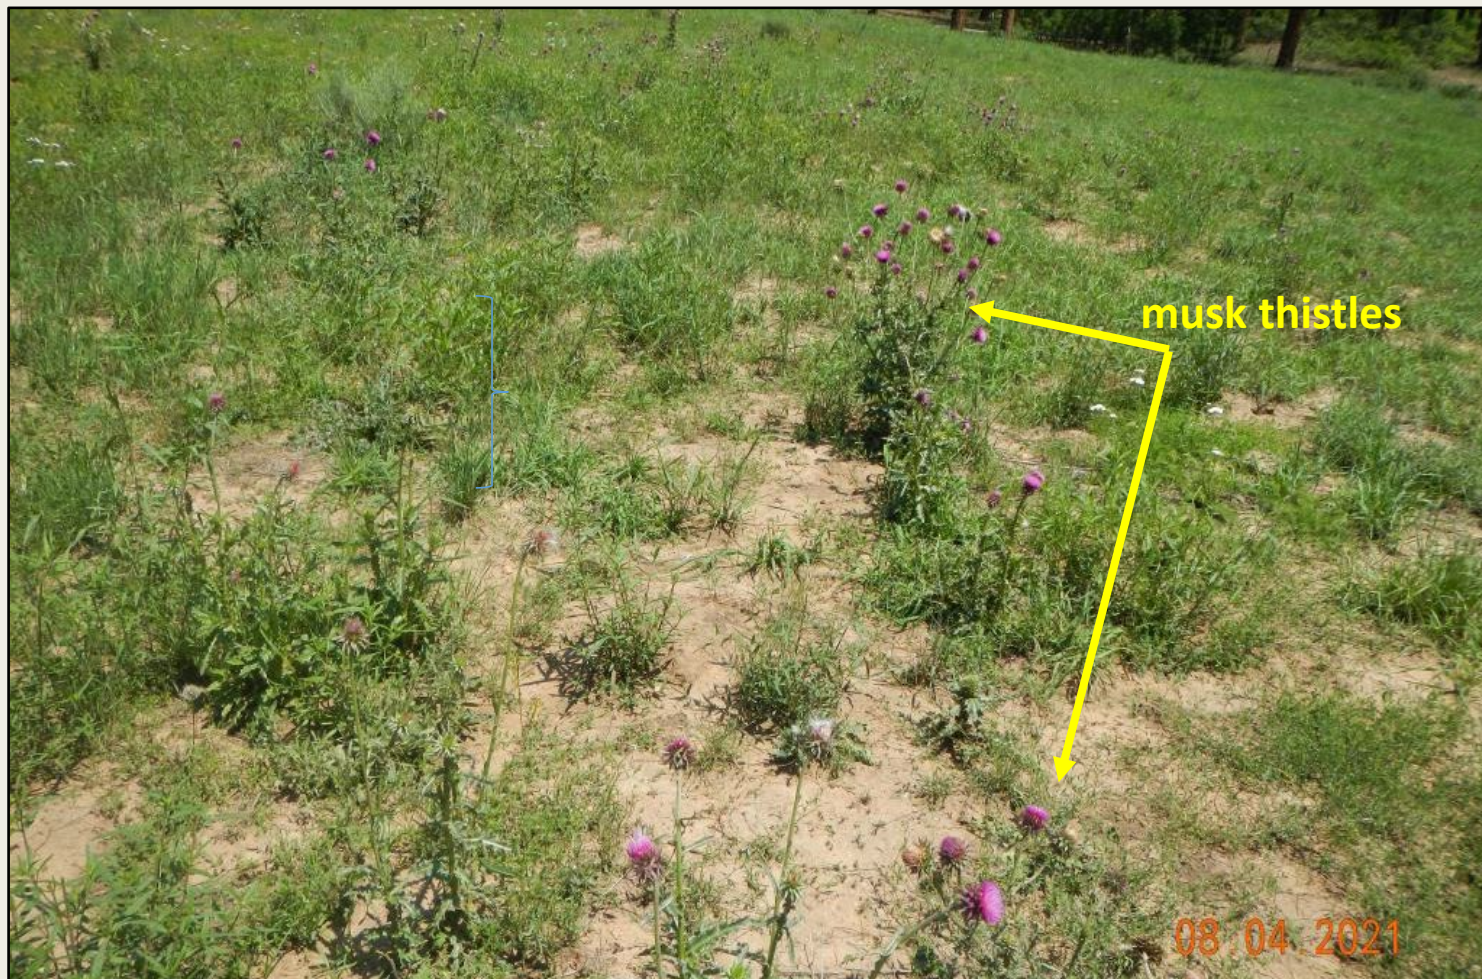
Photo 3. View musk thistles observed within the project area. Approximately 100 flowering individuals observed.

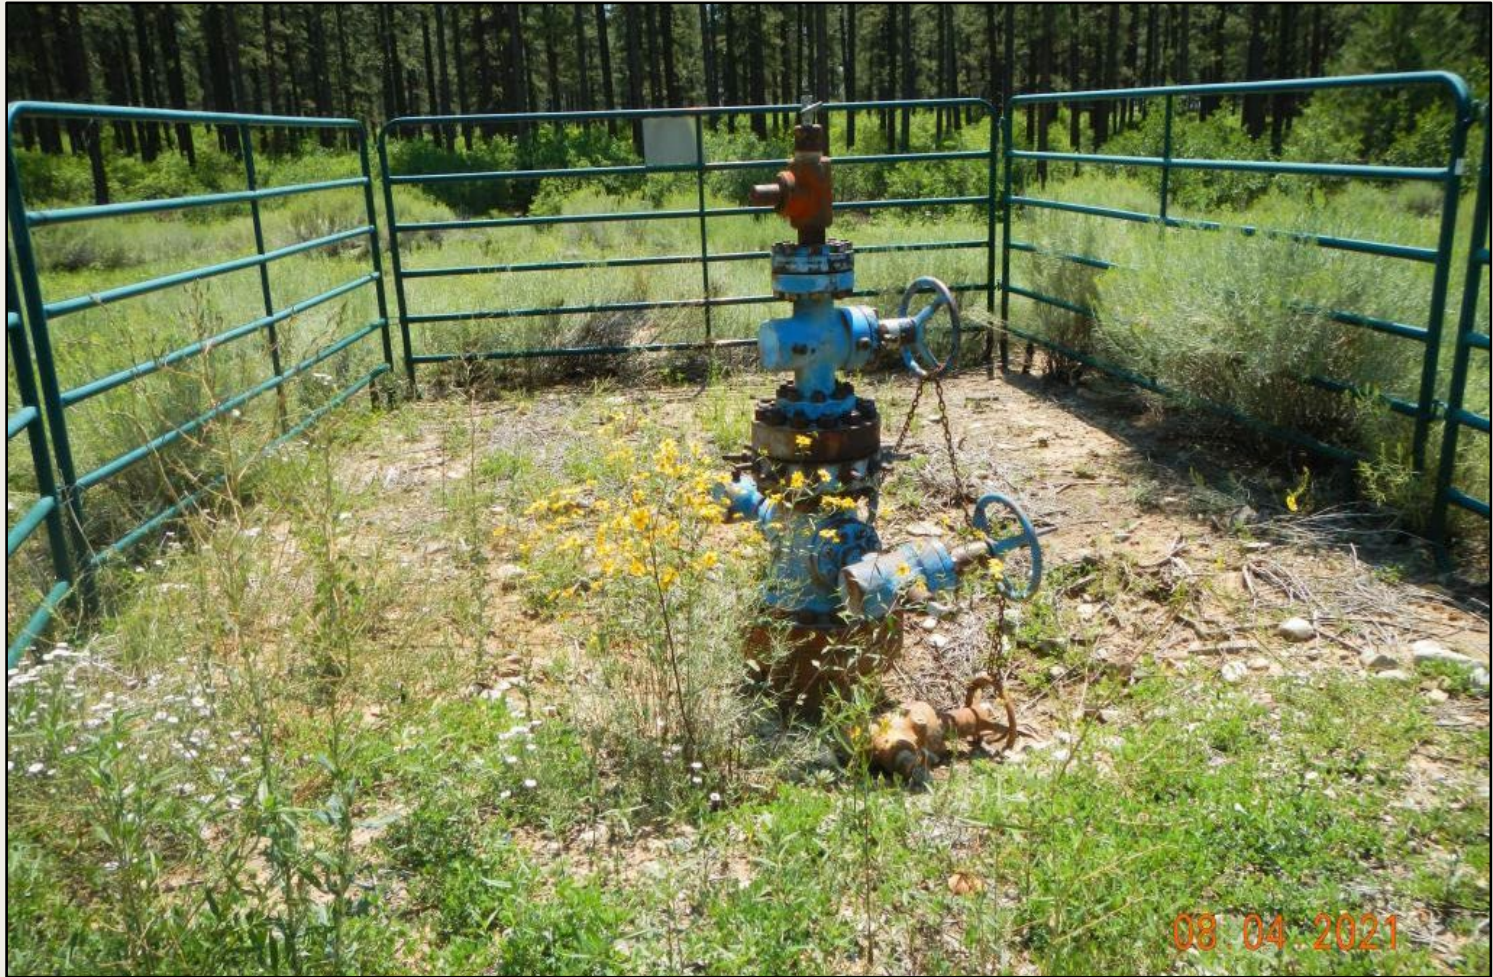
Photo 4. View of the well head facing southward.

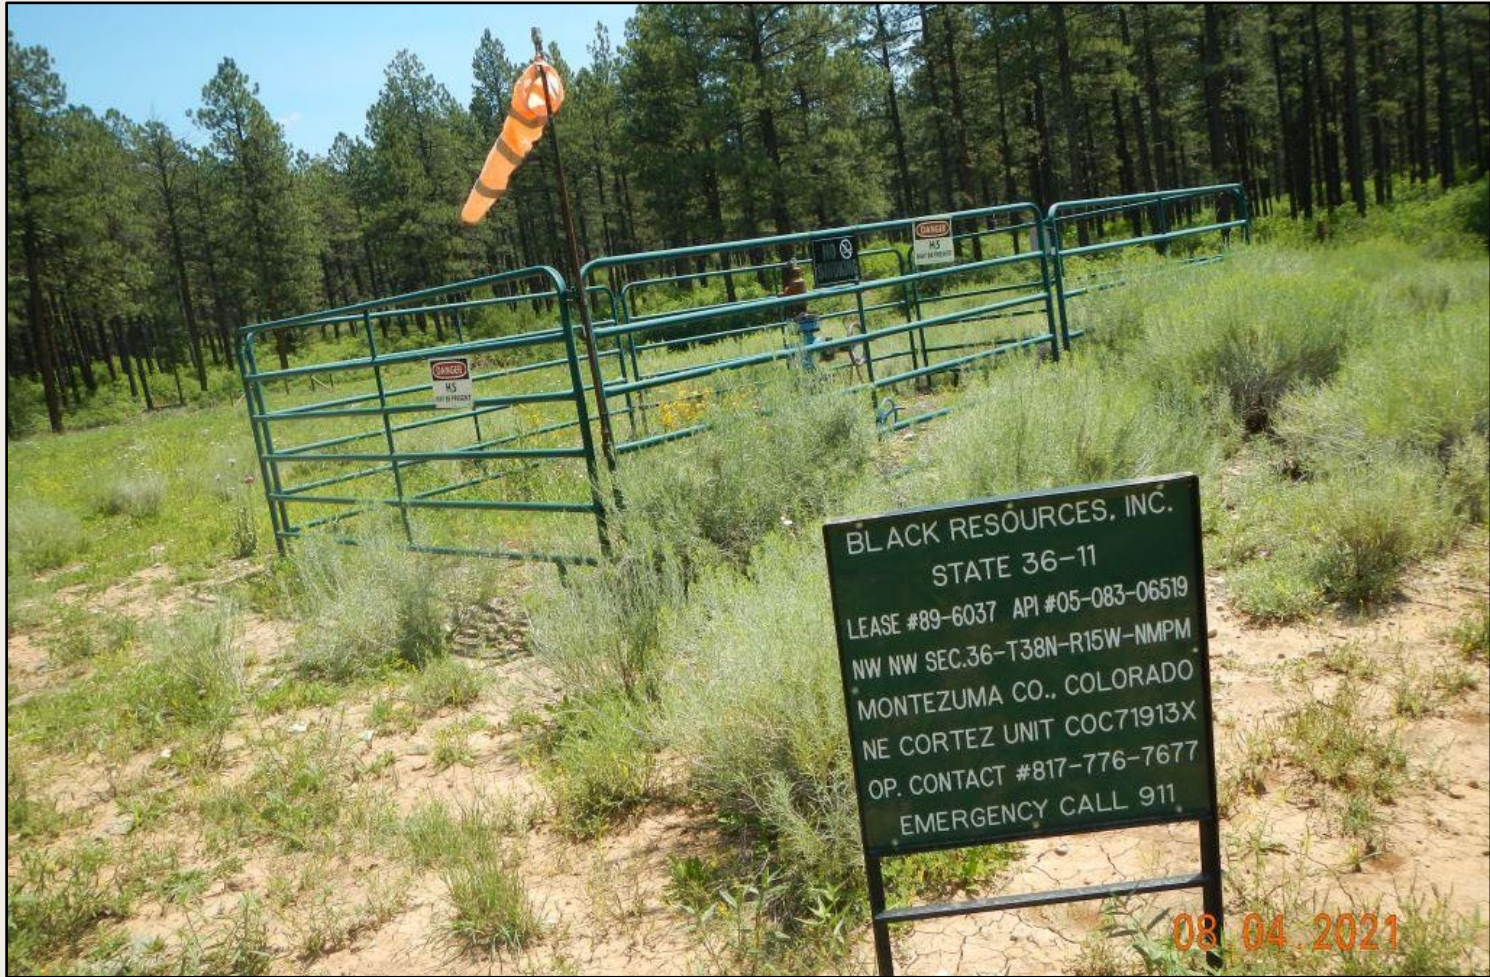
Photo 5. View of well sign, fencing, and well sock at the wellhead.

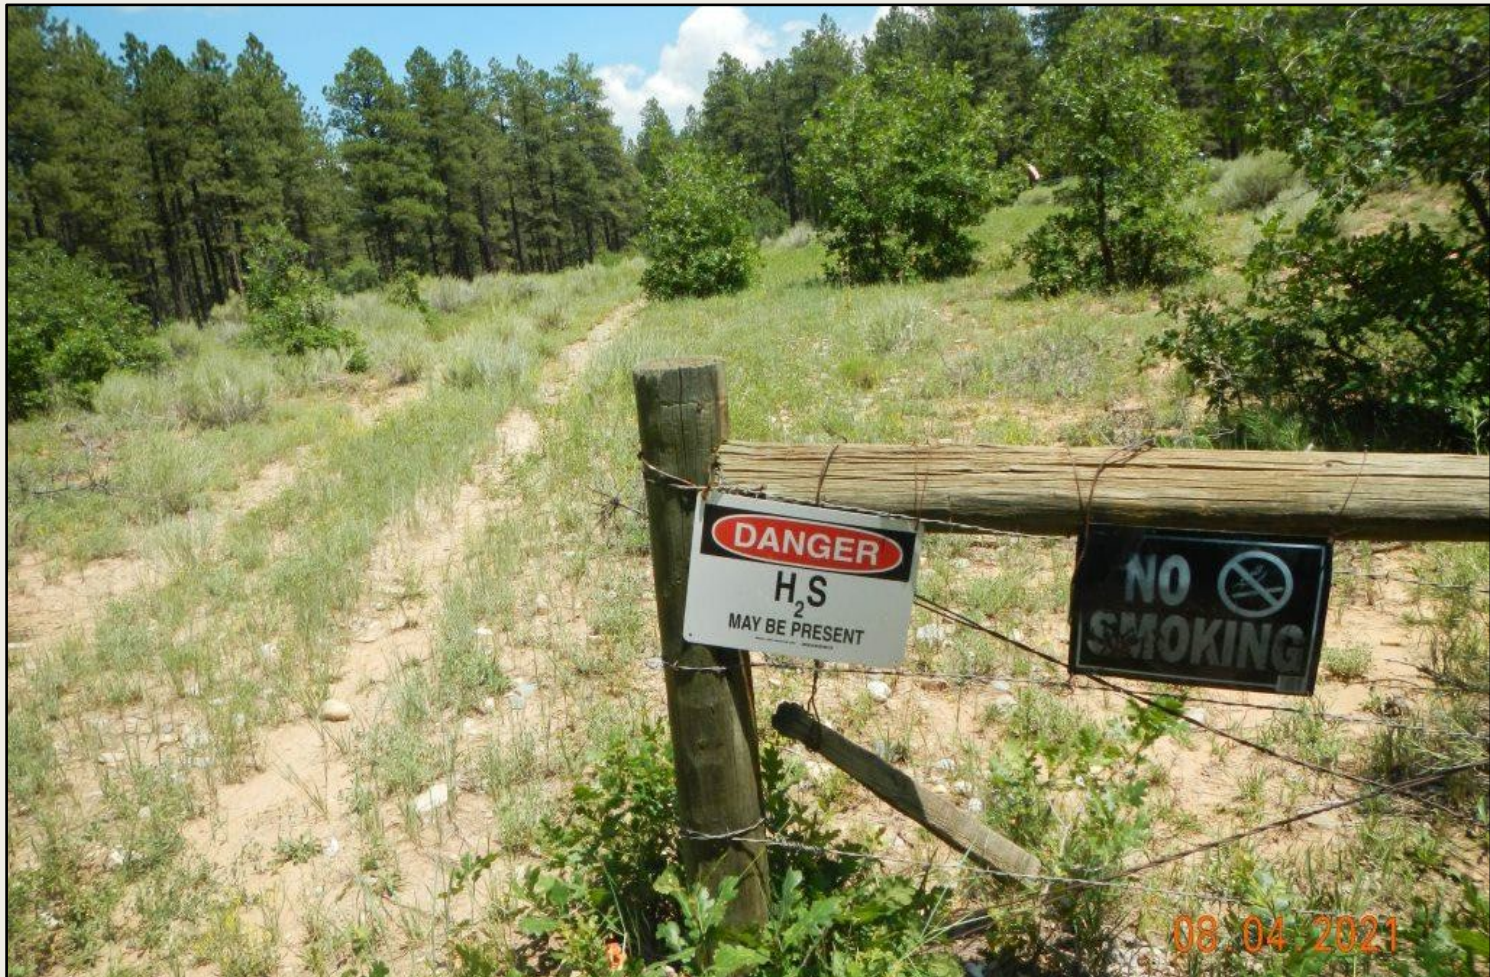
Photo 6. View of signage on the access road near the well pad entrance.

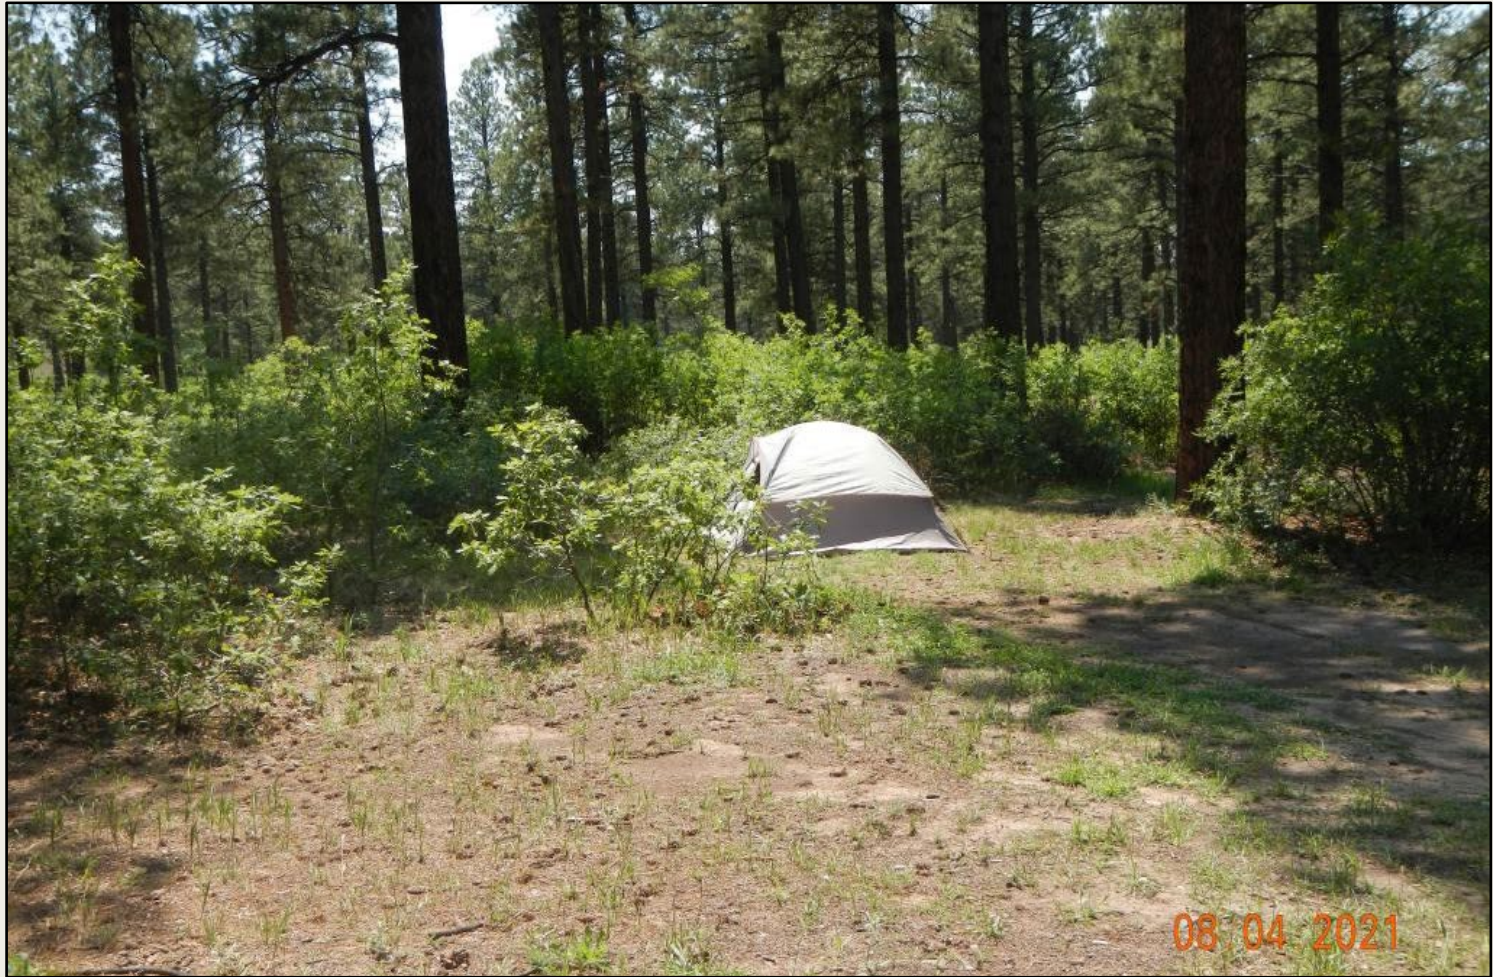
Photo 7. View of tent at gated access to location.

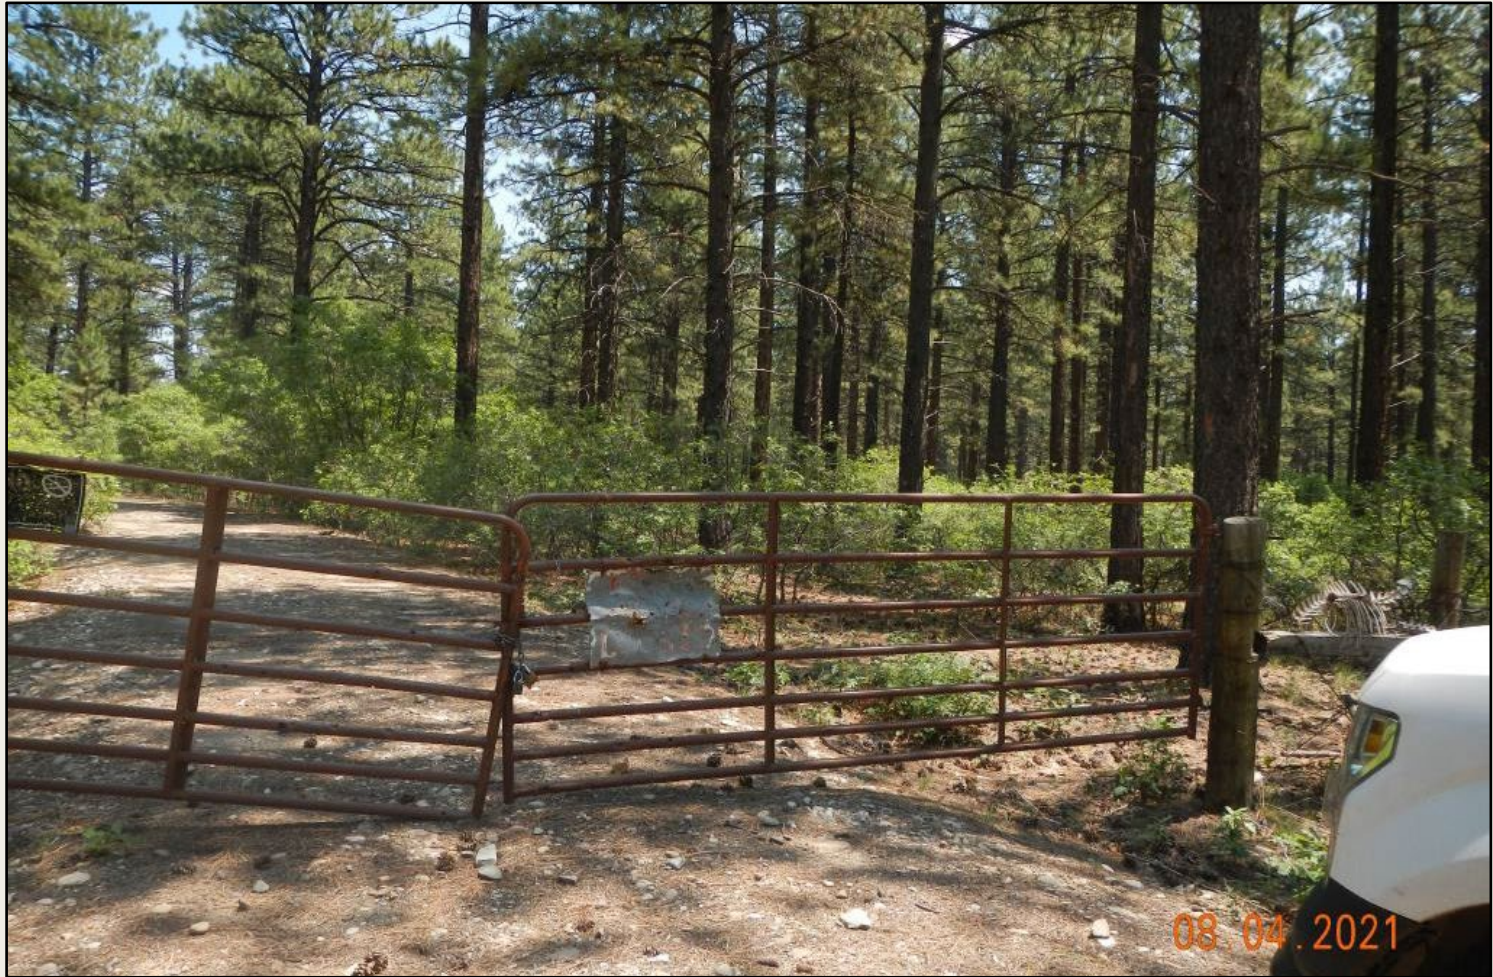
Photo 8. View of locked gate and entrance to access road.

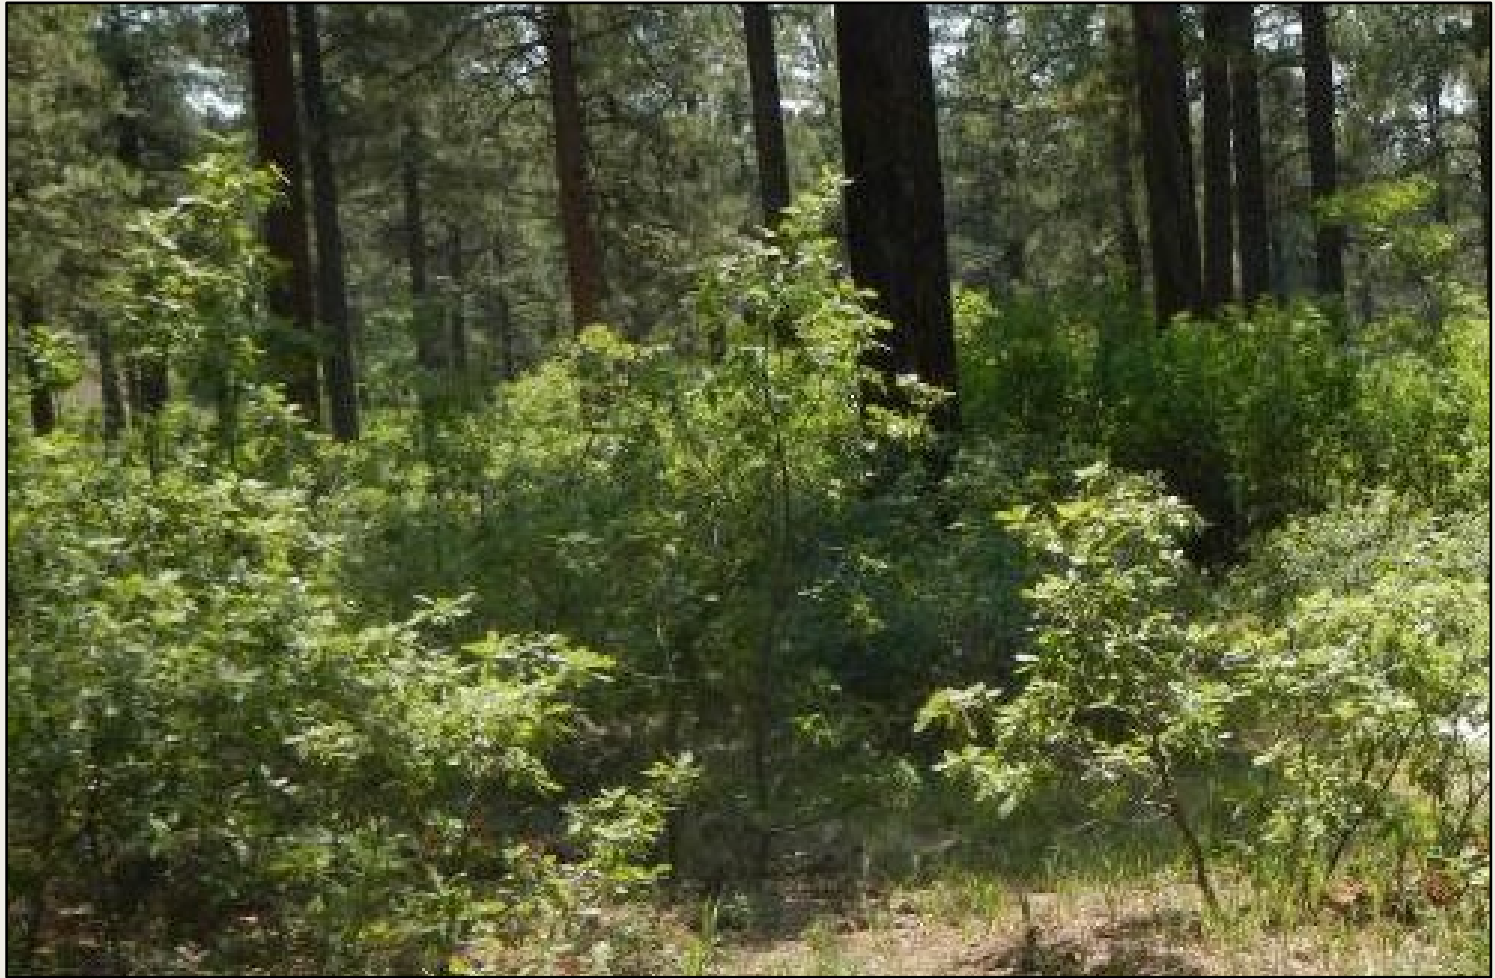
Photo 9. View of the reference area comprised of ponderosa pine and gambel oak woodland with understory of sandberg bluegrass, junegrass, yarrow, Oregon grape, and sugarbowl clematis.
