Inspection Photos
Operator: Grynberg
API: 083-06378
Date: 8/4/2021

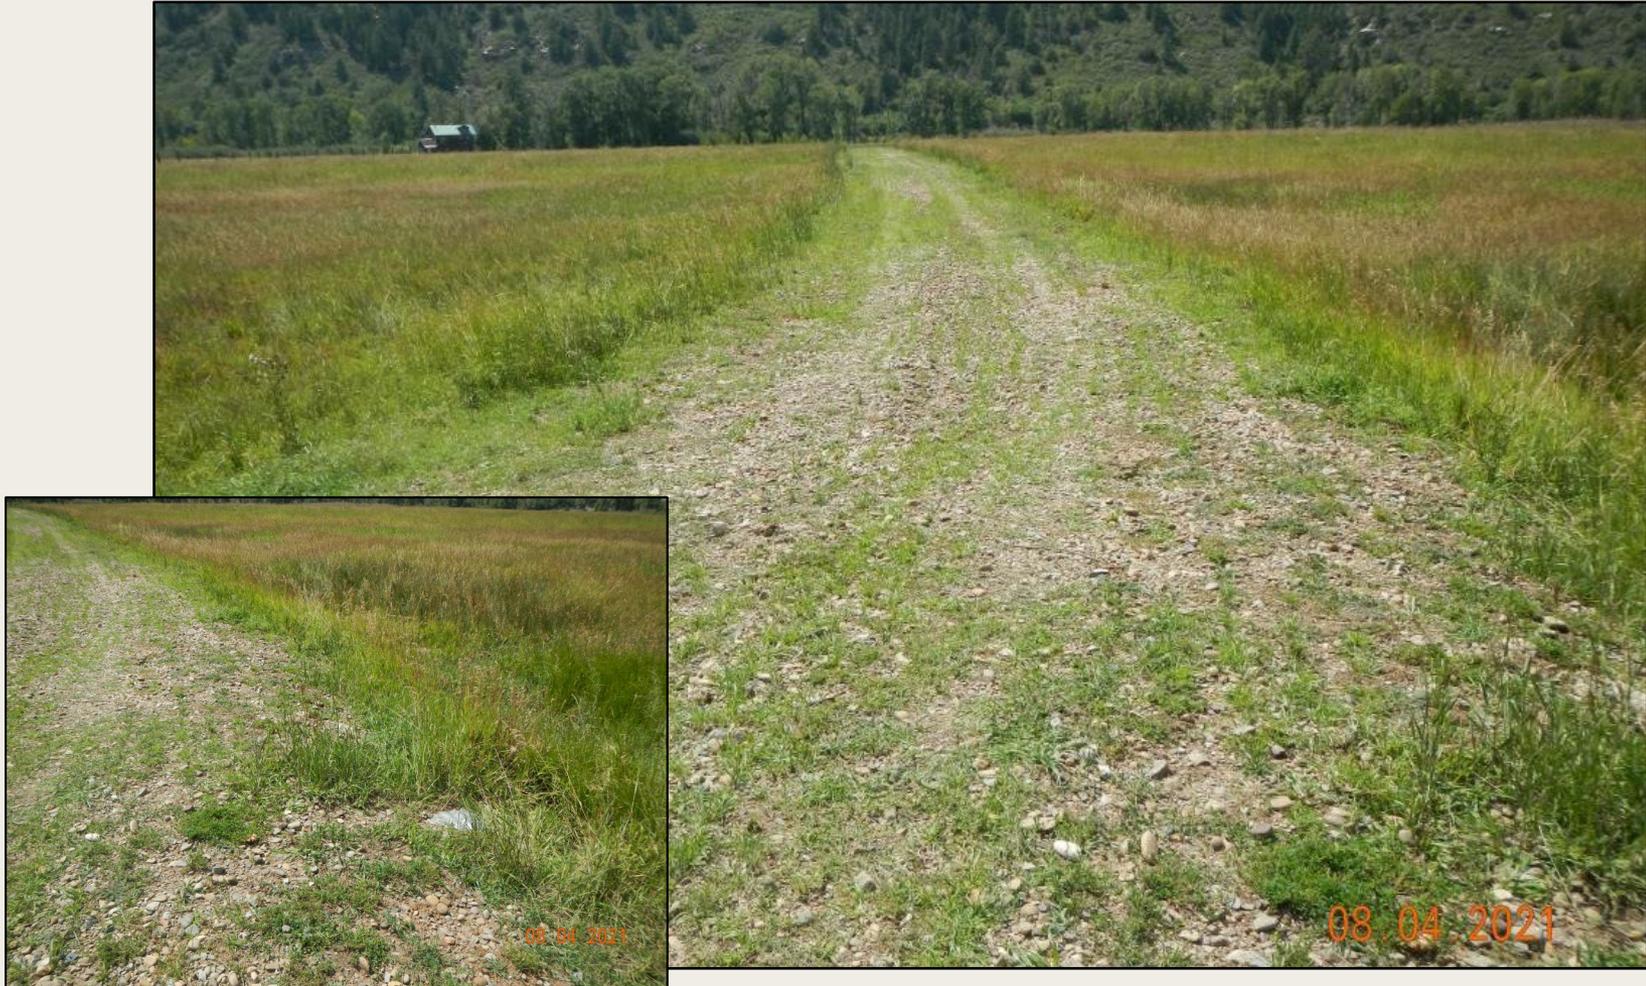
Photo 1. View of the access road from the access entrance facing north toward the well pad. Road fill, gravel, and culvert (inset) remain in place.

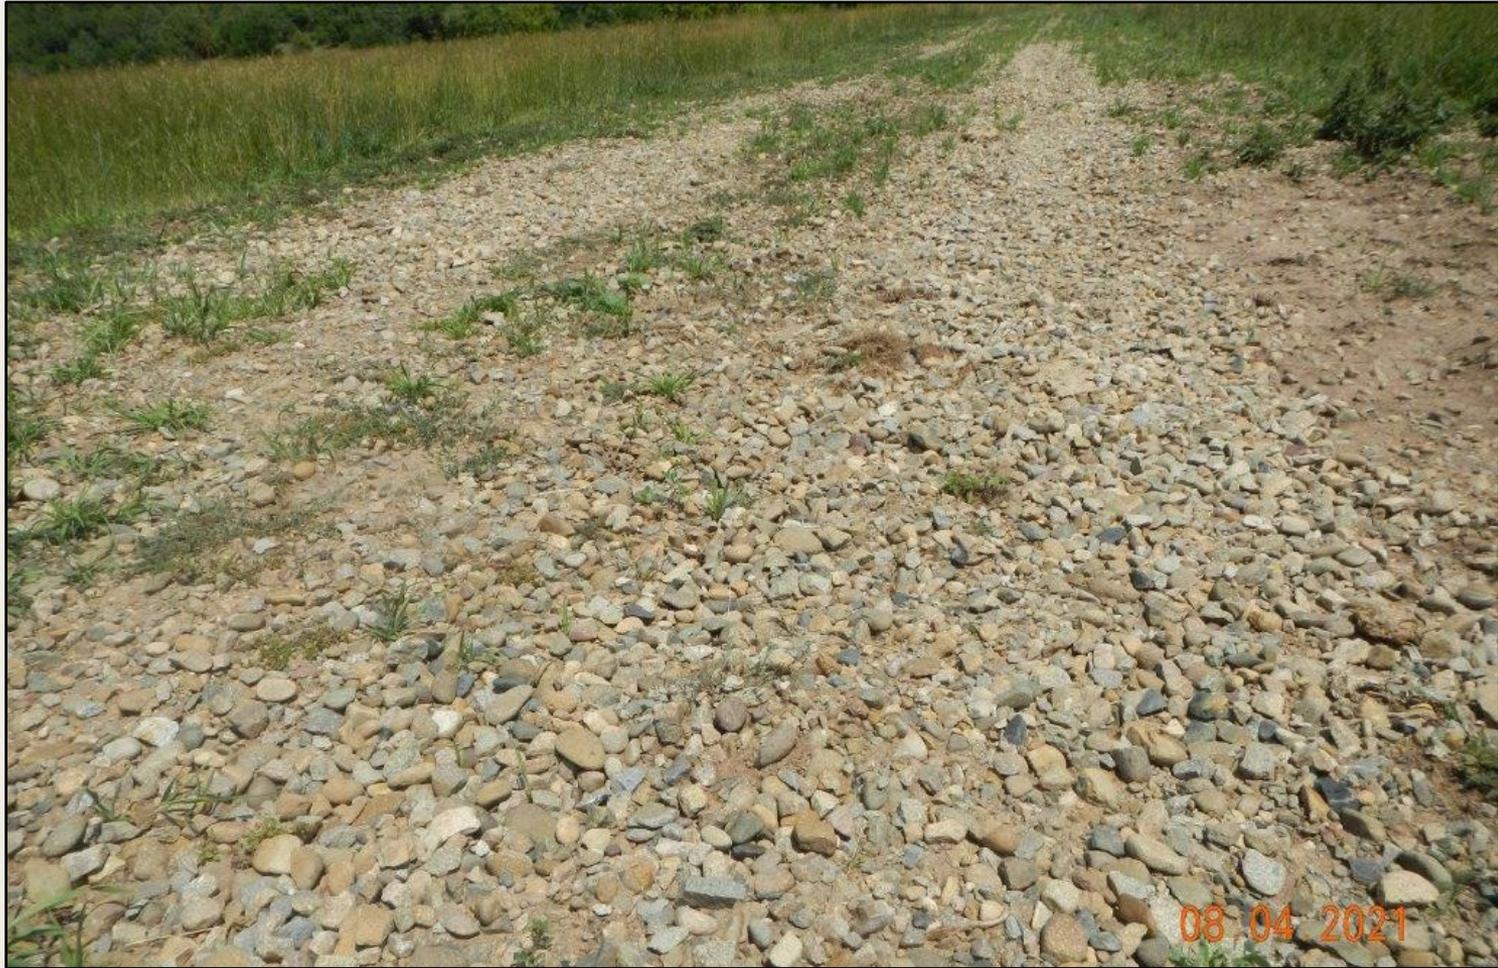
Photo 2. View of gravel and fill observed on the access road.

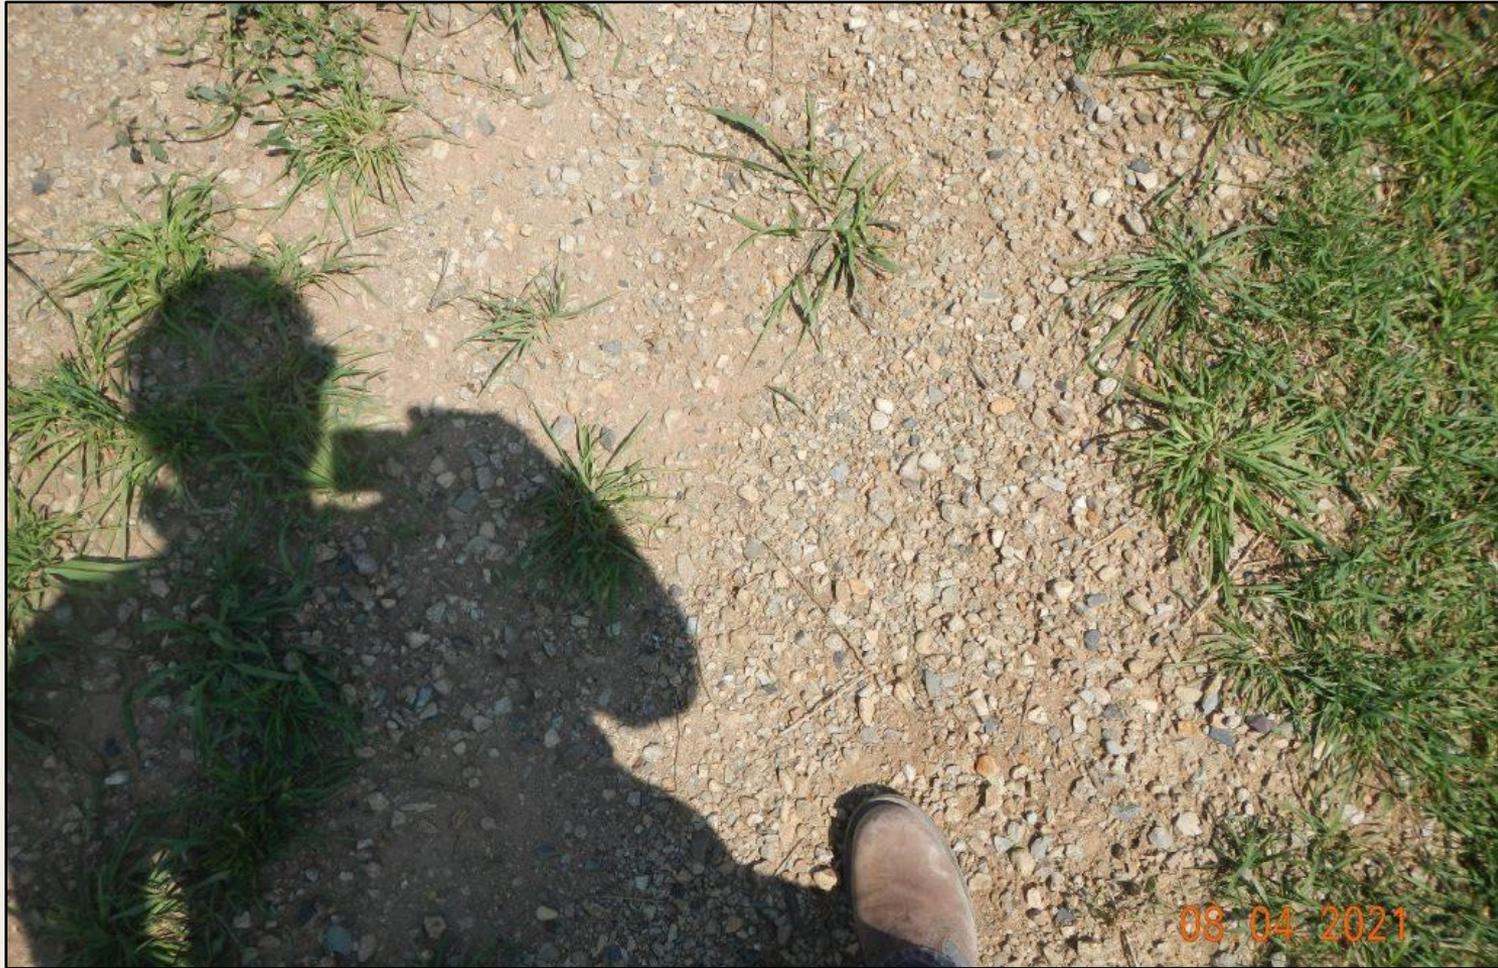
Photo 3. View of gravel on the well pad.

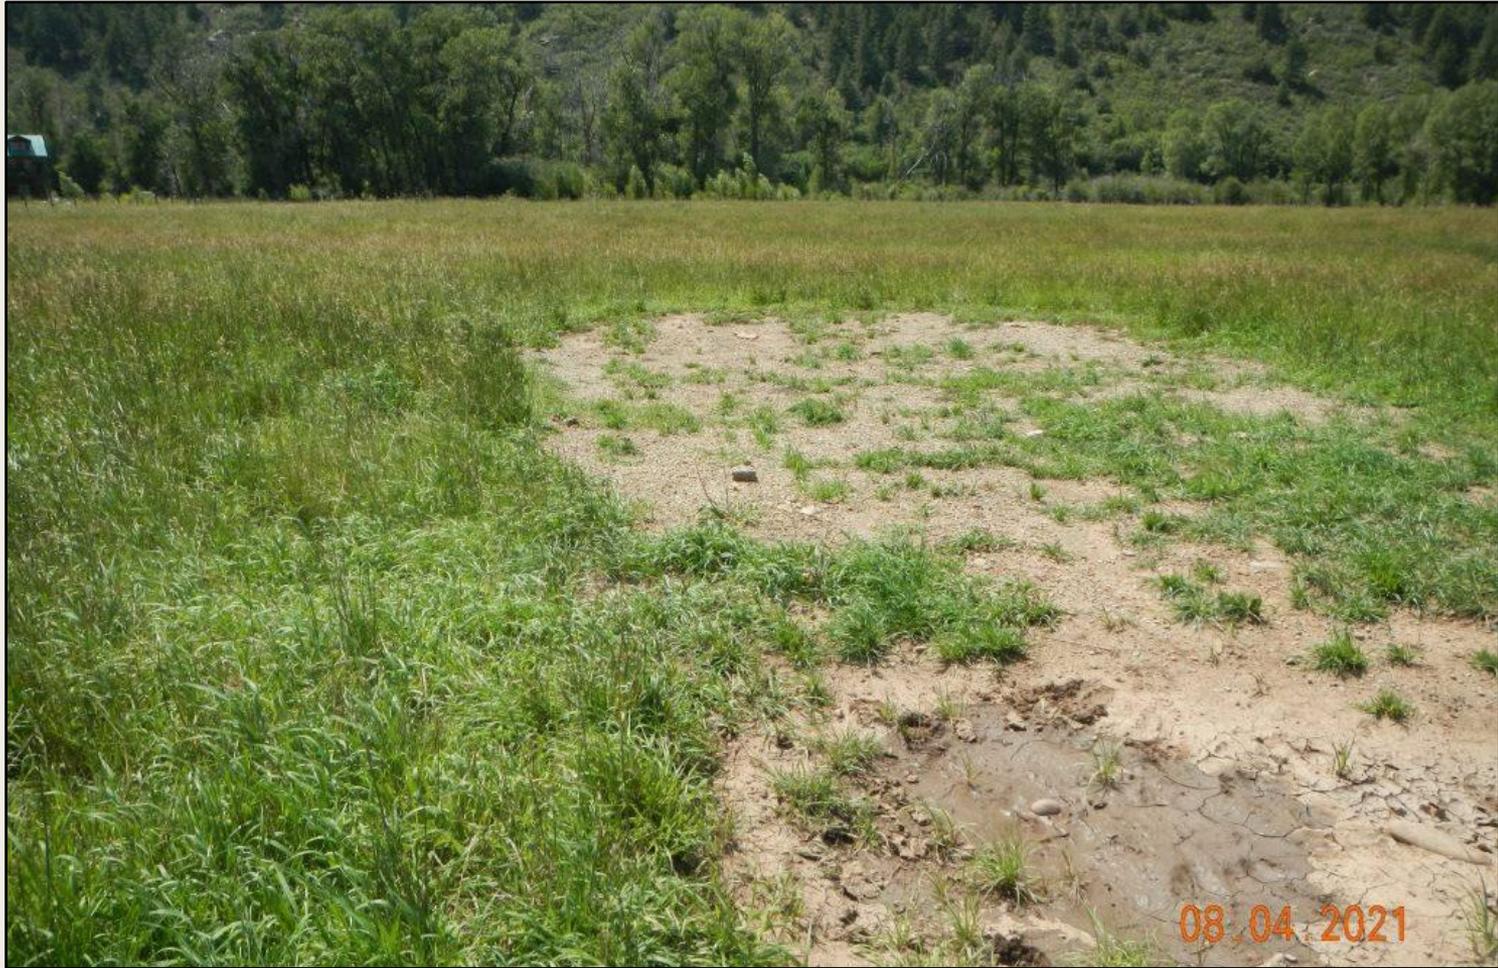
Photo 4. View of area on the former well pad where sparse vegetation remains. Soils may be compacted or contaminated here.

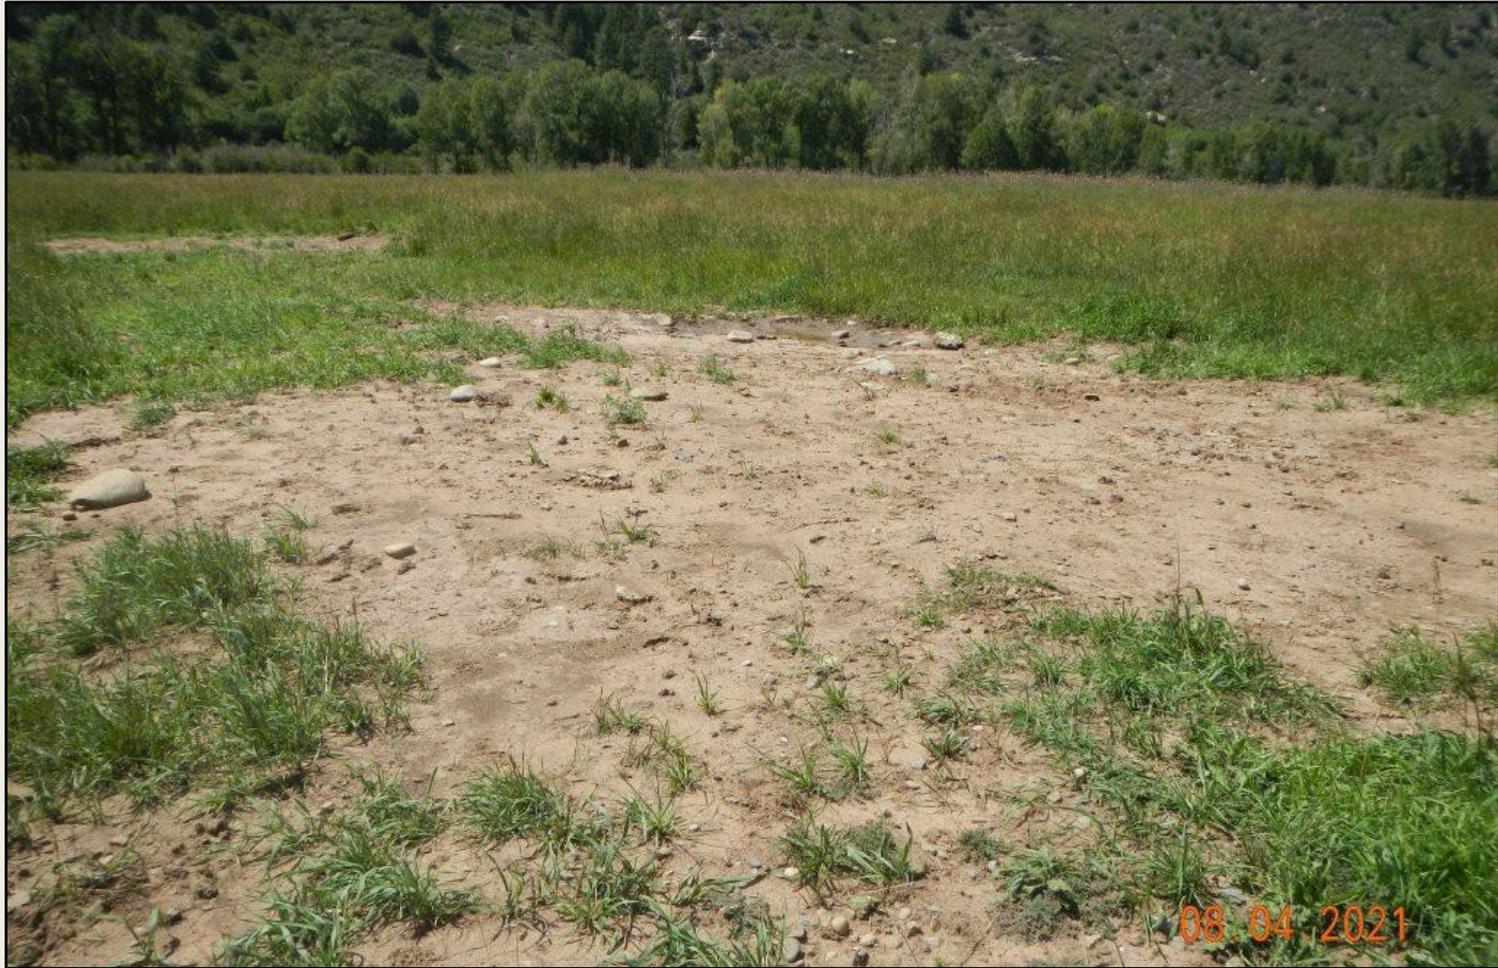
Photo 5. View of another portion of the project disturbance where revegetation is not progressing.

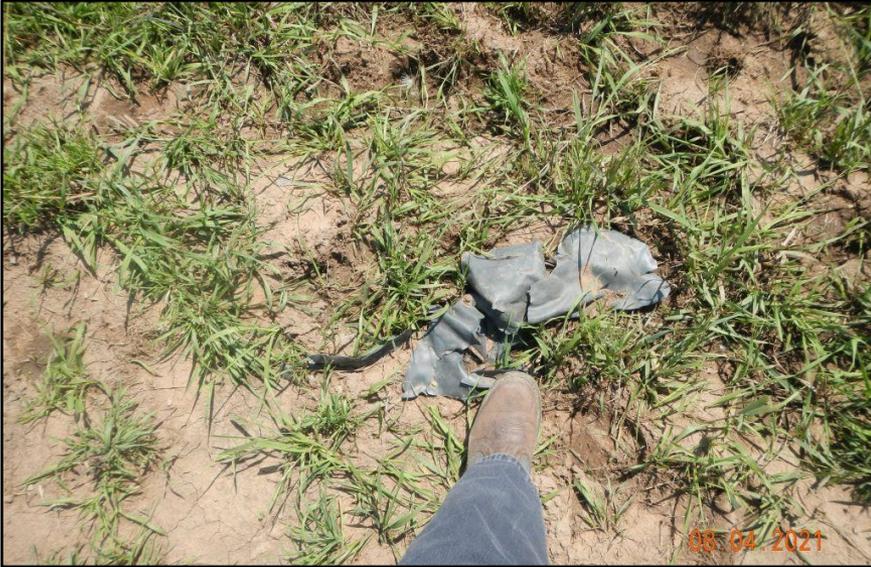
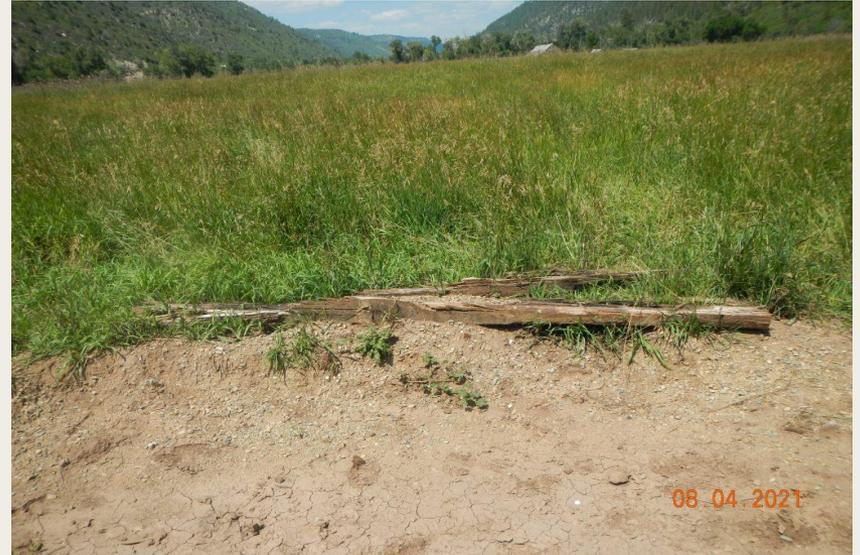
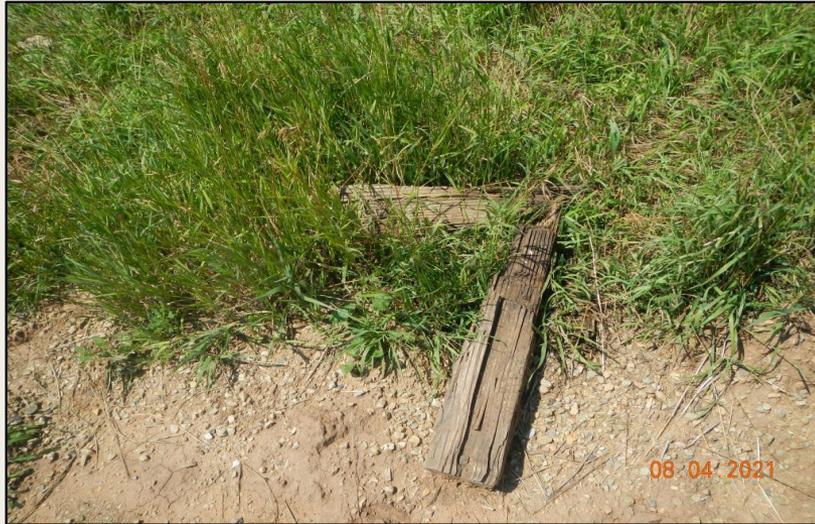
Photos 6-8. View of project wood and plastic liner debris observed partially buried within the project area, needs to be removed.

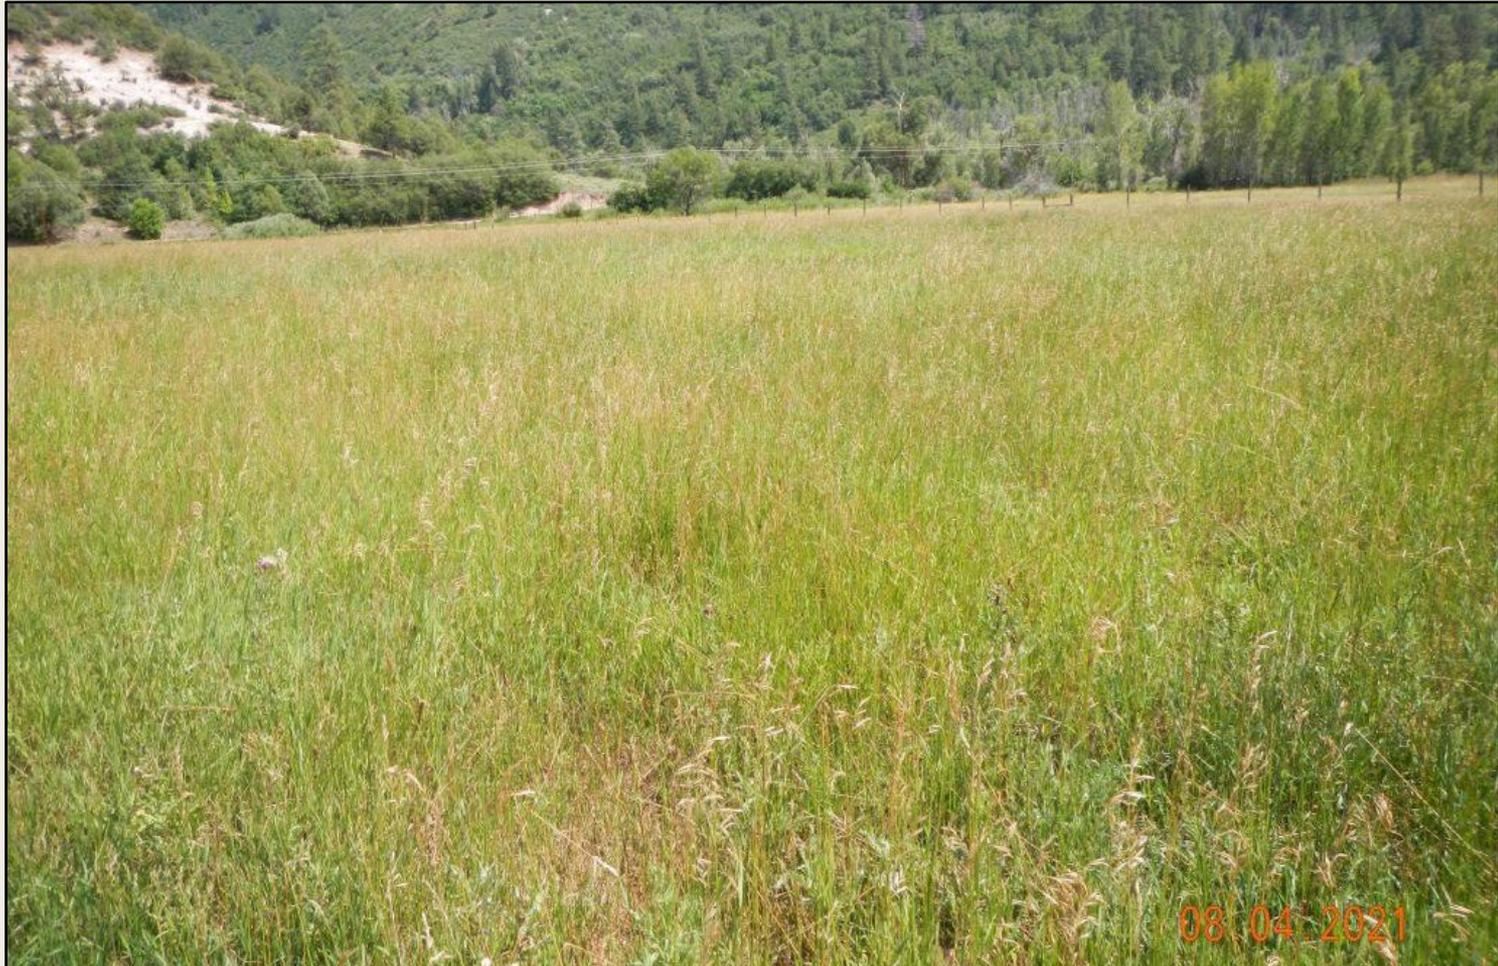
Photo 9. View of the reference area comprised of irrigated grass field with smooth brome, orchard grass, red fescue,
