Inspection Photos

8/3/2021

Operator: GUNNISON ENERGY LLC #10515

Location ID: 324464

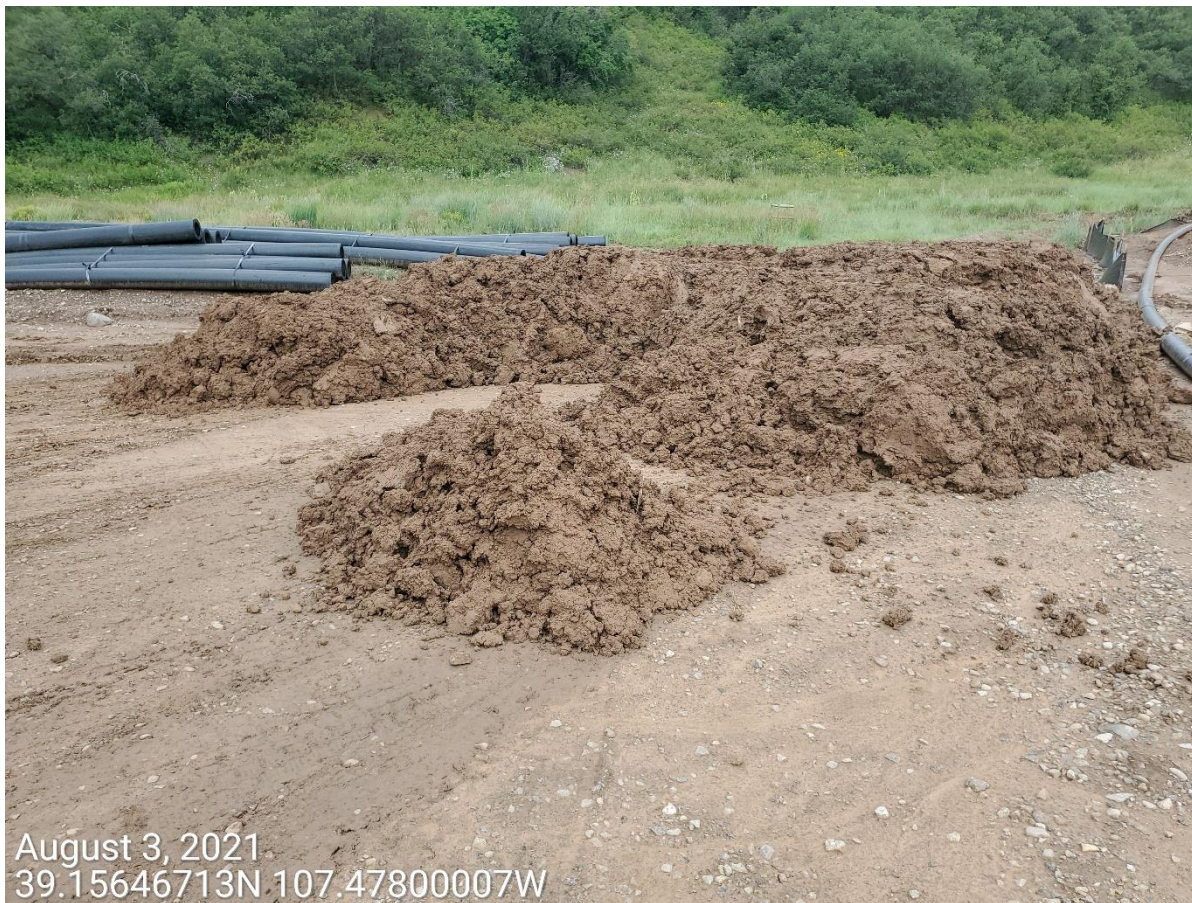
Photo 1: Photo shows sediment material improperly stored on the Location. Operator was observed removing/transporting sediment from the base of the cutslopes of the Trail Gulch Unit 1090 /30 Location, and placing/storing on the Federal 30-4 Location. No BMPs have been installed to prevent sediment transport from the stockpiled soils.

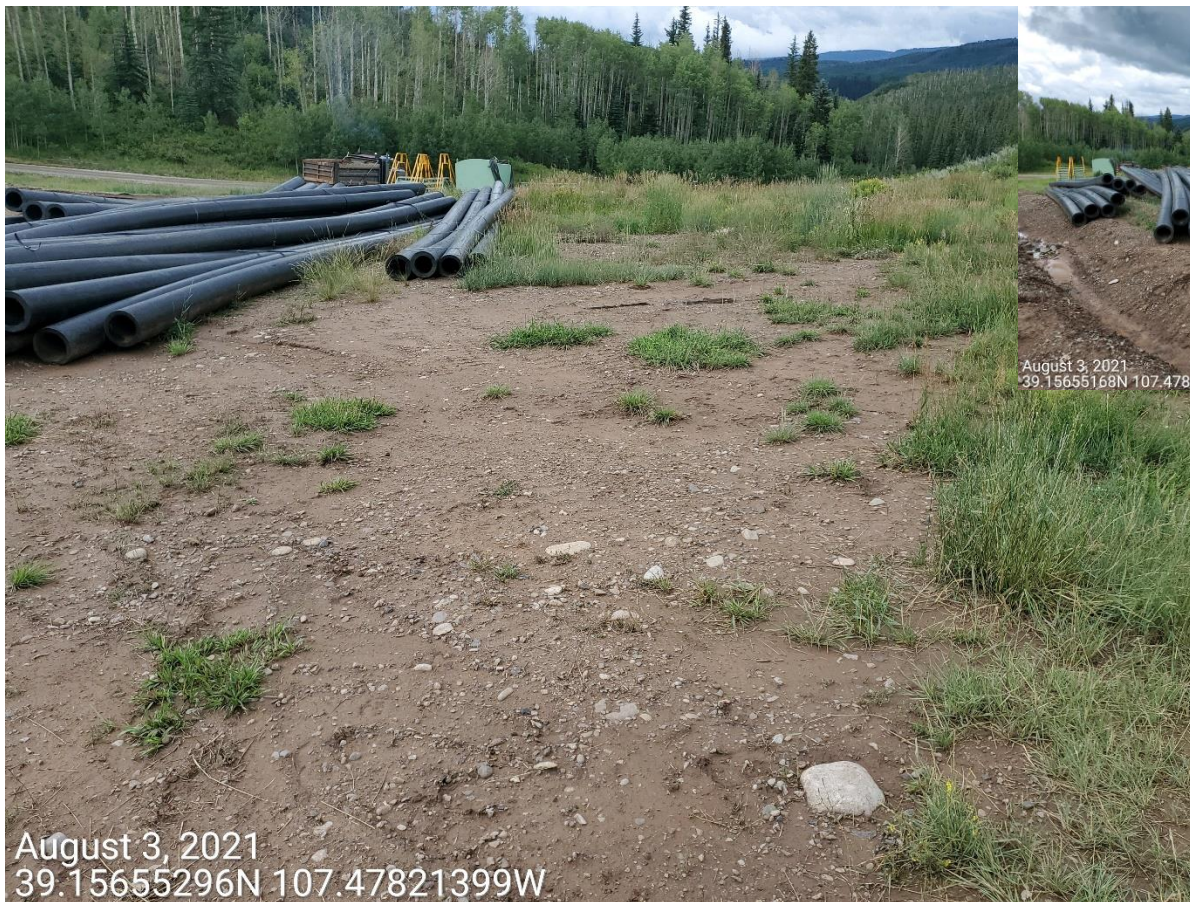
Photo 2: Photo taken from the north end of the Location. Previous inspections required Operator to reclaim areas in accordance with 1003 rules. Photo shows areas have not been reclaimed.

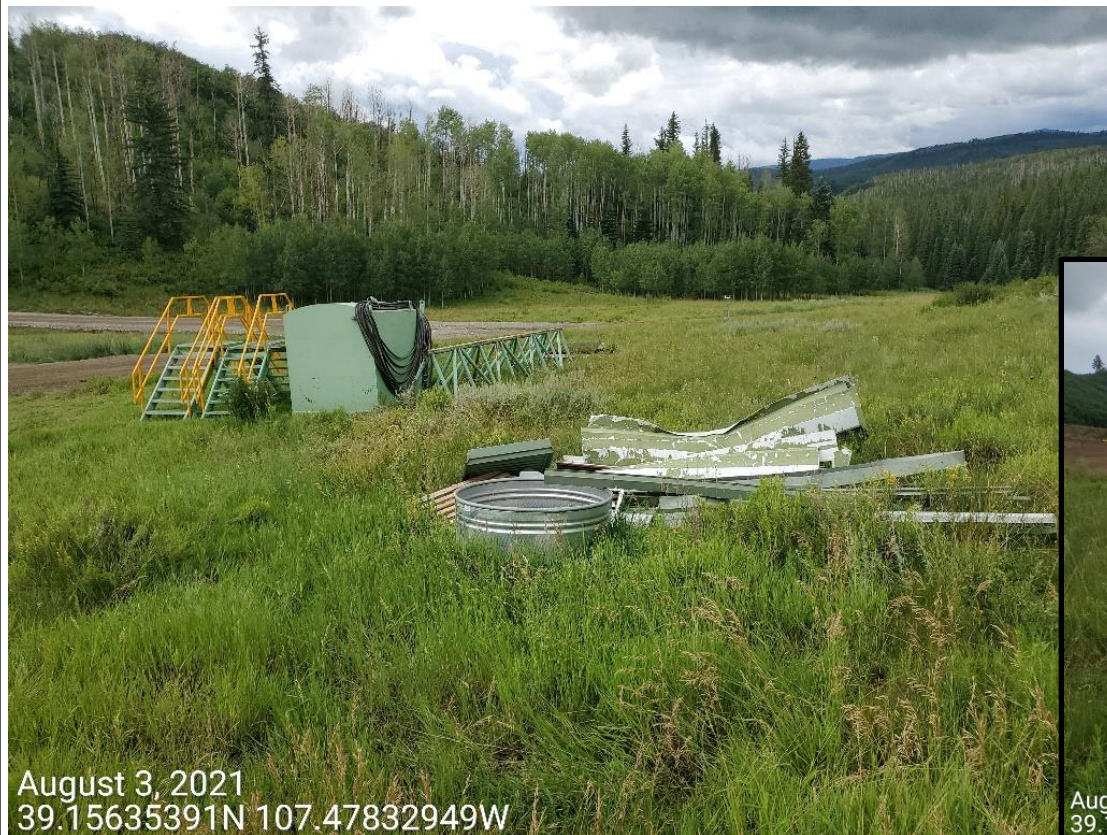
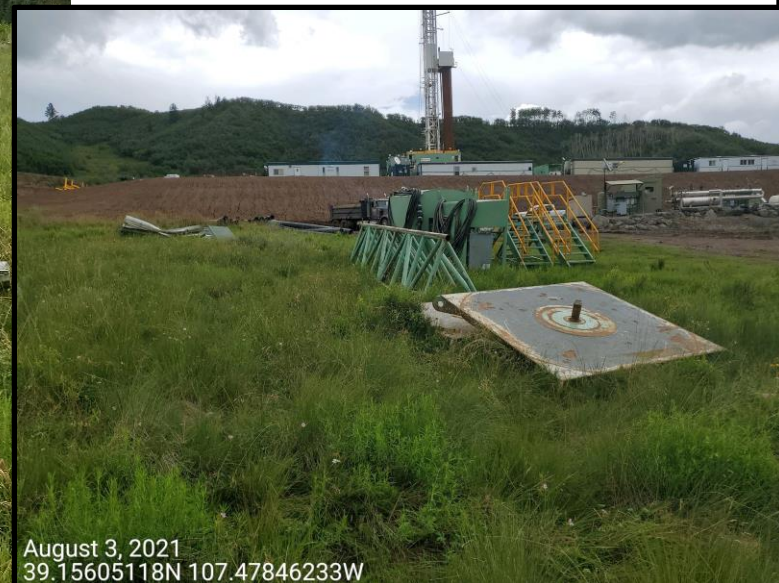
Photo 3: Photo taken from the west of the Location. Photo shows various unused equipment and/or debris remains stored off of the Location.

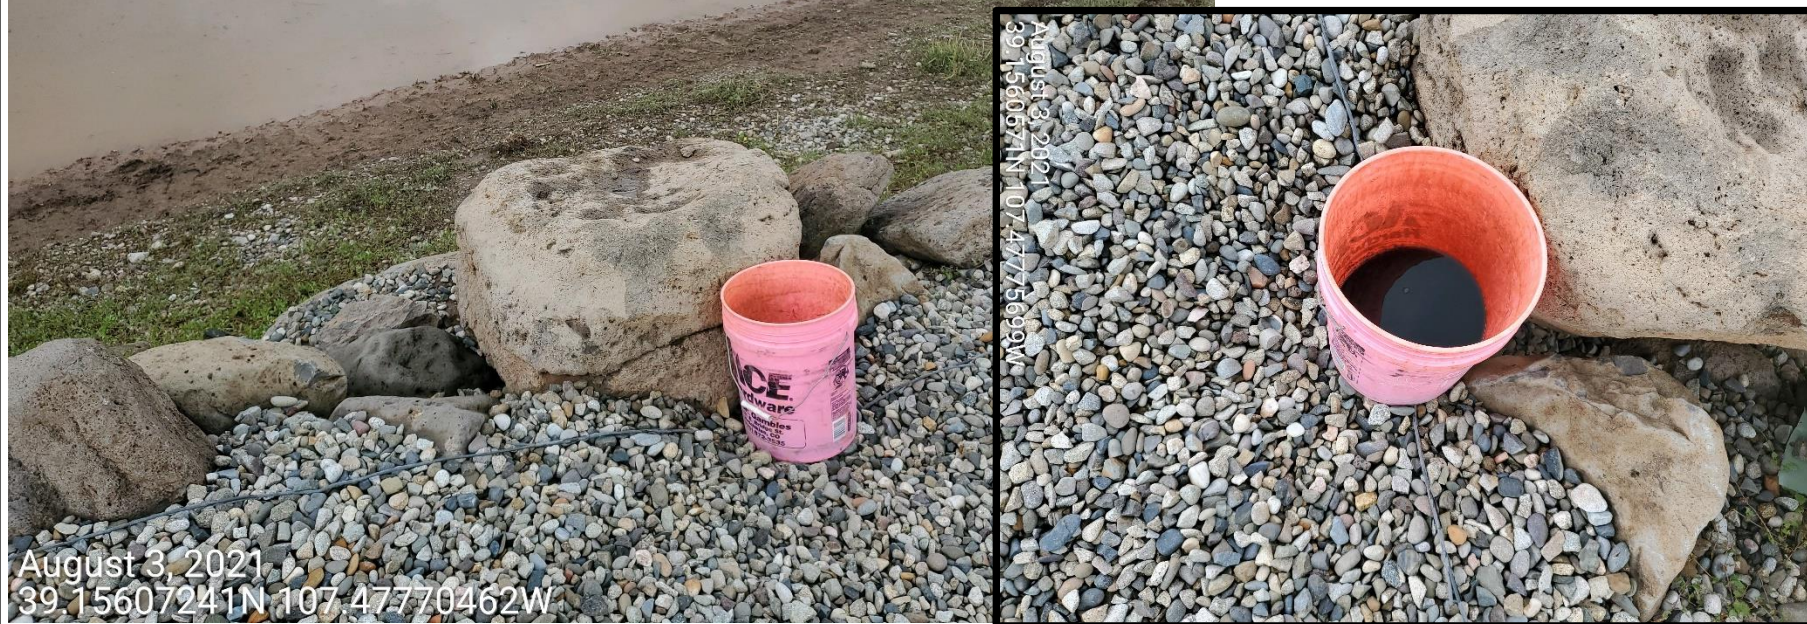
Photo 4: Photo taken from the west end of the Location. Photo shows bucket containing unmown fluids; safety labeling identifying contents remain missing; buck has not been placed into secondary containment. These issues were identified in the previous inspection.

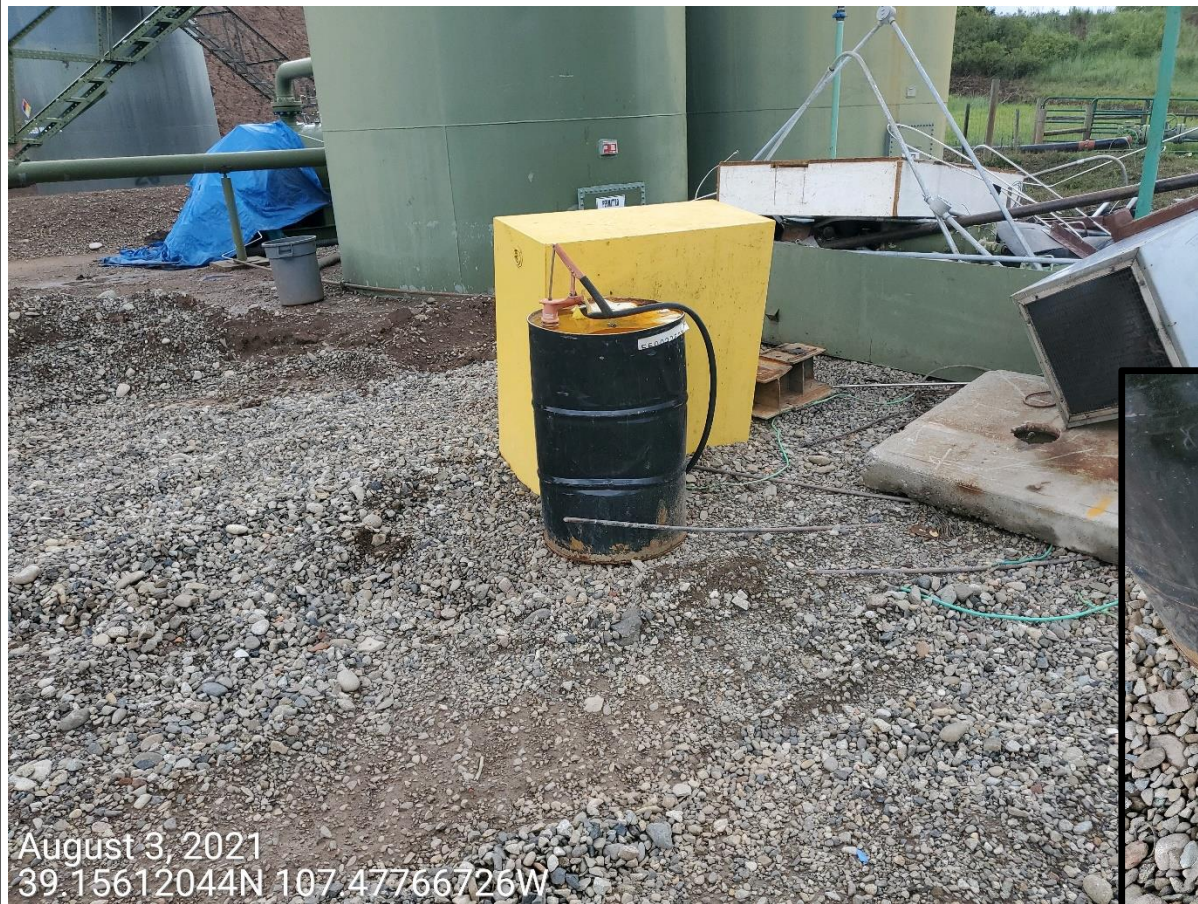
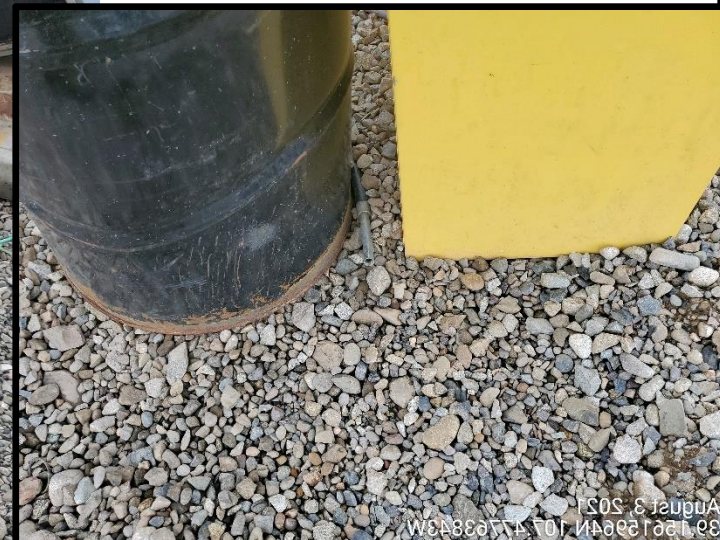
Photo 5: Photo shows barrel containing antifreeze/coolant stored on the Location without secondary containment. Photo also shows general Rule 606 good housekeeping issues observed on the location. Issues have been identified in previous inspections.

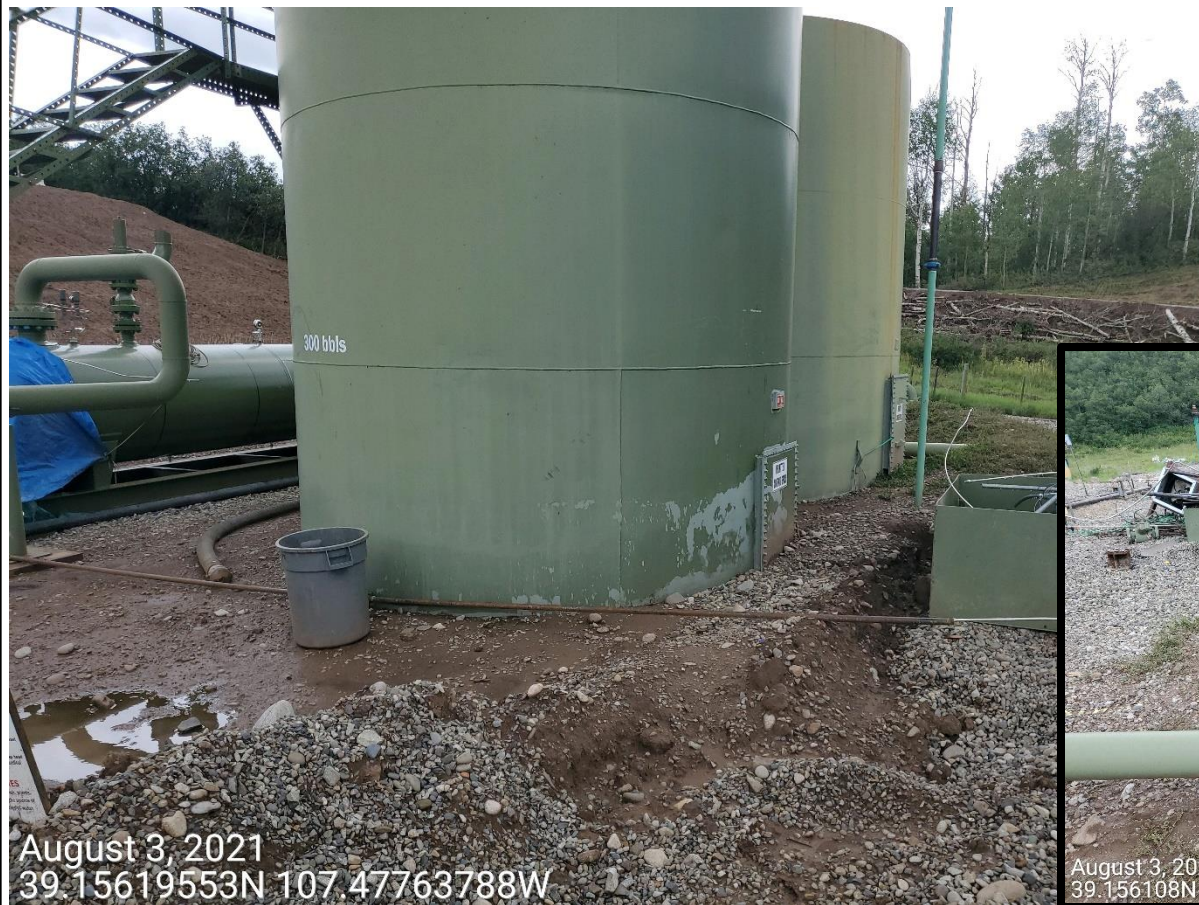
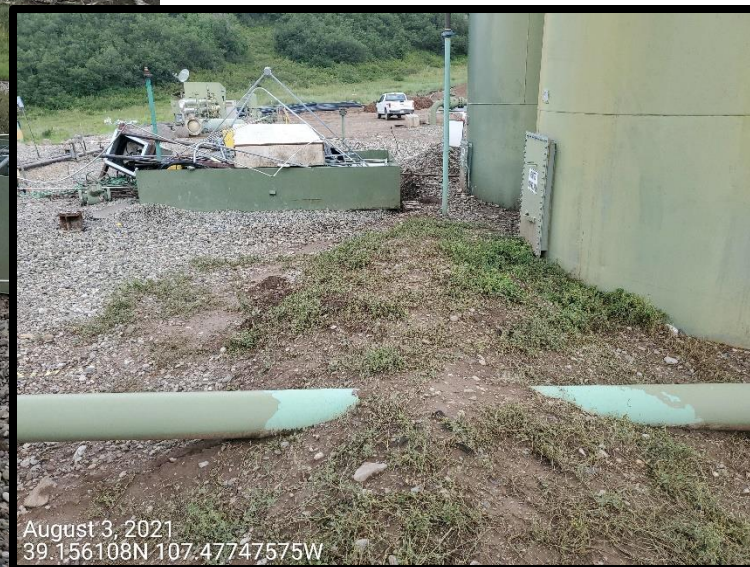
Photo 6: Photo taken from the south end of the Location, facing east. Photo shows vegetation establishment is predominantly undesirable weedy plant species. Little to no desirable plant germination observed.

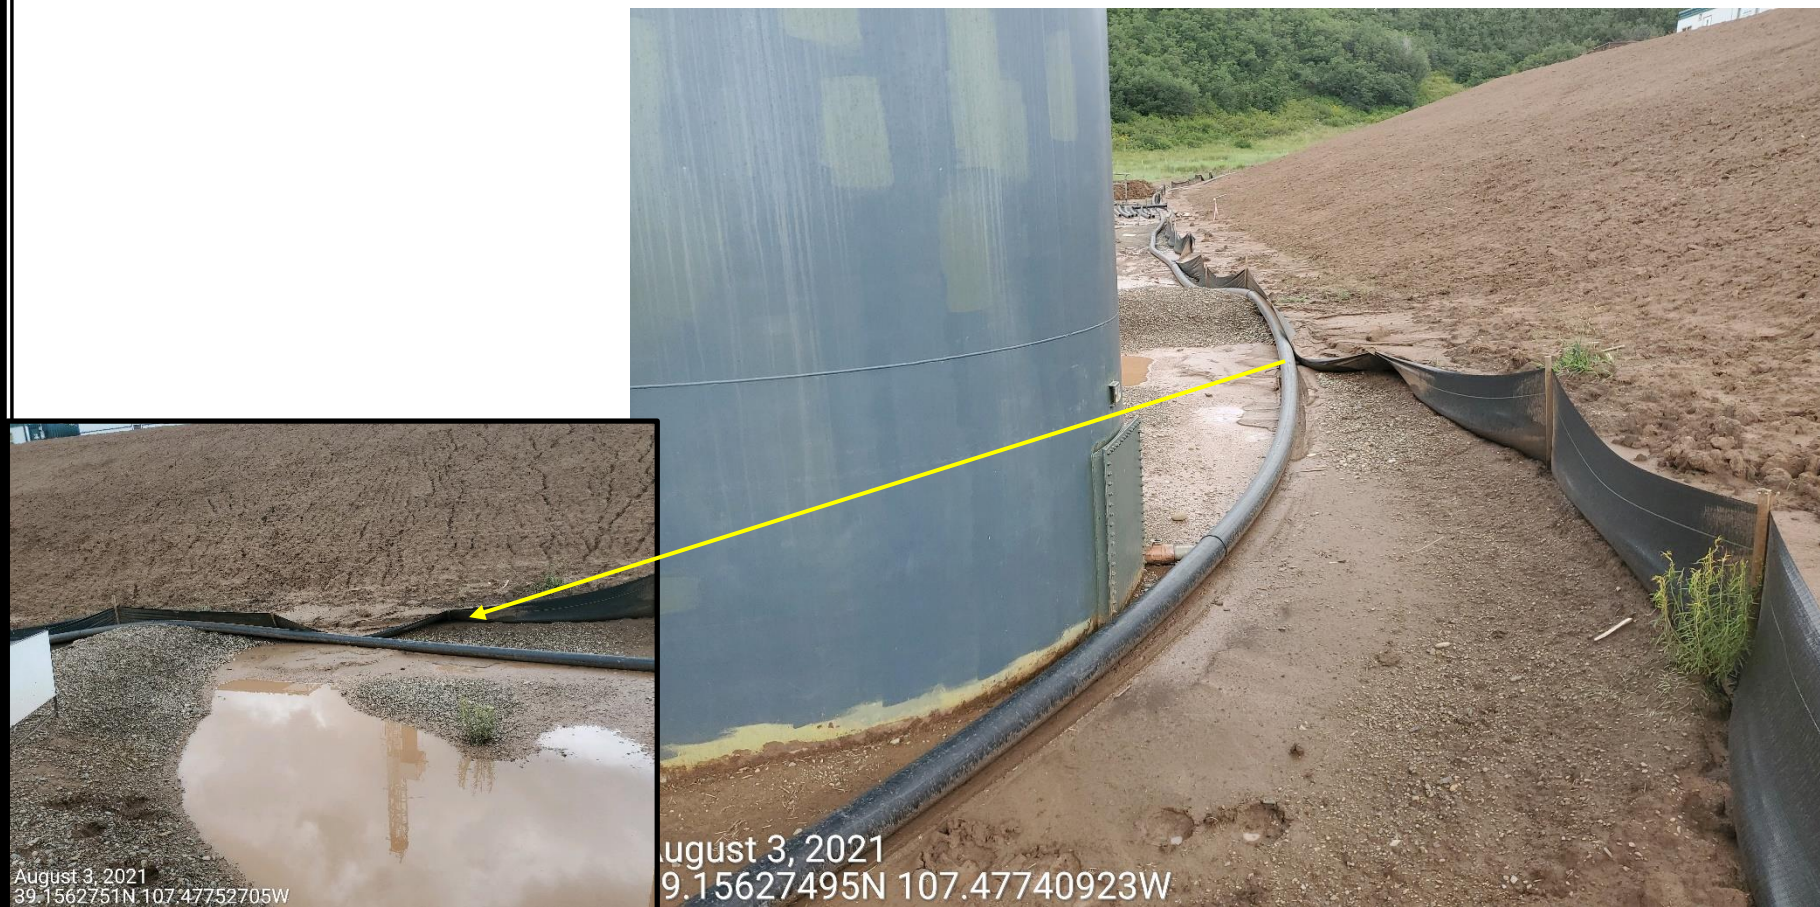
Photo 7: Photo shows example of impacted stormwater issues observed on the Location due to various spills.

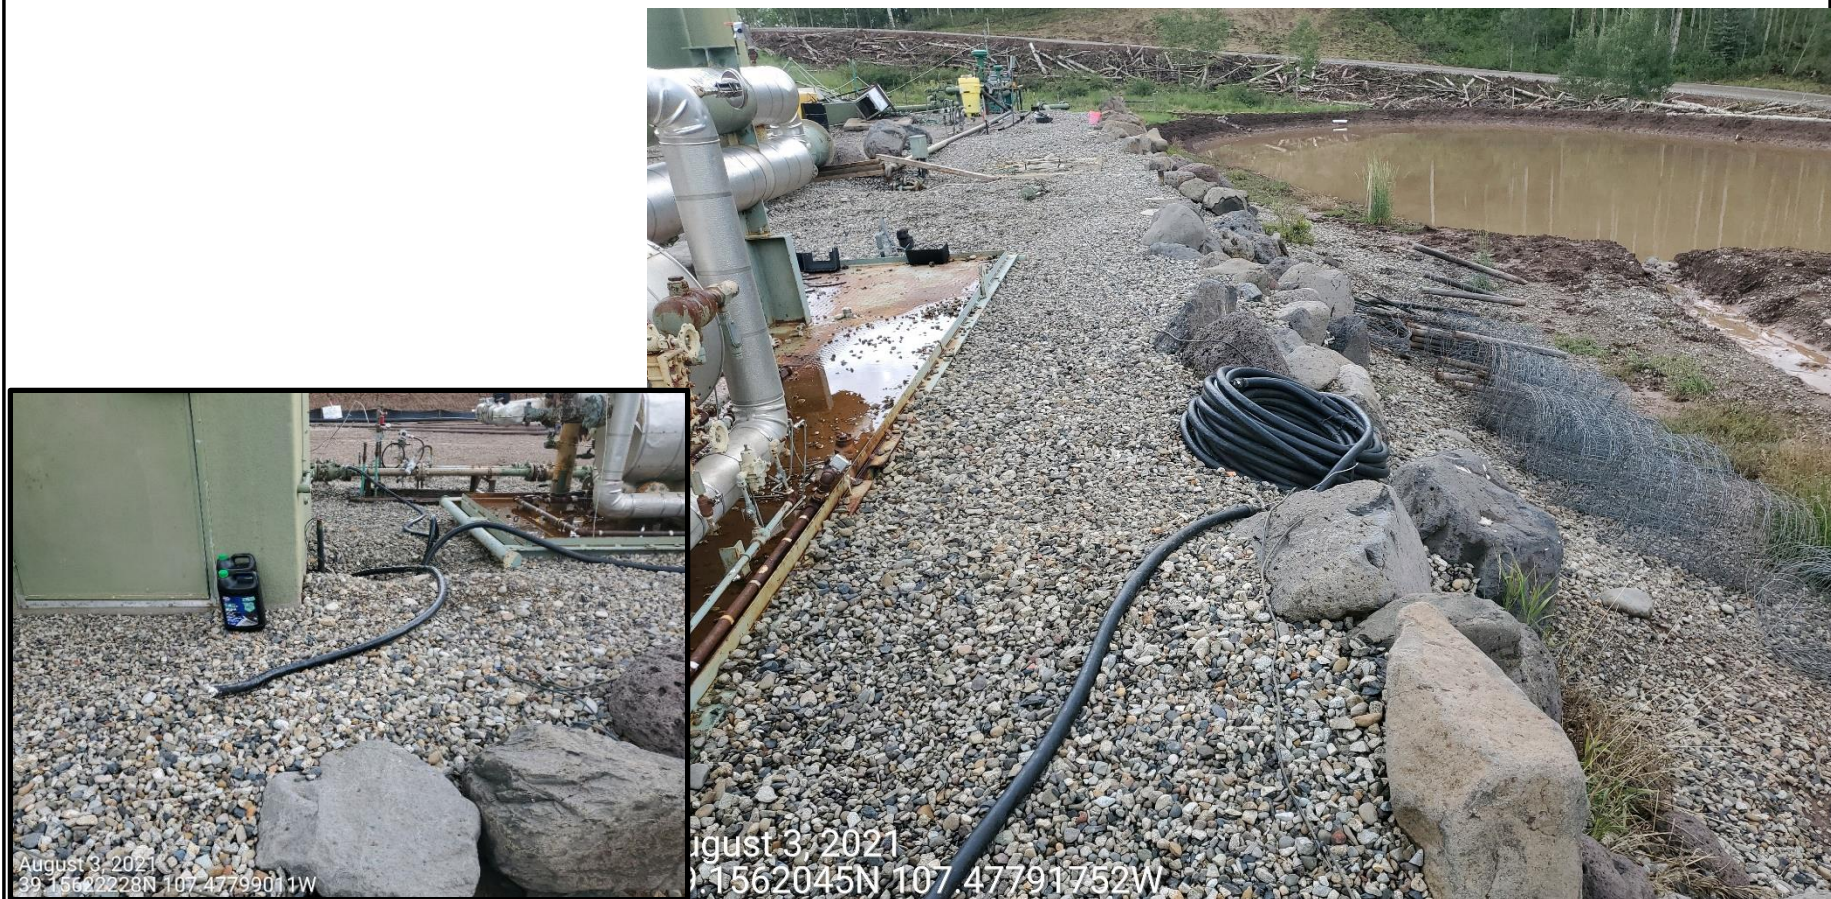
Photo 8: Previous inspections observed that good-housekeeping practices were not being performed; various unused equipment, trash debris, and equipment not necessary for production on this Location observed stored on the site.

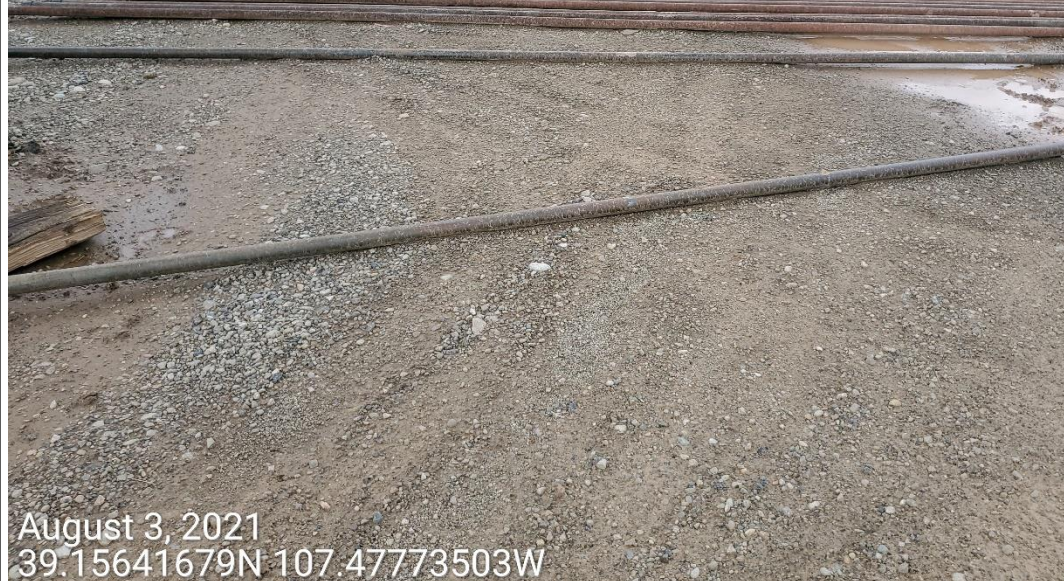
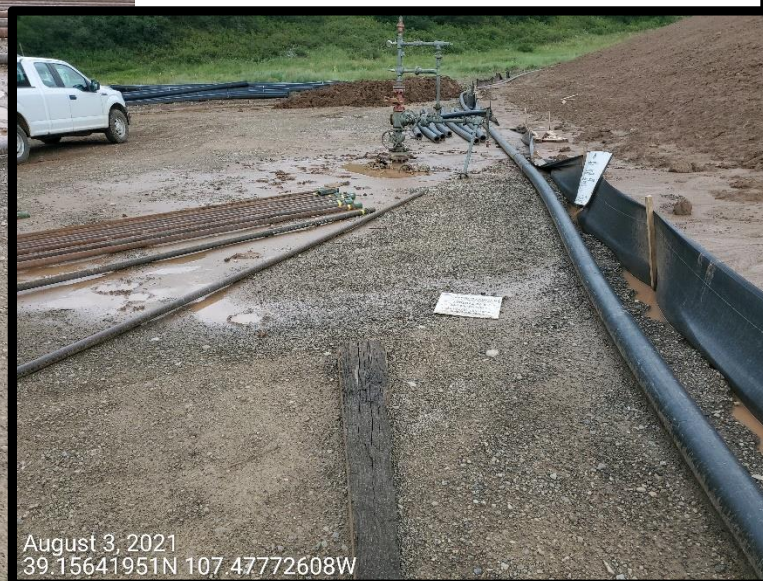
Photo 9: Photo shows tubing on the Location that has not been stored in a workman-like manner.

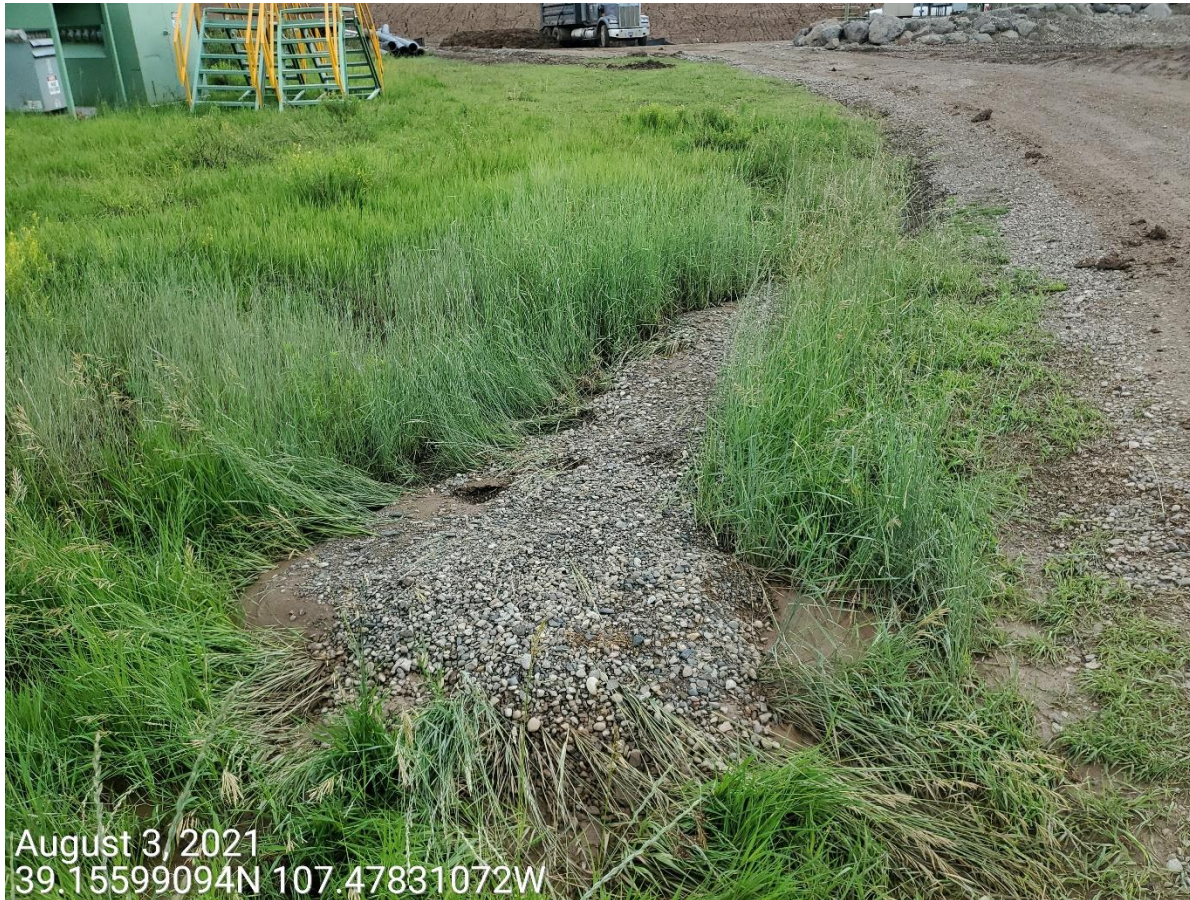
Photo 10: Photo taken from the access road west of the Location. Photo shows sediment discharge from the Location observed parallel to the access road.

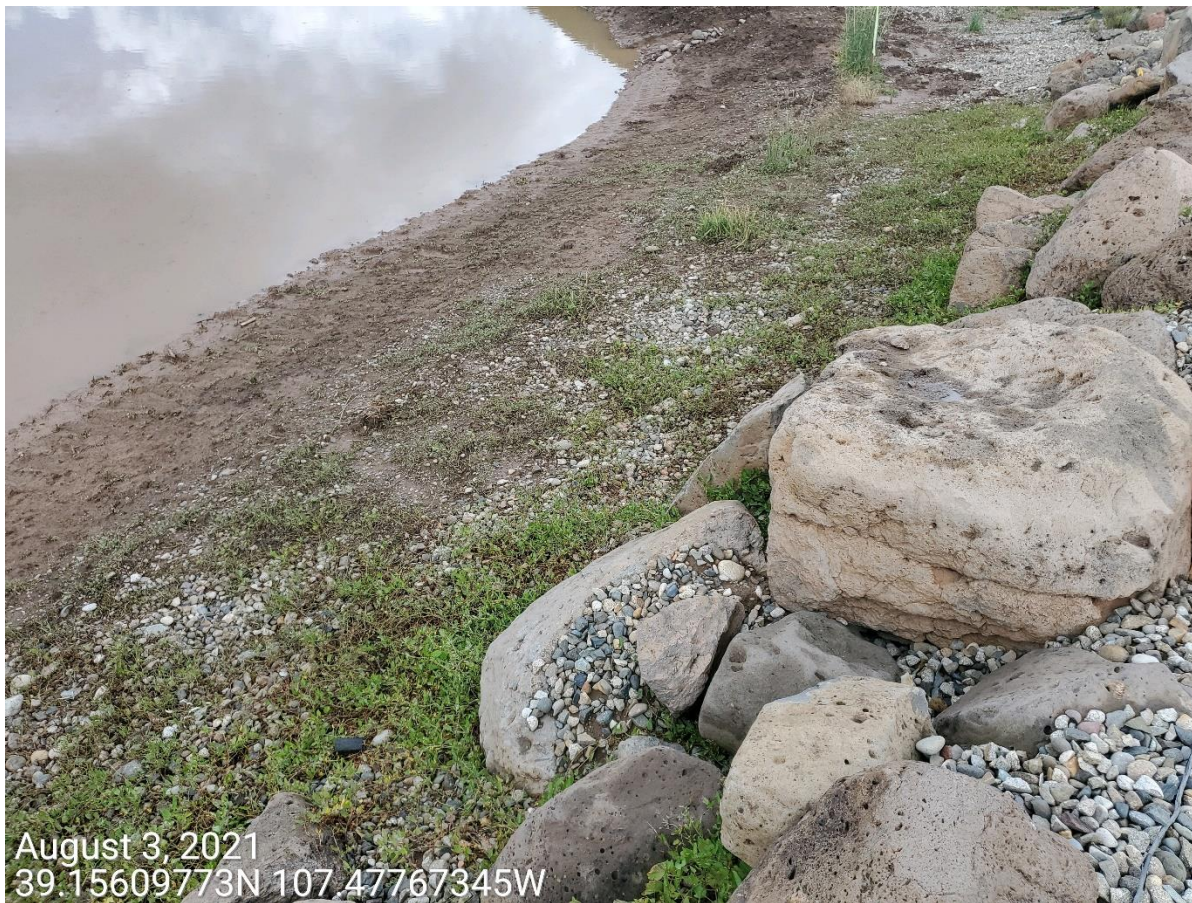
Photo 11: Photo shows noxious weeds (bindweed) observed on the Location appears to have been sprayed with herbicide.
