# Inspection Photos

API: 071-08897

Operator: EVERGREEN NATURAL RESOURCES

Inspection Date: 8/12/2021

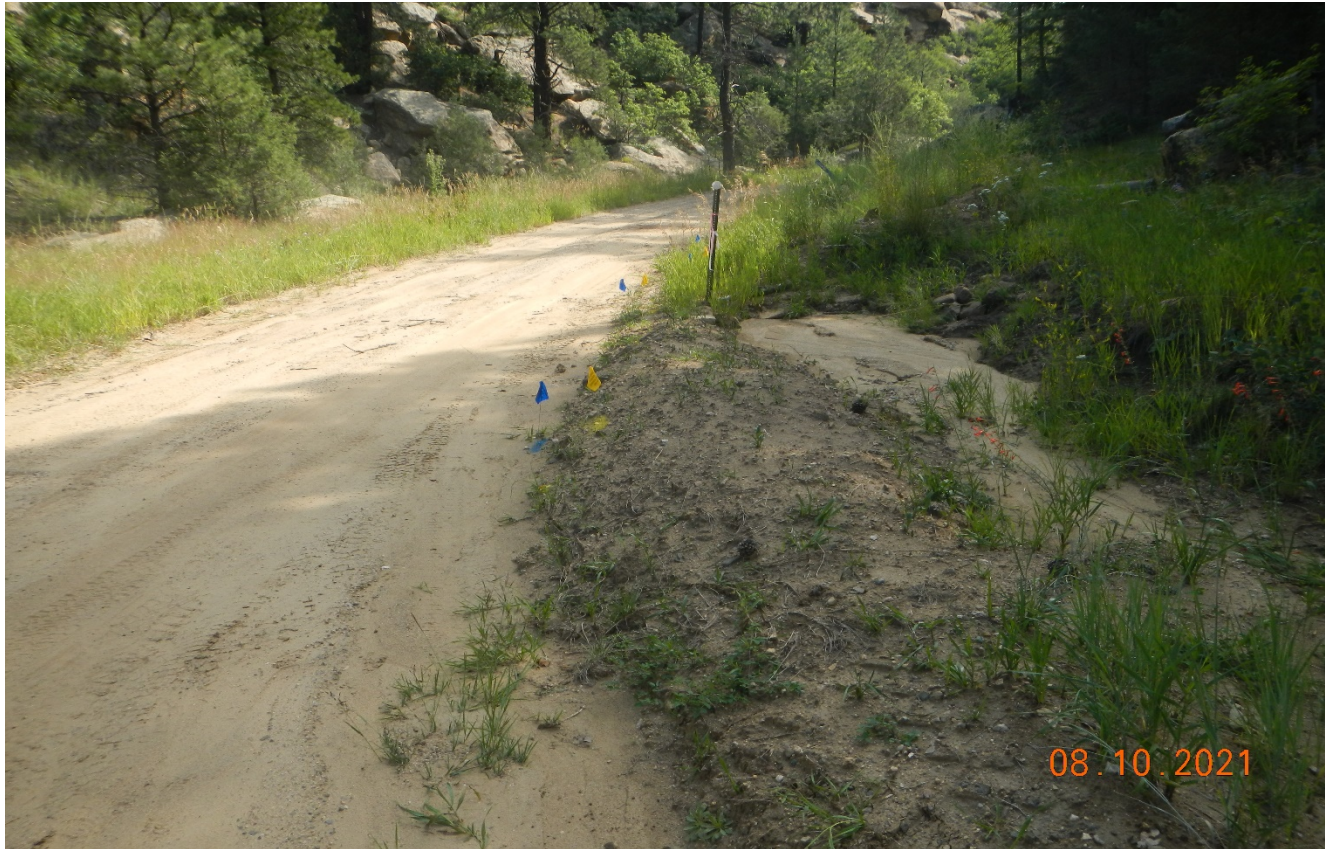
**Photo 1.** There is culvert at the beginning of the access road in the canyon that is filled in with sediment.

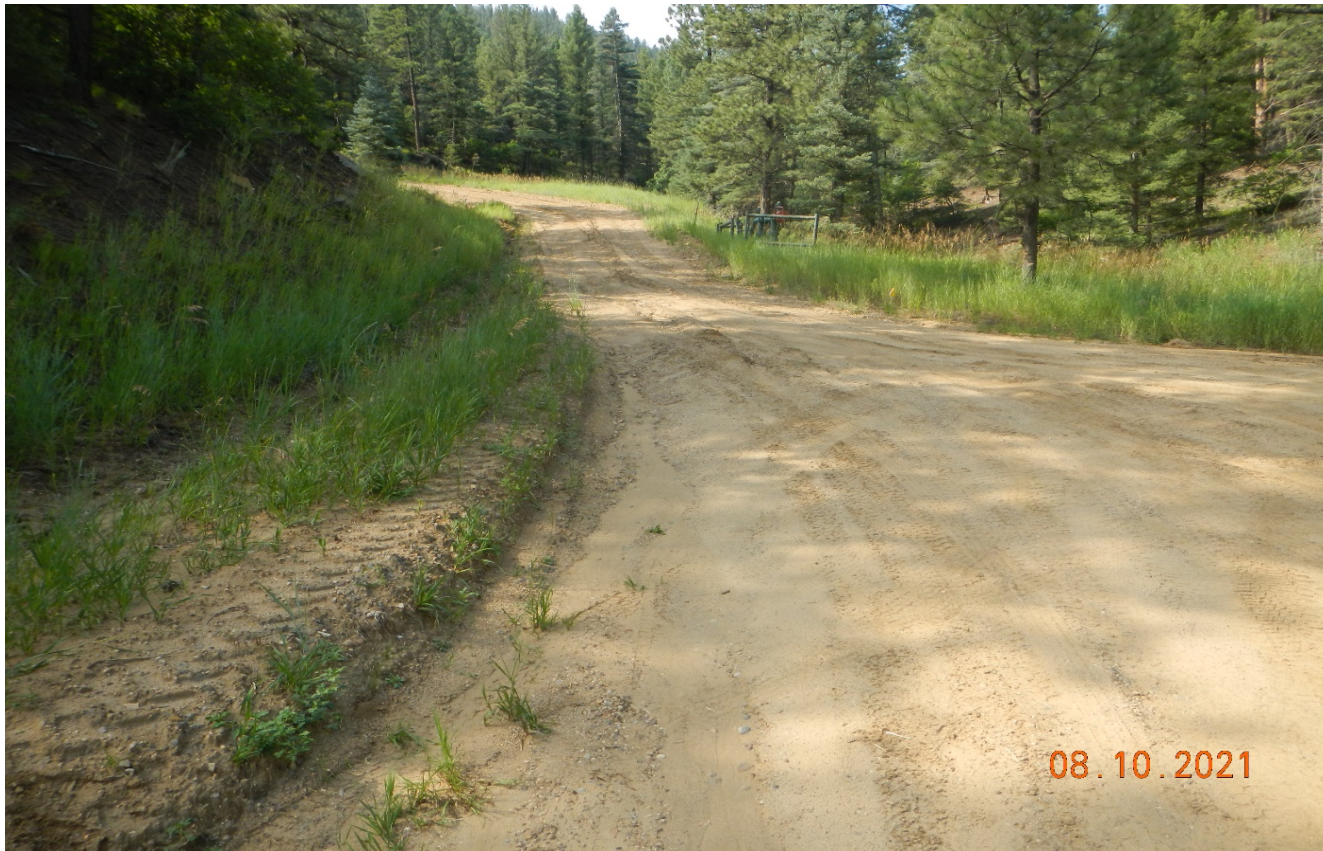
**Photo 2.** Facing south toward the access road. The access road has been regraded.

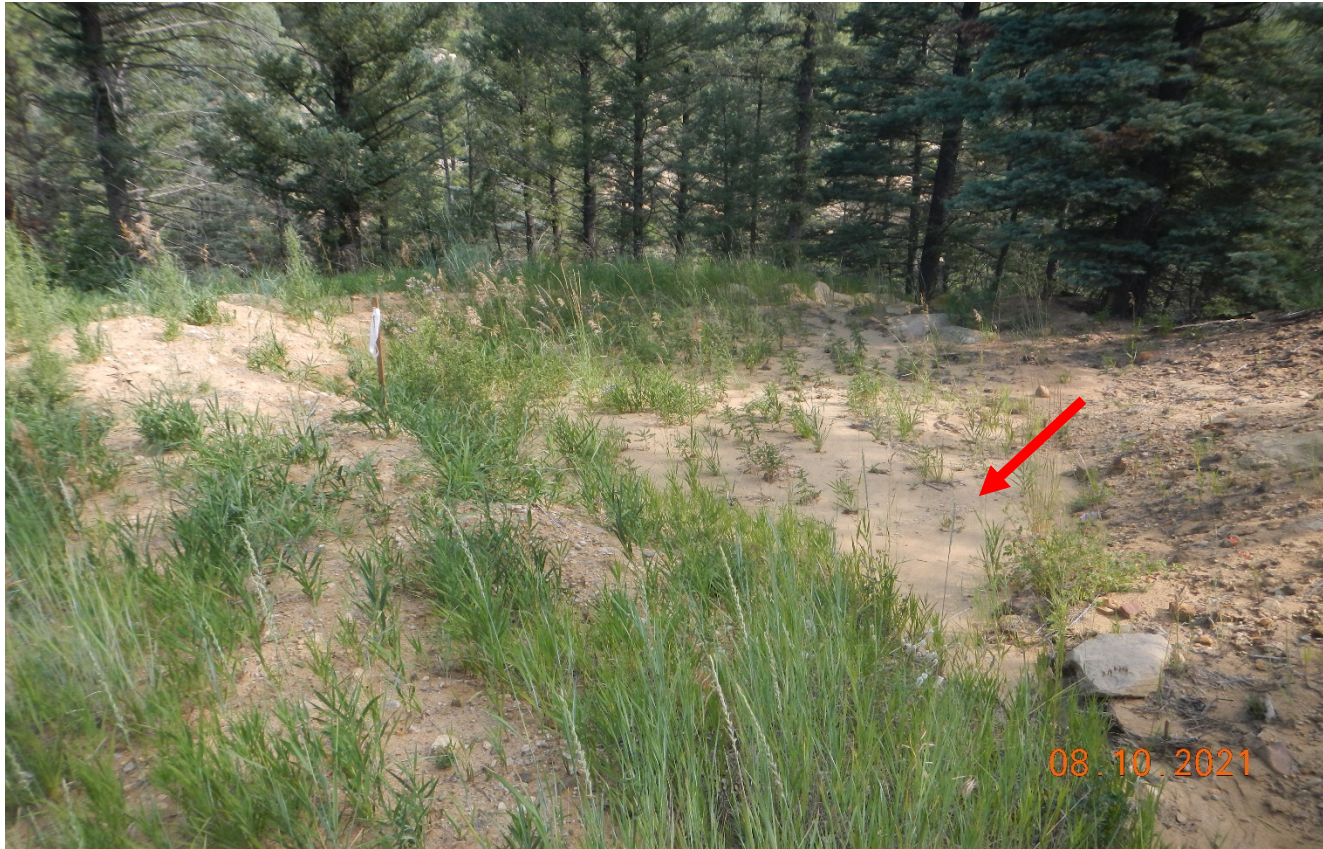
**Photo 3.** There is a sediment trap along the access road that is filled in with sediment. The sediment trap was not cleaned out. This could have been done by hand to avoid vegetation disturbance at the area shown at red arrow. Previous correction action was not performed.

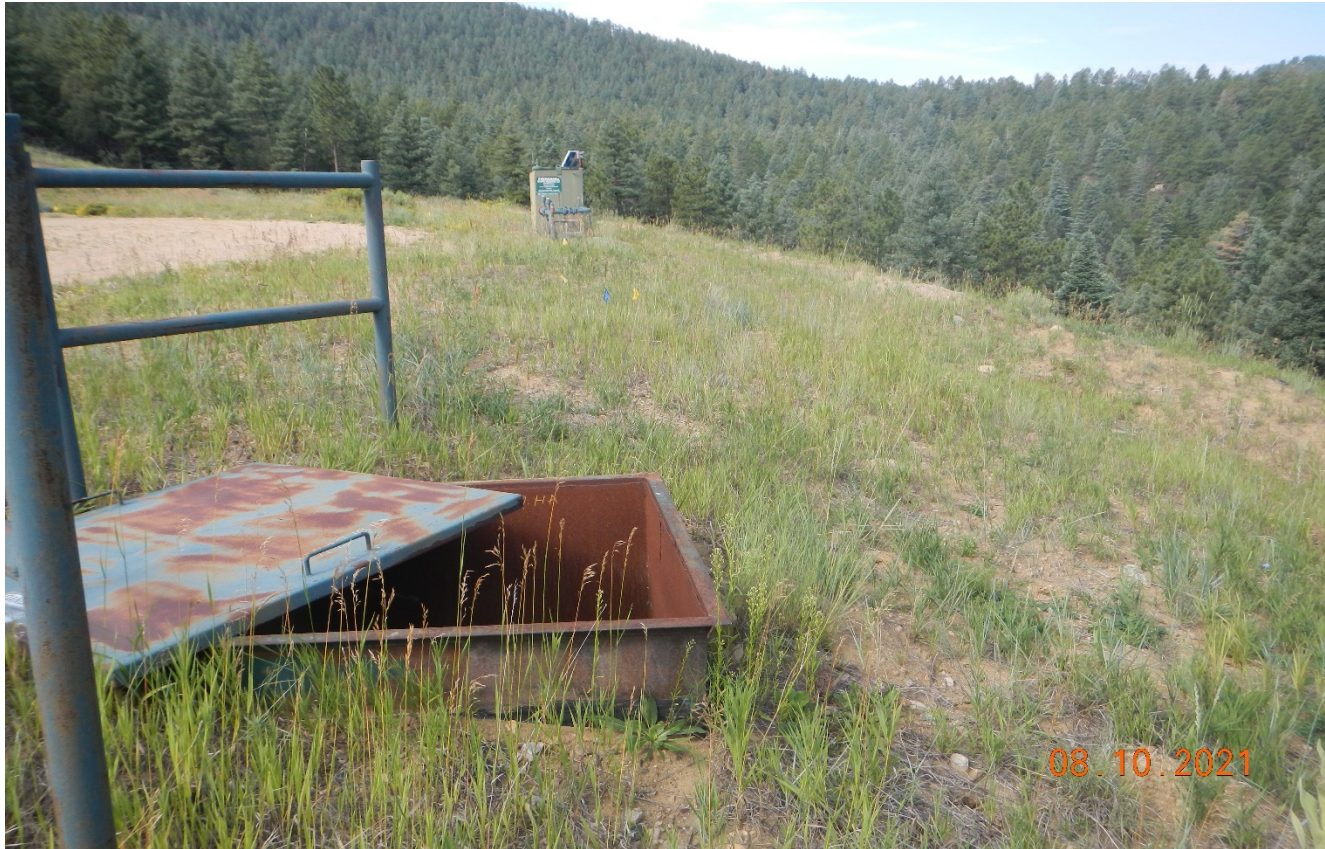
**Photo 4.** Facing west toward the location fill slope. The valve box lid was left open and needs to be kept closed to prevent entry.

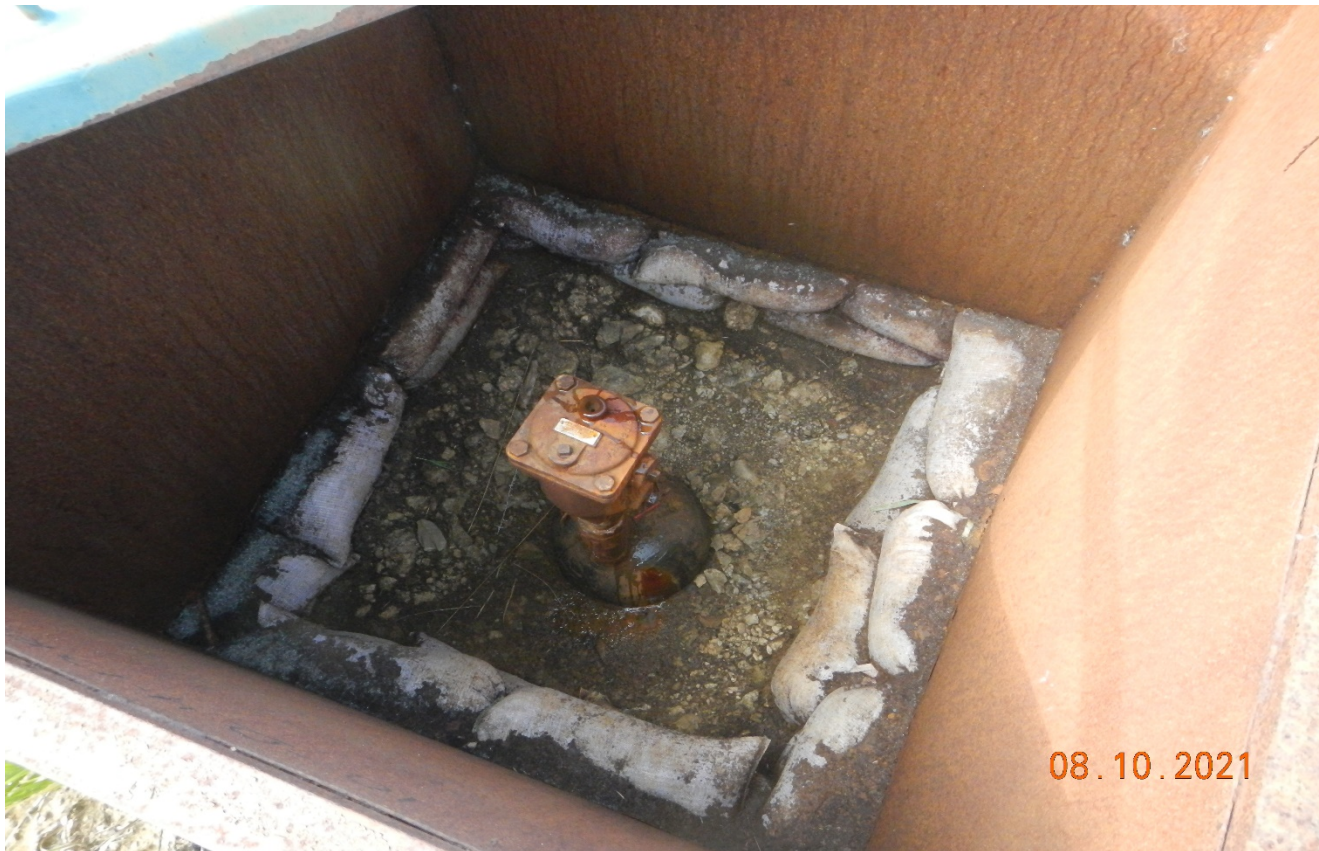
**Photo 5.** There was a slight PW drip at the valve inside the box.
