Inspection Photos
Operator: Advanced Wireless
API: 067-09317
Date: 8/6/2021

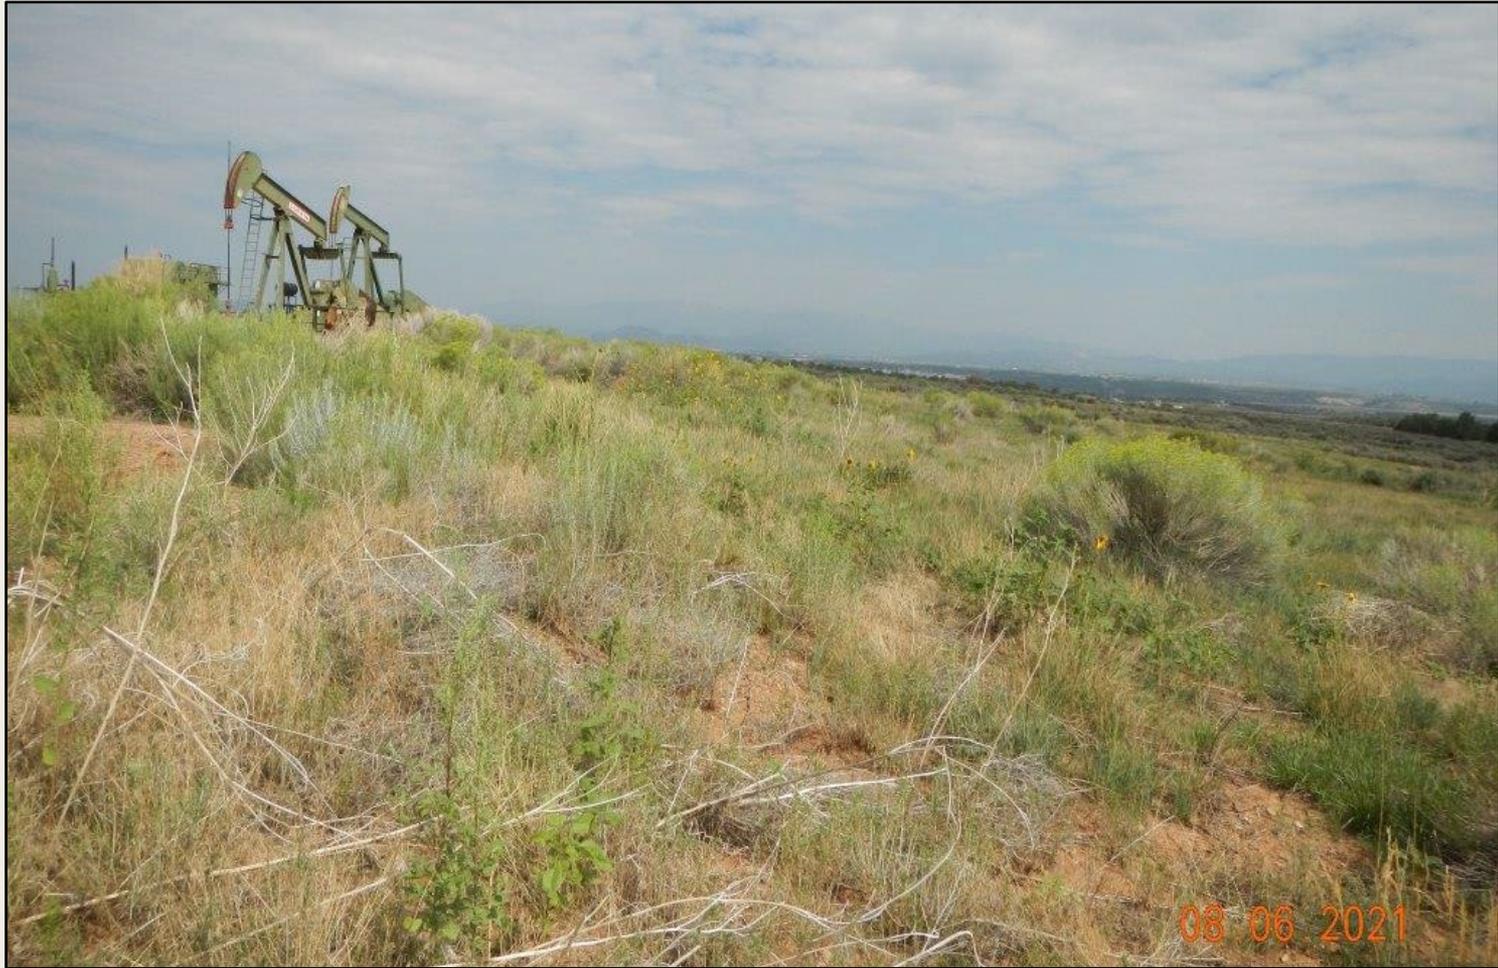
Photo 1. View of the northern project area from the northeastern corner facing westward.

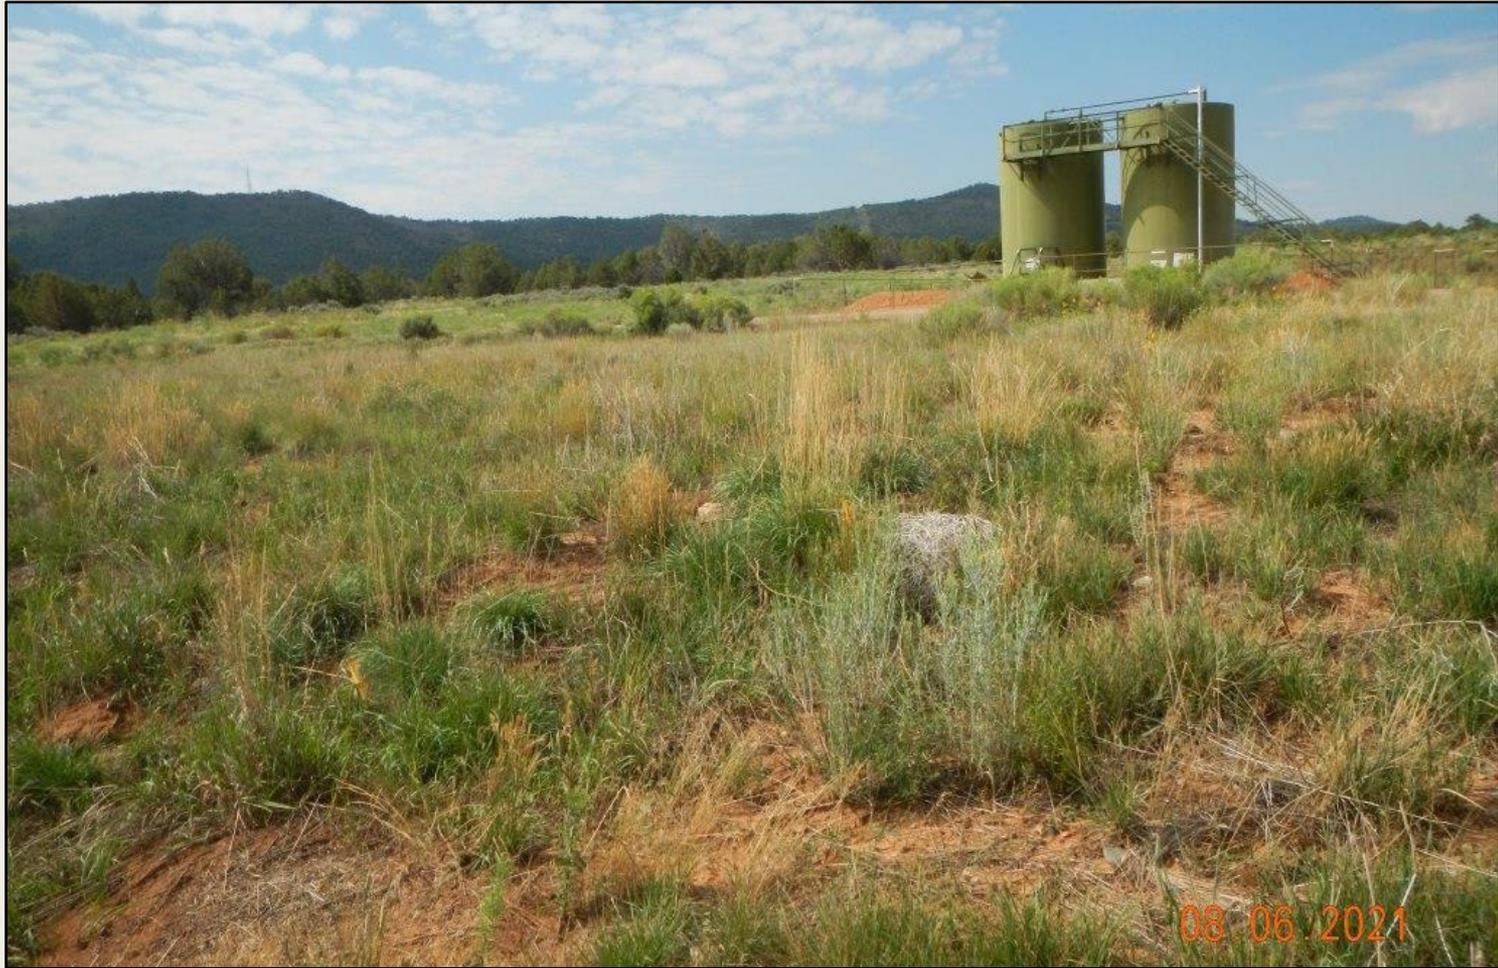
Photo 2. View of the eastern project area from the northeastern corner facing southward. Revegetation is progressing here, as described in July 2021 inspection.

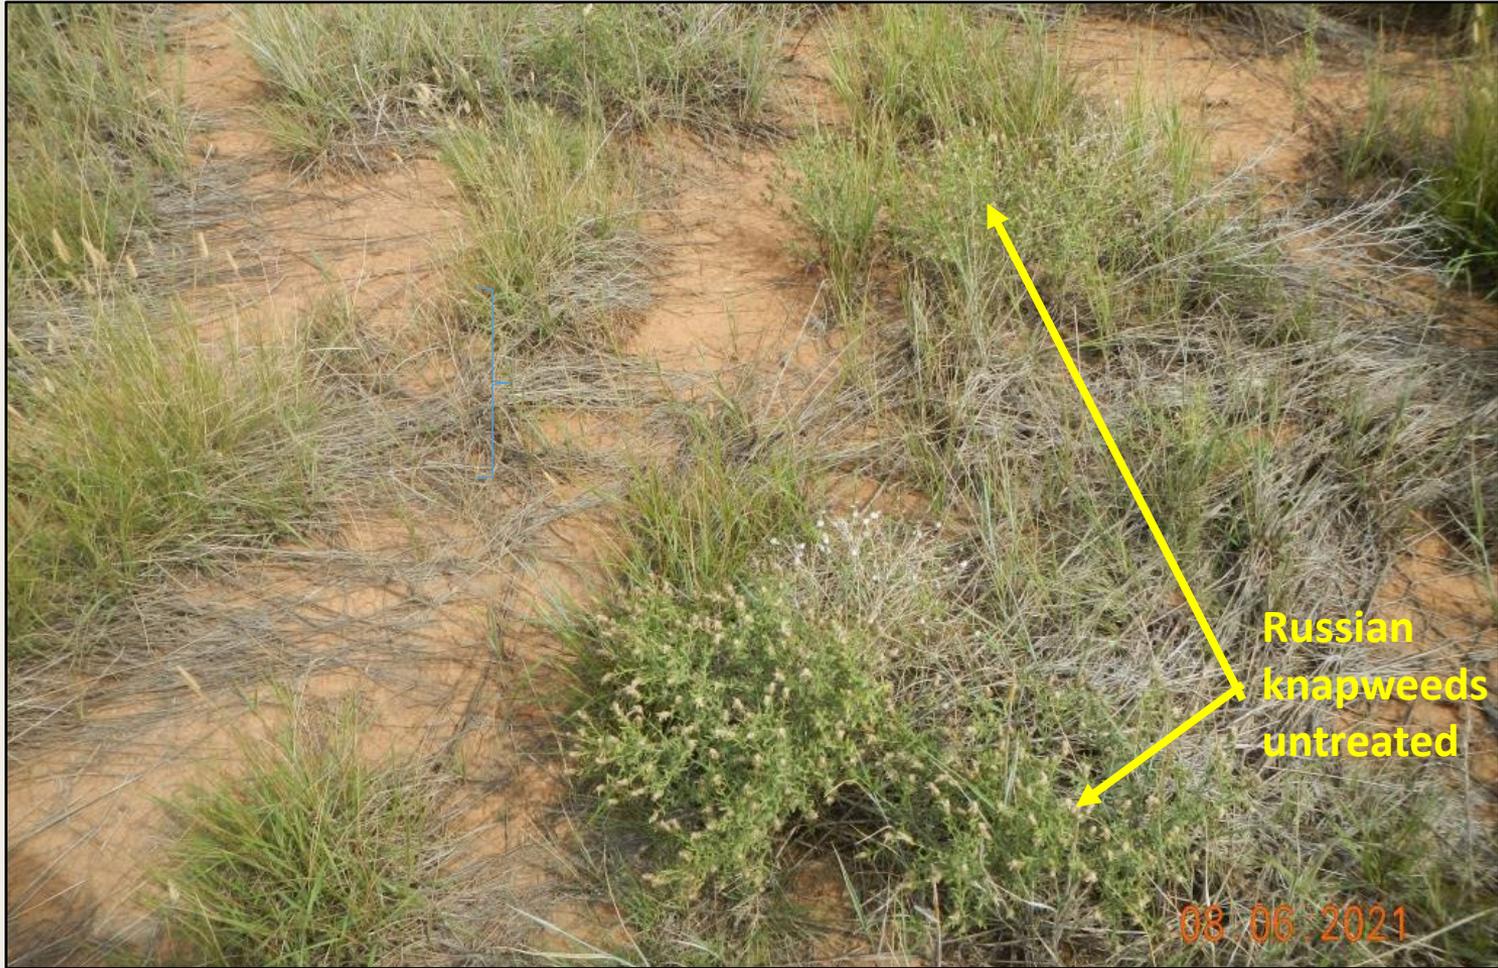
Photo 3. View of Russian knapweeds remaining untreated within the interim reclamation area. Approximately 300 individuals observed.

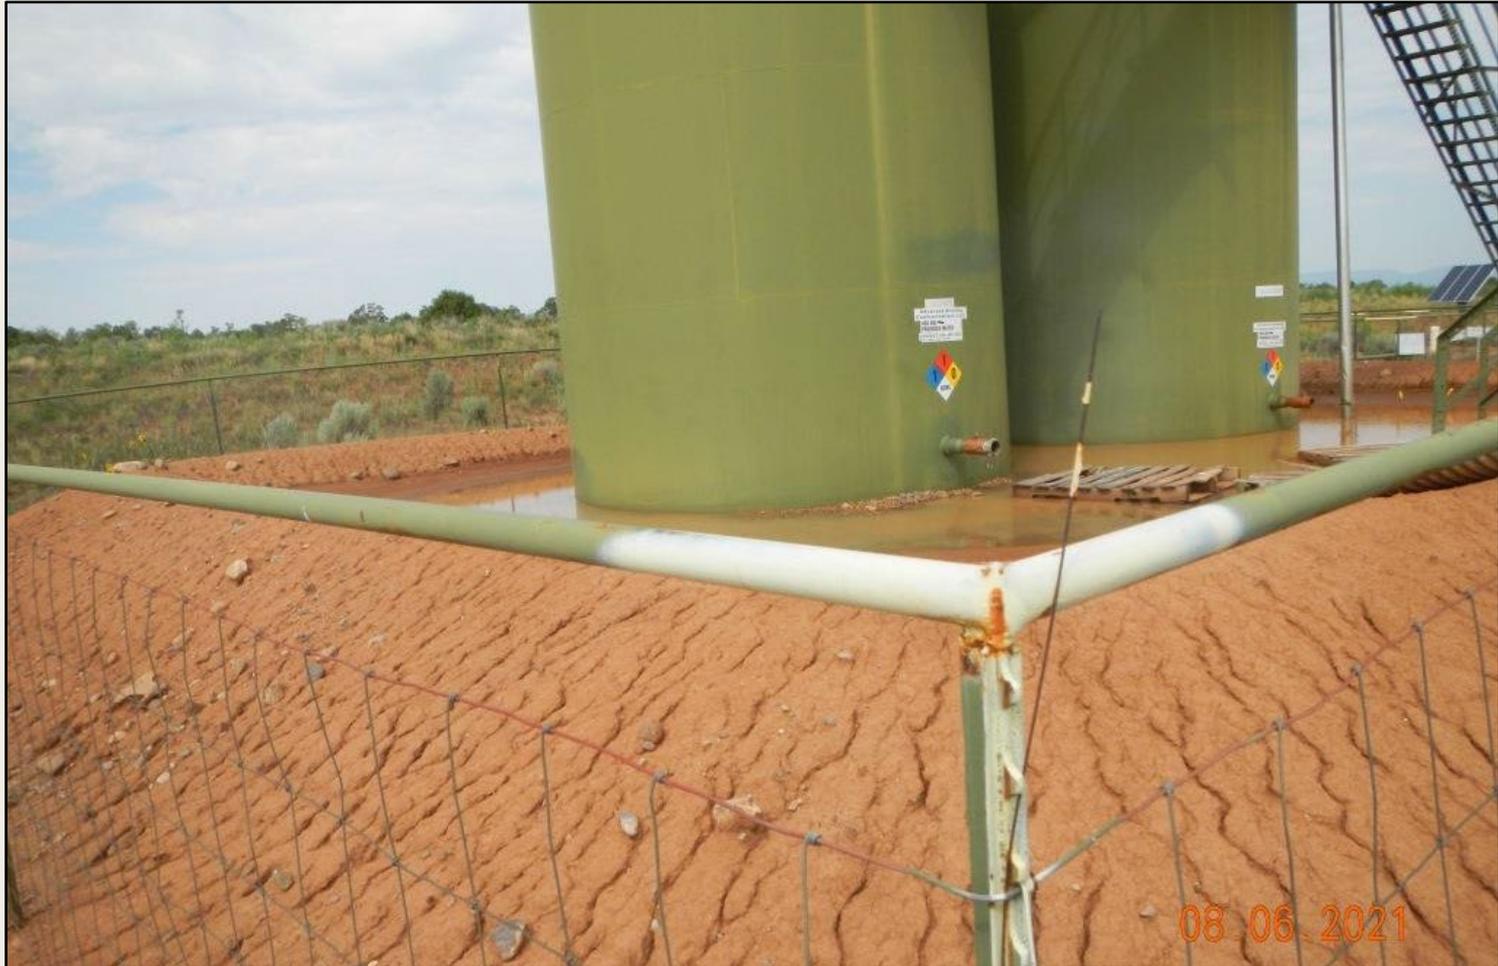
Photo 4. View of eroding berms and water in tank containment. Sediment and water accumulation within containment is resulting in reduced and inadequate containment volume.

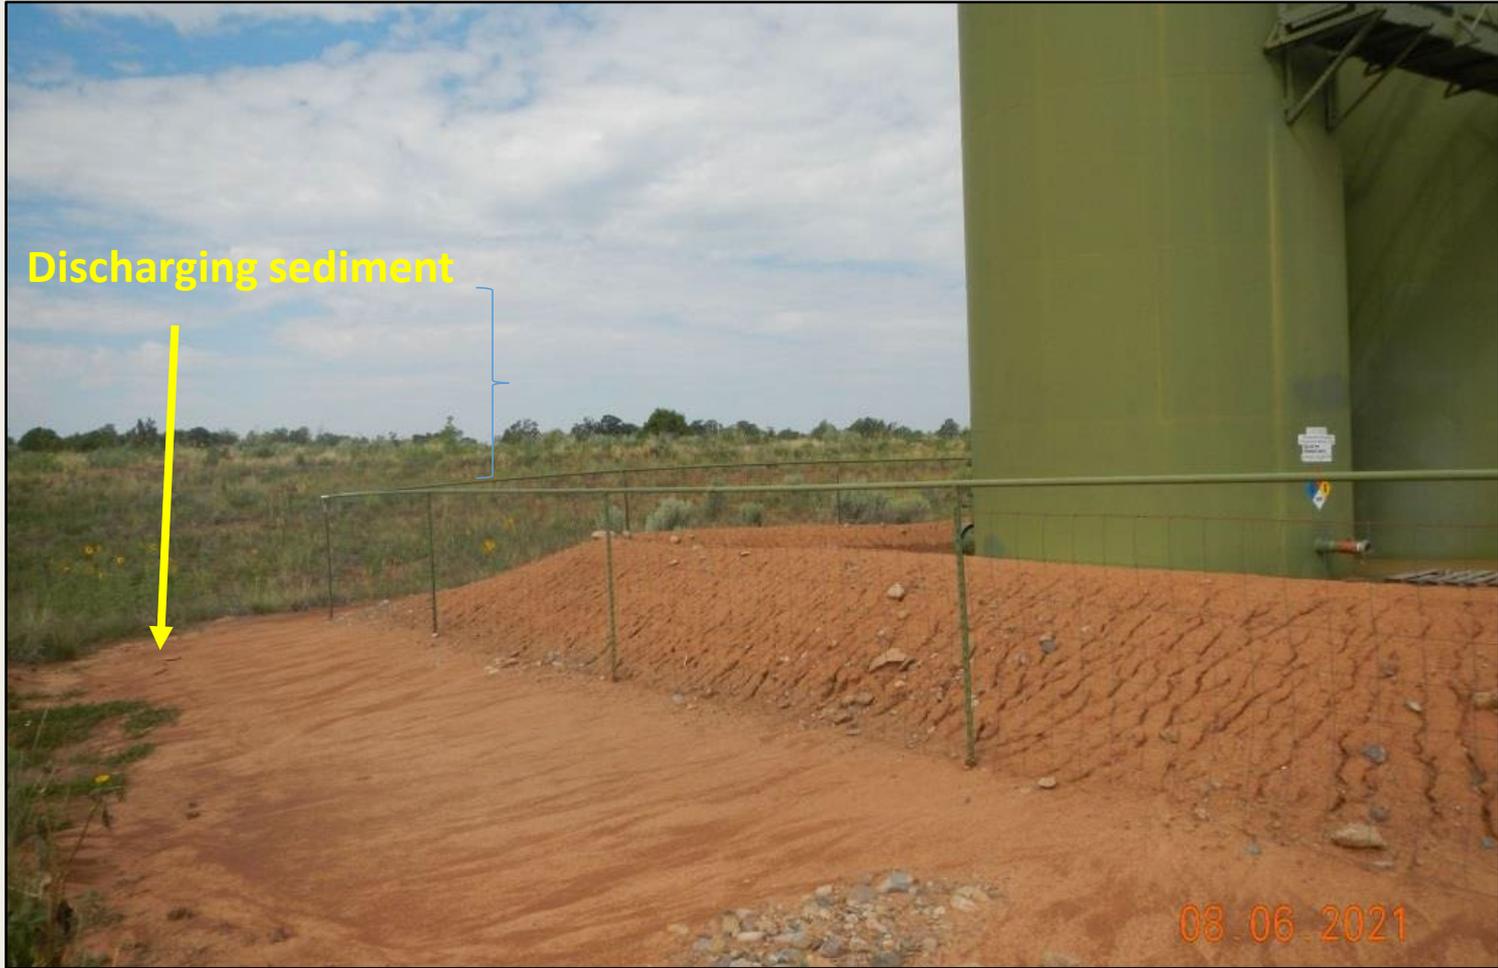
Photo 5. View of sediment discharge and rilling from unstabilized berms around tanks.
