Inspection Photos
Operator: Arkoma/Catamount
API: 067-05412
Date: 8/6/2021

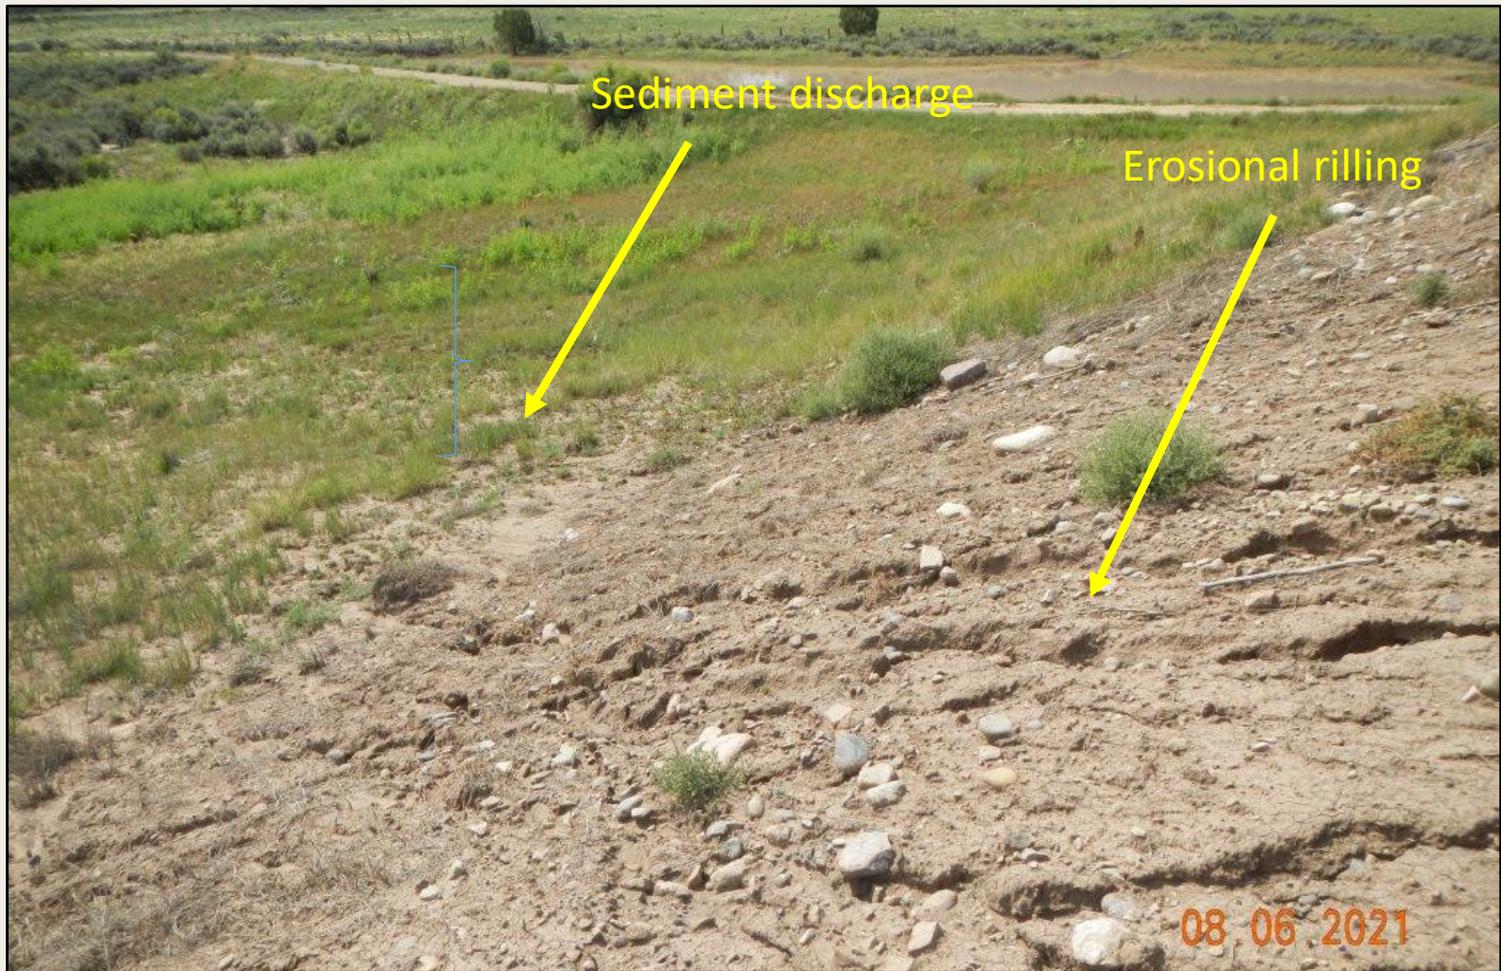
Photo 2. View of erosional rilling and sediment deposition within the eastern fill slope. Area needs erosion controls and sediment controls installed and maintained until stabilized with long term perennial vegetation.

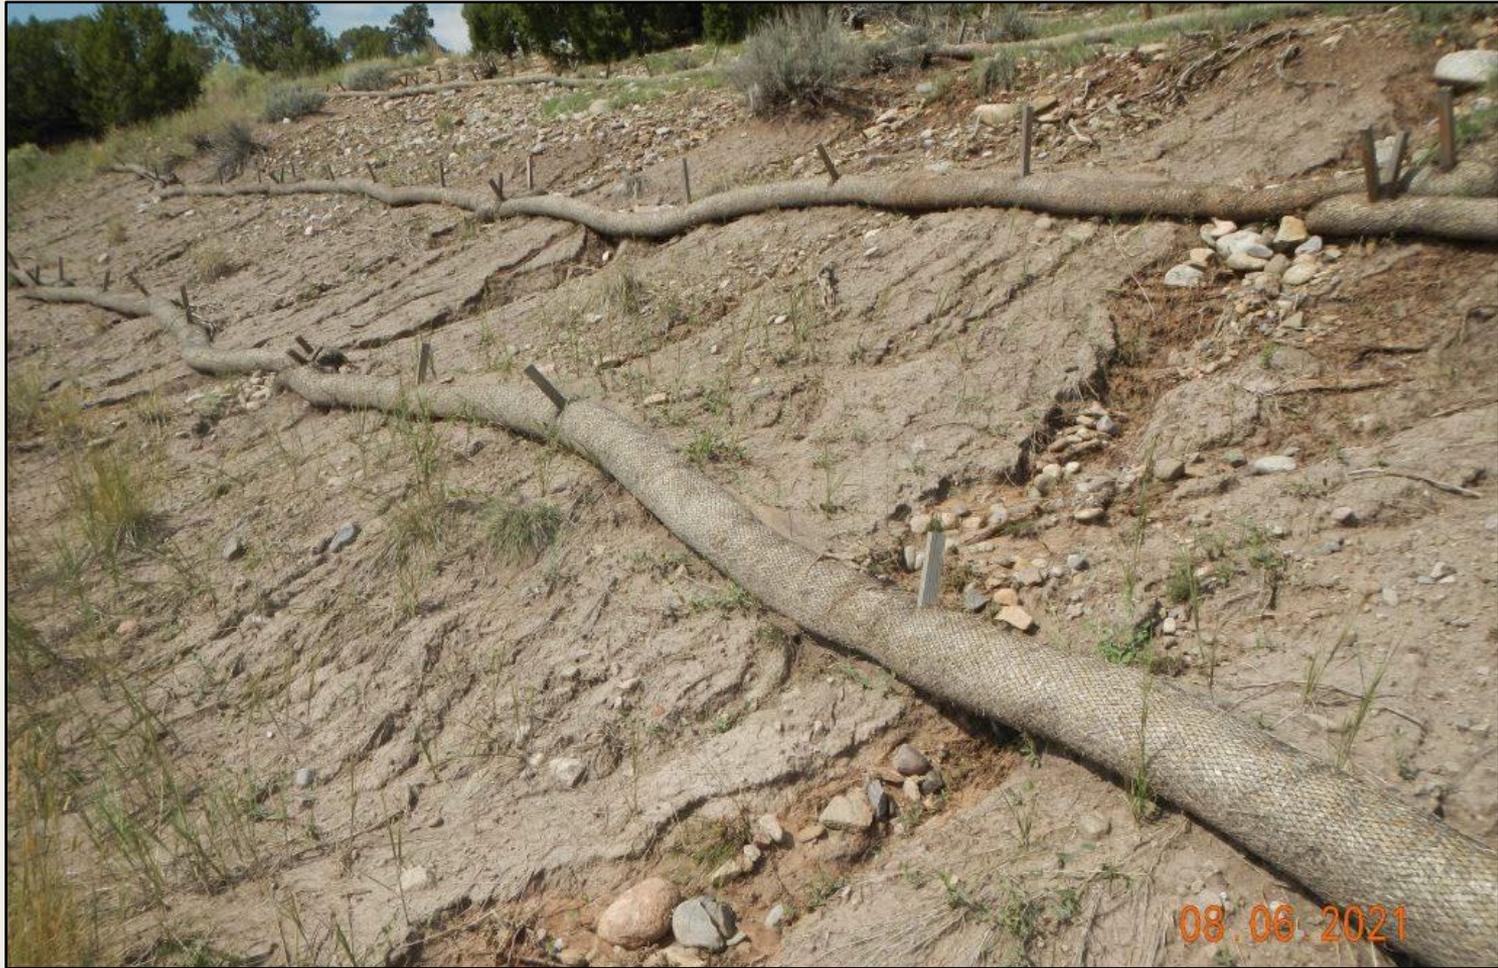
Photo 3. View of failed wattles and erosion occurring on the well pad cut-slope. Wattles are not an adequate BMP here. Long term stabilization measures are needed until stabilized with desirable perennial vegetation.

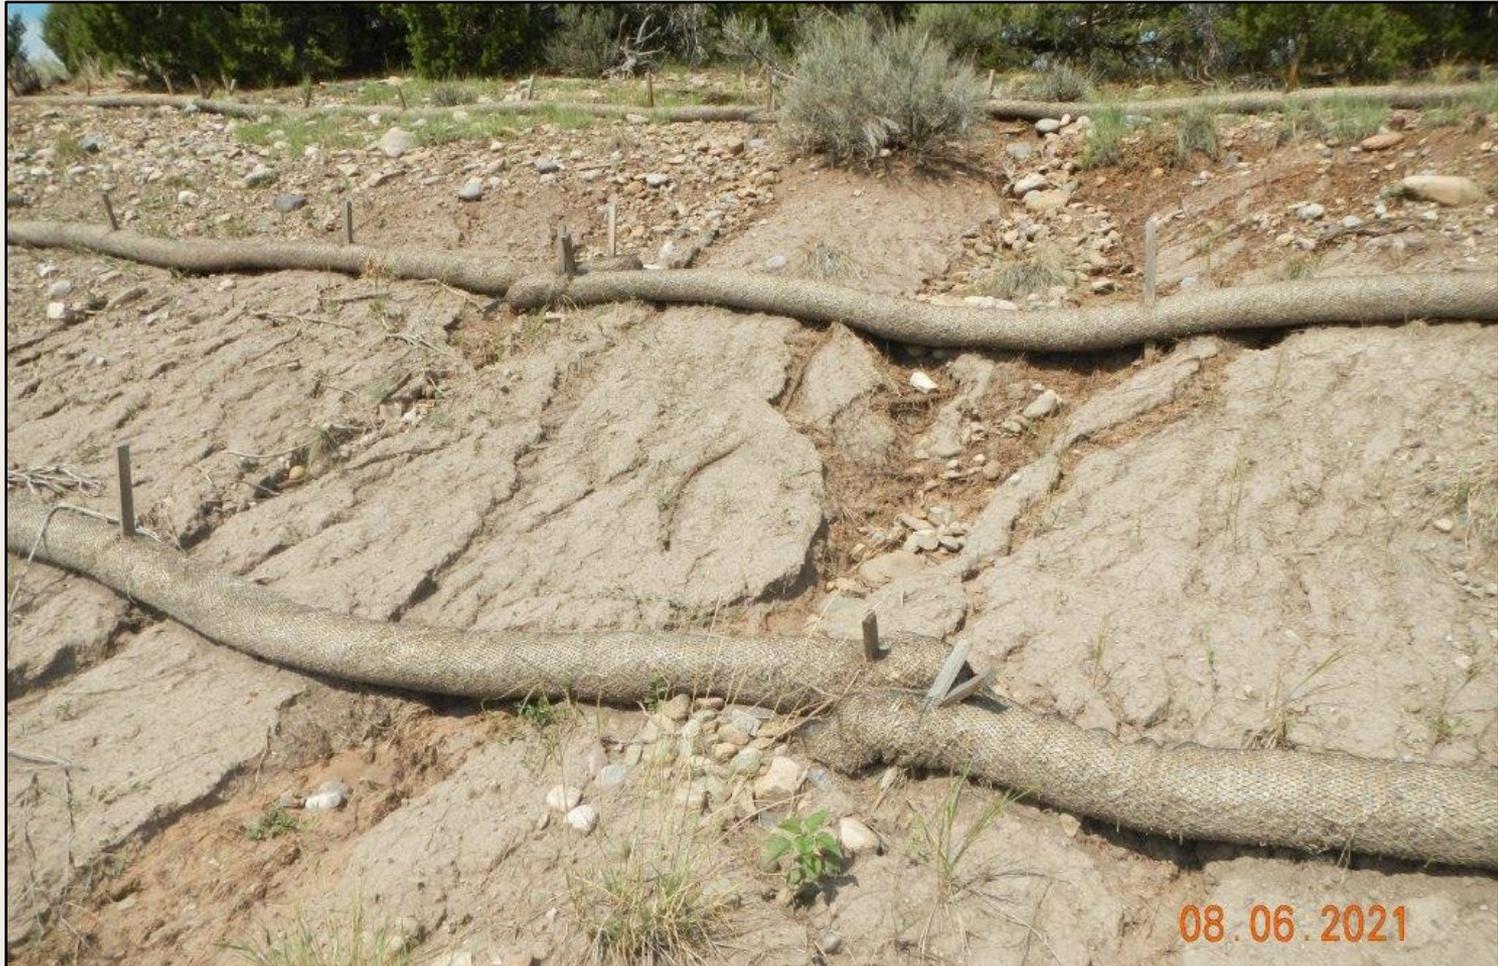
Photo 4. Another view of erosional channeling and failure of wattles on well pad cut-slope.
