Inspection Photos
Location Name: UPRR 43 Pan AM I #19
Location ID: 332976

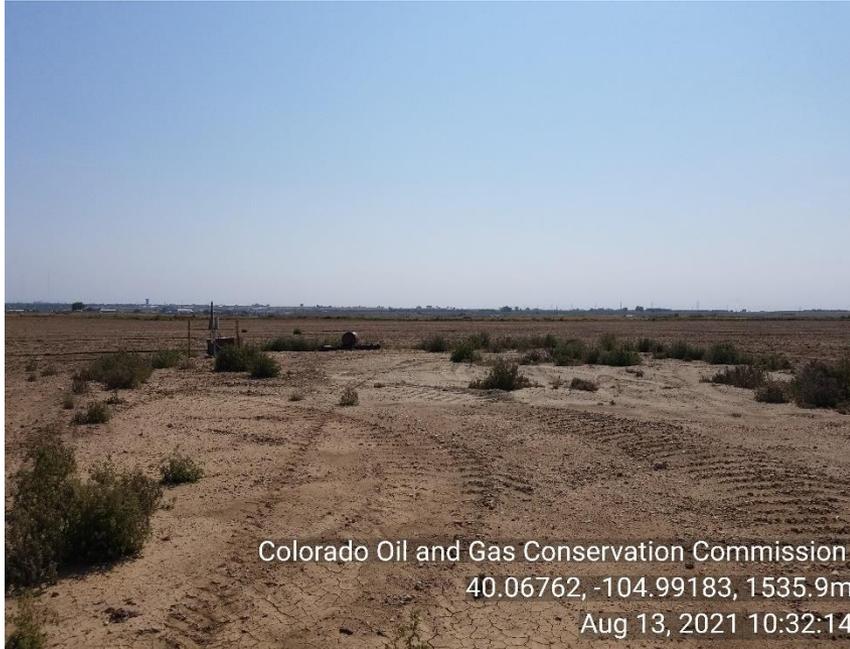
Photo 1 P&A well site

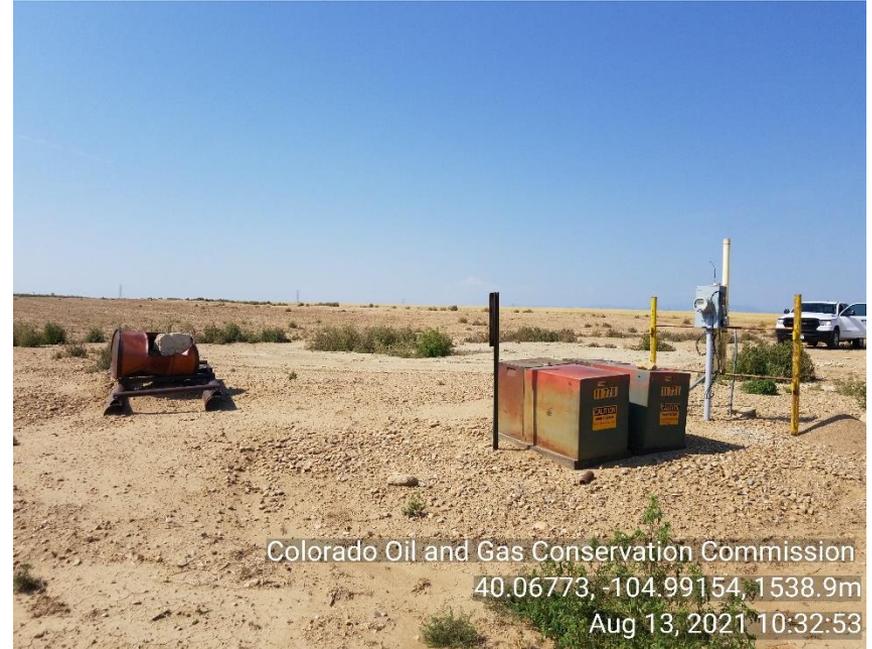
Photo 2 unused equipment on P&A well site Electric pane and grading equipment.

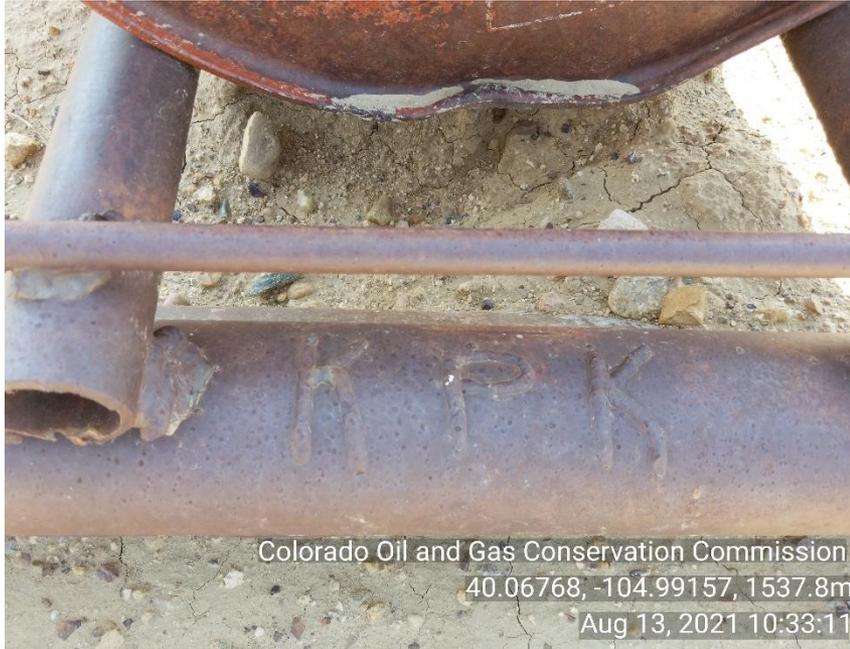
Photo 3 KPK's equipment left on site.
