Inspection Photos
Operator: Arkoma/Catamount
API: 067-07893
Date: 8/6/2021

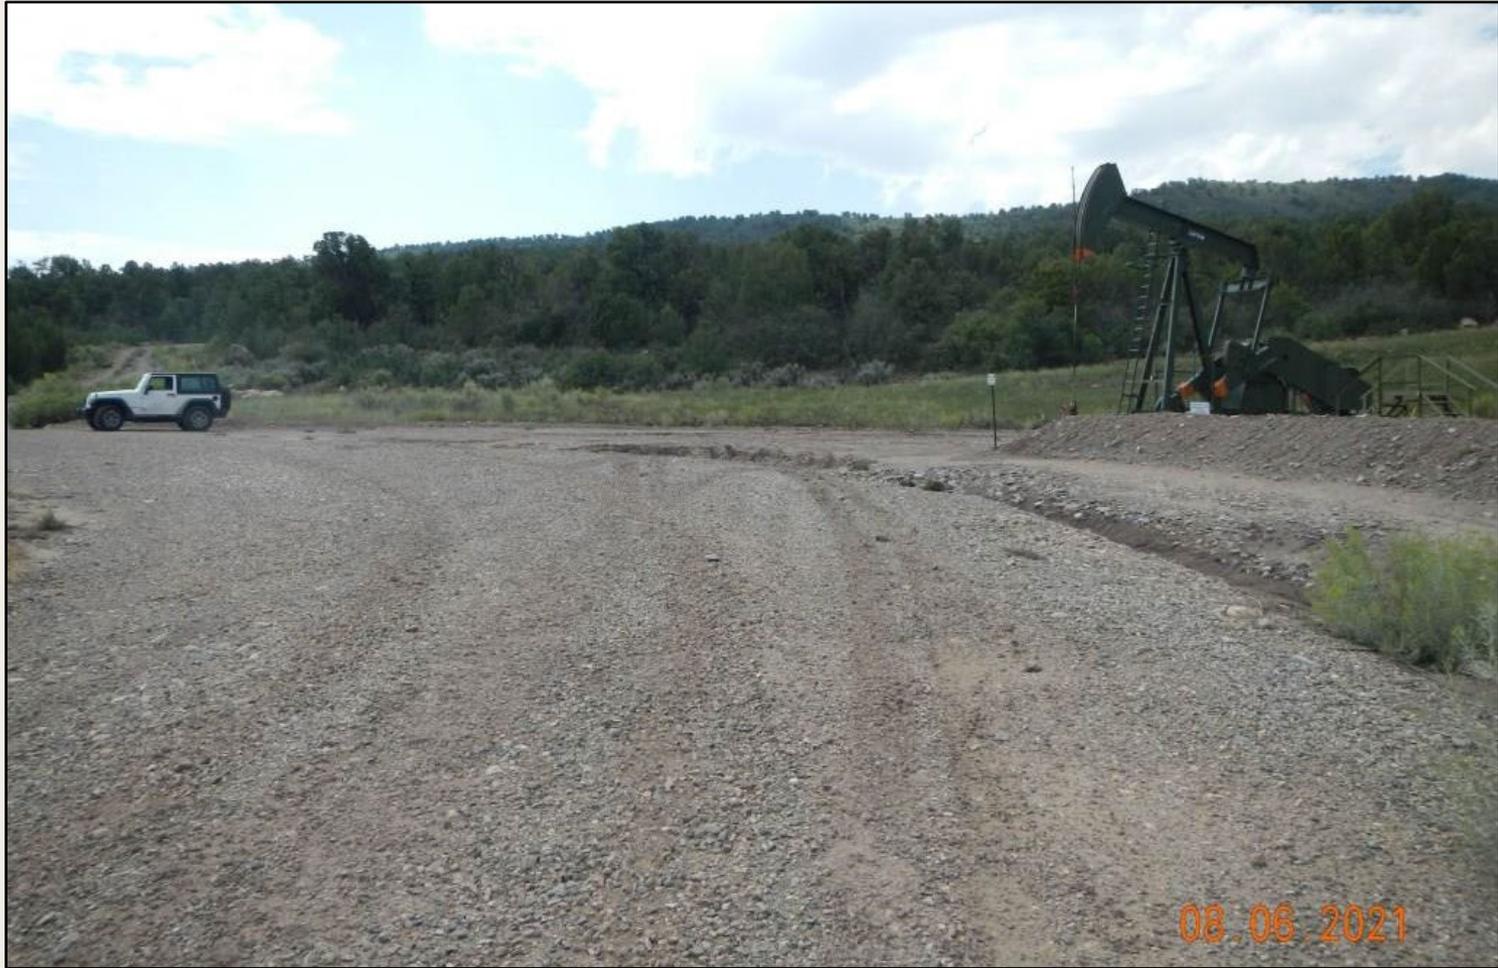
Photo 1. View of the project area from the well pad entrance facing center.

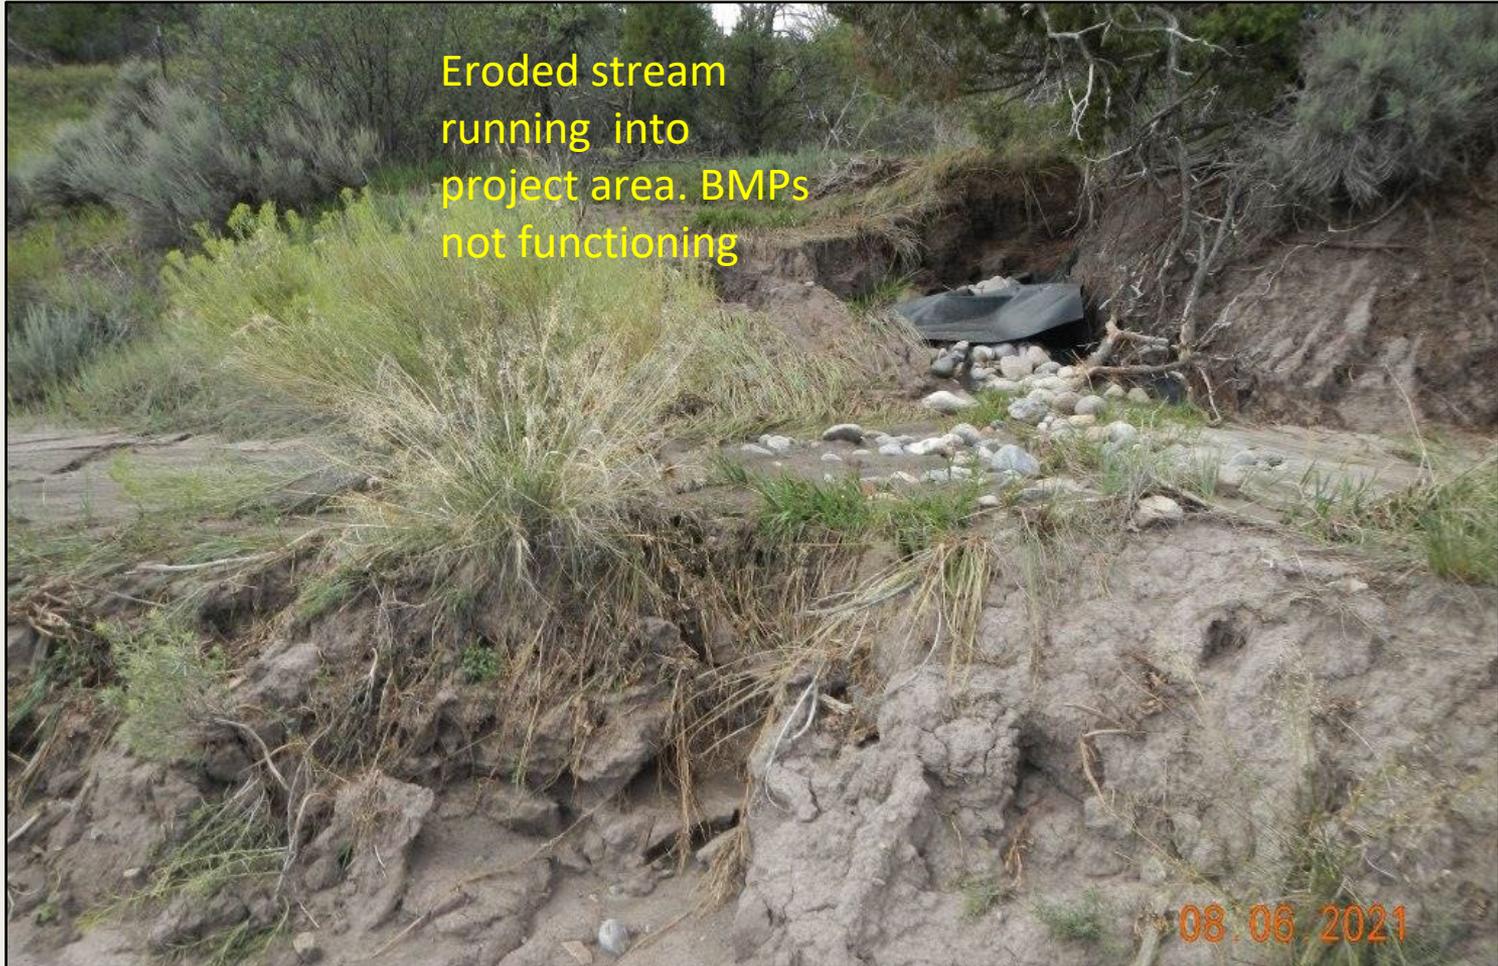
Eroded stream
running into
project area. BMPs
not functioning

Photo 2. View of erosional headcutting and sediment deposition due to failed BMPs within the western project area.

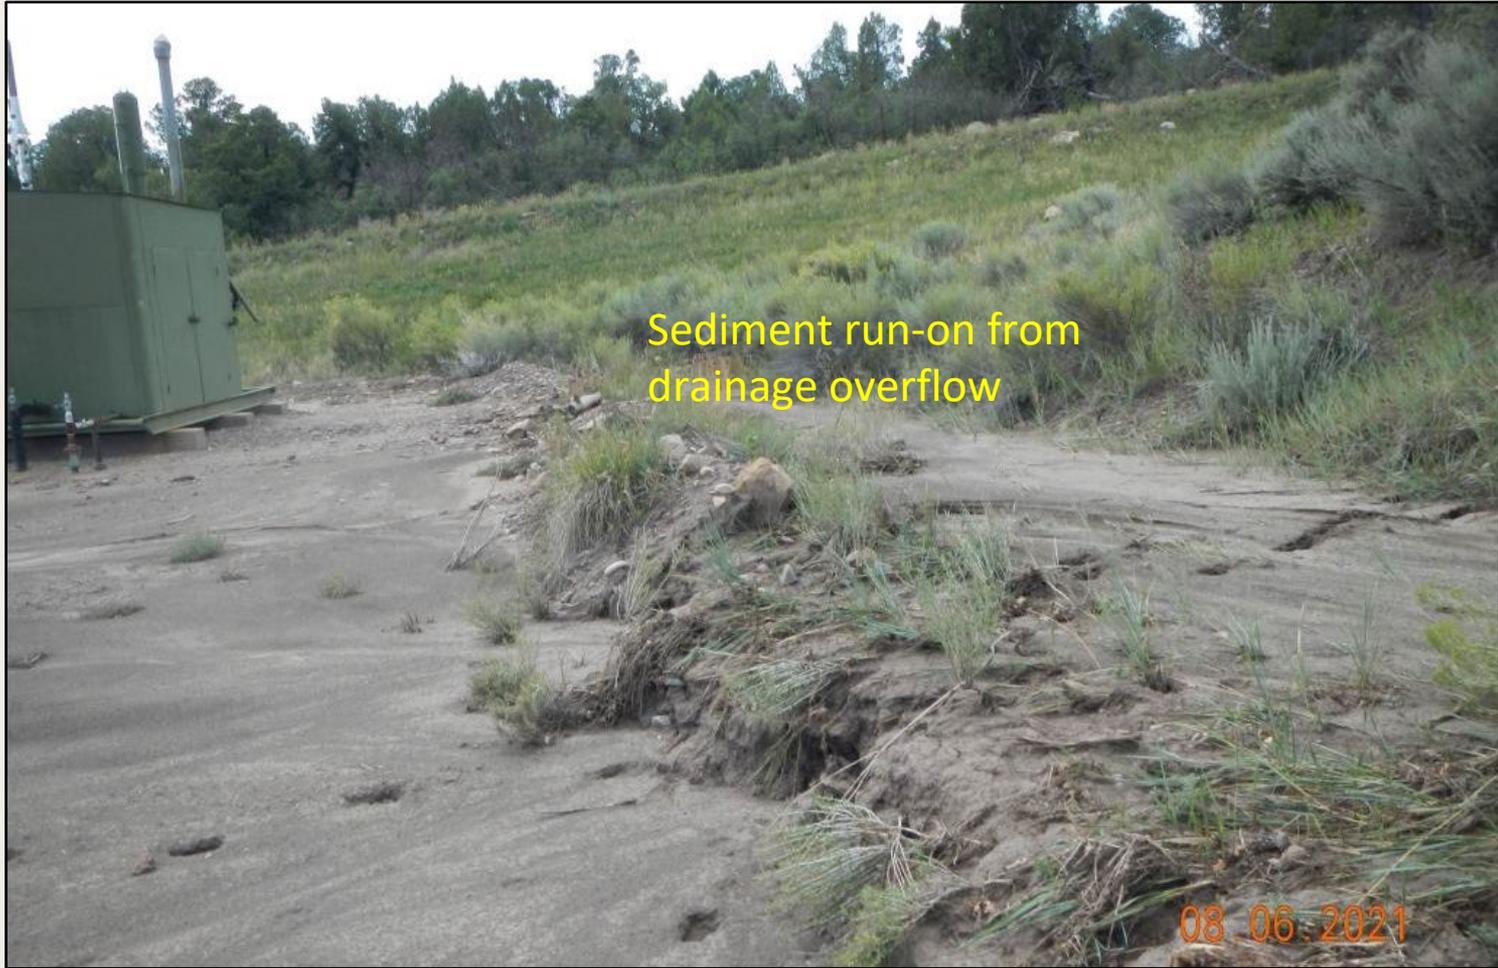
Photo 3. View of sediment discharge and run-on from overflowing in the northwestern stormwater diversion.

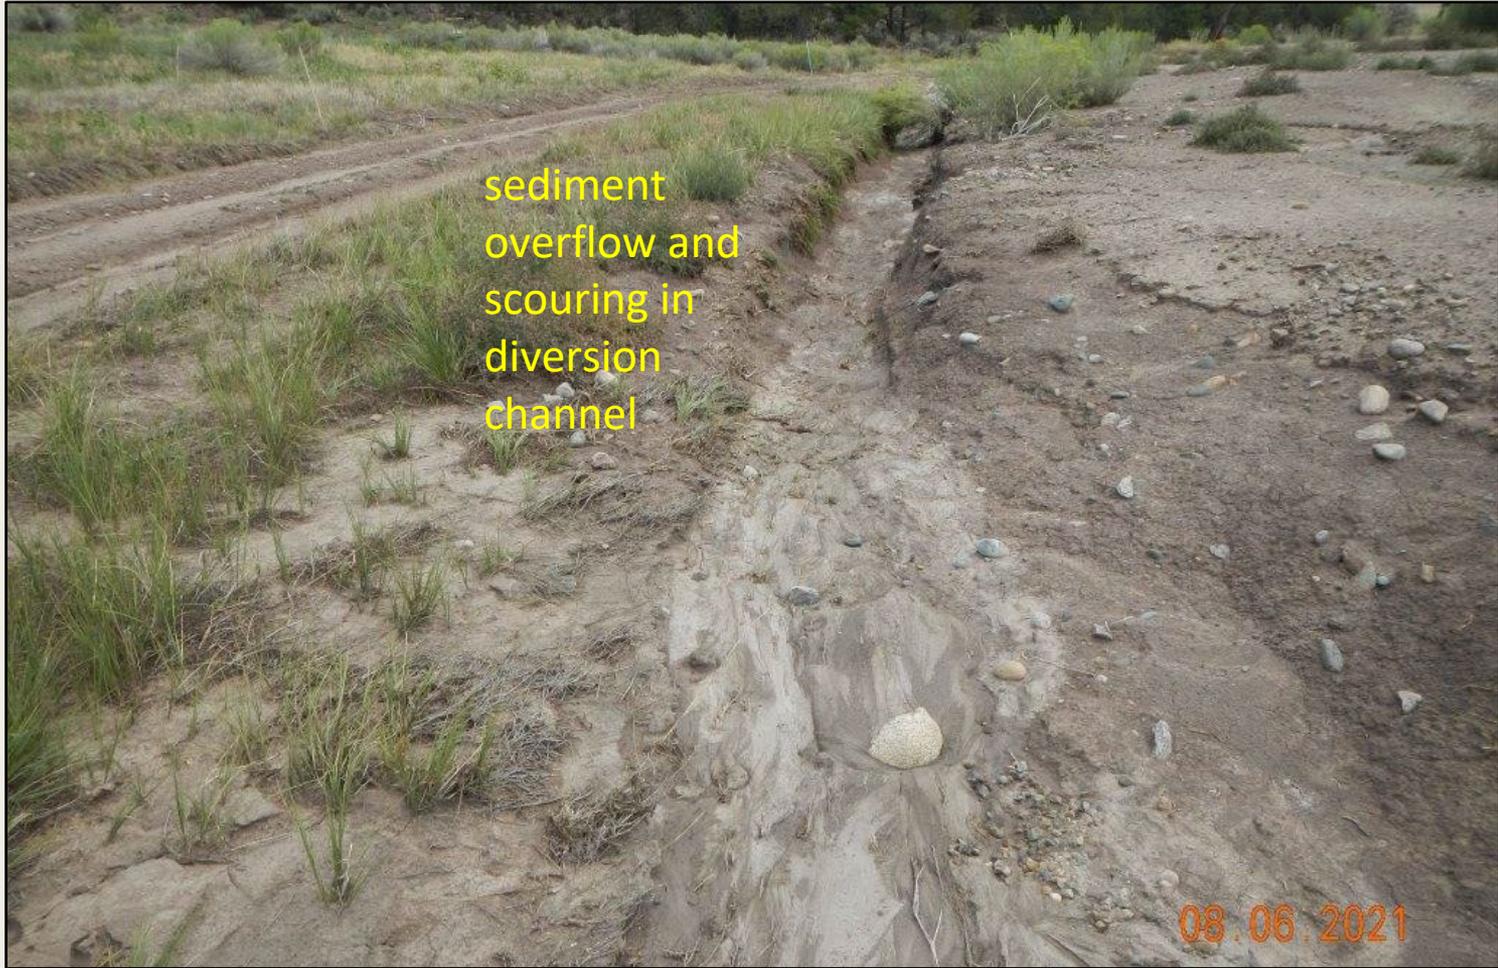
Photo 4. View of erosional down-cutting and sediment discharge within the northern well pad diversion.

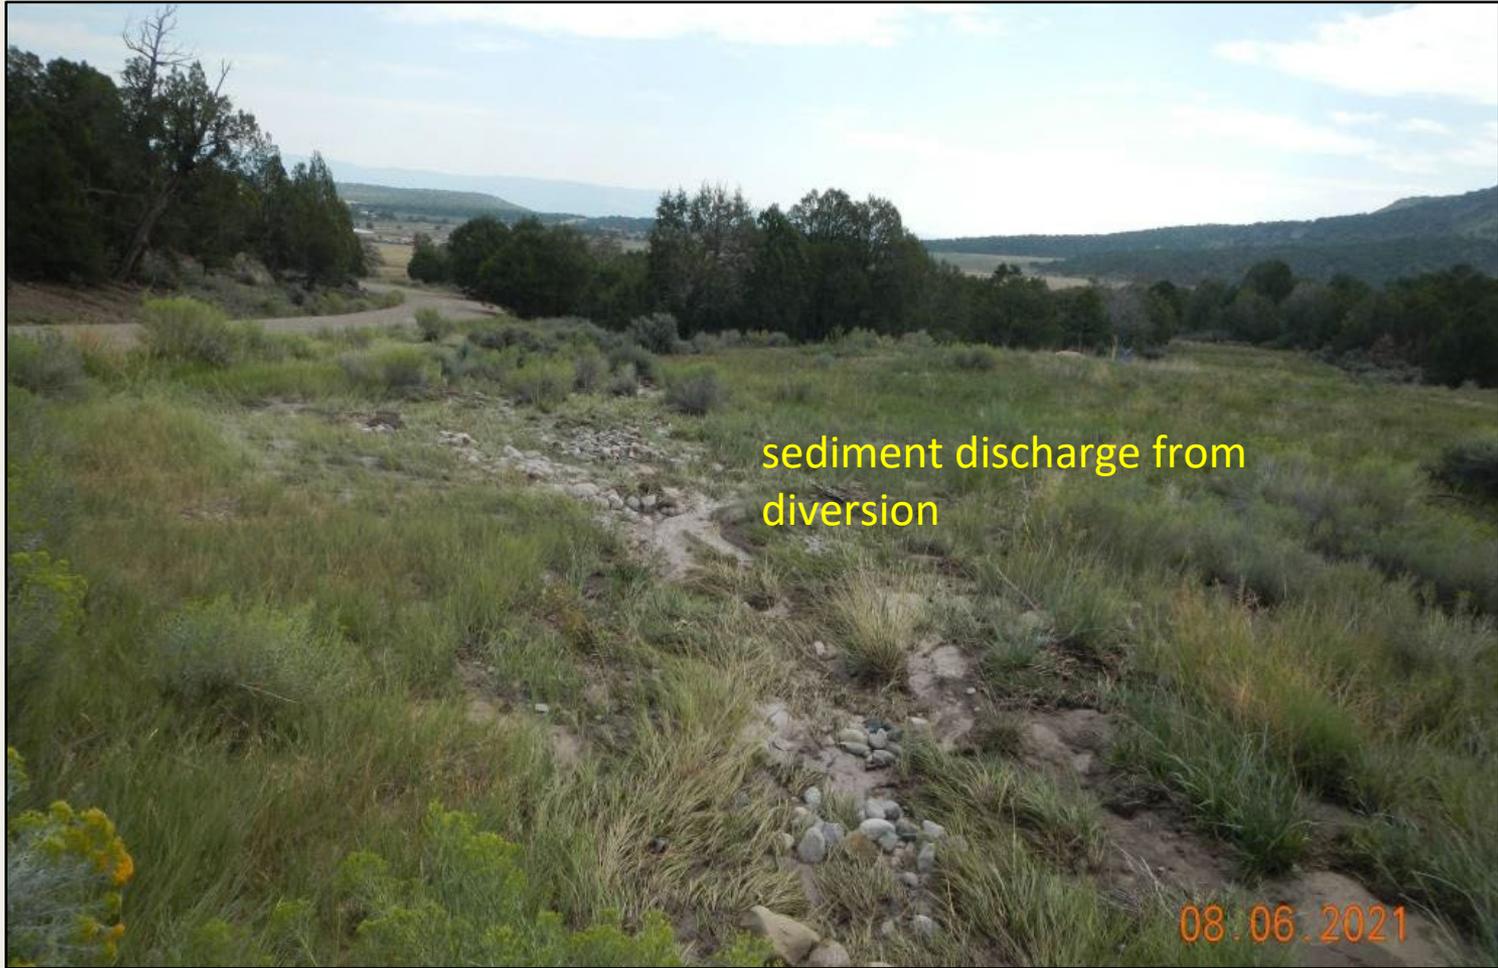
Photo 5. View of rock, gravel, and sediment discharge from the northern well pad diversion. Facing eastward (downslope). Material needs to be removed

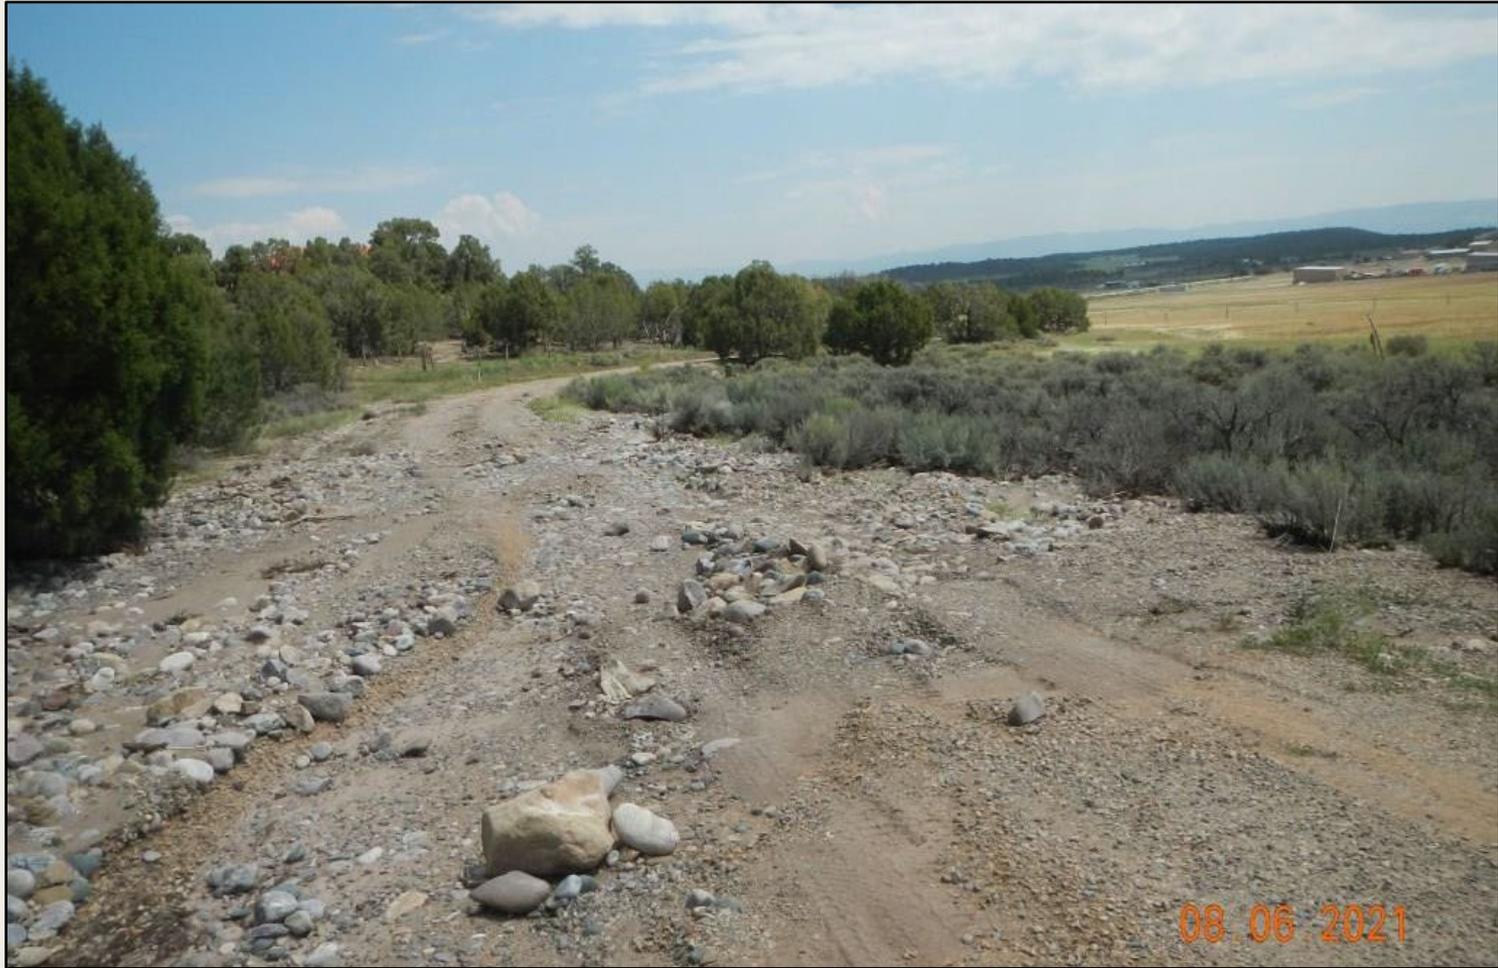
Photo 6. View of area along the access road where stormwater flows have washed out the road.

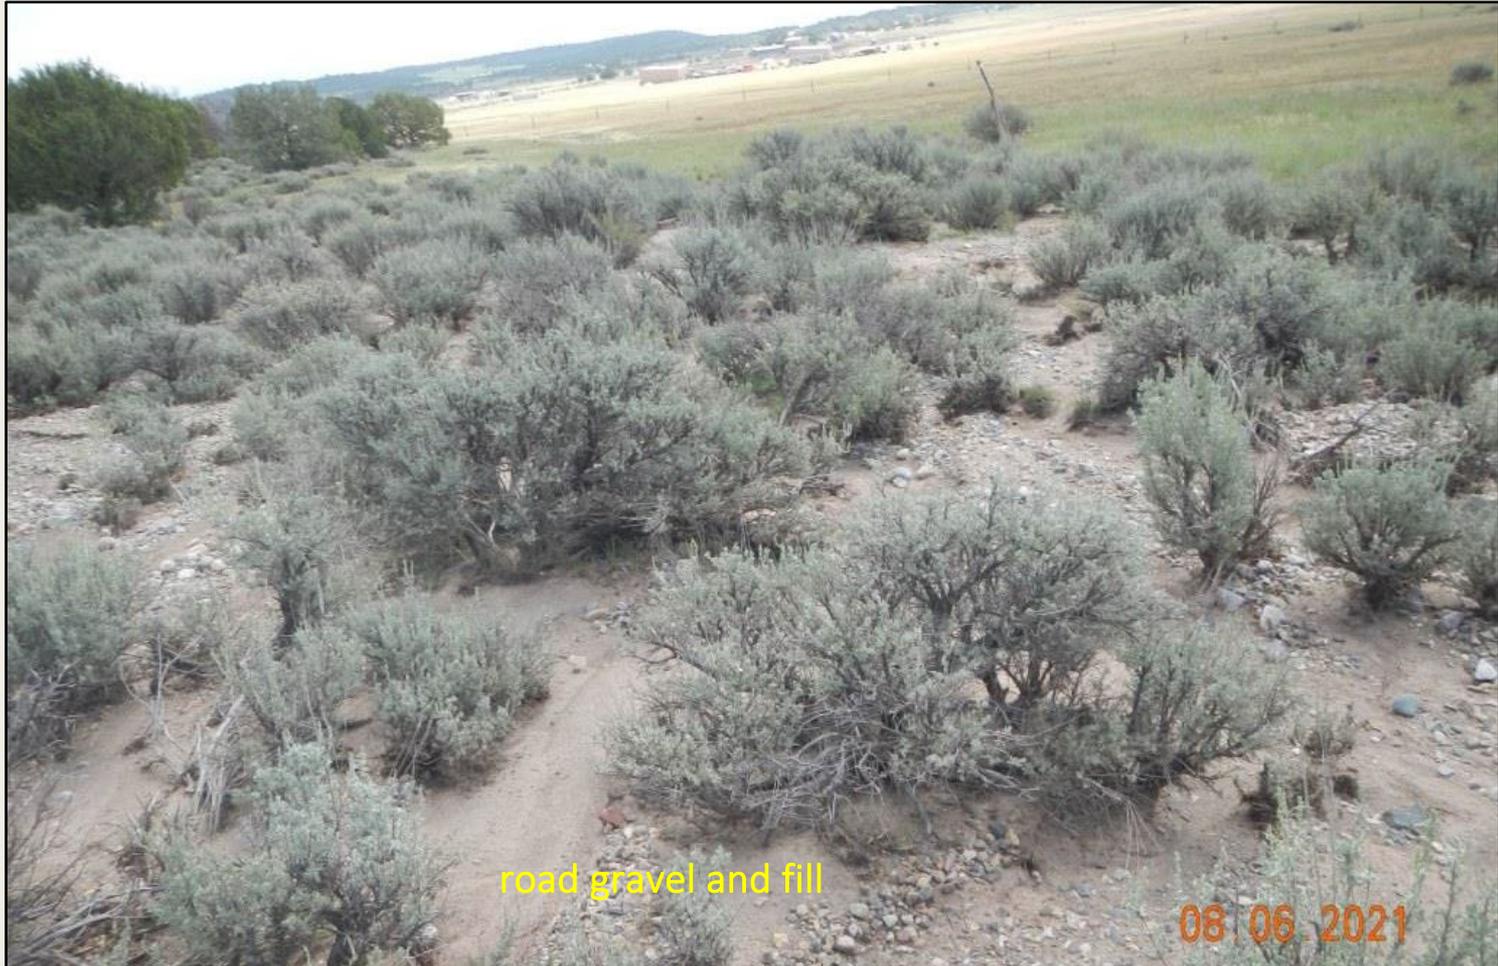
Photo 7. View of area downstream from Photo 6, where gravel, cobble, and sediment is discharged from the access road.

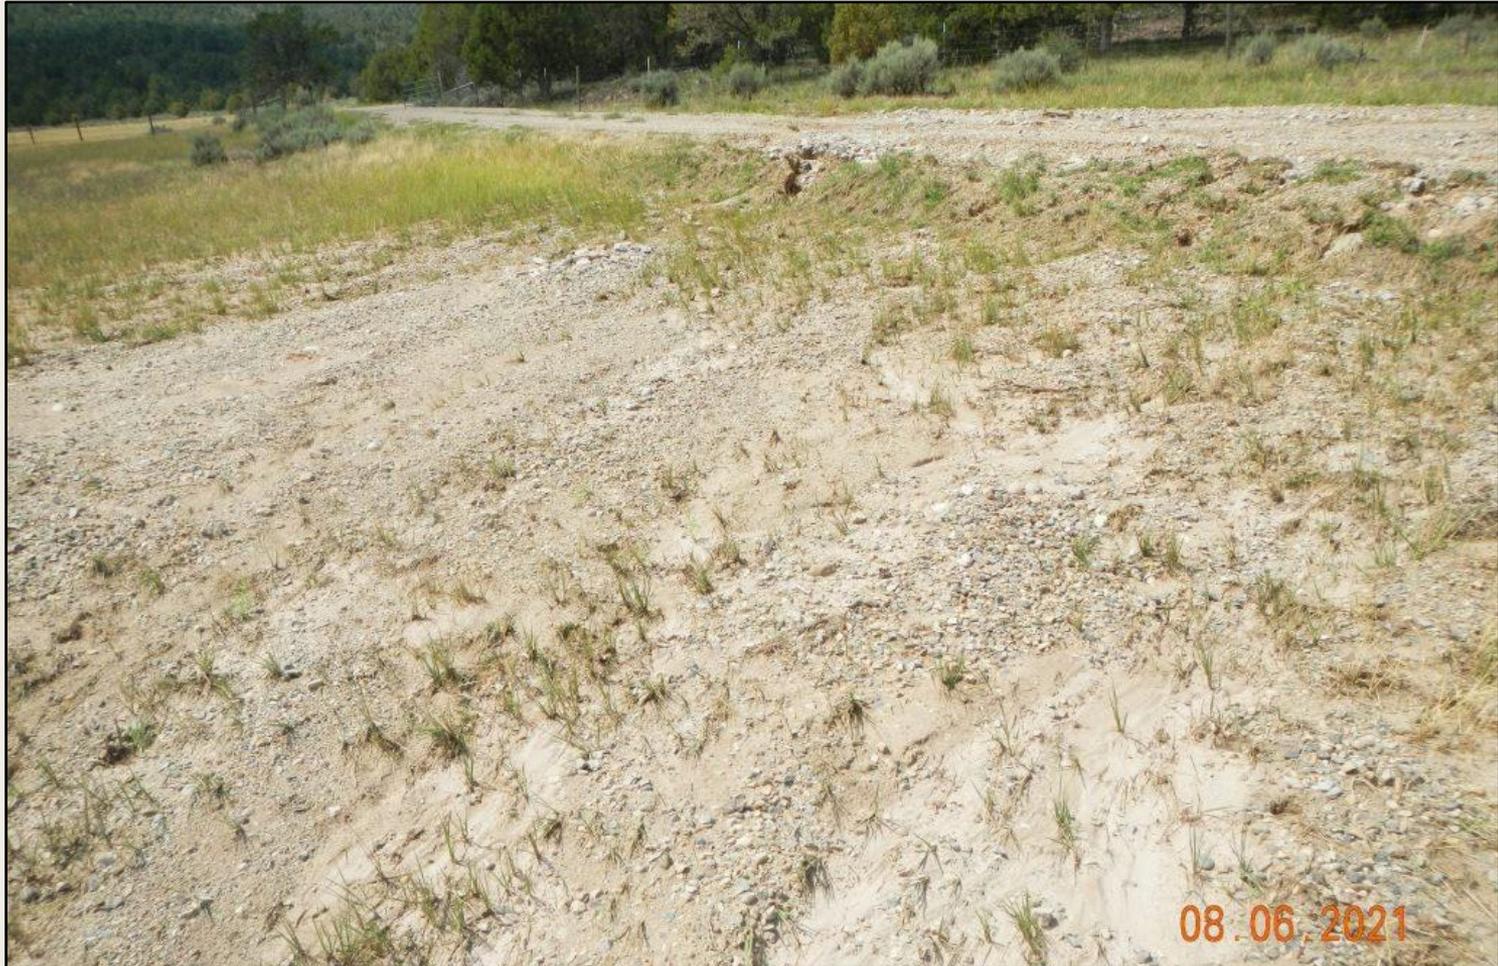
Photo 8. View of another portion of the access road (facing up-slope) where stormwater flows have not been properly contained and resulted in overflow and sediment discharge.

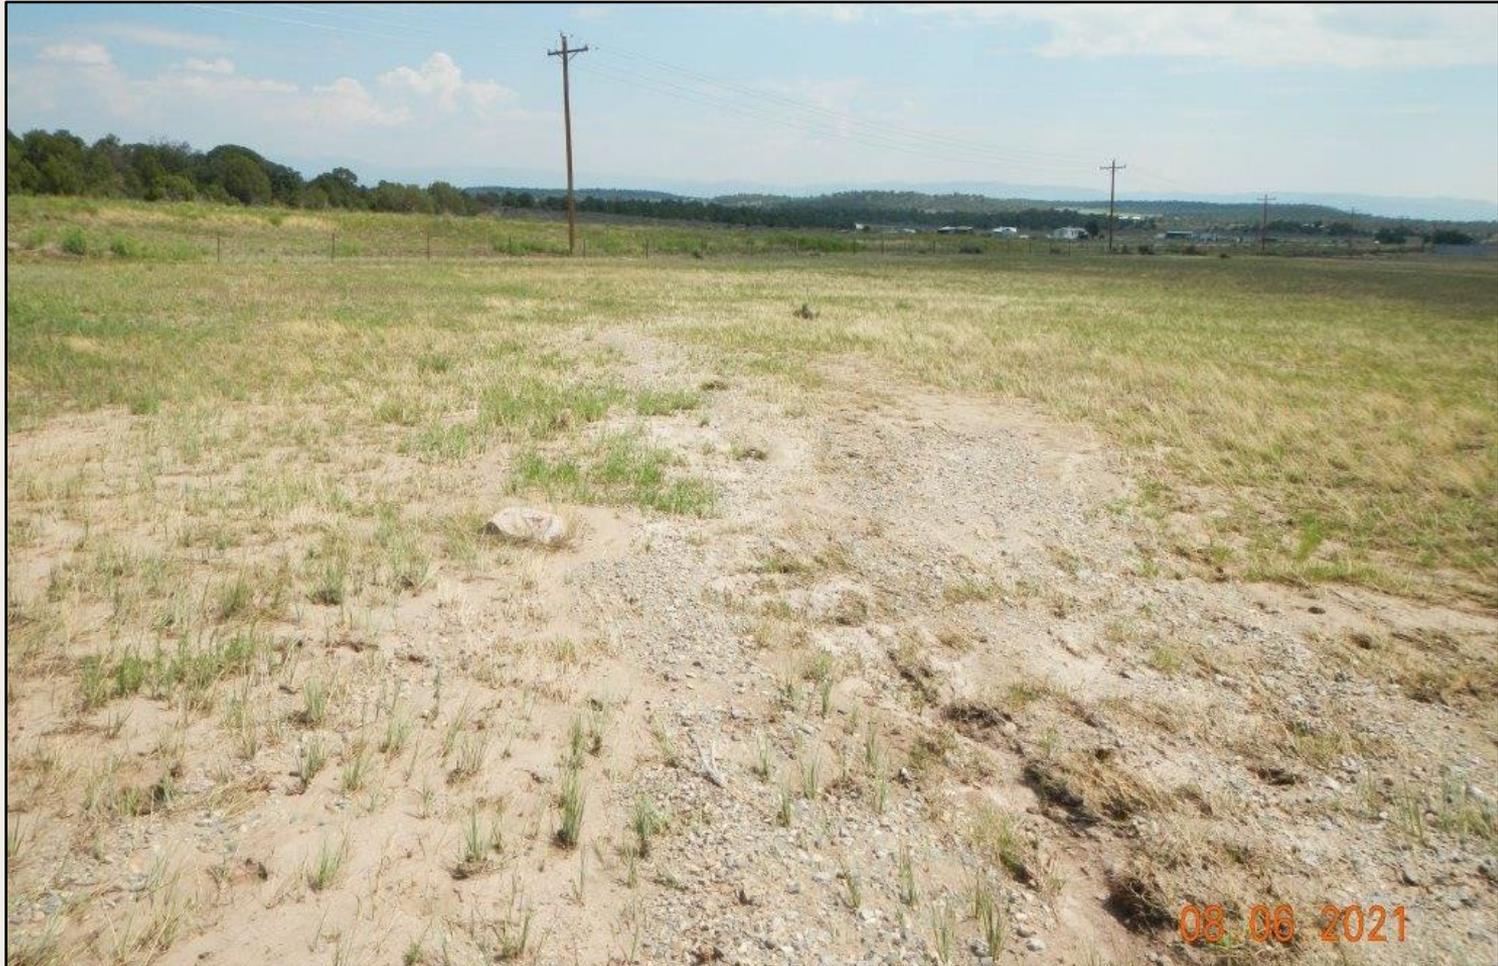
Photo 9. View of discharged sediment and gravel, as well as an erosional feature forming down-slope of Photo 8, facing downstream. Gravel and excess material needs to be removed and area needs revegetation.

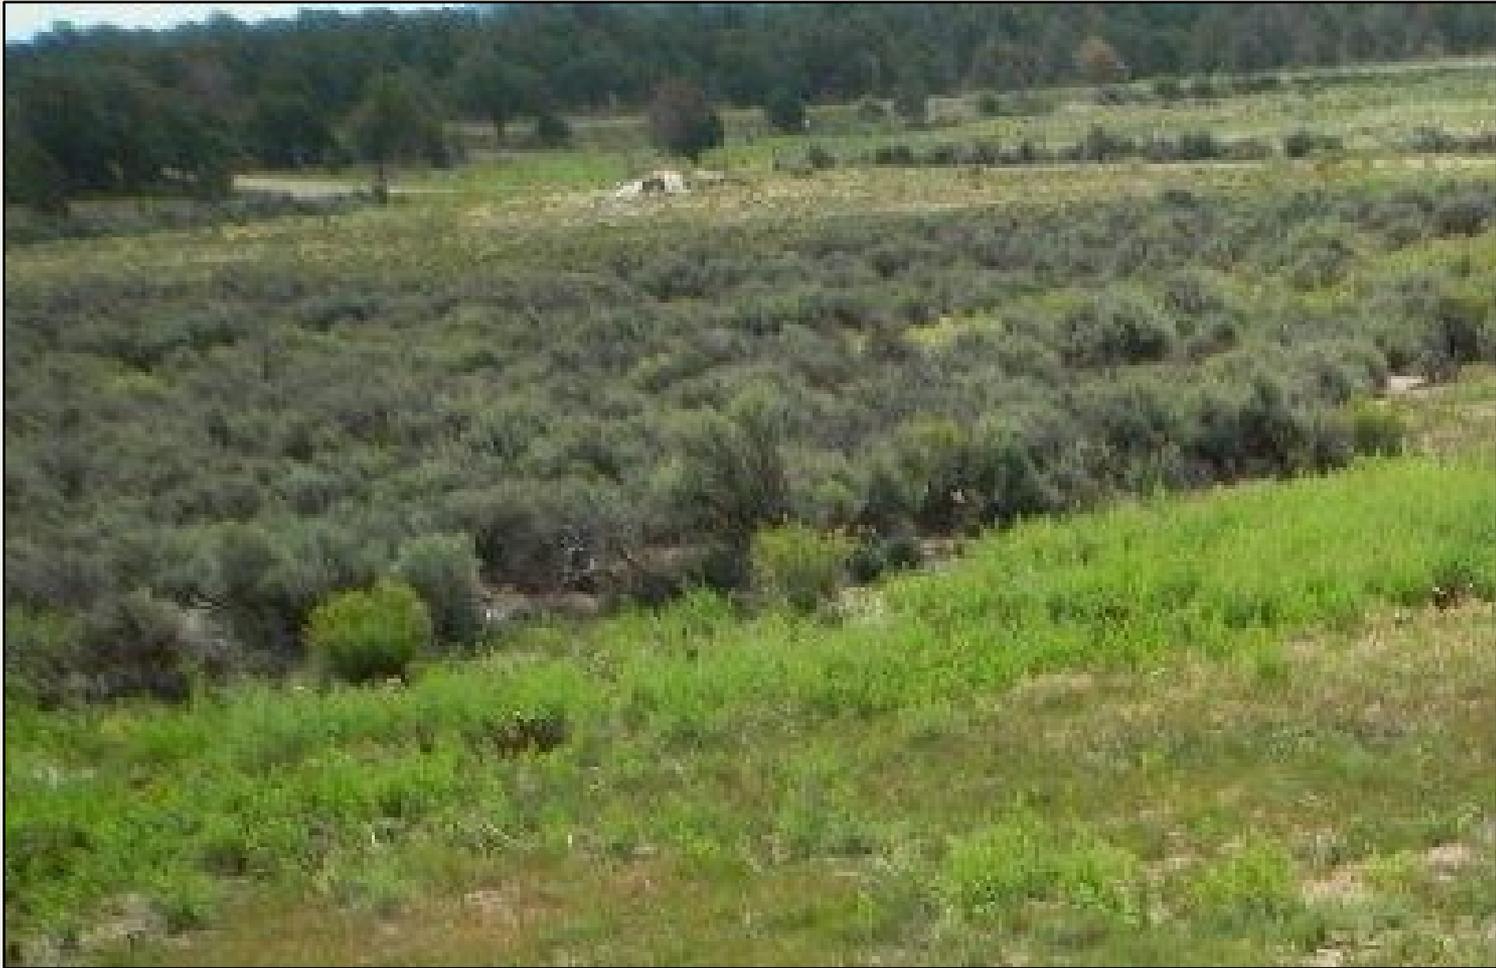
Photo 10. View of reference area comprised of sagebrush shrubland, open grass field, and pinyon and juniper woodland mosaic, with grasses and forbs such as western wheatgrass, James galleta, matt penstemon, and goldenaster.

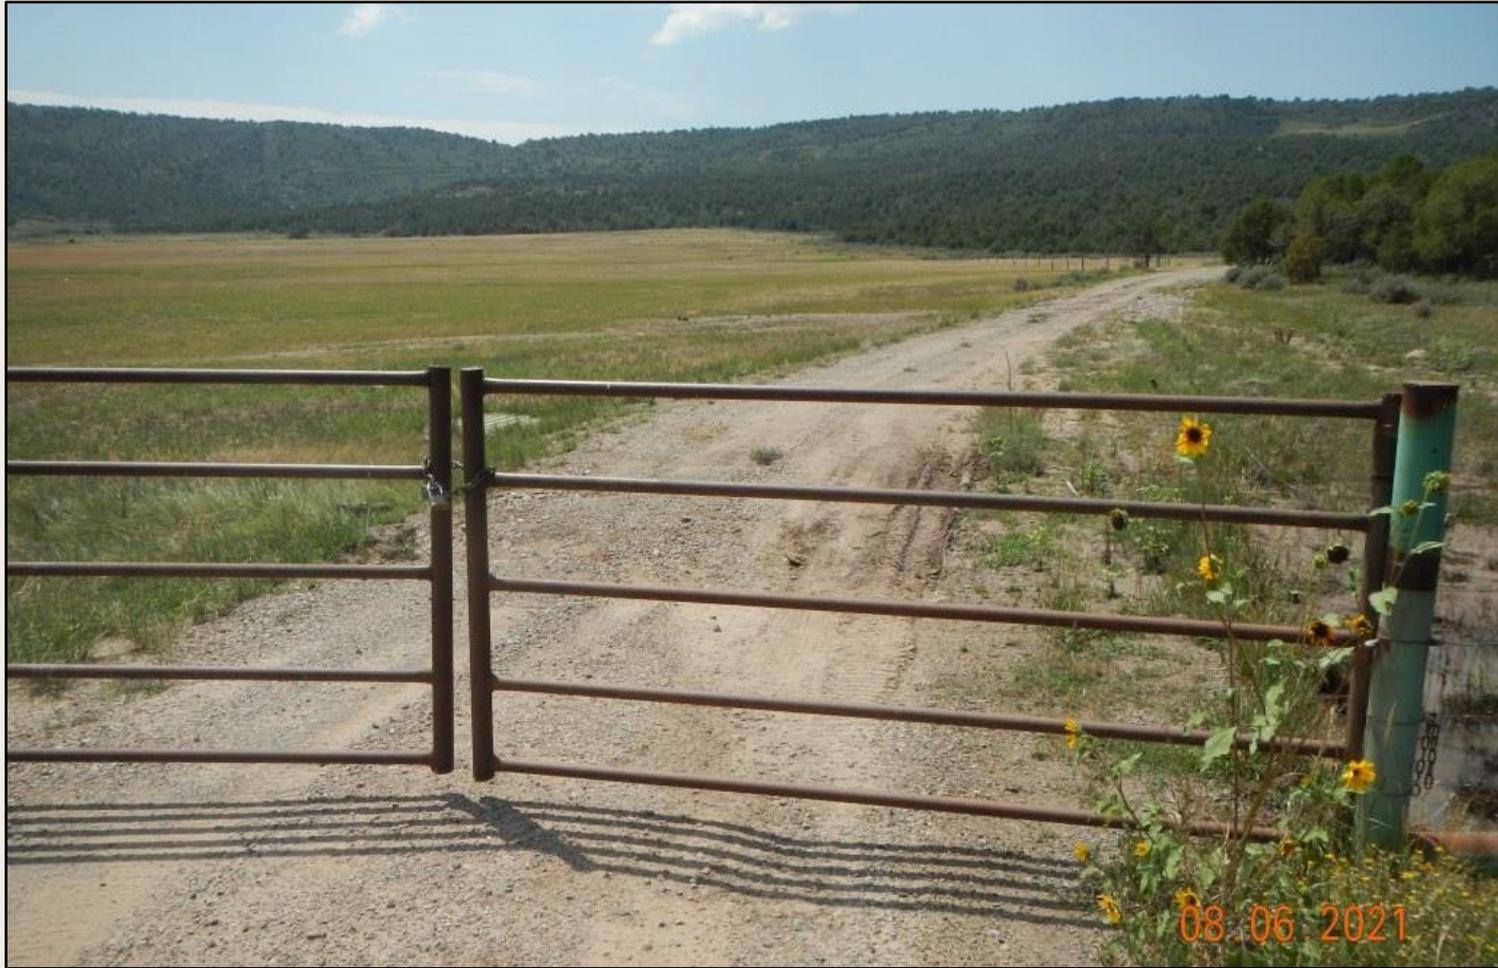
Photo 11. View of closed gate after leaving location.
