HILL RANCH 32-06 CH API# 05-071-08278 – OGRIS OPERATING  
OGCC OPERATOR NUMBER 10758 - DATE: AUGUST 11, 2021  
CORRECTIVE ACTIONS COMPLETED REGARDING COGCC FIR DOCUMENT # 690201931

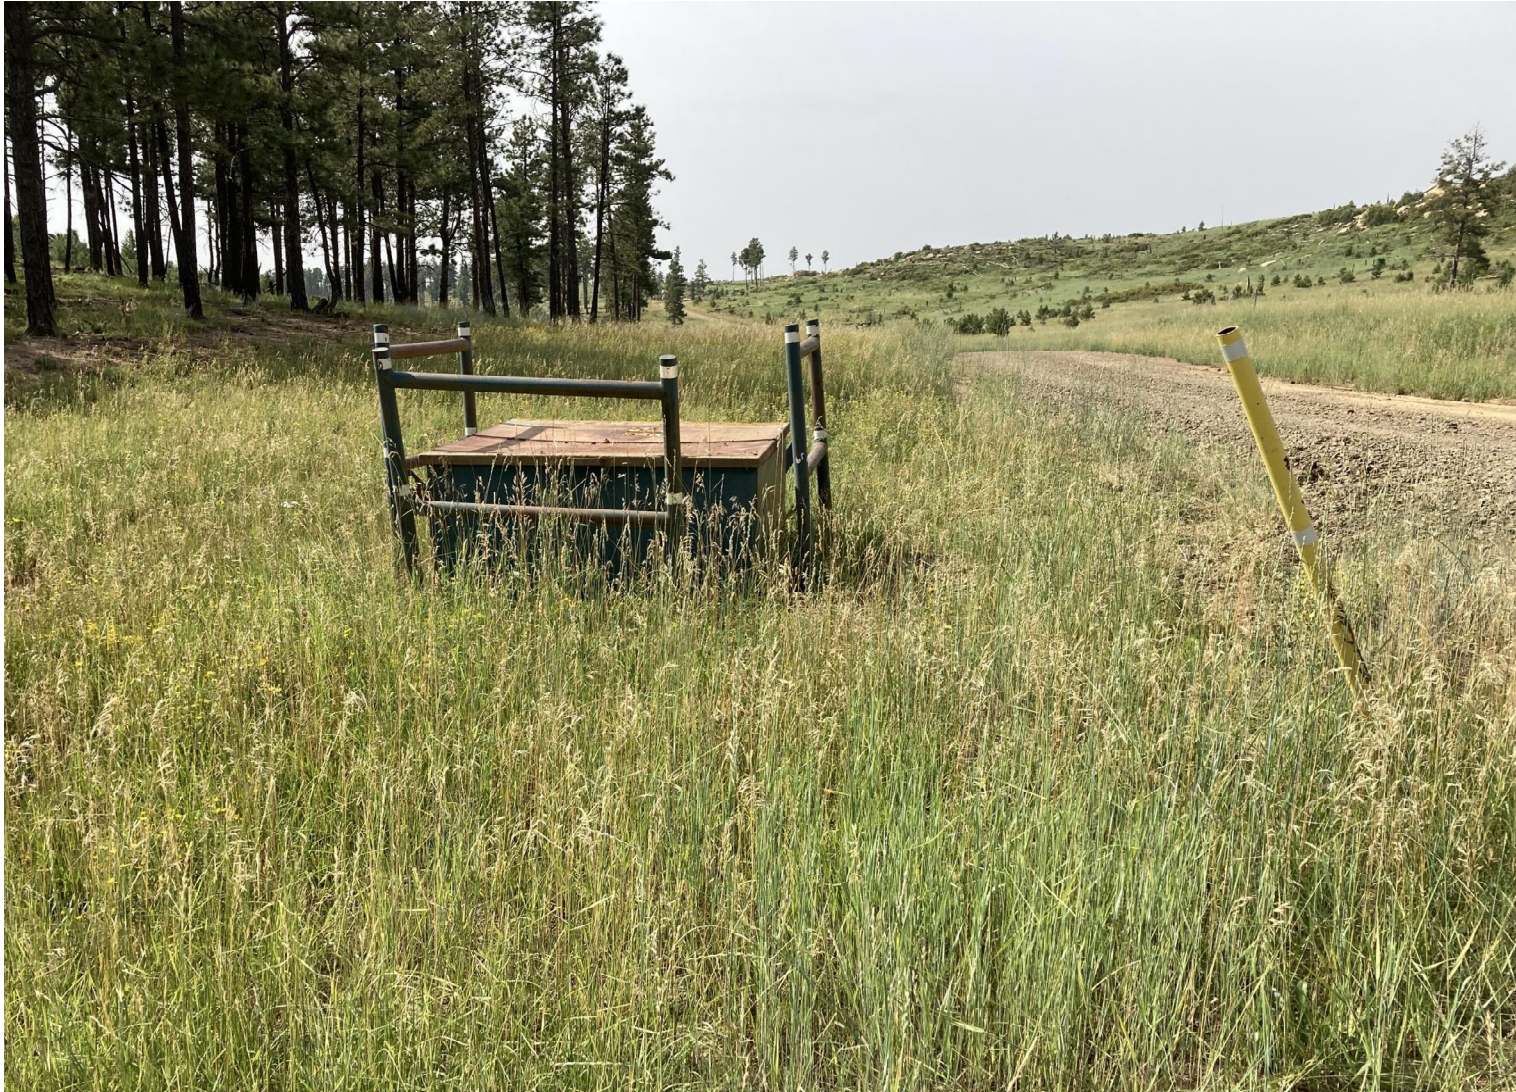
PHOTO 1: THE ORANGE FLAGGER TAPE WAS REMOVED. THIS WAS USED TO MARK THE END OF THE LEASE RUN FOR NEW HIRES. THERE WERE NO PIPELINE ISSUES, SOMEONE UNCOVERED THE VALVE CAN TO SEE WHAT WAS INSIDE AND FAILED TO REPLACE THE LID AS IT WAS TOO HEAVY. THE VALVE CAN COVER WAS PLACED BACK ON TOP OF THE VALVE CAN.

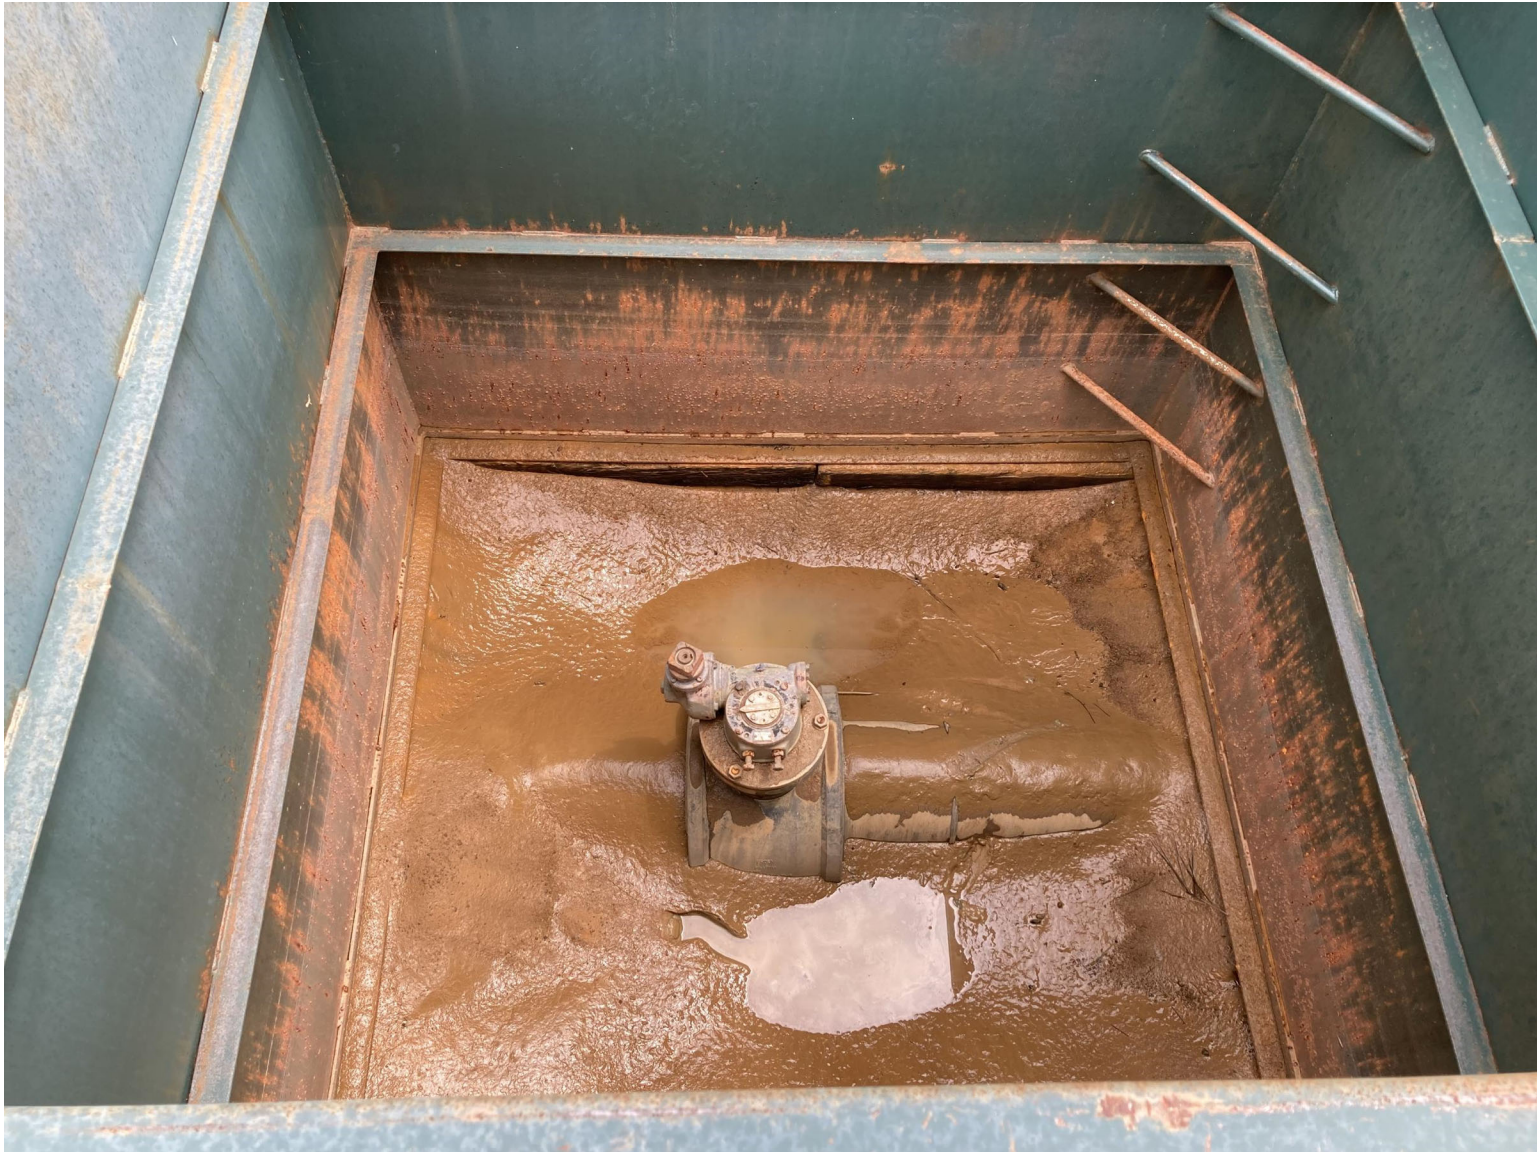
PHOTO 2: THE PIPELINE VALVE IS IN GOOD MECHANICAL CONDITION, THERE WERE NO ISSUES WITH THE PIPELINE. THE WATER IN THE VALVE BOX WAS RAIN WATER ONLY. THE ORANGE FLAGGER TAPE THAT WAS USED AT THIS INTERSECTION TO INDICATE THE END OF THAT RUN FOR NEW EMPLOYEE'S/CONTRACTOR'S HAS BEEN REMOVED.
