# Inspection Photos

API: 071-08576

Operator: RED RIVER RANCH HOLDINGS LLC

Inspection Date: 8/11/2021

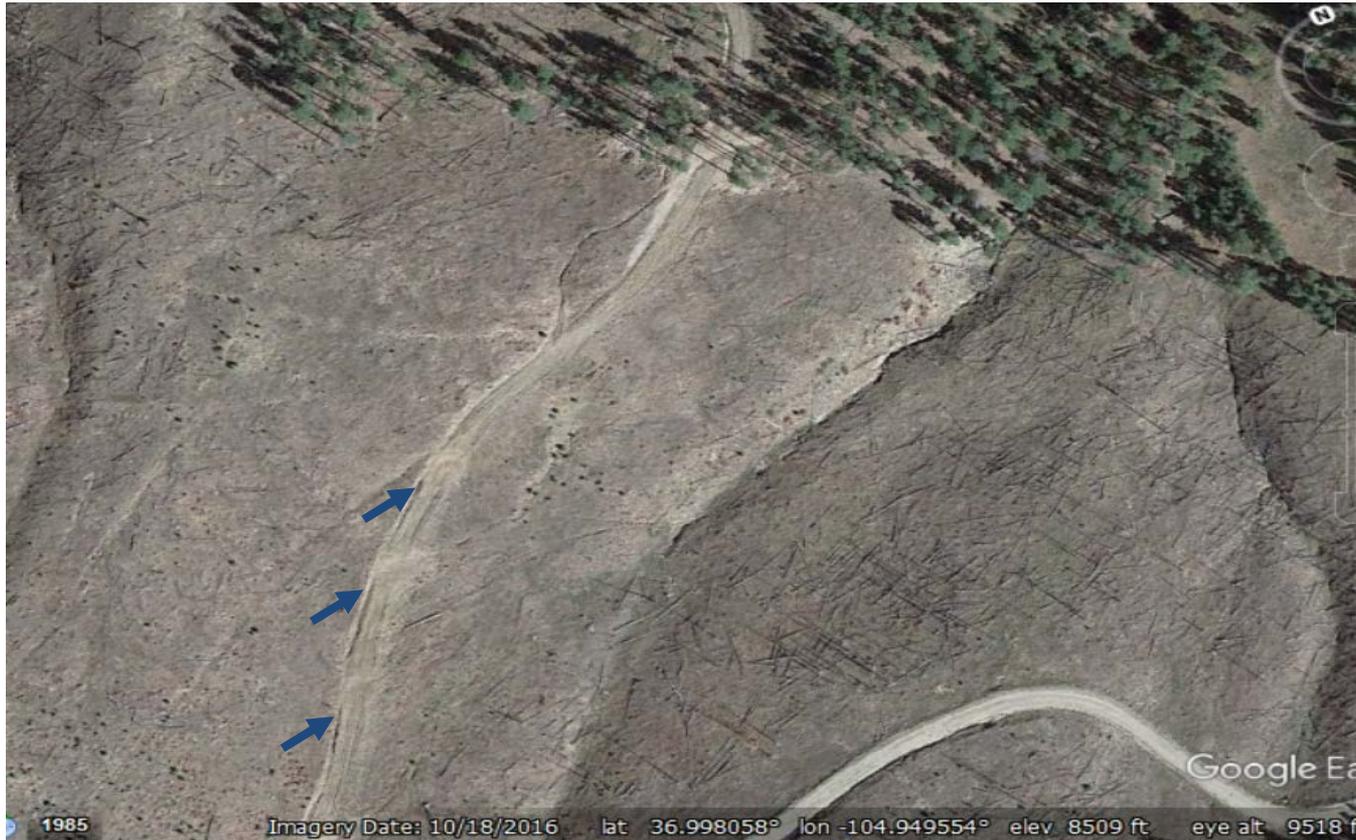
**Photo 1.** Refer to the 2016 aerial image for issues observed during inspection. There was erosion shown at blue arrow which stormwater is causing erosion along the road side and at the water bars. BMP's need to be installed to prevent further erosion of these area. (e.g. rock rip/rap, rock check dams, sediment trap, ect.)

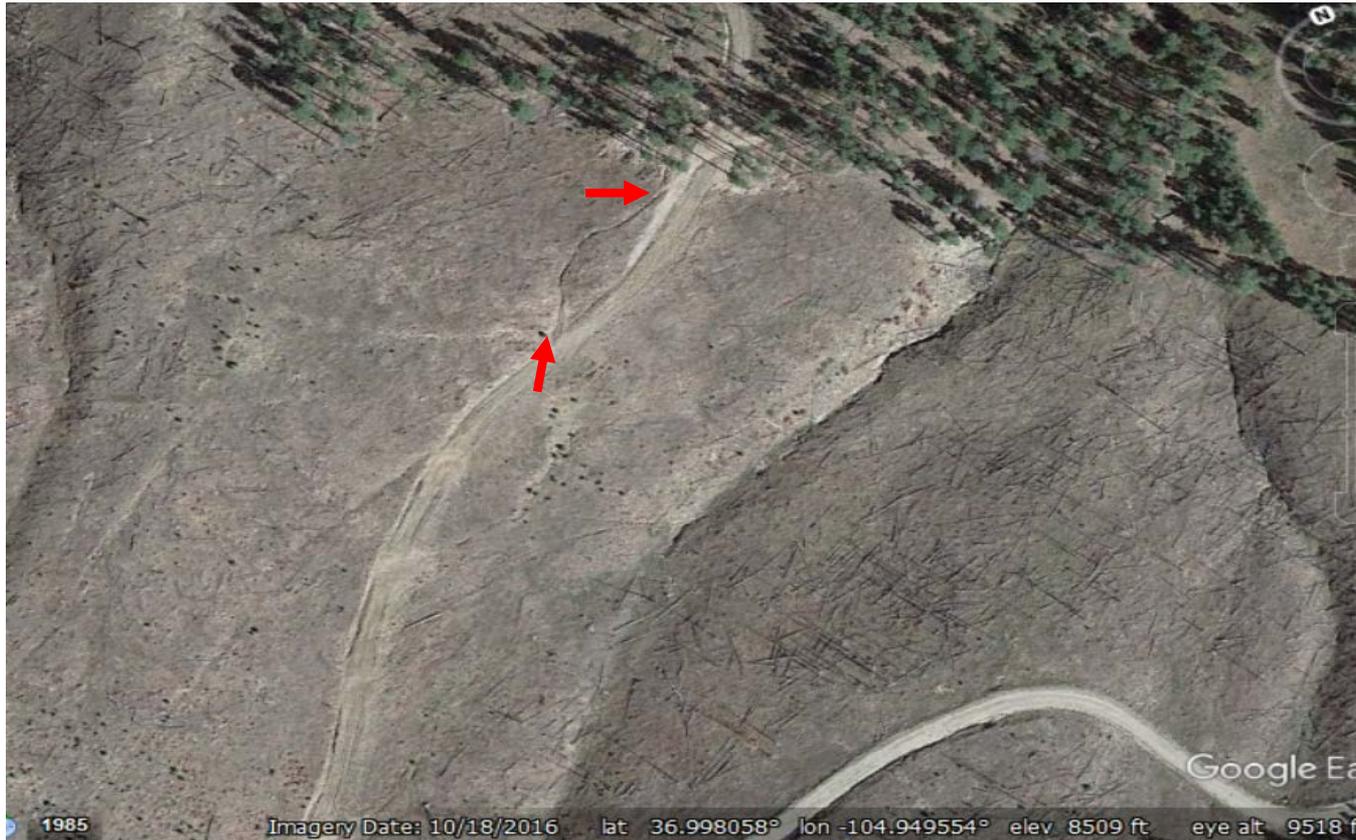
**Photo 2.** Refer to the 2016 aerial image for issues observed during inspection. There was erosion shown at red arrow which concentrate stormwater off the road which then is redirected back onto the road. BMP's need to be installed to prevent further erosion of this area. (e.g. rock rip/rap, rock check dams, sediment trap, ect.)

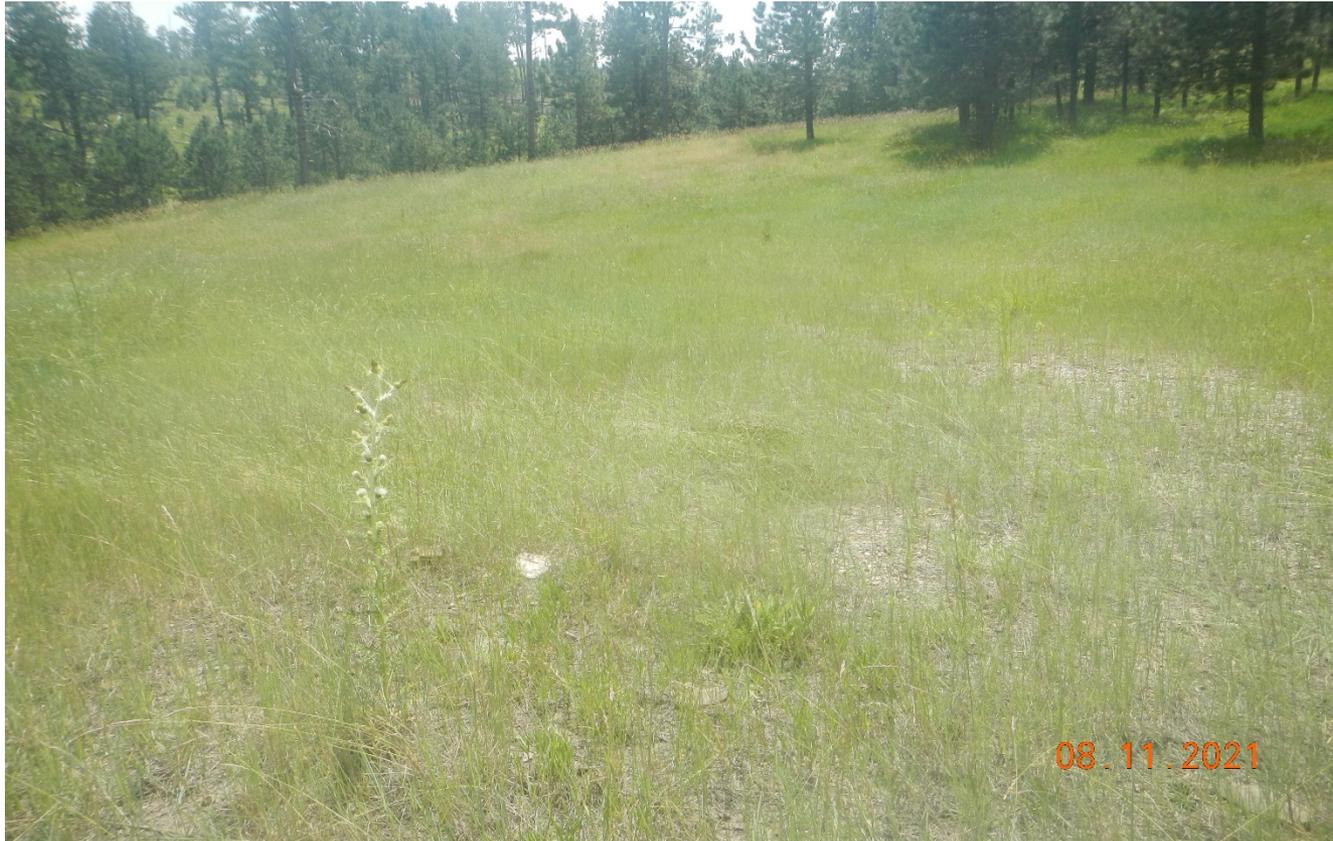
**Photo 3.** Facing east toward the location. The location is stabilized with native perennial vegetation cover.
