# Inspection Photos

API: 071-09344

Operator: RED RIVER RANCH HOLDINGS LLC

Inspection Date: 8/11/2021

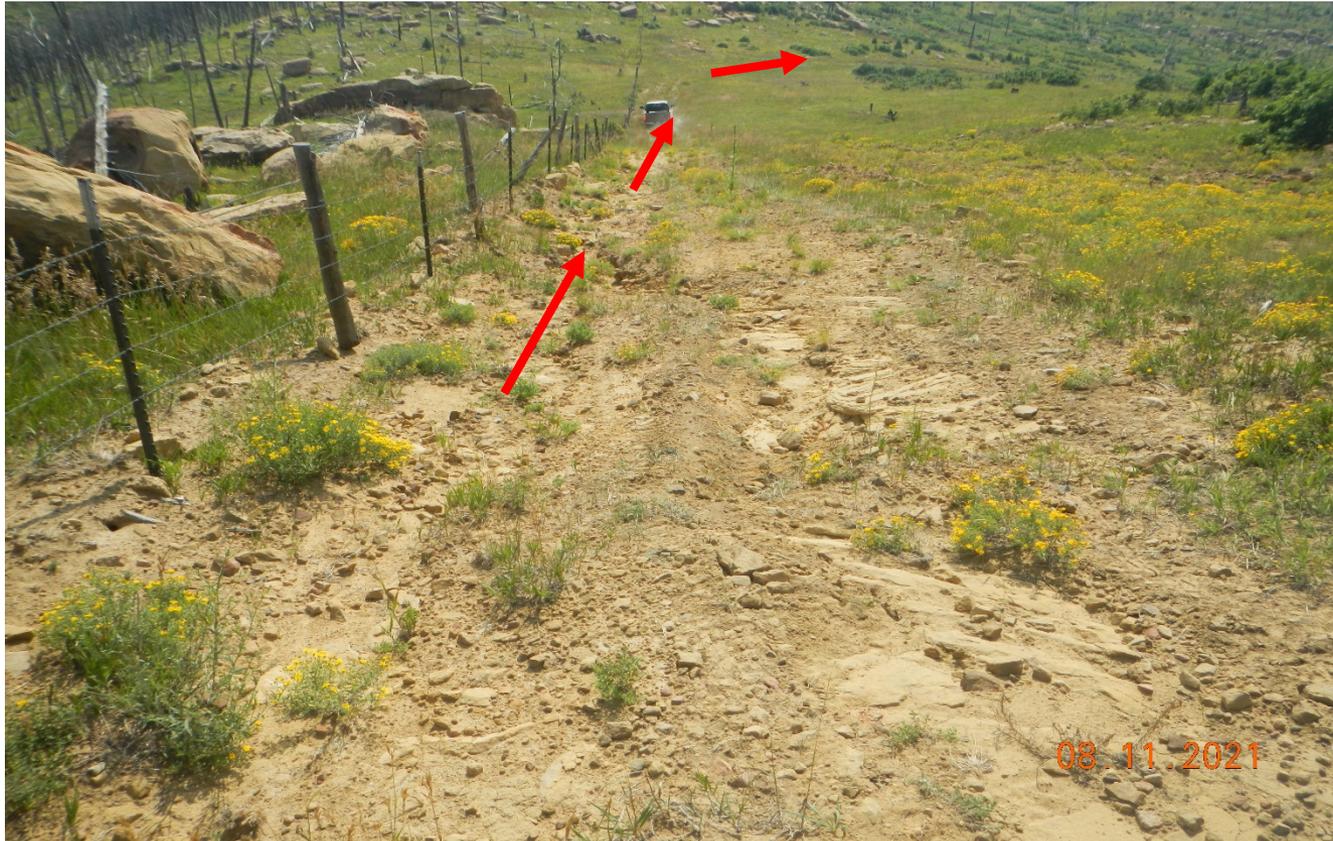
**Photo 1.** Facing southeast along the pre-existing access road. There is erosion occurring down the road. Stormwater is not being diverted off the road and is concentrating flow down toward the location shown by red arrows.

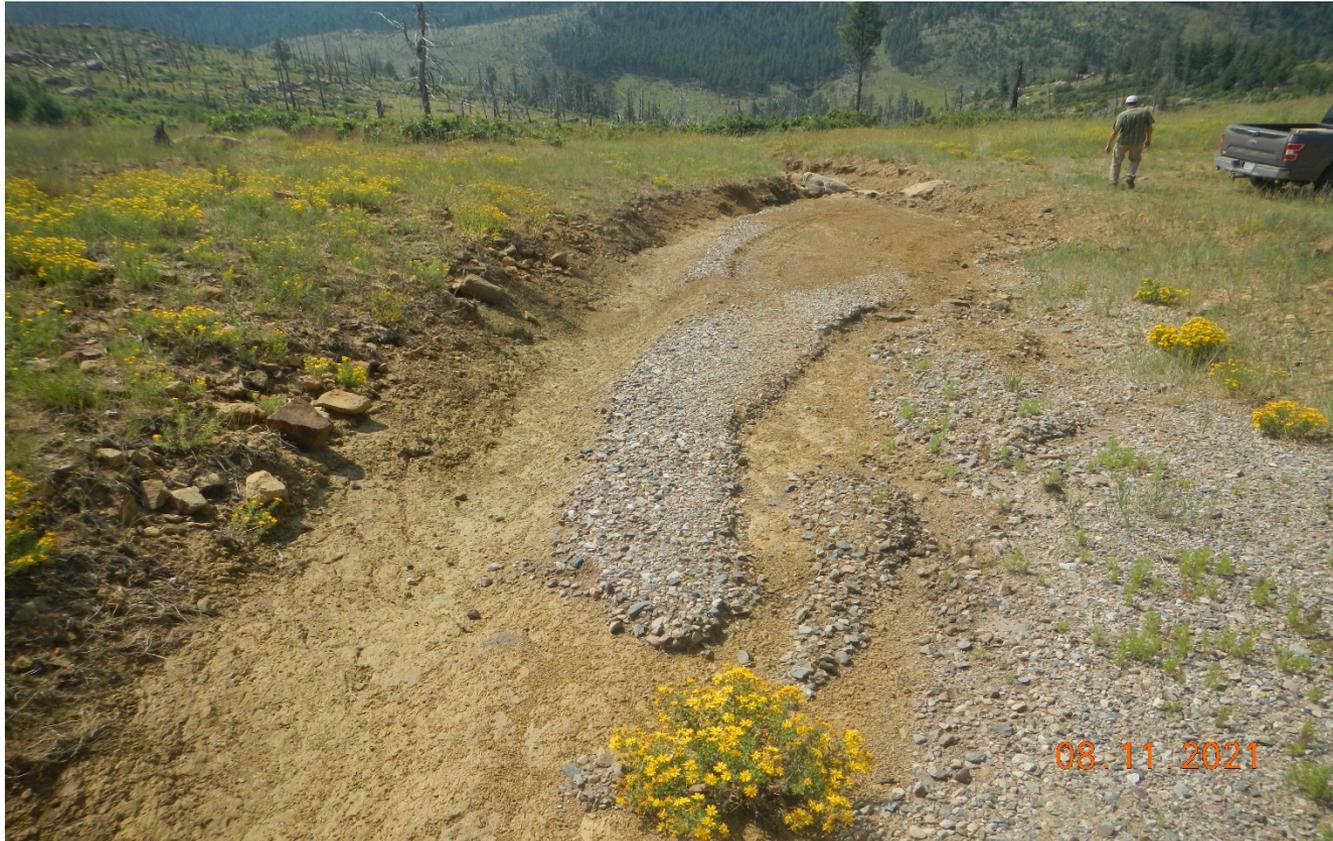
**Photo 2.** Facing south toward the access road at the location. The concentrated stormwater flow from previous photo has caused erosion of the access road. This area needs to be repaired and stabilized or reclaimed.

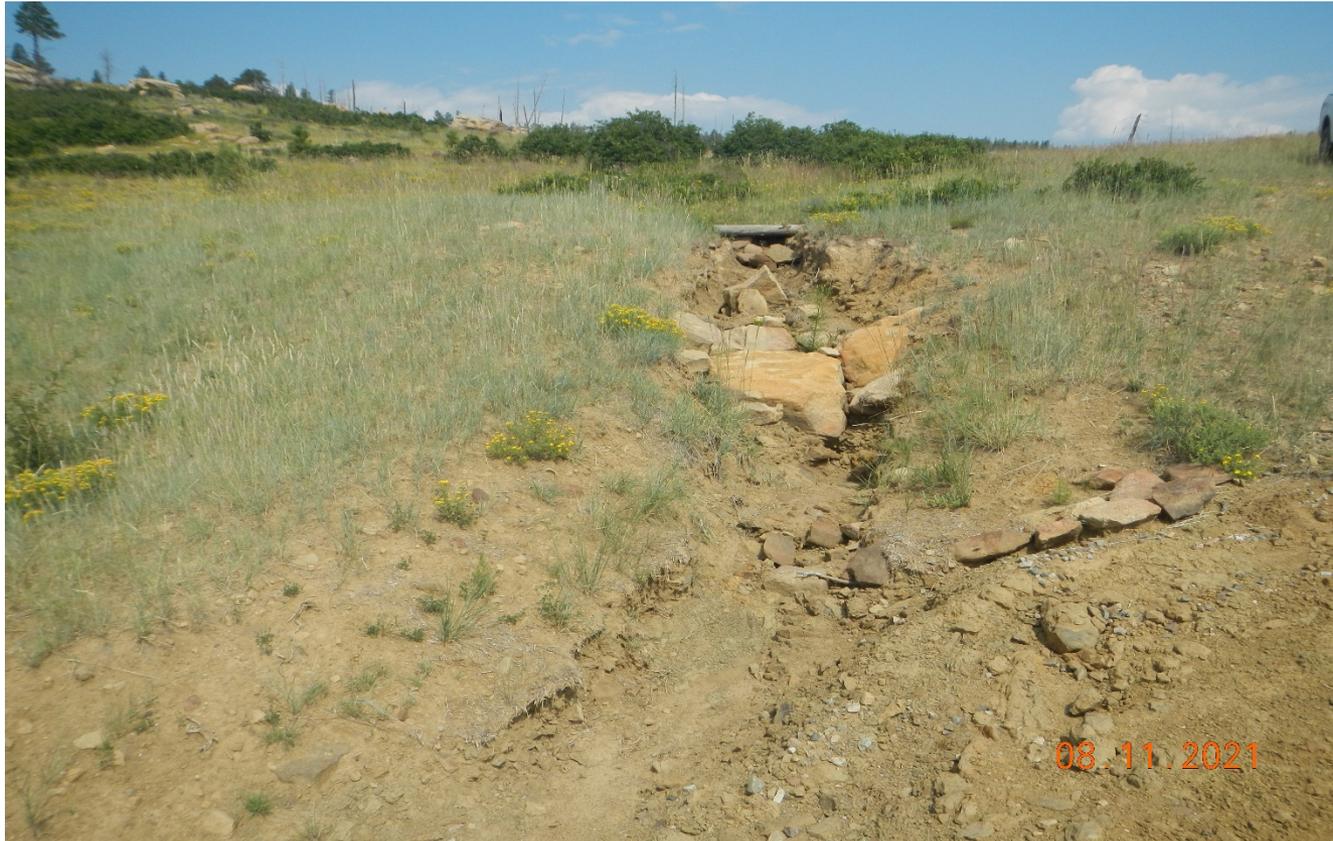
**Photo 3.** Facing northwest at the area shown in previous photo. There is an erosion channel which is caused by stormwater from the pre-existing access road shown in photo 1. This area will need to be repaired and stabilized.

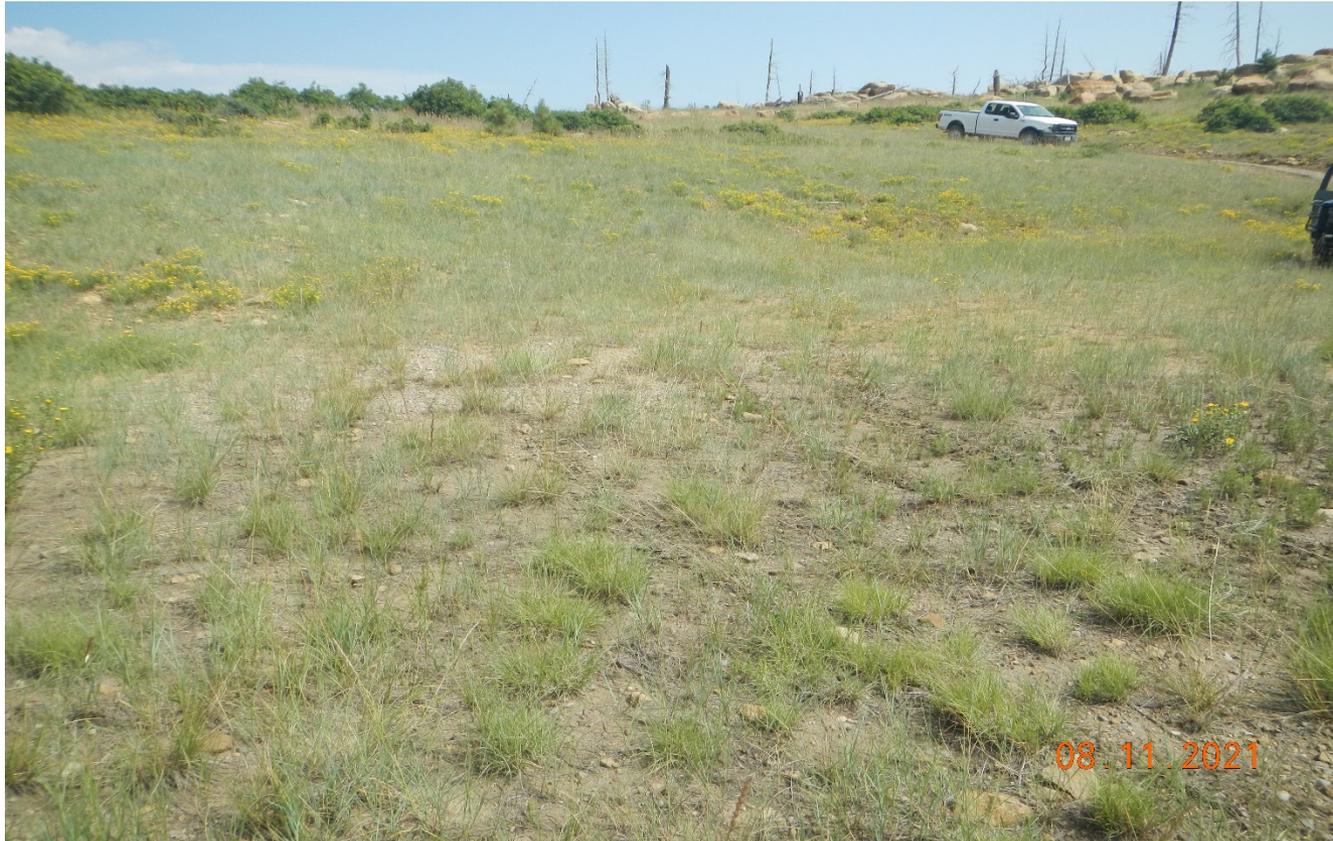
**Photo 4.** Facing northeast toward the location. The location is stabilized with native perennial vegetation cover.
