Final Reclamation Inspection

Operator: PDC ENERGY INC - 69175

Location ID: 330601

Inspection Document #: 701900028

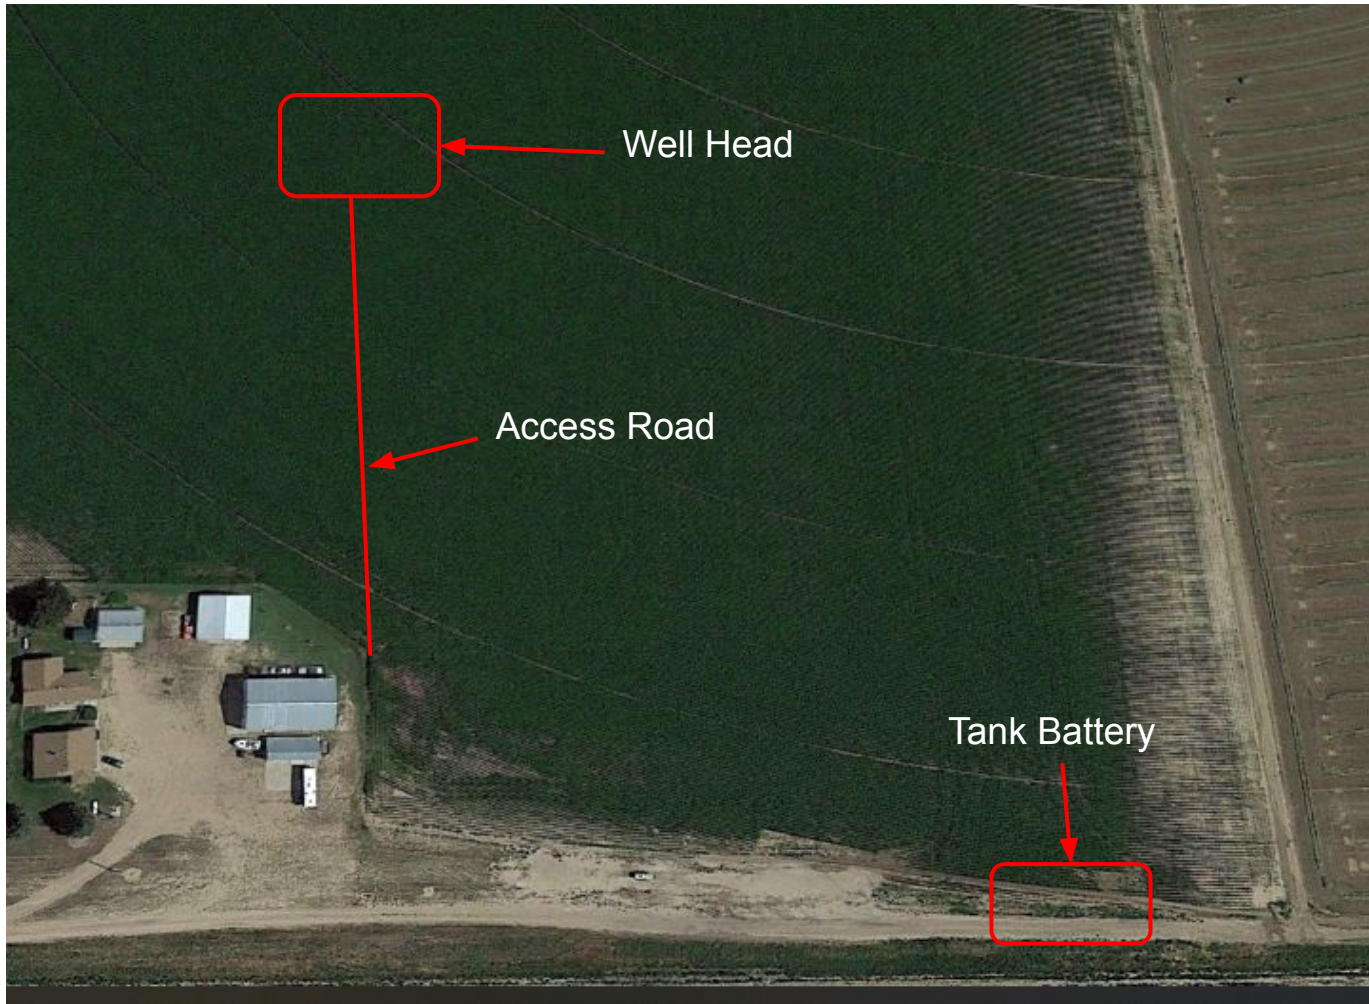
Photo 1. 2019 aerial imagery shows well head and associated access road, north is up.

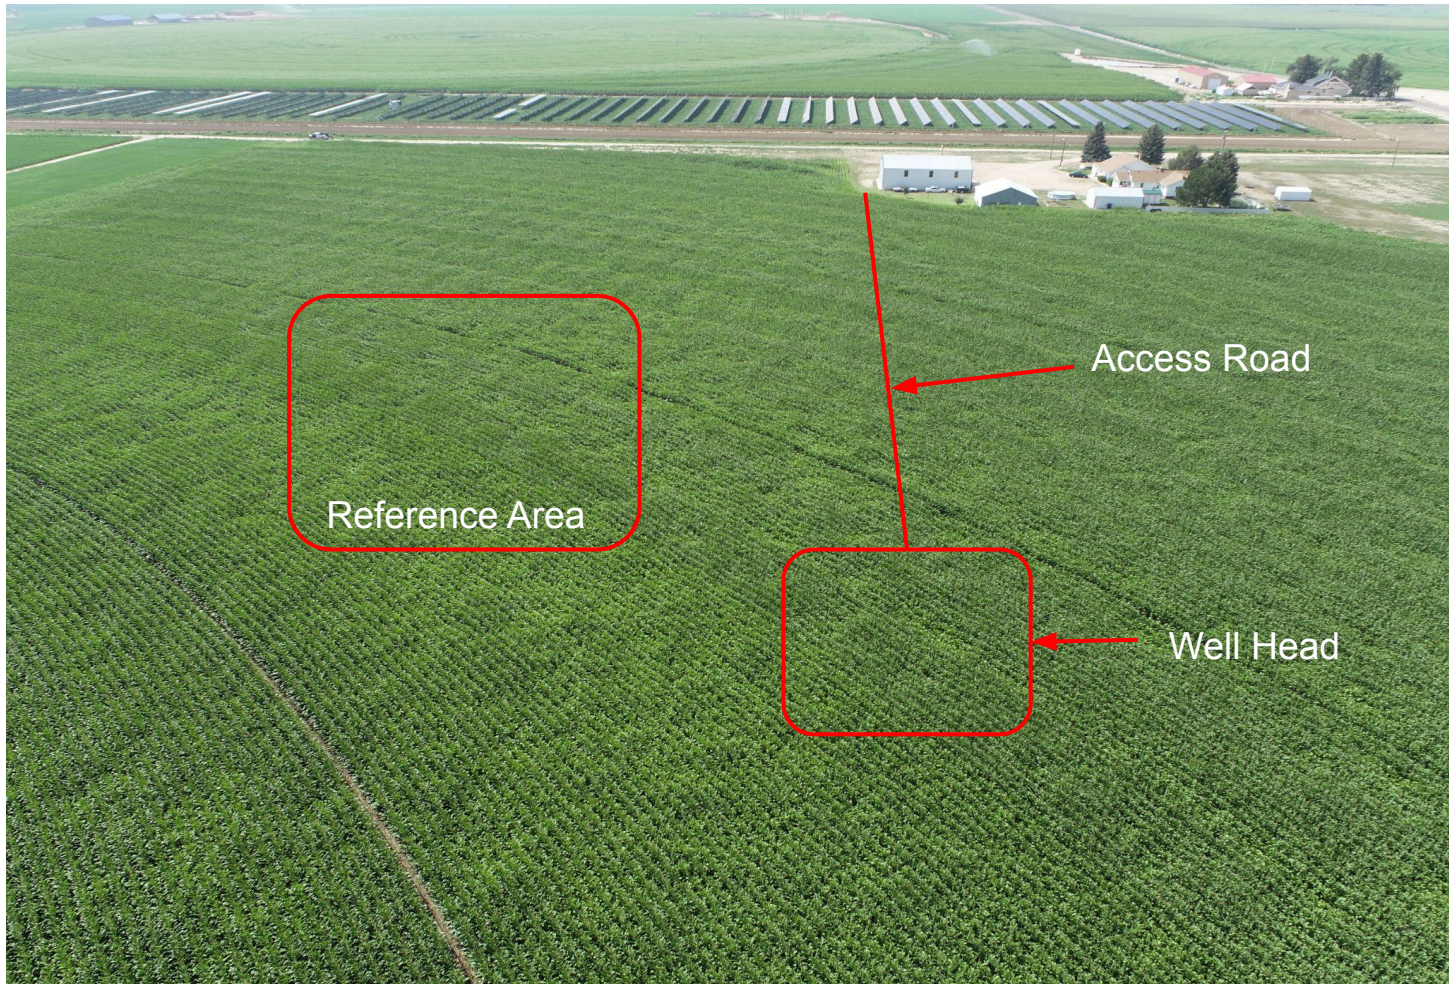
Photo 2. Overview photo of well head, access road and reference area taken north of well head looking south using a drone. Photo shows that well head and access road crop growth appear consistent with the reference area.

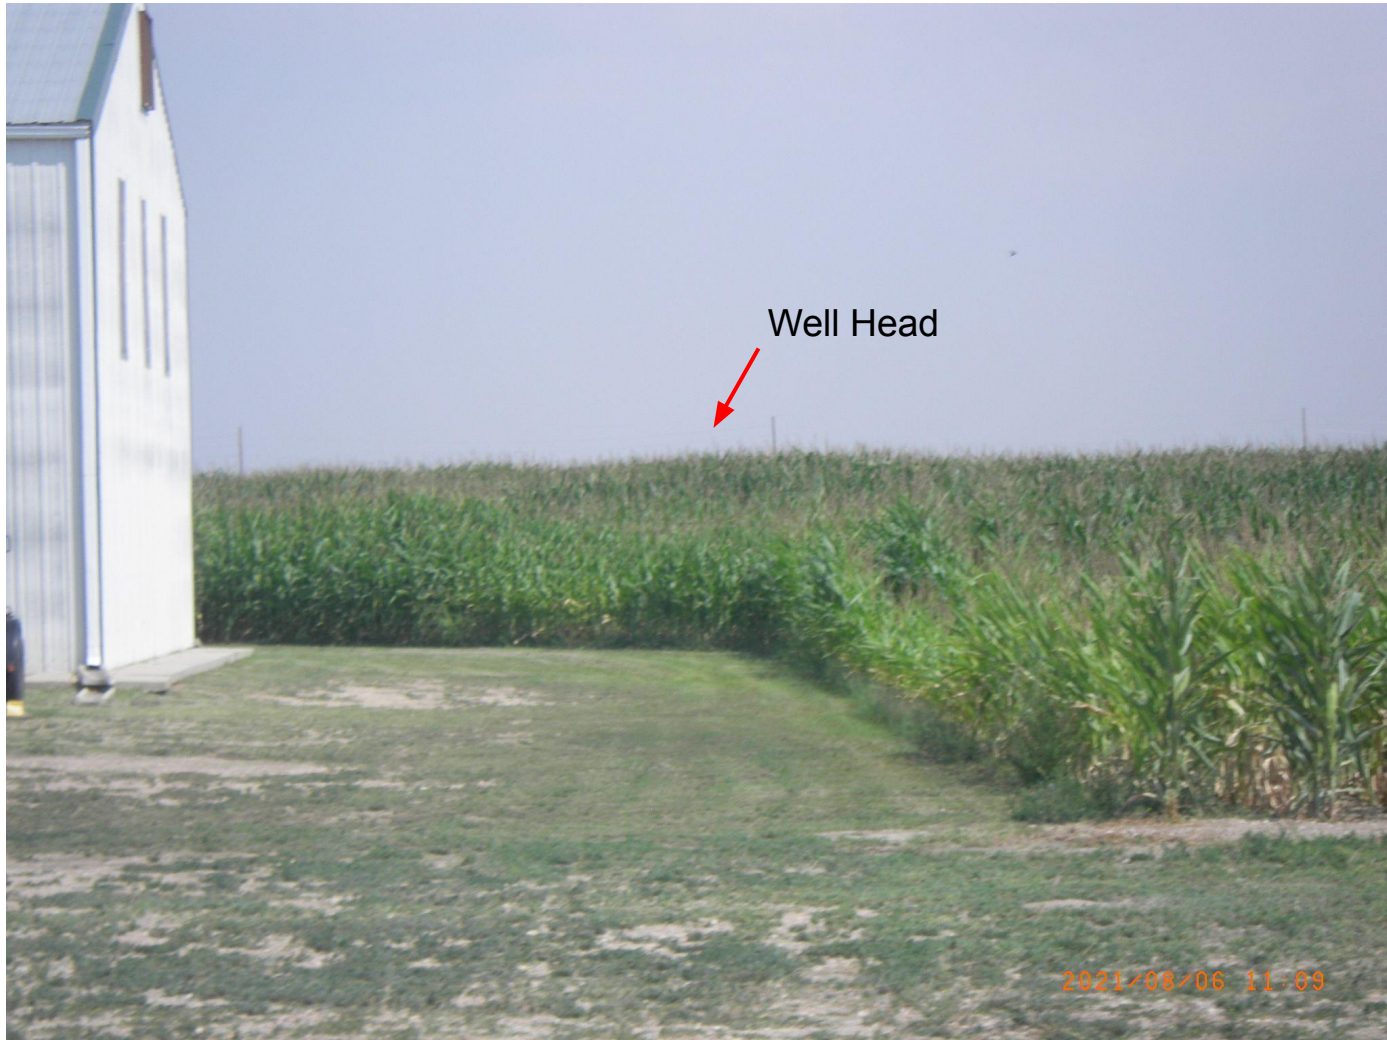
Photo 3. Photo taken at ground level from south side of well head looking north down the access road.

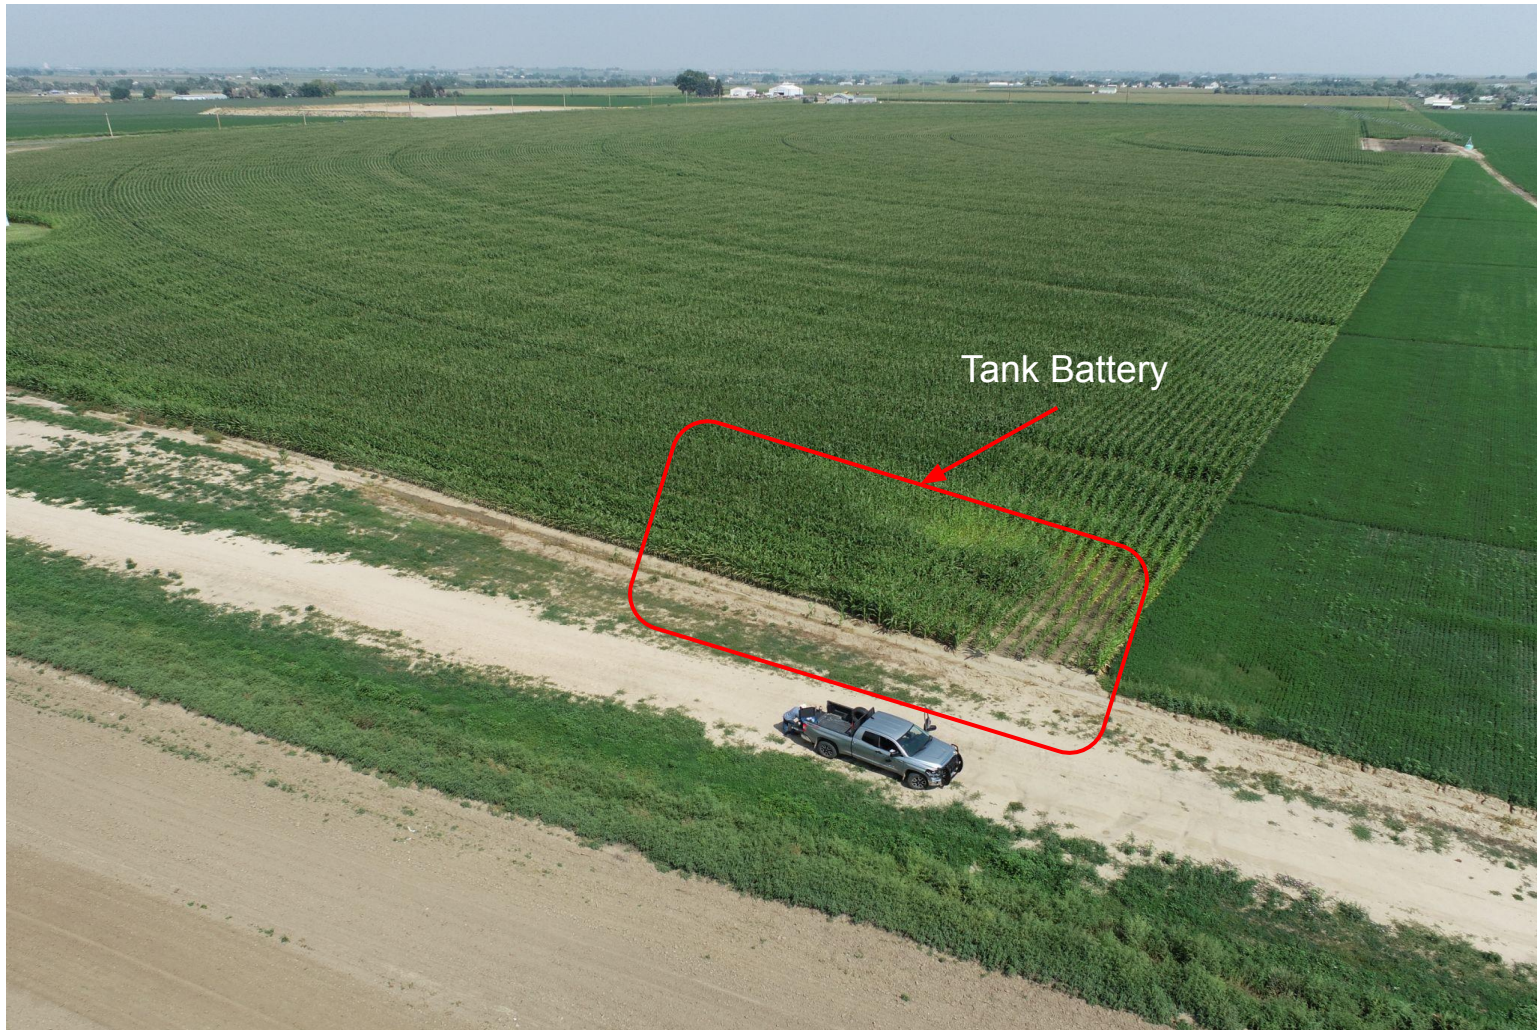
Photo 4. Photo taken from south east end of tank battery looking norwest using a drone.

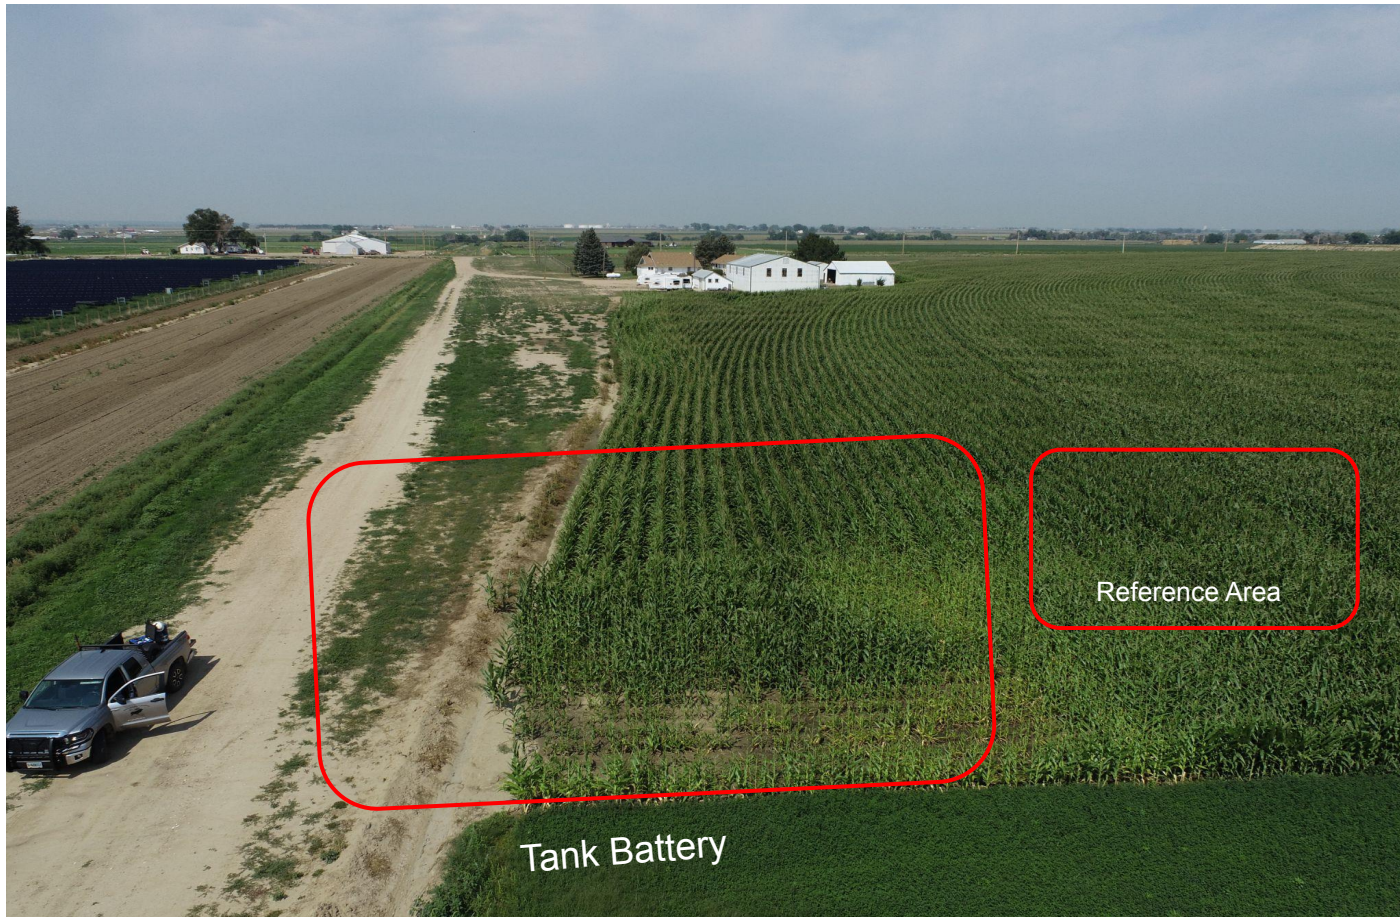
Photo 5. Photo of tank battery and reference area taken from eastern edge of tank battery looking west (using a drone). Photo shows stunted crop growth on eastern edge of tank battery compared to adjacent reference area. Note: A portion of the tank battery footprint (south) appears to be utilized for agricultural growing purposes while the other portion is part of the agricultural access road which has been properly compacted and stabilized. See photo 6 for plant elevation model.

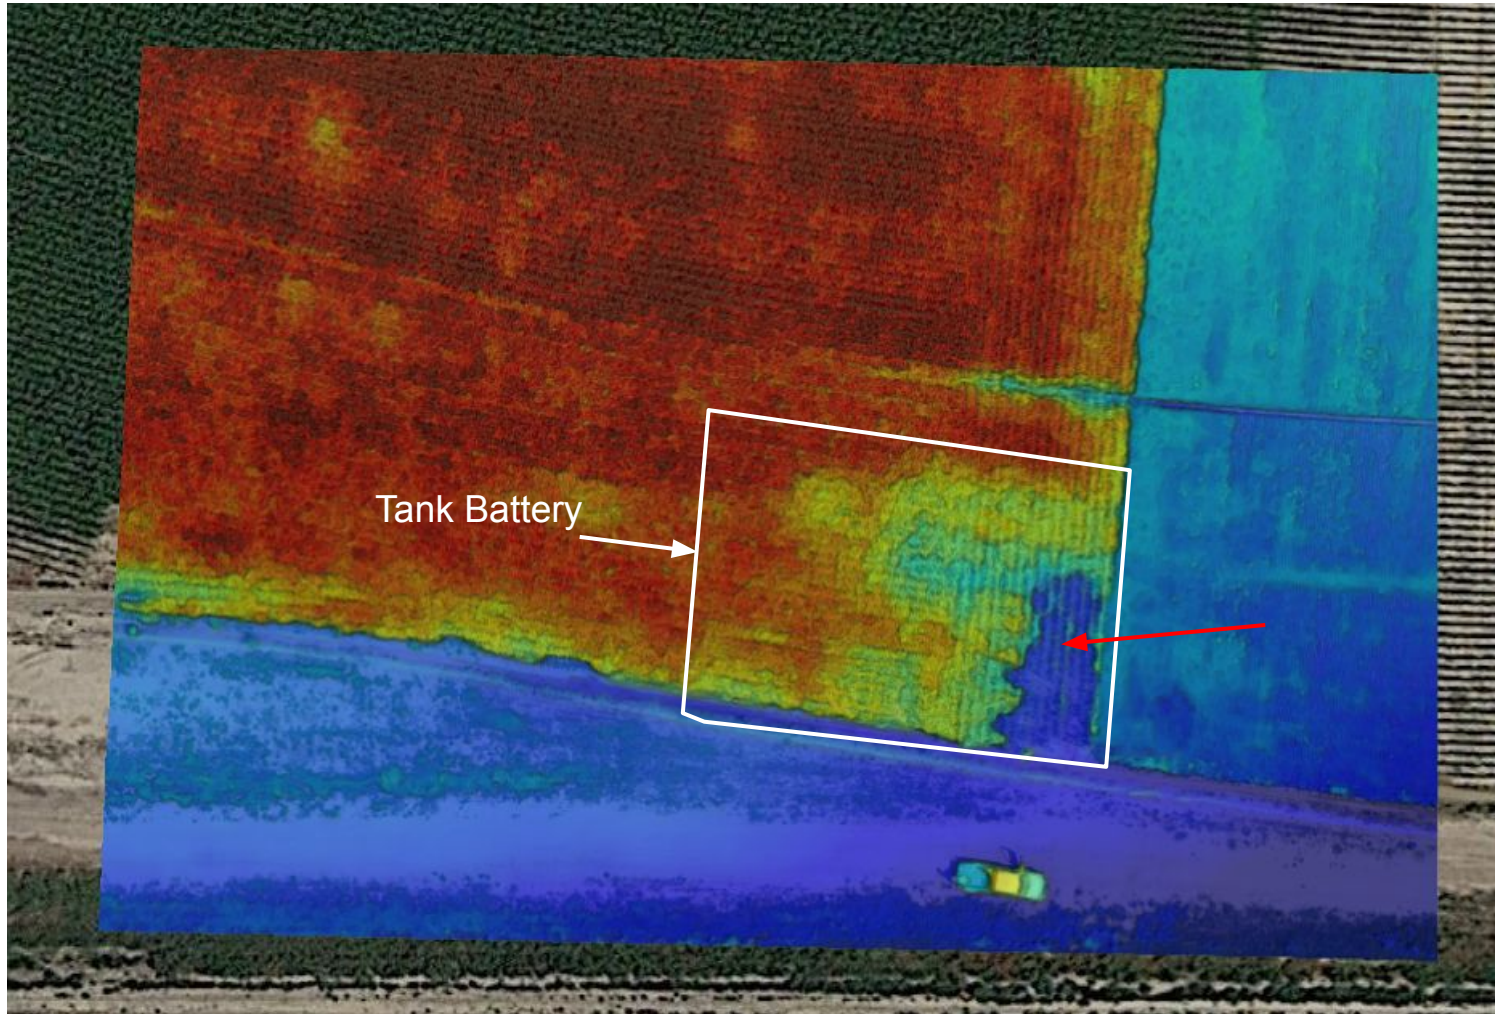
Photo 6. Overview plant elevation photo taken using a drone. Photo shows stunted growth in eastern portion of tank battery (indicated by red arrow).

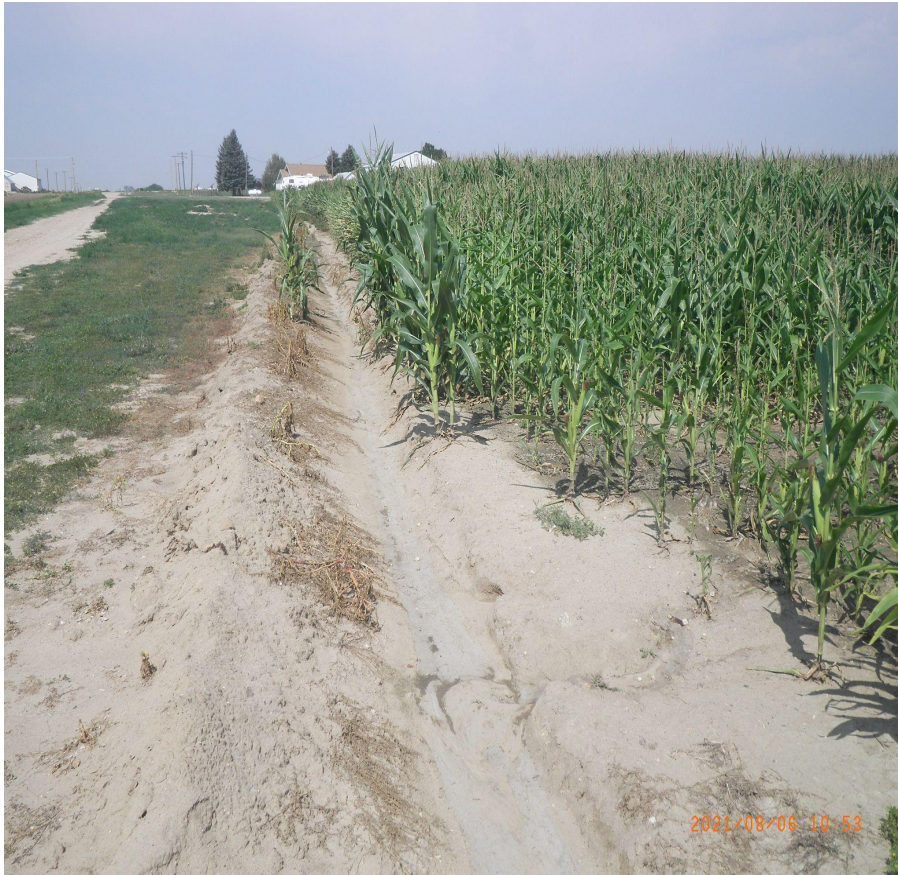
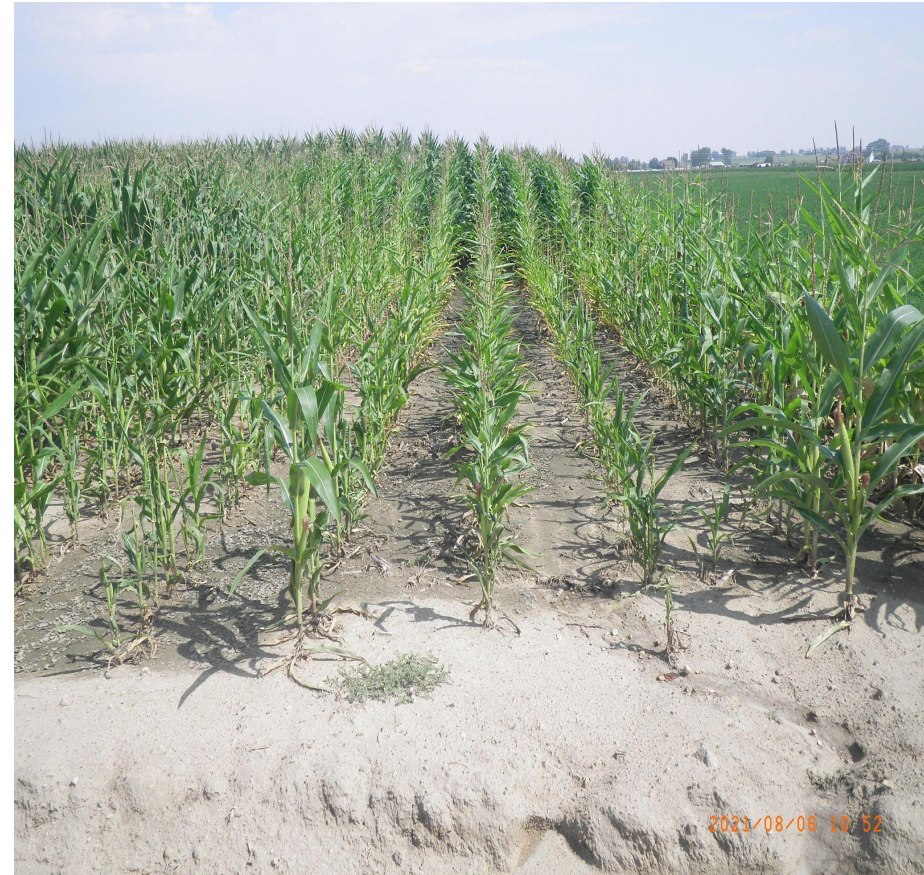
Photo 7. Left photo taken at ground level from eastern edge of tank battery facing west. Right photo taken at ground level from southeast corner of tank battery facing north. Photos show stunted growth in eastern portion of tank battery.
