Inspection Photos
Operator: Hilcorp Energy
API: 067-08159
Date: 8/10/2021

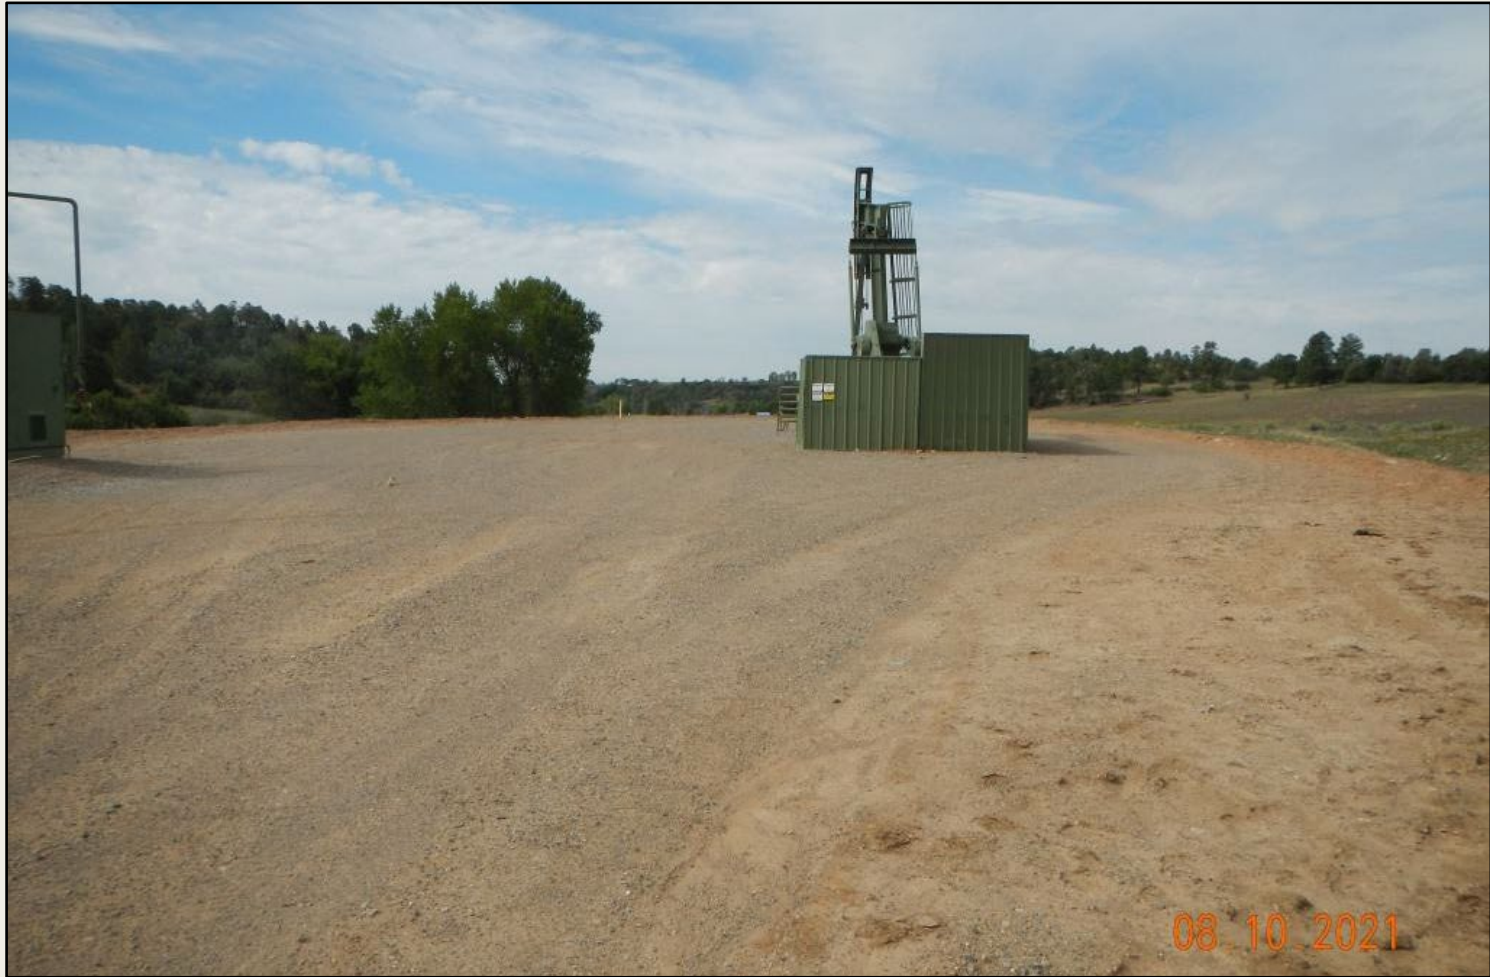
Photo 1. View of the project area from the well pad entrance facing center.

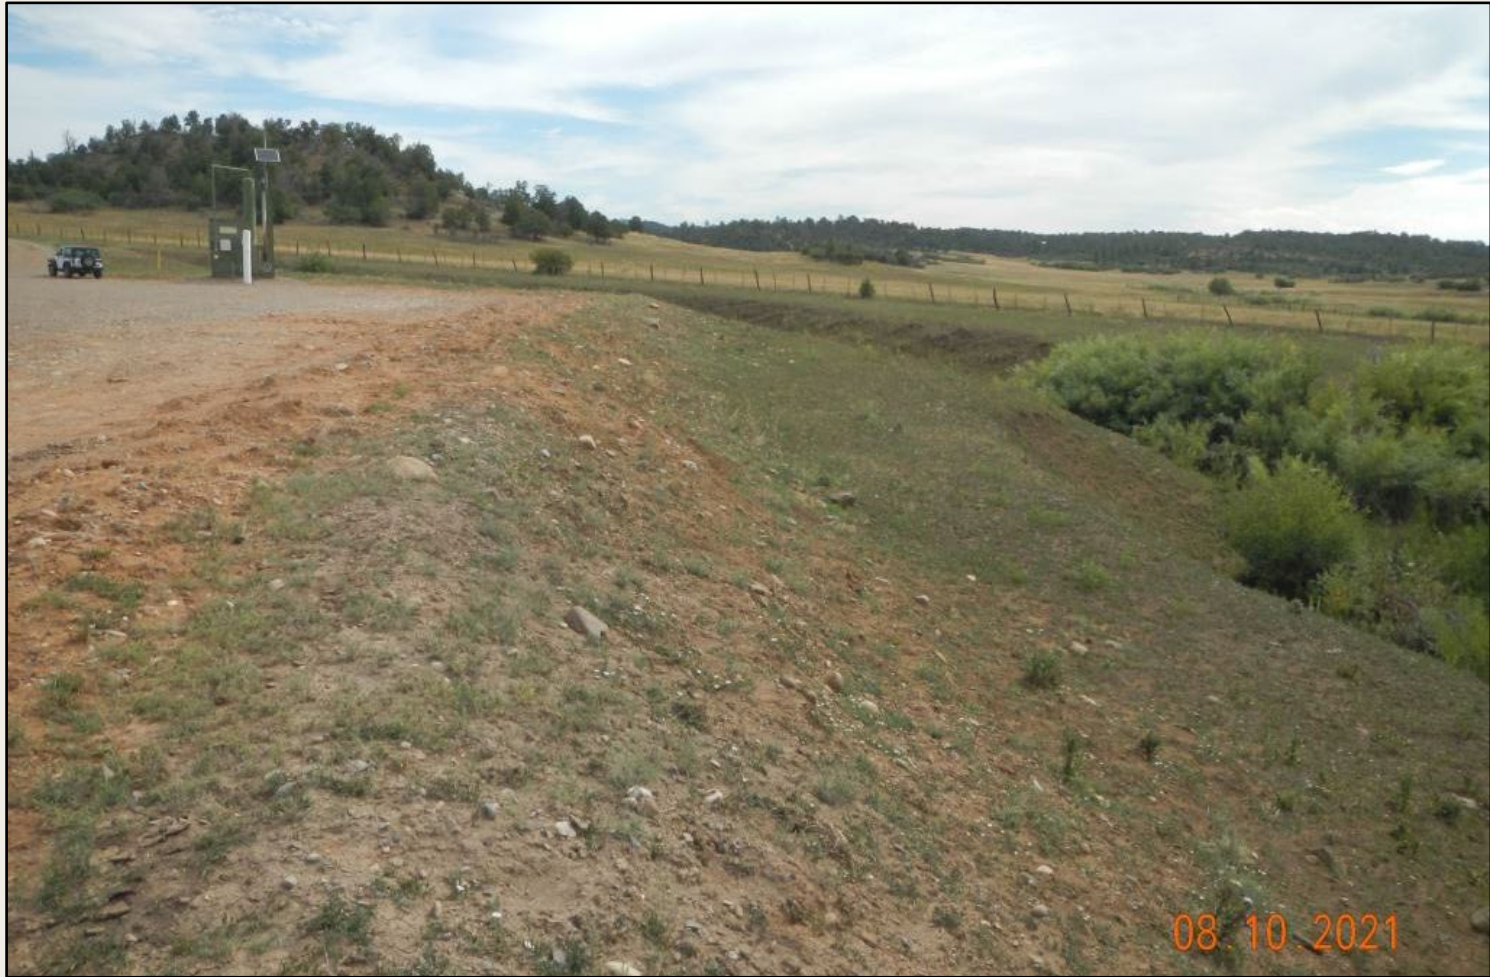
Photo 2. View of the eastern cut-slope from the southeastern corner facing northward. Revegetation is progressing similar to the reference area with smooth brome and western wheatgrass, as well as perennial weeds such as bindweed, largely in a grazed condition.

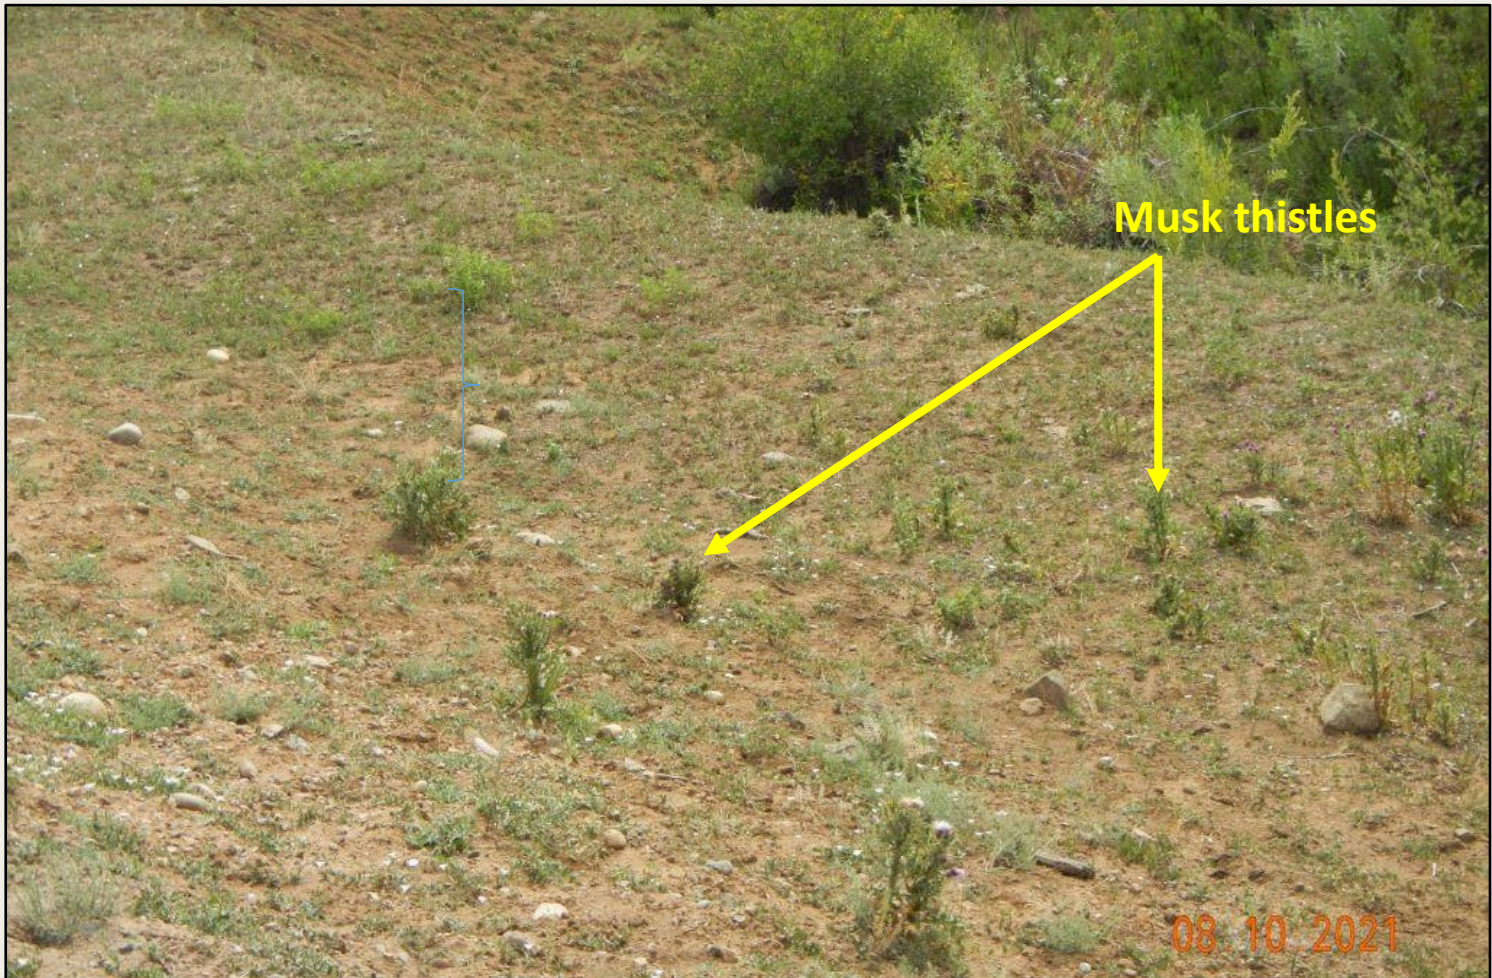
Photo 3. View of musk thistles within the project area. Approx. 25 individuals observed.

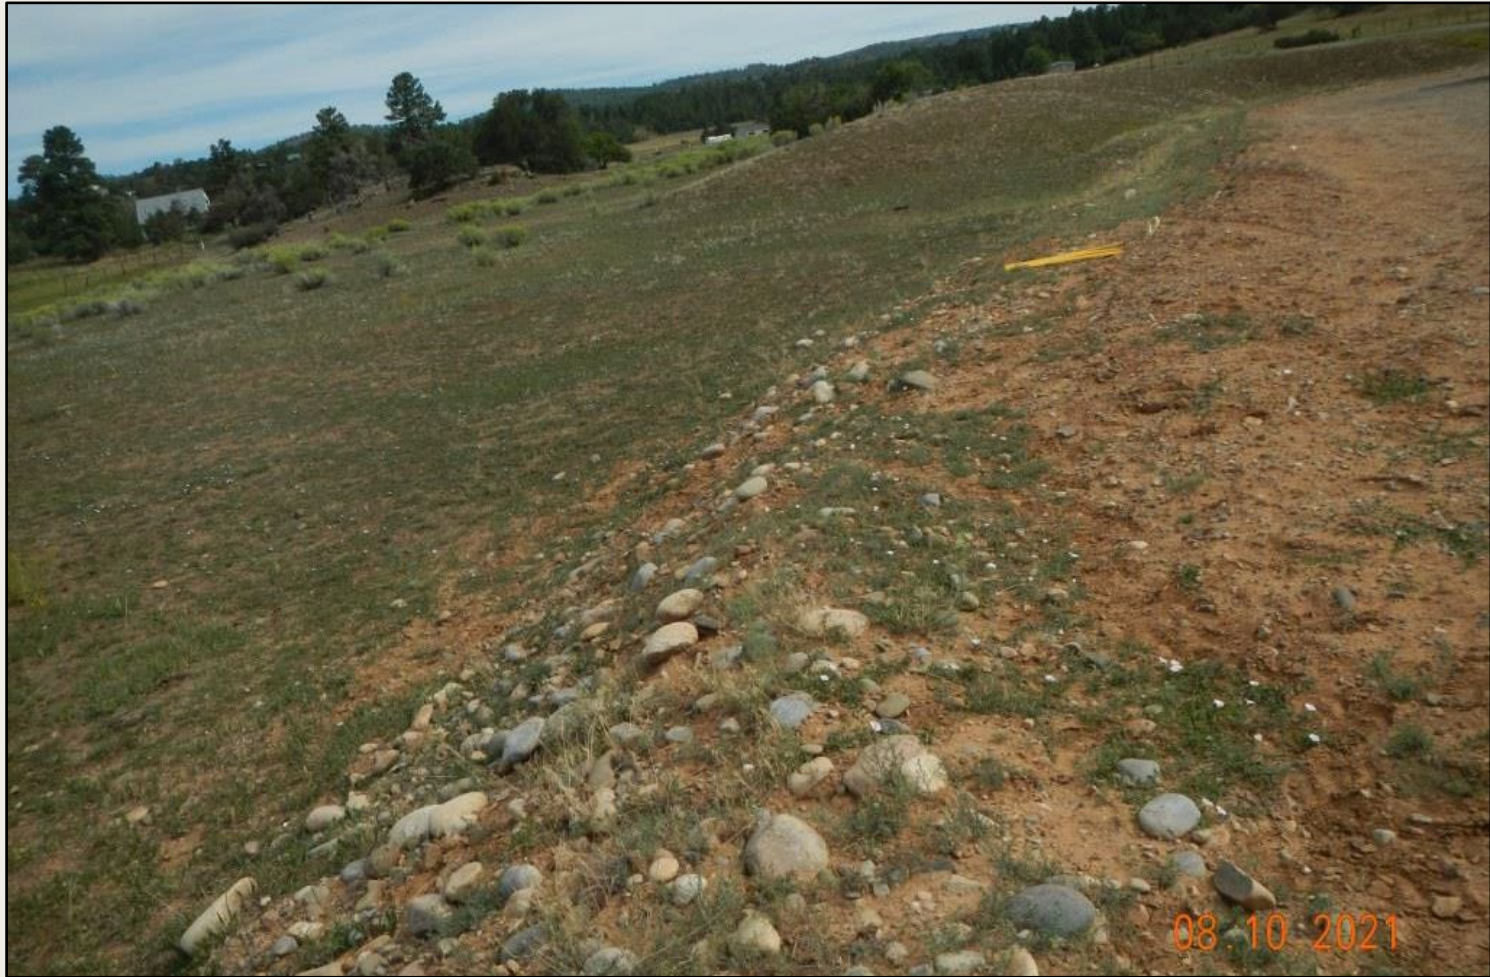
Photo 4. View of the western project area from the southwestern corner facing northward.

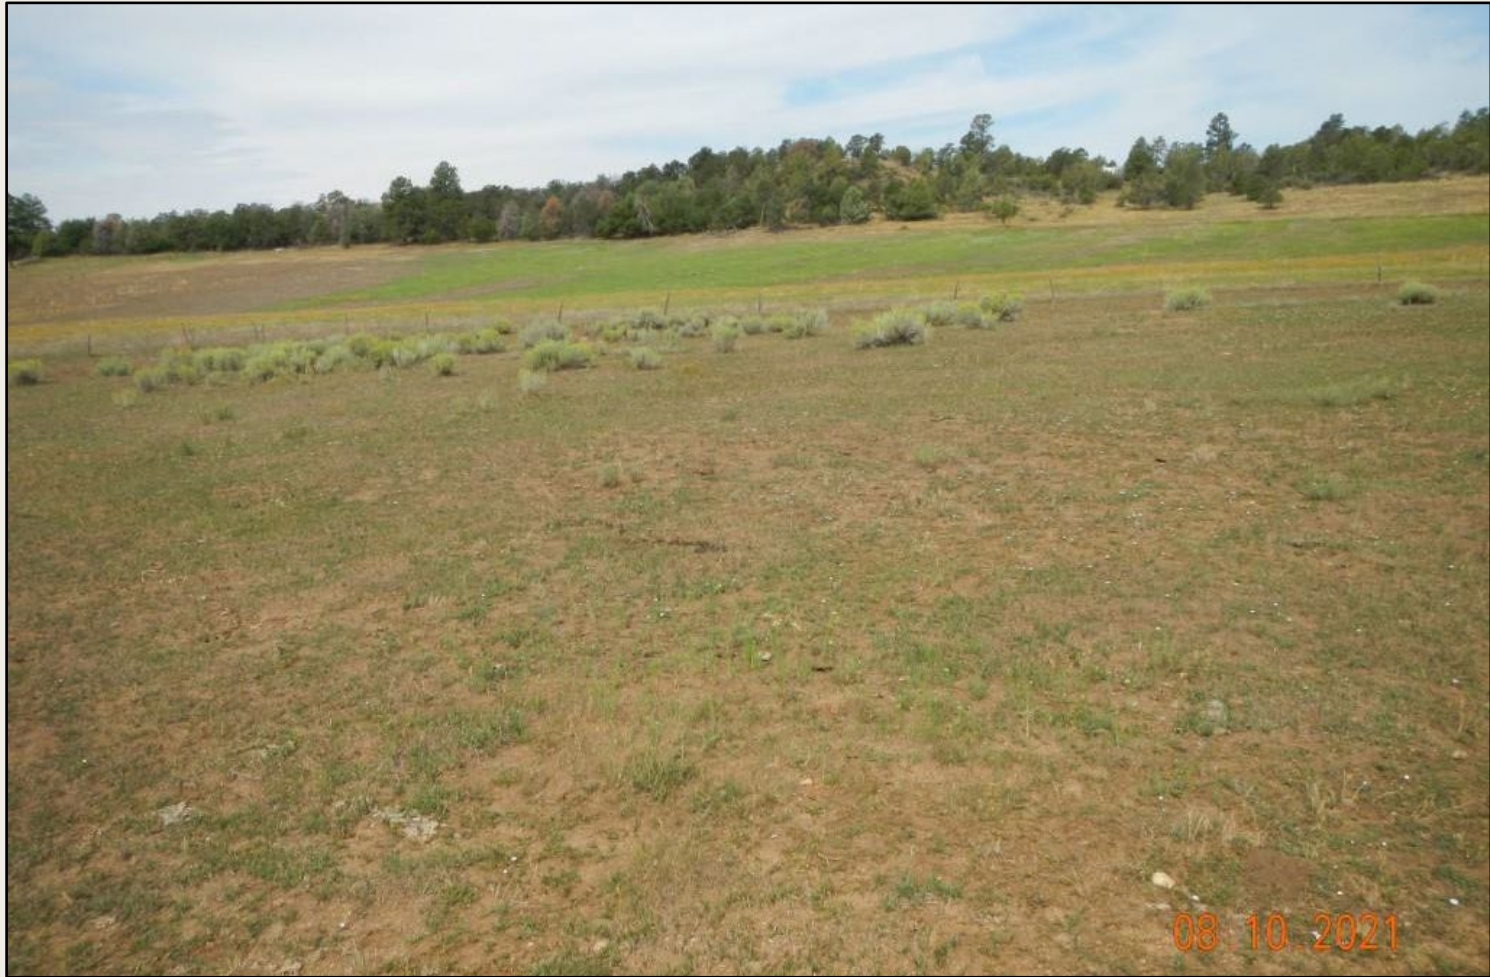
Photo 5. View of the reference area comprised of open grass field with smooth brome, western wheatgrass, and rubber rabbitbrush.
