Inspection Photos
Operator: Hilcorp Energy
API: 067-08247
Date: 8/10/2021

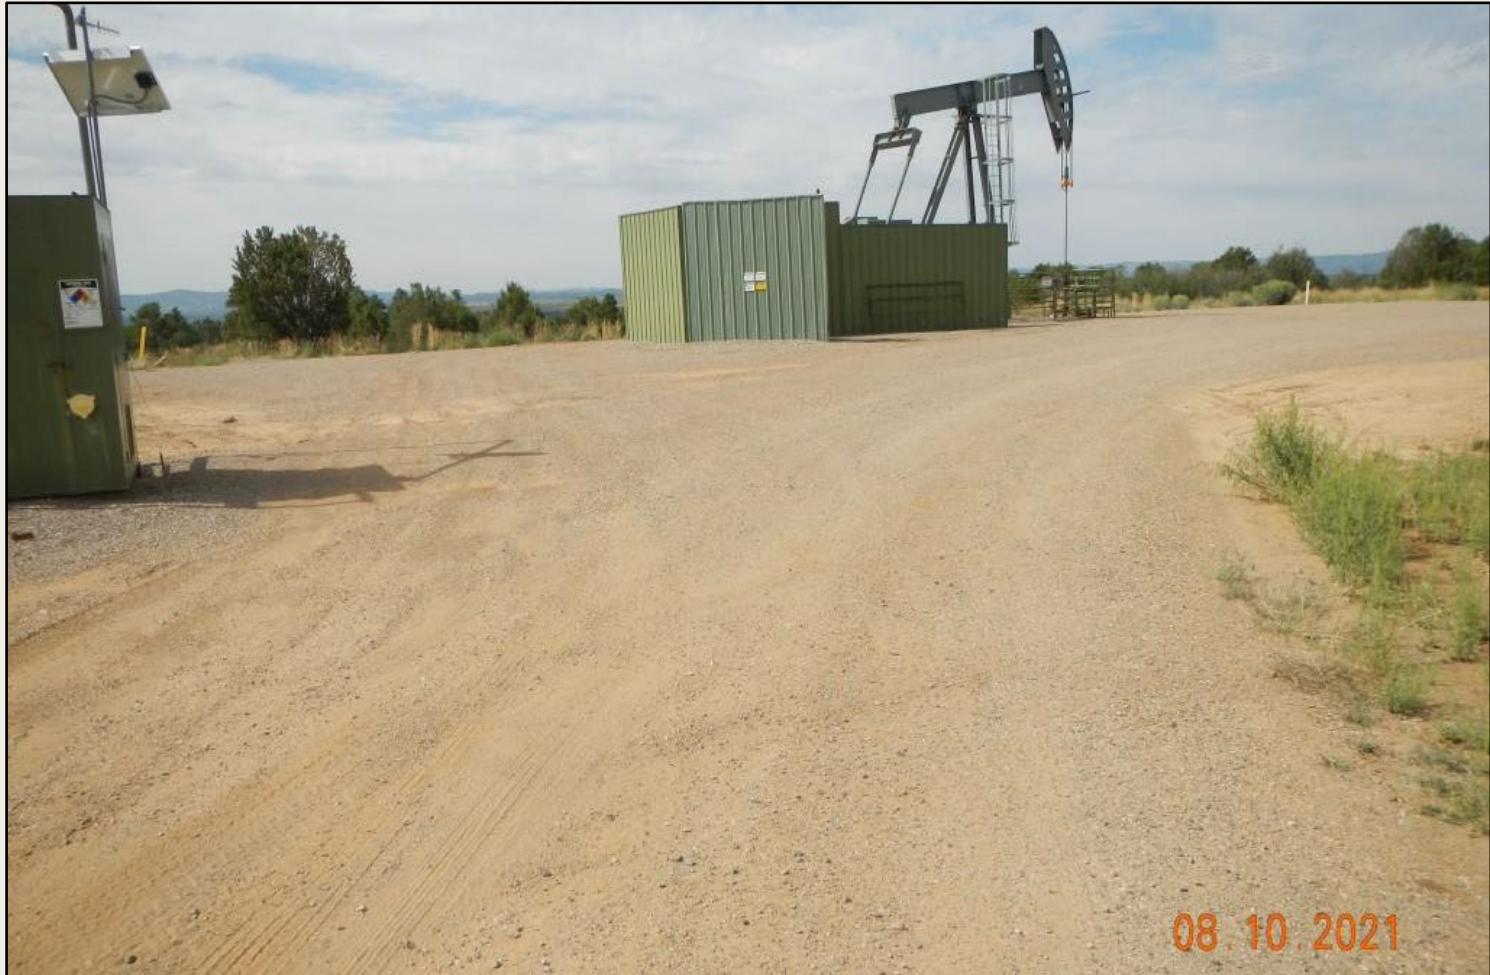
Photo 1. View of the project area from the well pad entrance facing center.

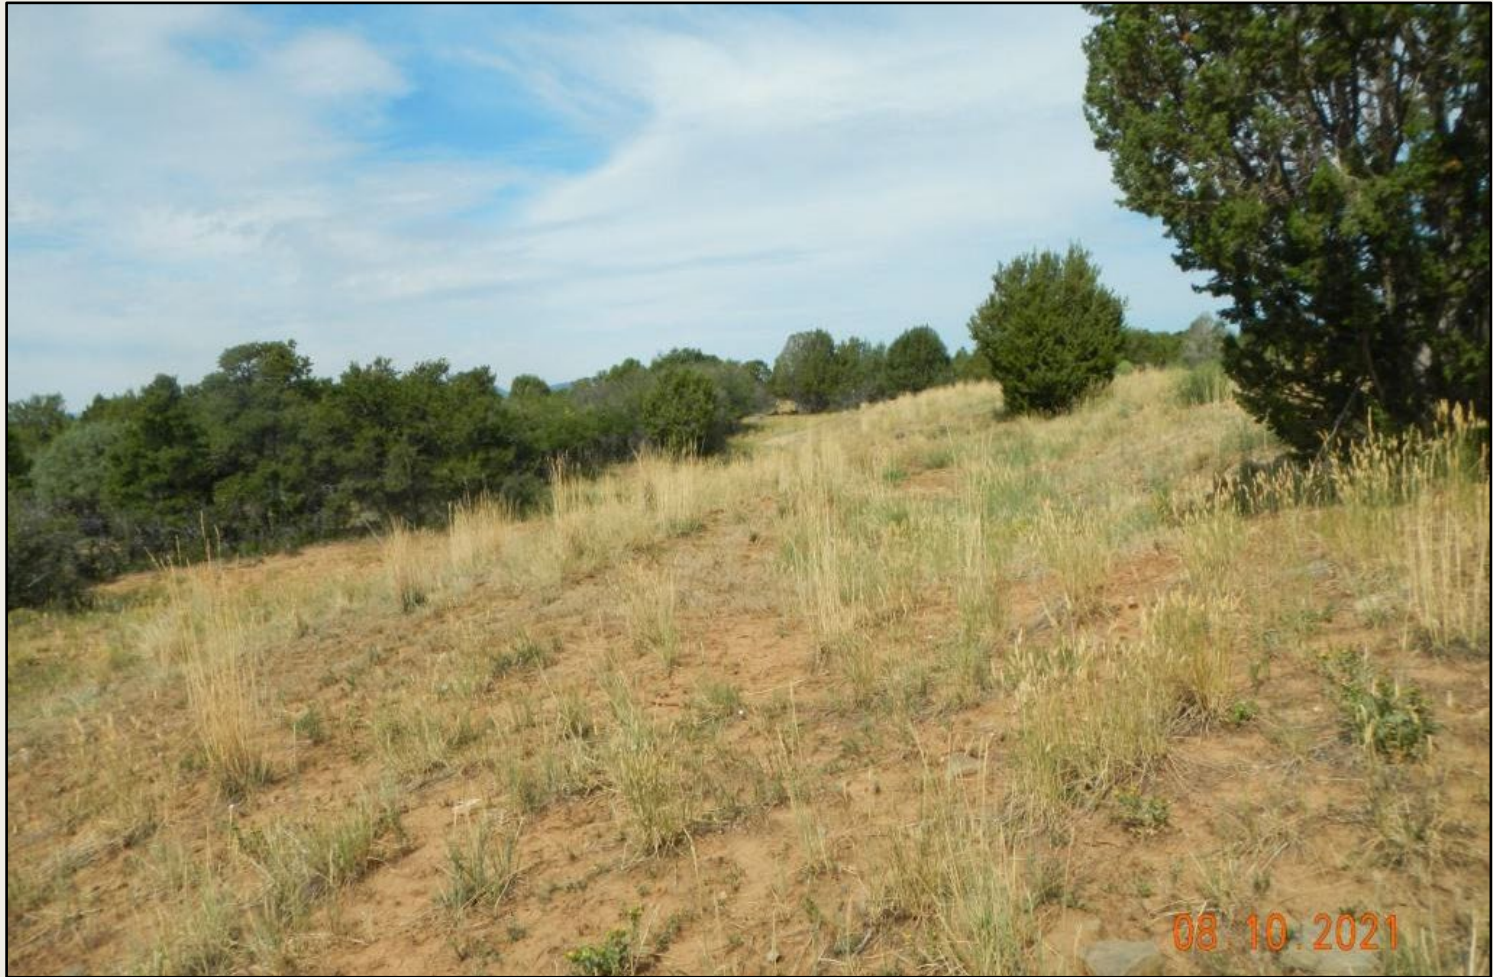
Photo 2. View of the southern fill slope from the southeastern corner facing westward. Revegetation is progressing with western wheatgrass, crested wheatgrass, and smooth brome.

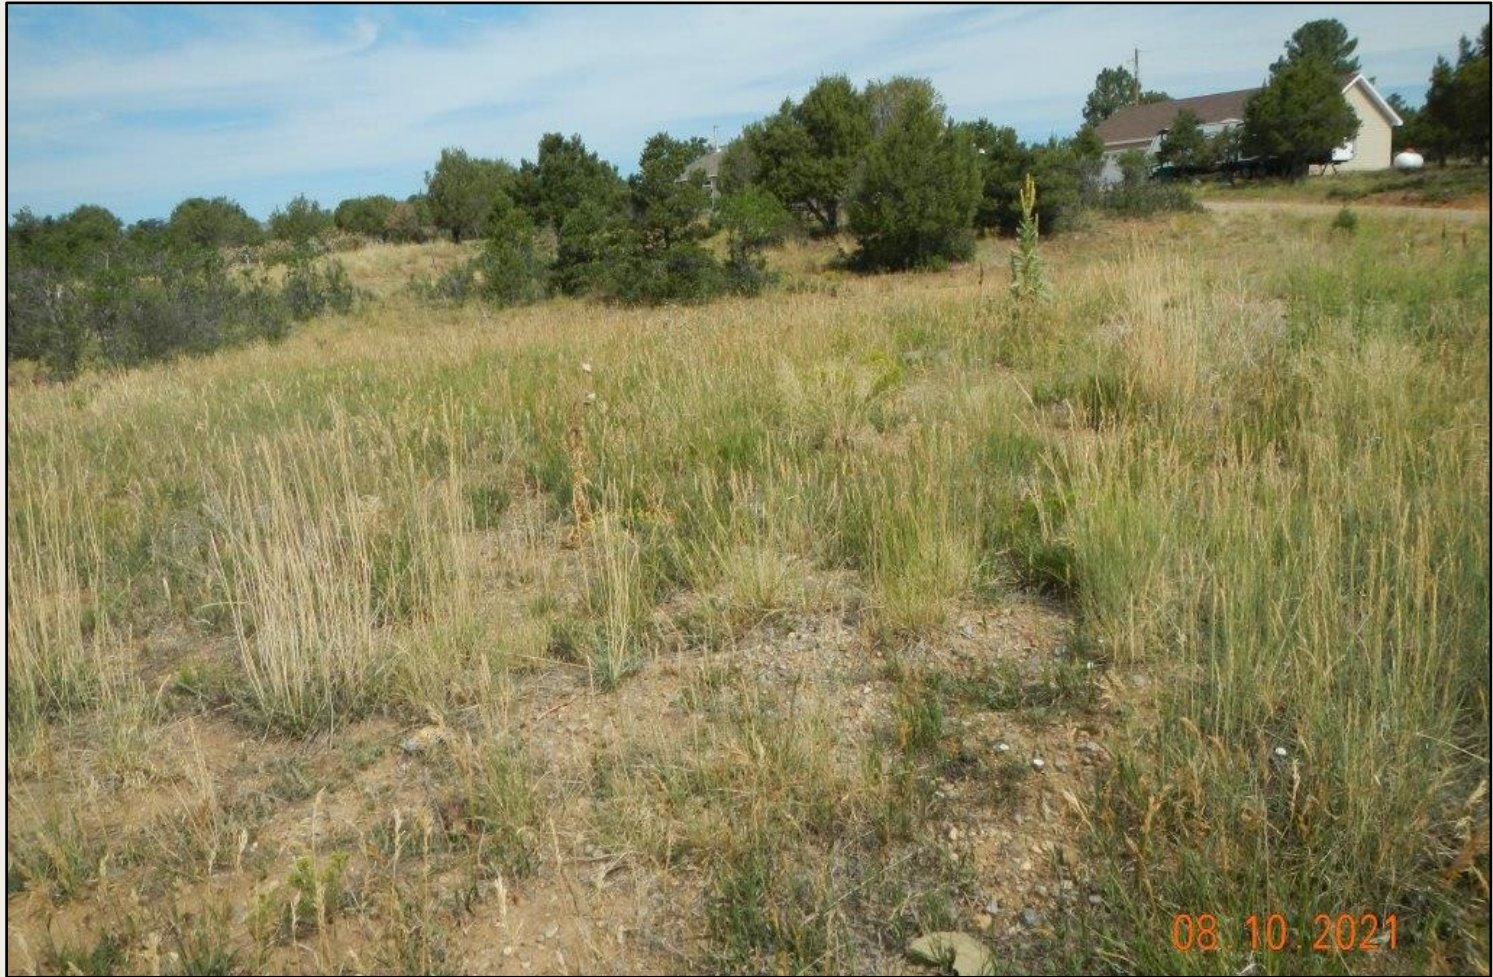
Photo 3. View of the western project area from the southwestern corner facing northward.

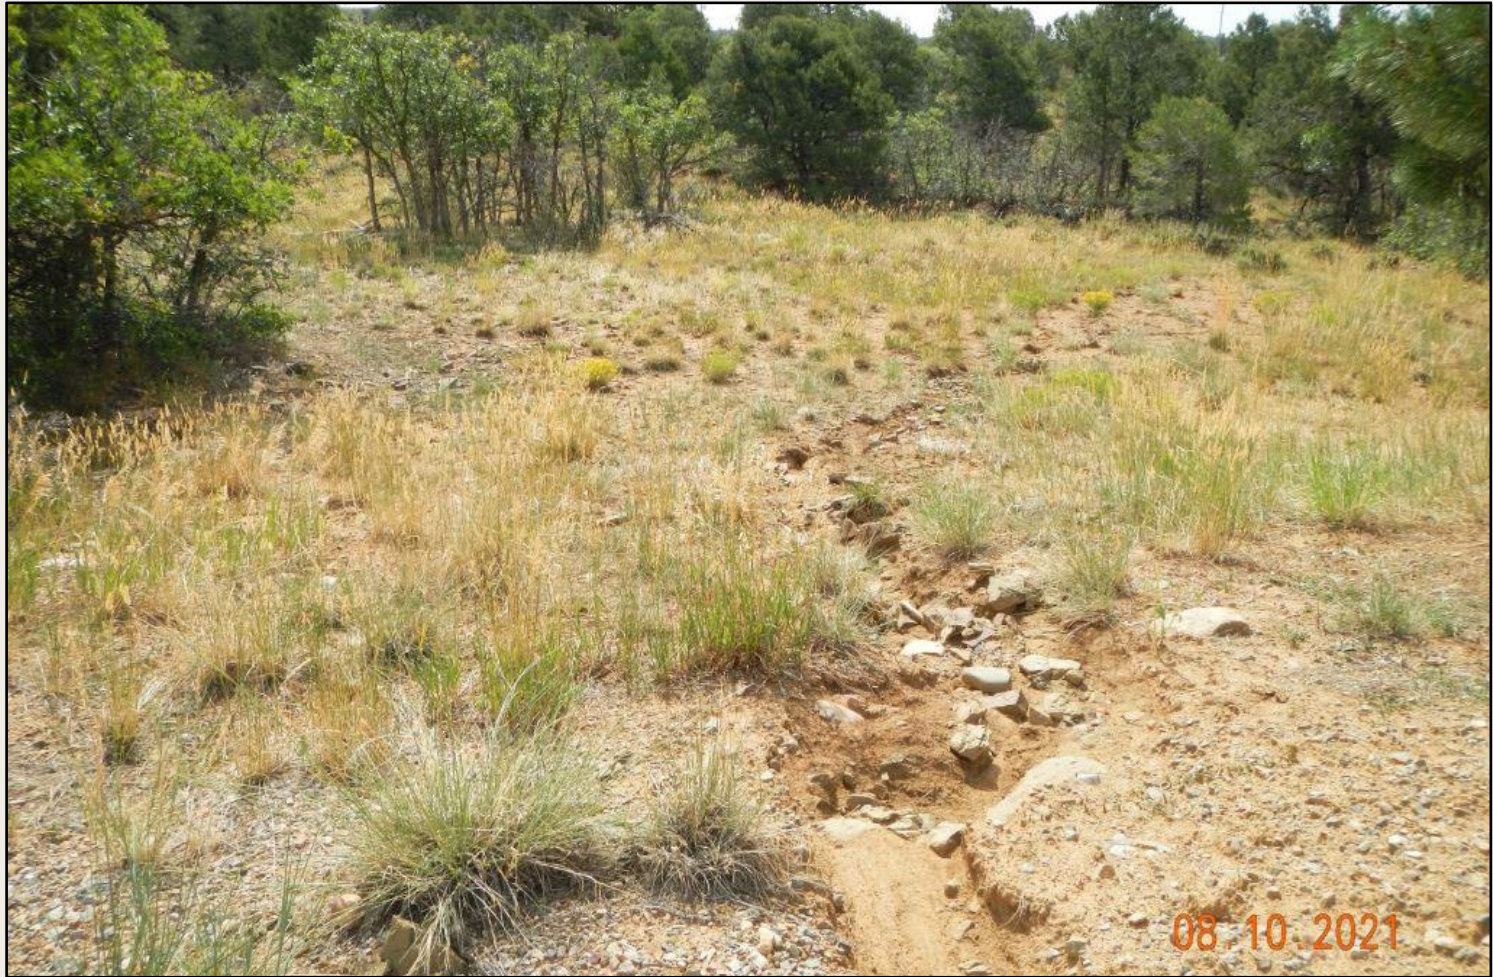
Photo 1. View of erosional down-cutting and scouring (approx 2ft wide and 1ft deep) within the southern project area.

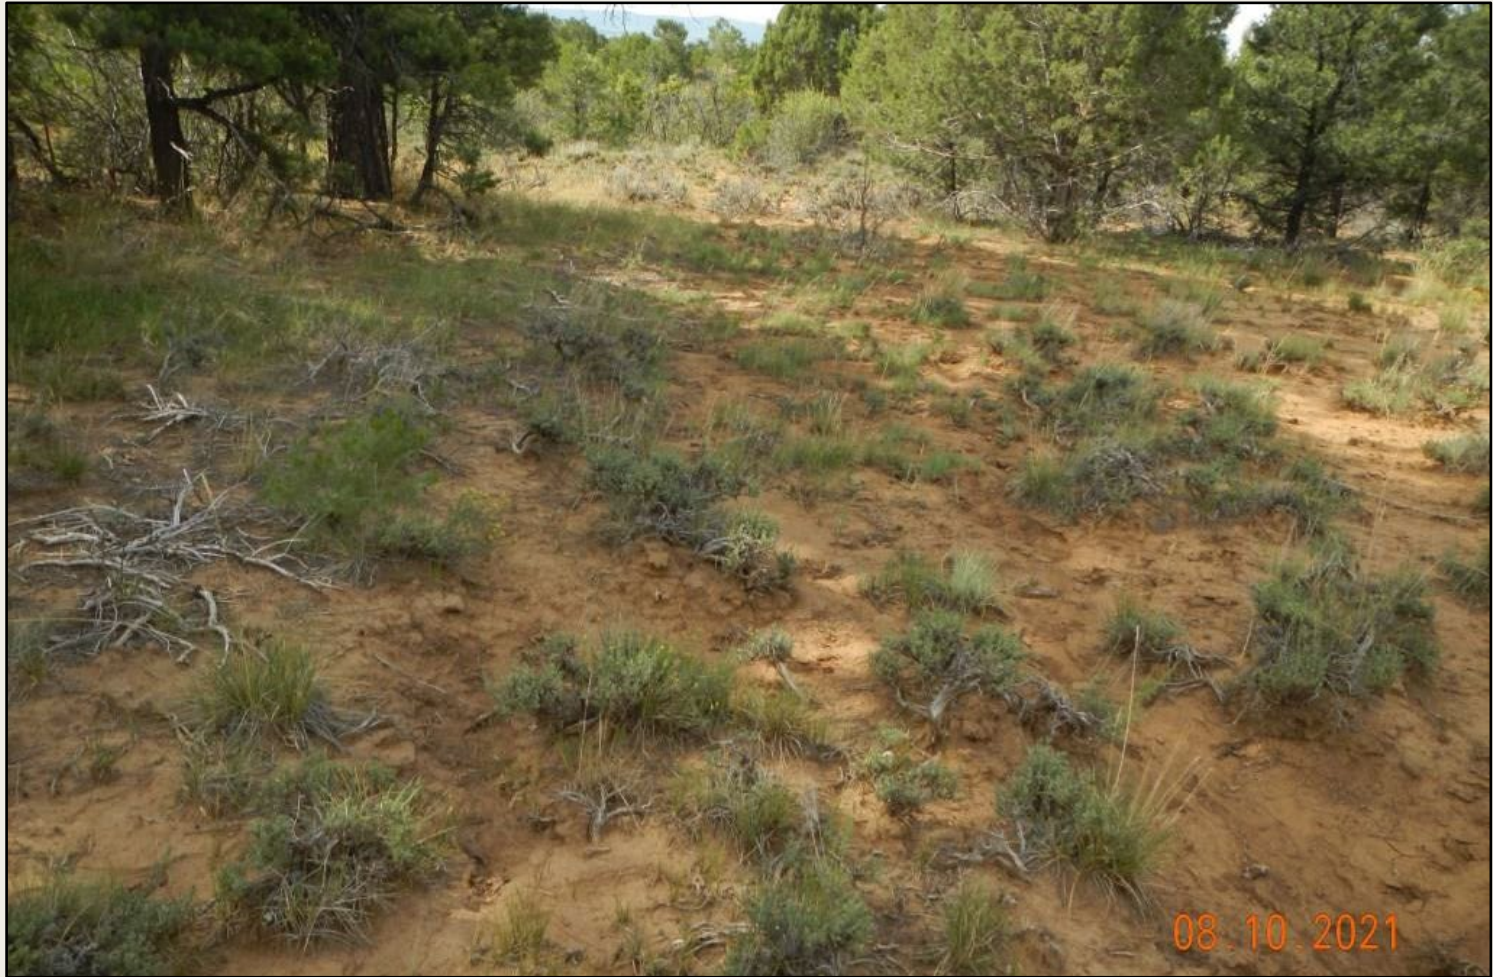
Photo 4. View of the reference area comprised of pinyon and juniper woodland with understory of black sage, James galleta, and green rabbitbrush.
