**Inspection Photos**  
**Operator: Hilcorp Energy**  
**API: 067-08747**  
**Date: 8/10/2021**

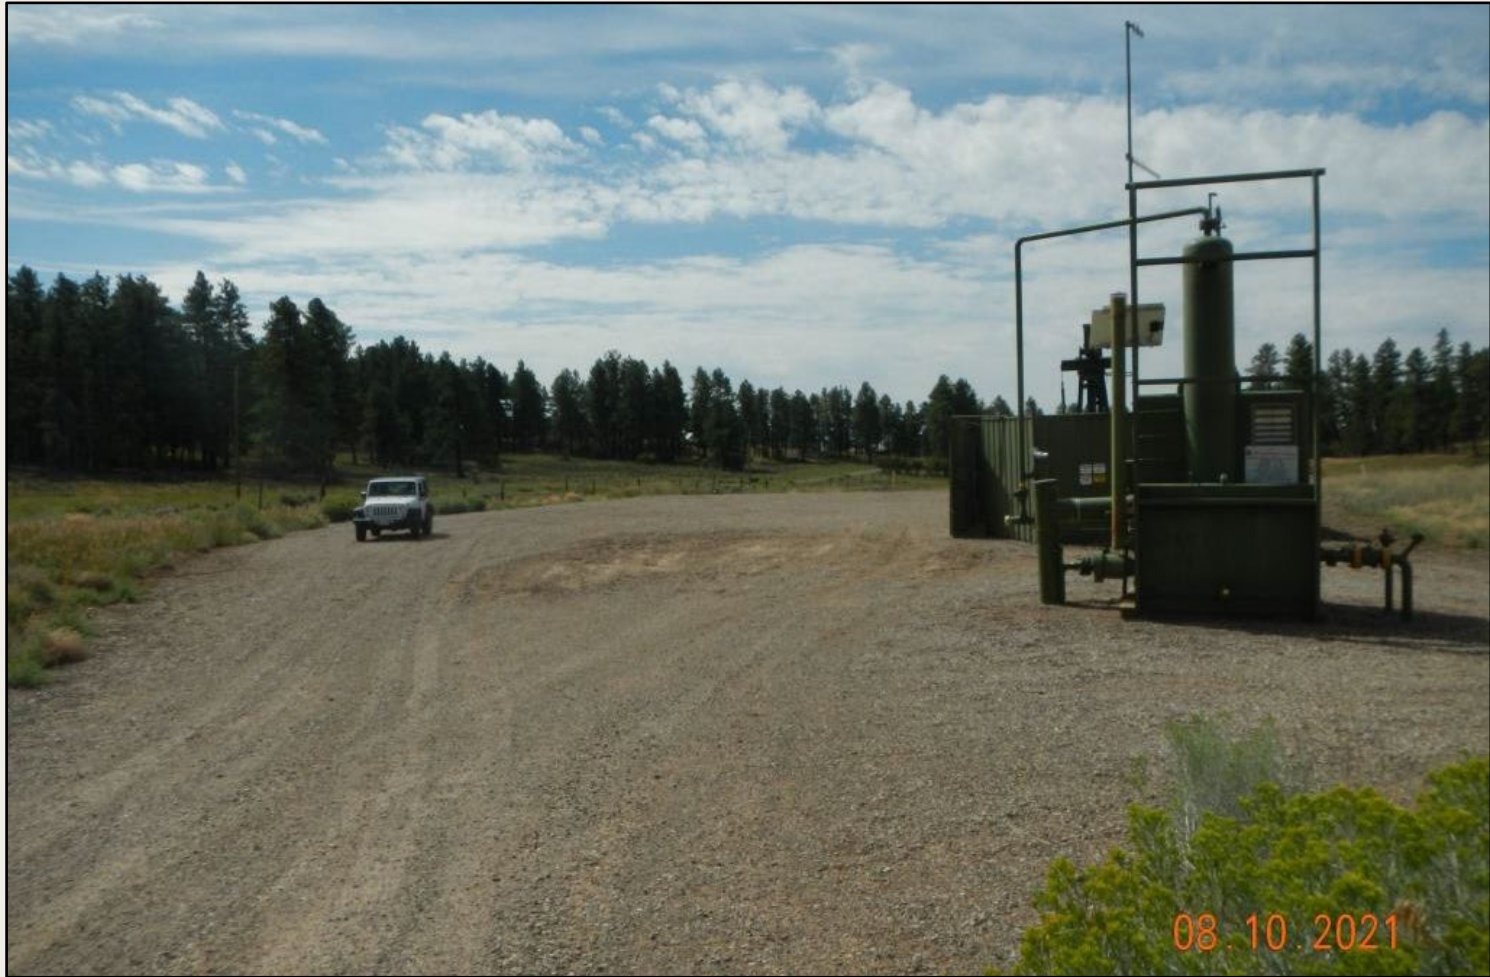
Photo 1. View of the project area from the well pad entrance facing center.

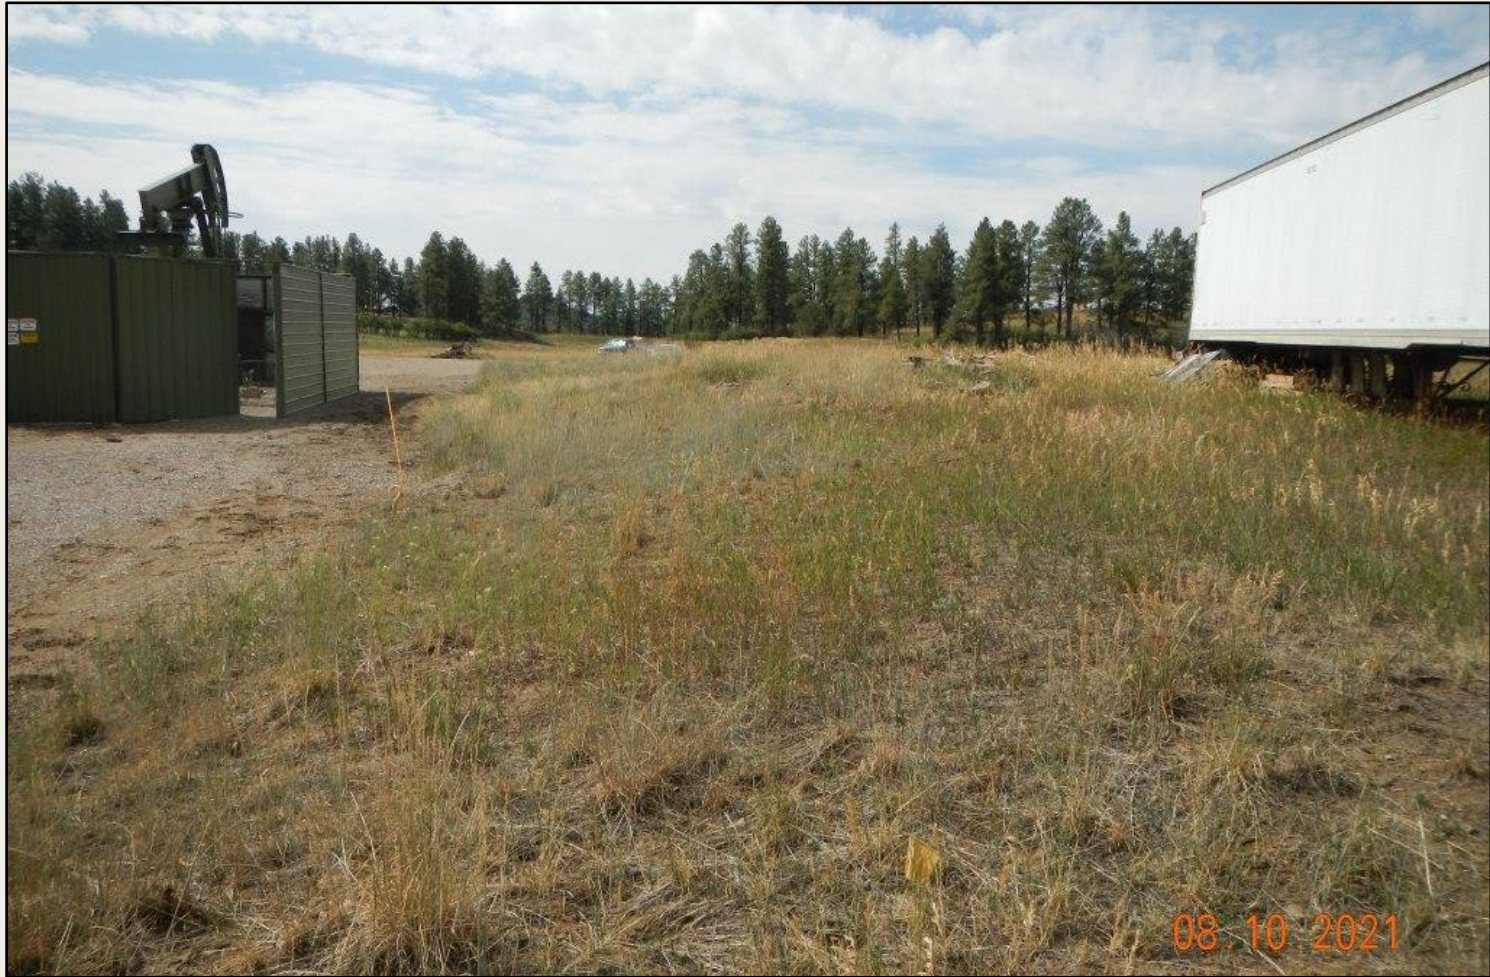
Photo 2. View of the western project area from the northwestern corner facing southward. Revegetation is progressing with western wheatgrass, crested wheatgrass, and smooth brome.

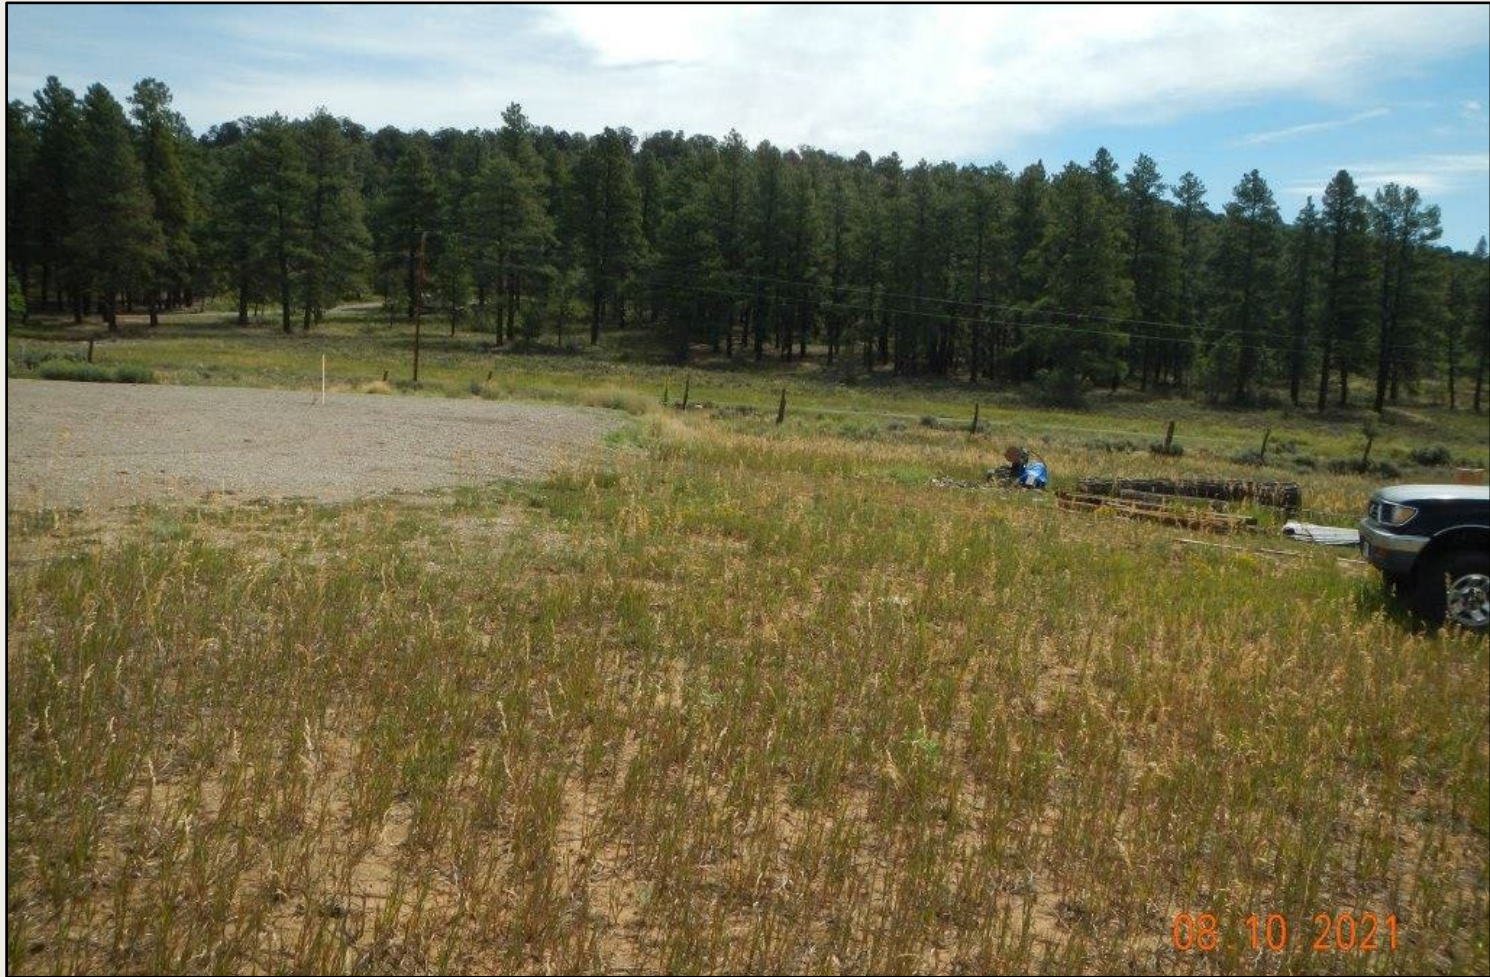
Photo 3. View of the southern project area from the southwestern corner facing eastward.

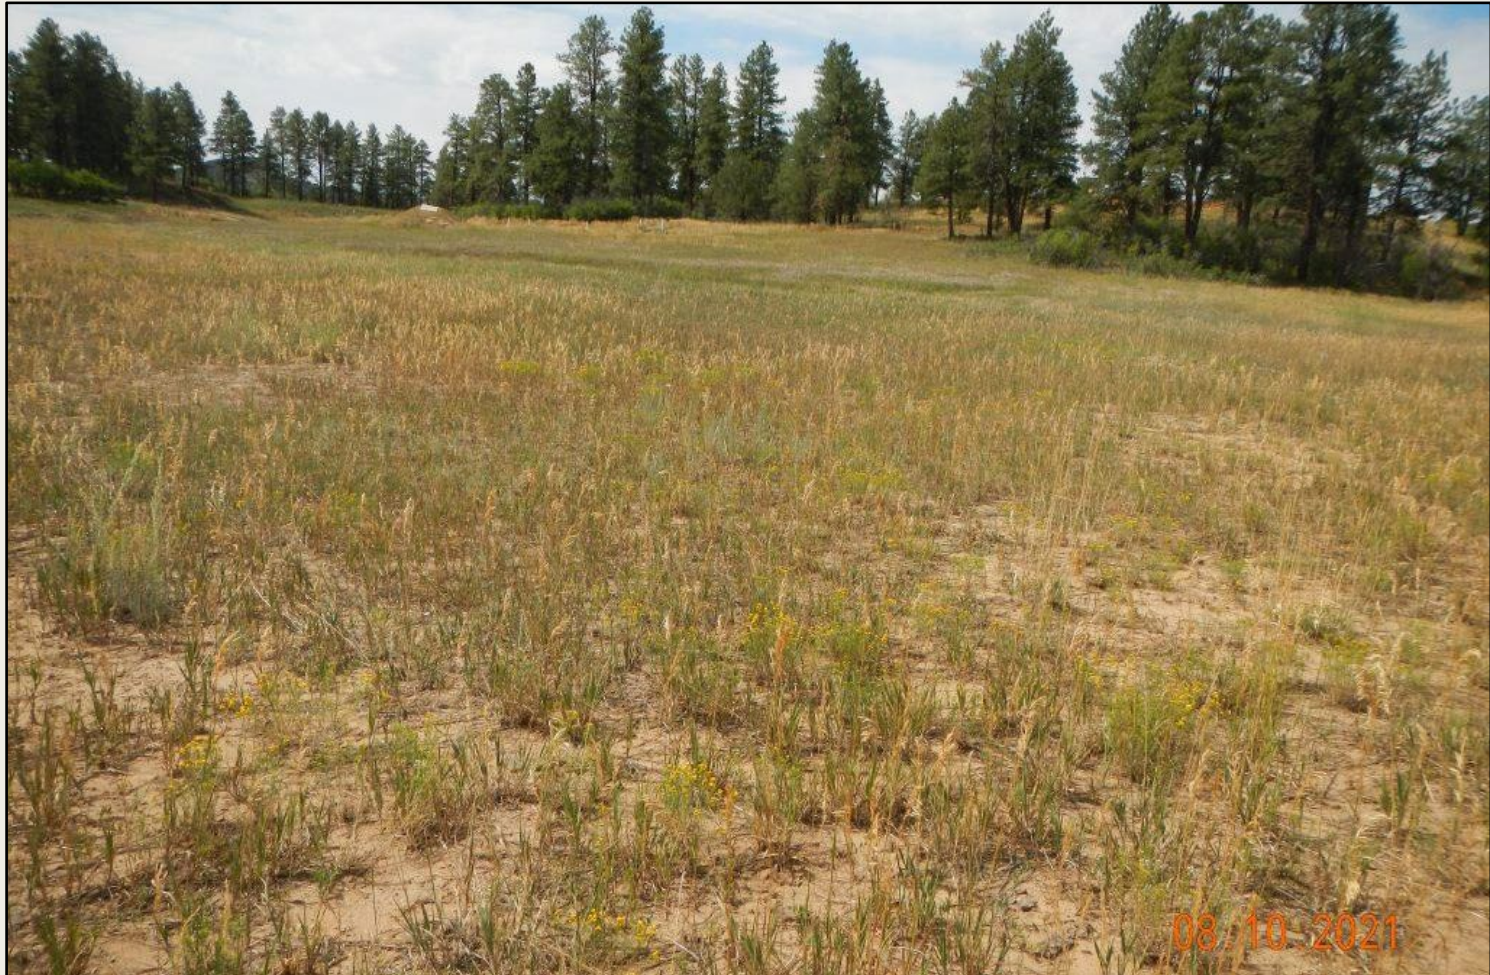
Photo 4. View of the reference area comprised of open grass field and ponderosa pine woodland mosaic with smooth brome gambel oak and yellow sweetclover.
