# Inspection Photos

Operator: Hilcorp Energy  
API: 067-07647  
Date: 8/10/2021

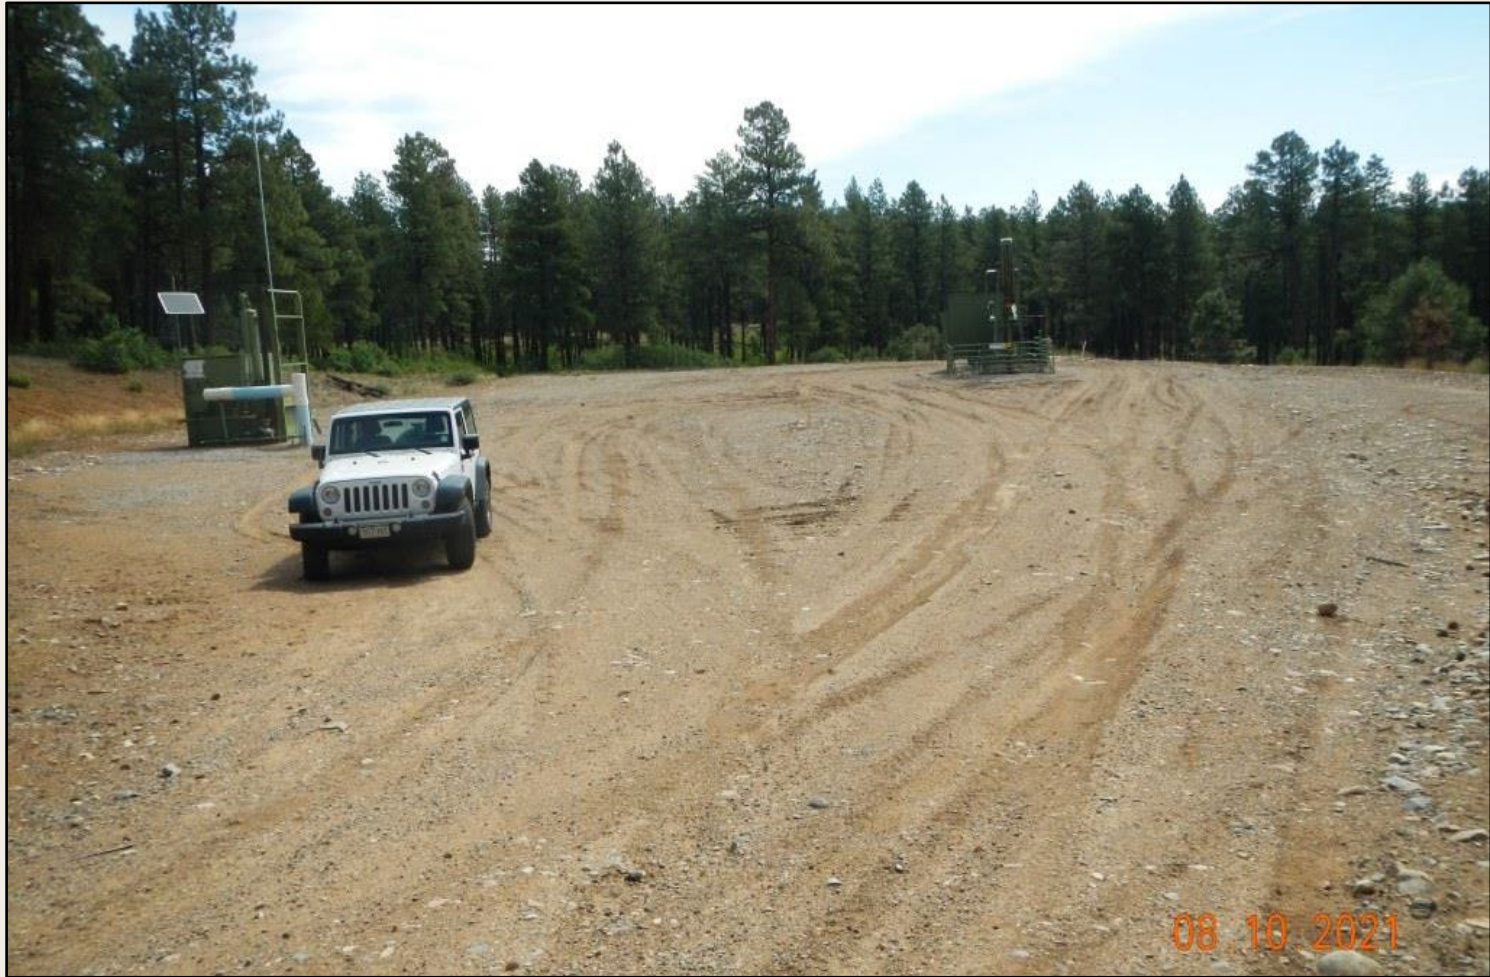
Photo 1. View of the project area from the well pad entrance facing center.

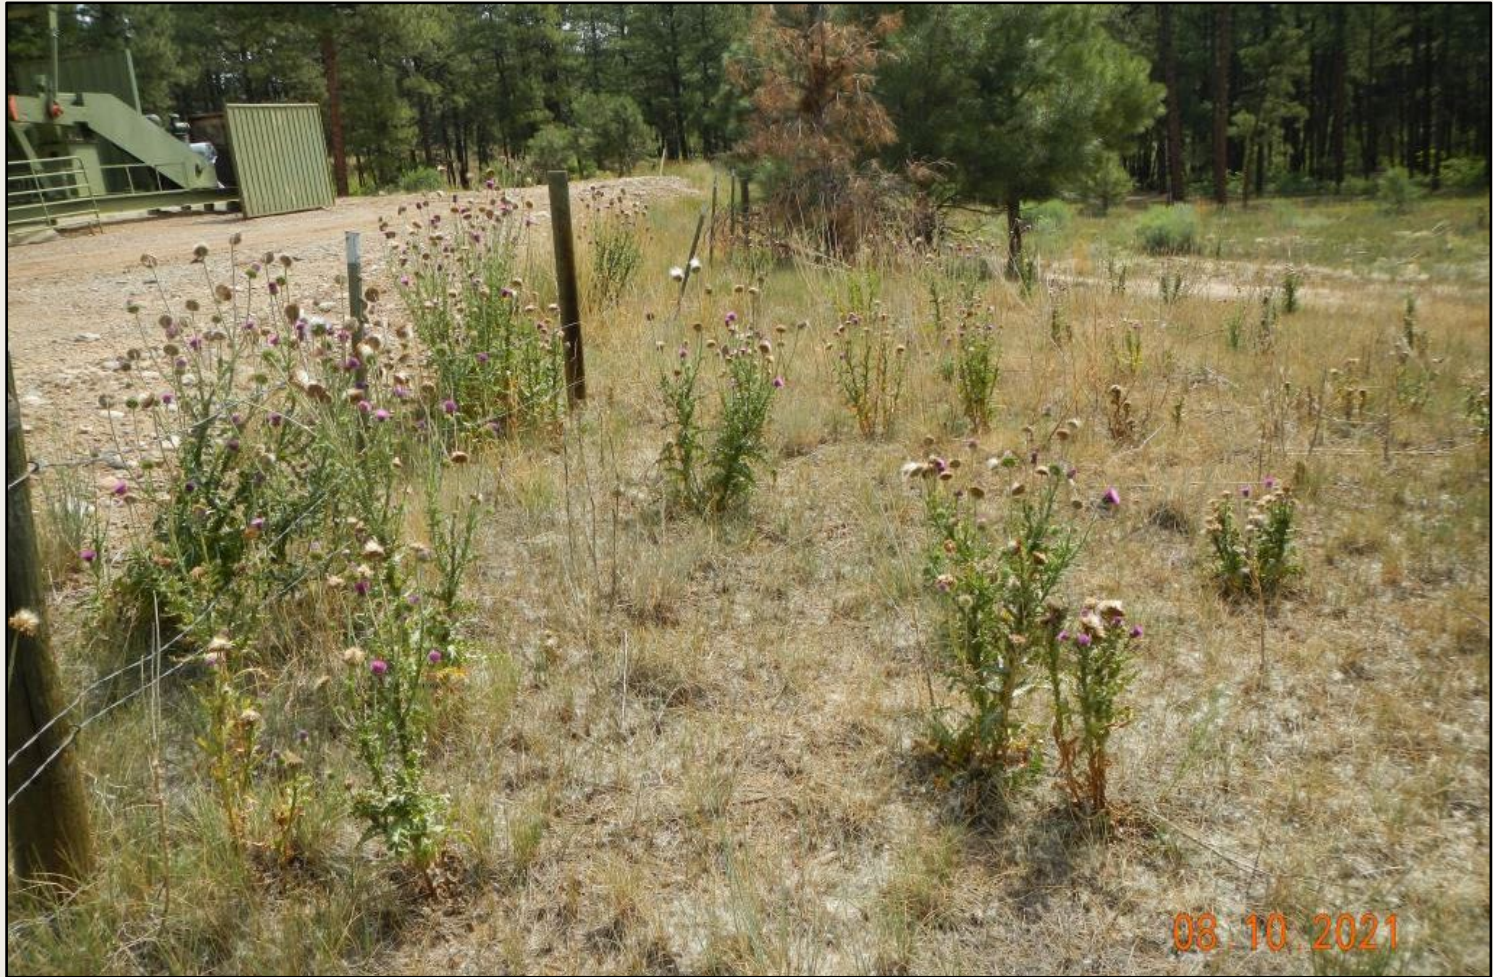
Photo 2. View of the southern project area from the southeastern corner of the working area facing westward. Interim reclamation area extends beyond working area fence and comprises open areas surrounding the well pad. Approximately 150 flowering musk thistles observed.

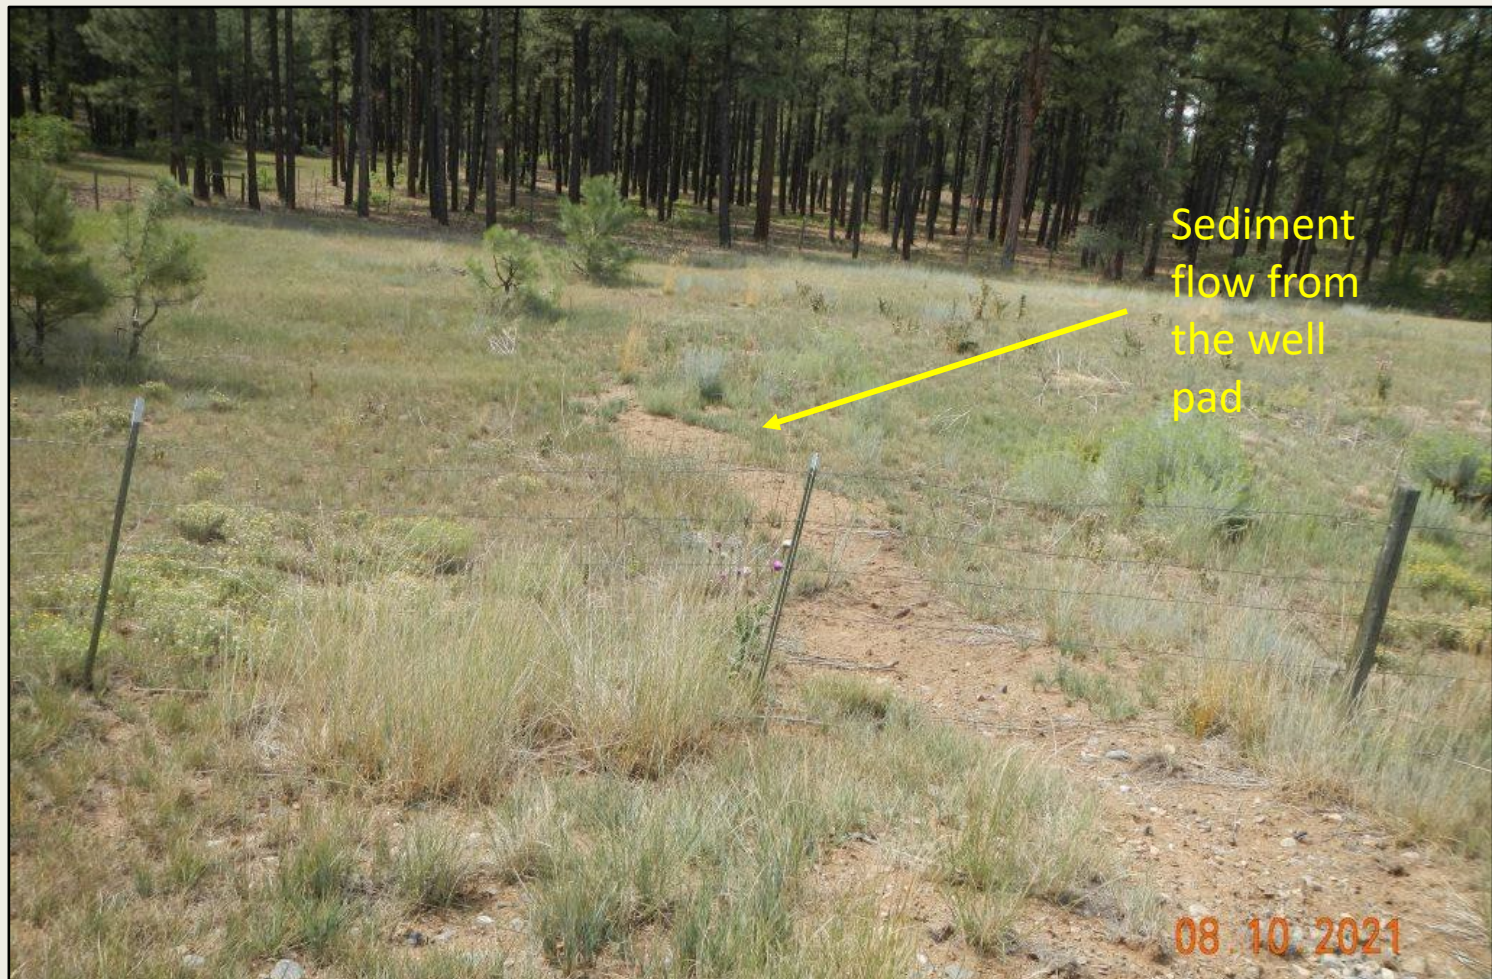
Photo 3. View of sediment discharge point within the southern project area.

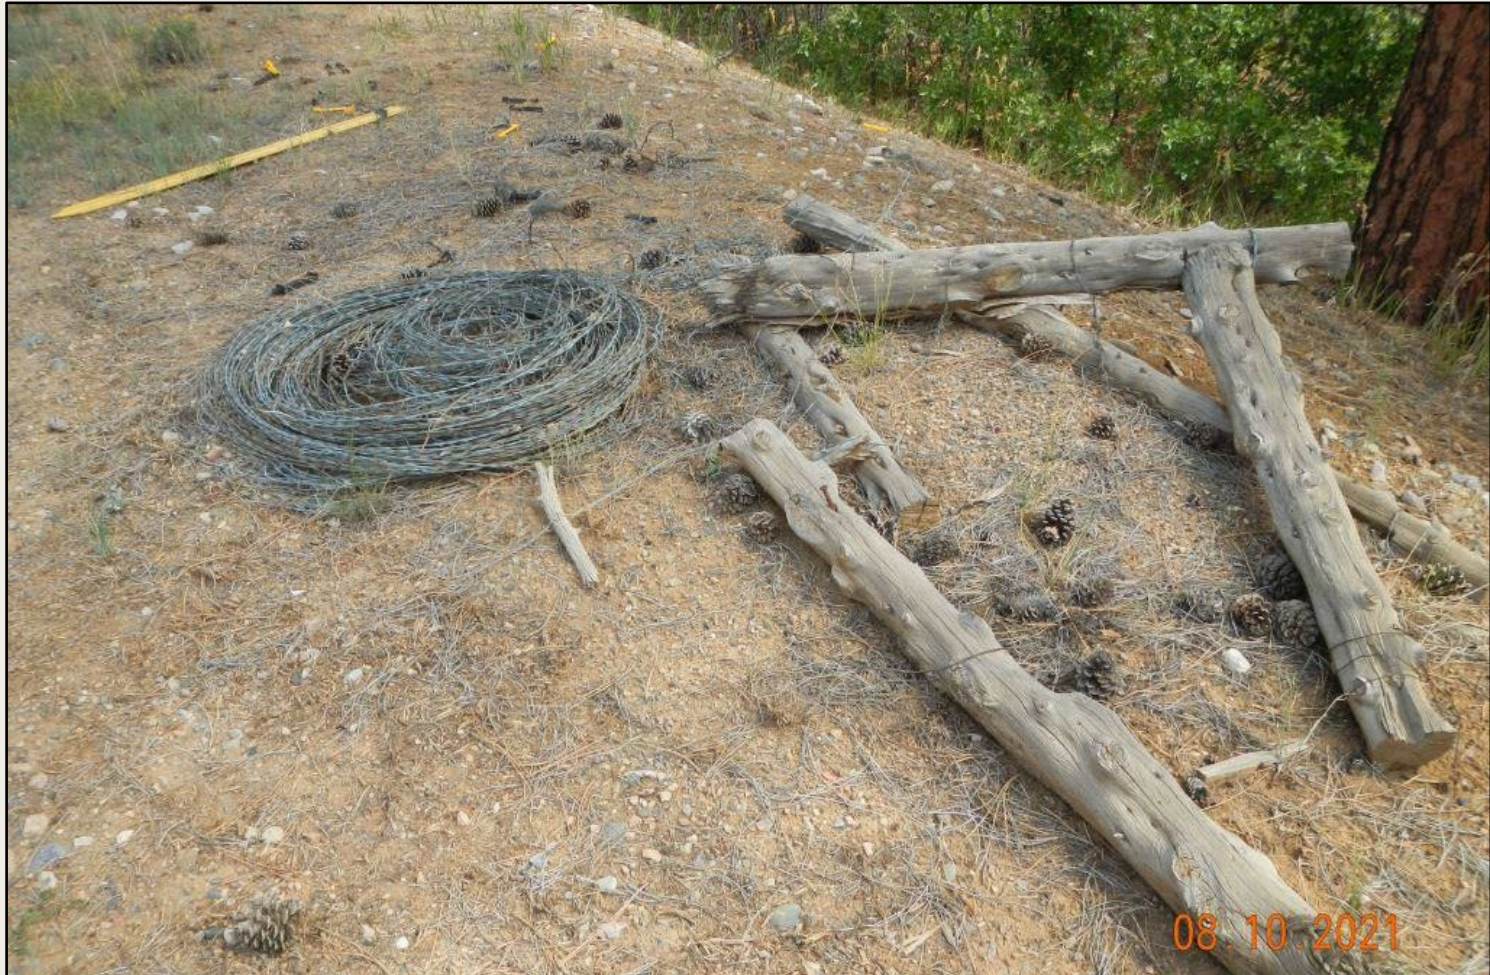
Photo 4. View of fencing debris in the eastern portion of the well pad.

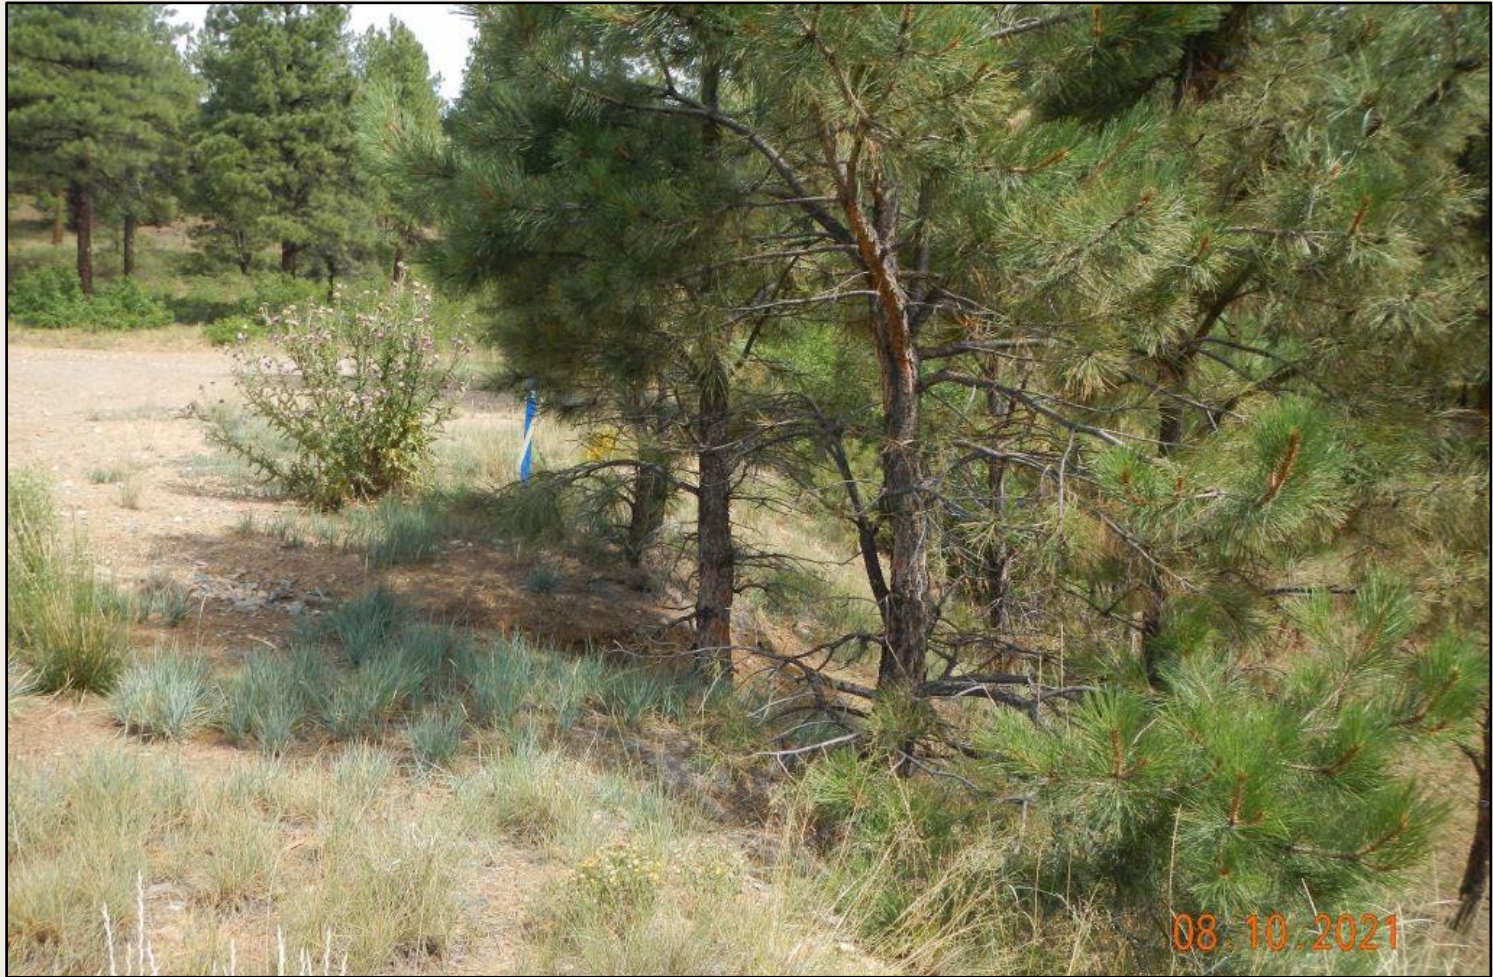
Photo 5. View of the eastern project area from the southeastern corner facing northward.

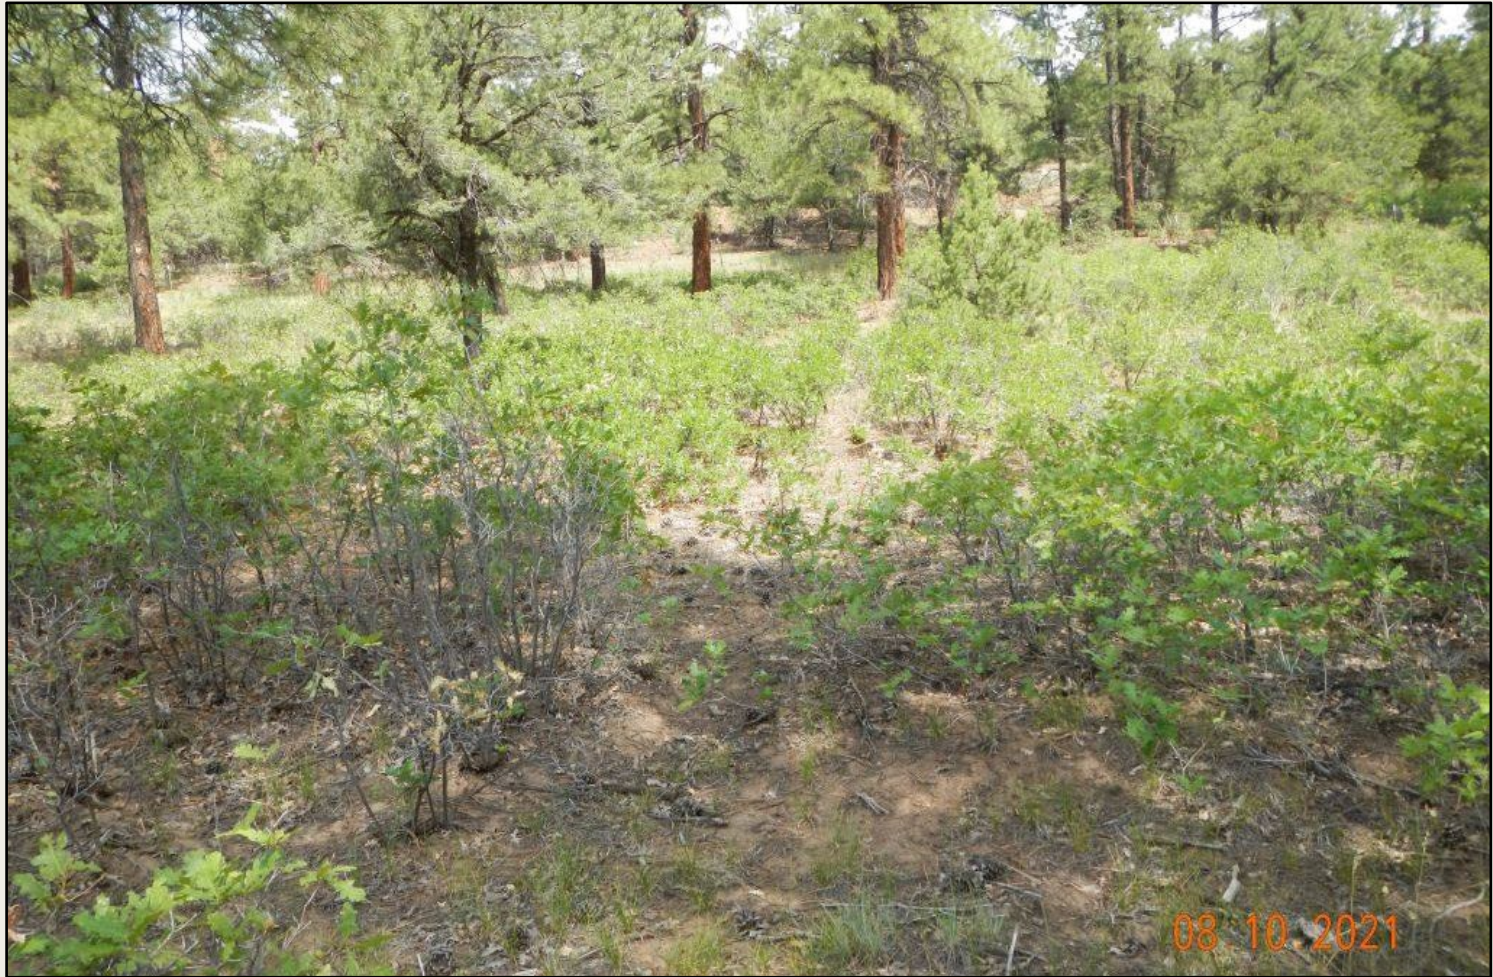
Photo 6. View of the reference area comprised of ponderosa pine woodland with understory of gambel oak, Oregon grape, Junegrass, and squirreltail.
