**GROUNDWATER INVESTIGATION FOR  
LONGMONT FARMS UNIT #5 FLOWLINE  
WELD COUNTY ROADS 7 & 16  
FREDERICK, WELD COUNTY, COLORADO**

**Date Issued: July 27, 2021  
APEX Project Number 1-0025.038.00**

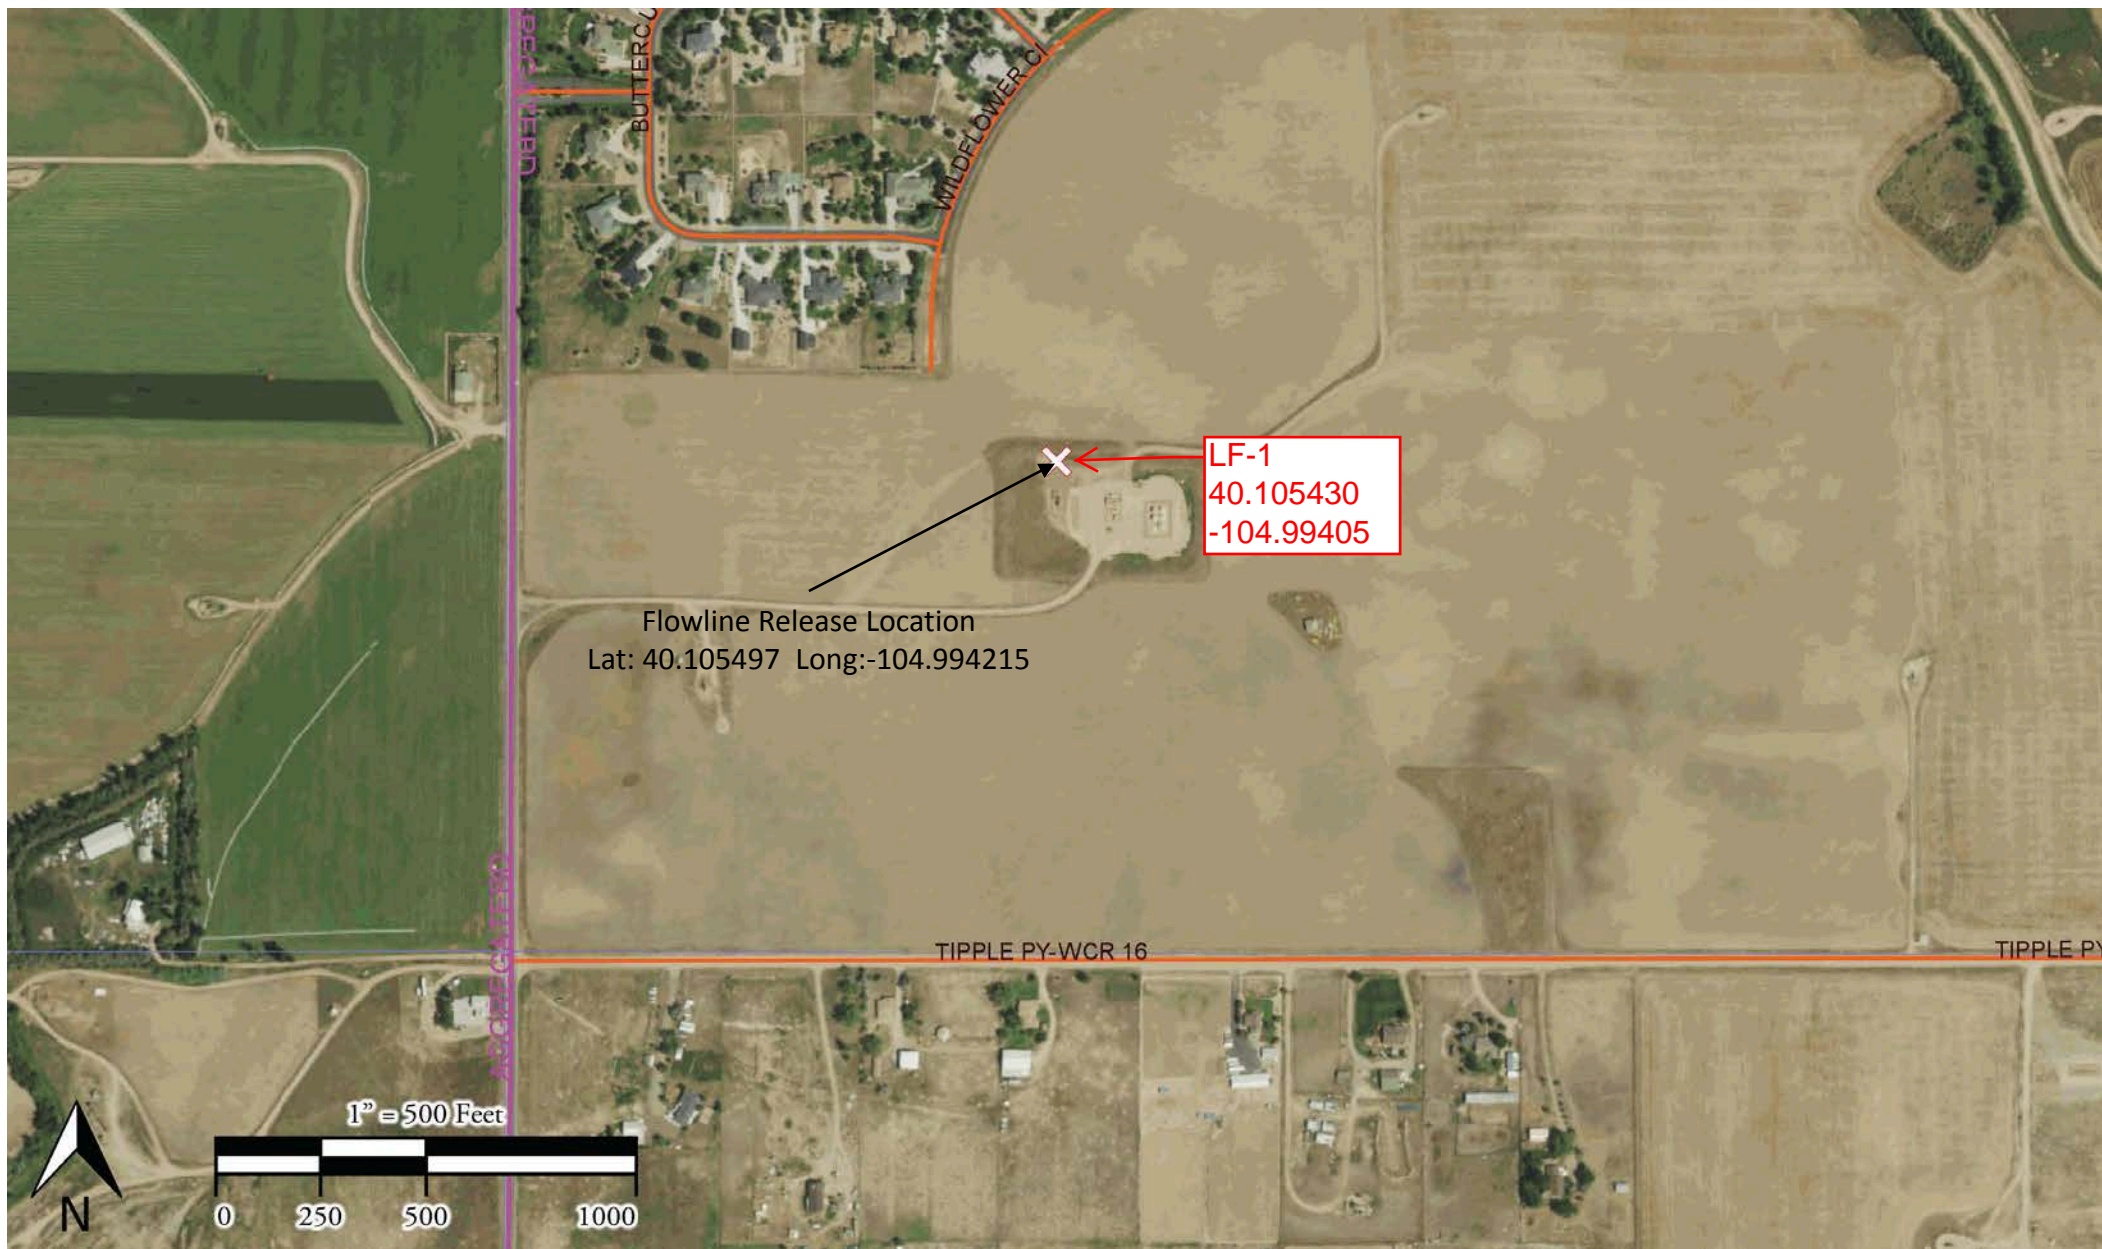
**Figure #1**  
Site Map

On June 17, 2021, APEX contracted Drill Pro of Denver, Colorado to provide and operate probing equipment. Drill Pro, under the direction of APEX, advanced a probe boring (LF-1) with a direct-push, truck-mounted GeoProbe probe rig equipped with a four-foot-long stainless-steel system. All drilling rods and/or sampling equipment were decontaminated between samples and/or borings to prevent cross-contamination. The boring was installed to terminal depth of 17.5 (refusal) feet below ground surface (BGS). The boring was completed immediately east of the excavation. The location of the boring is illustrated on Figure 1 which is included in Appendix A.
