Inspection Photos
Location Name: Champlin 86 Amoco F#4
Location ID: 319002

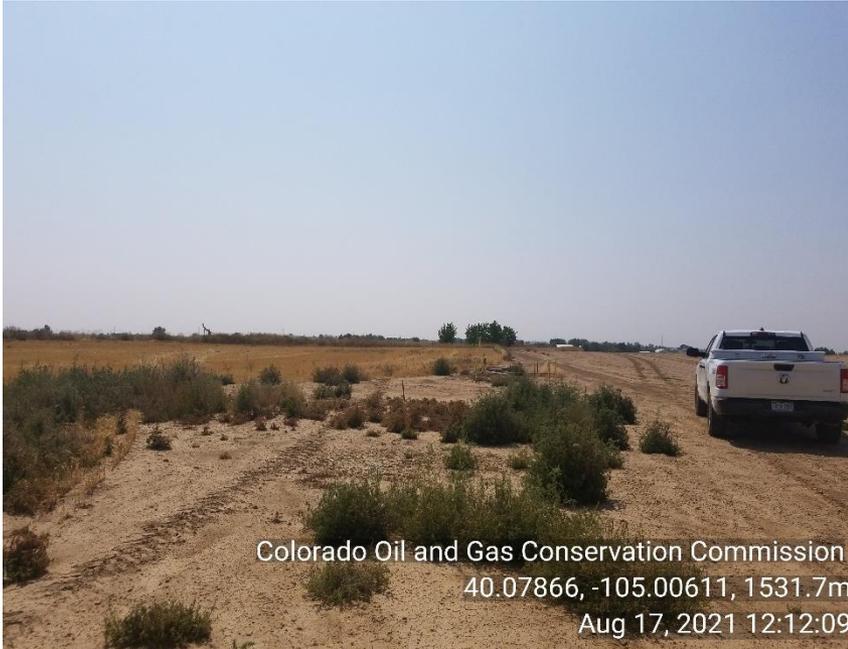
Photo 1 loc pic facing south

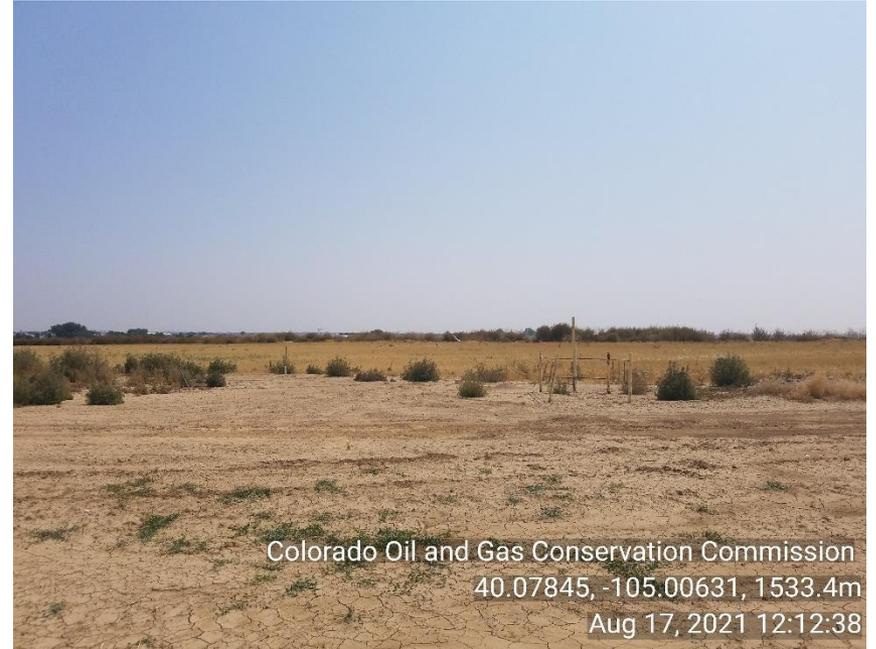
Photo 2 loc pic facing east.

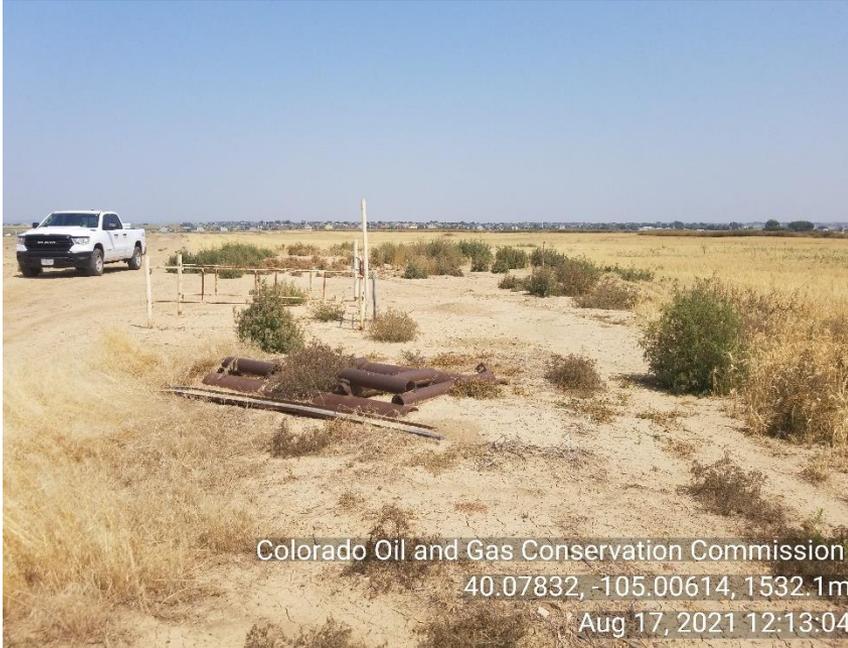
Photo 3 loc pic facing North

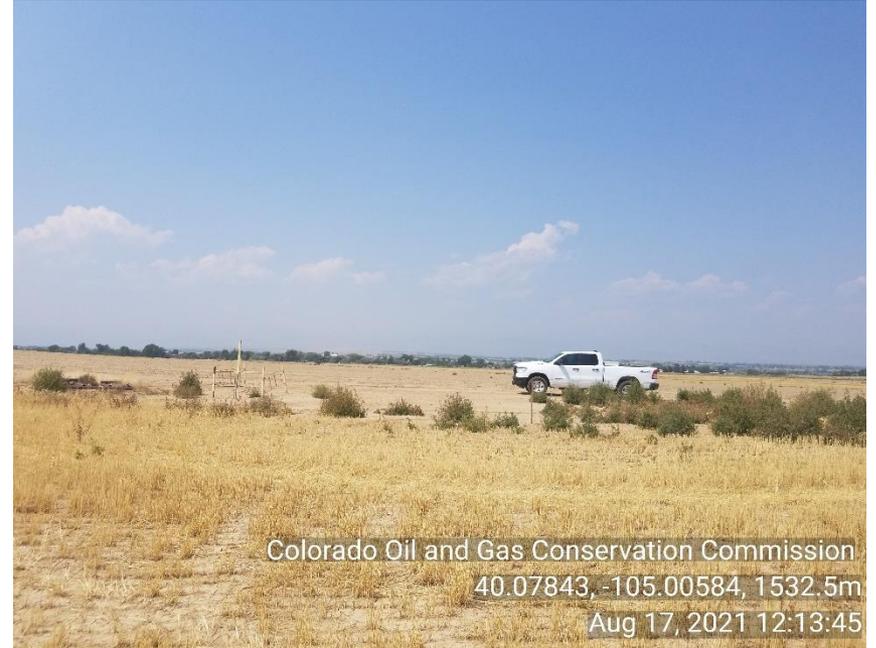
Photo 4 loc pic facing West

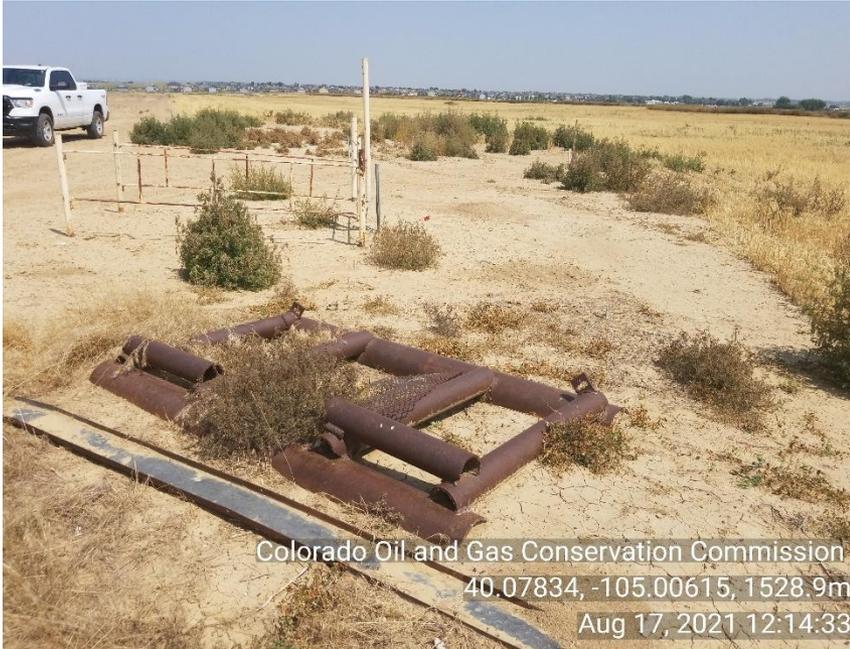
Photo 5 Unused equipment and electrical piping.
