Inspection Photos
Location Name: Champlin 86 Amoco F# 7
Location ID: 323149

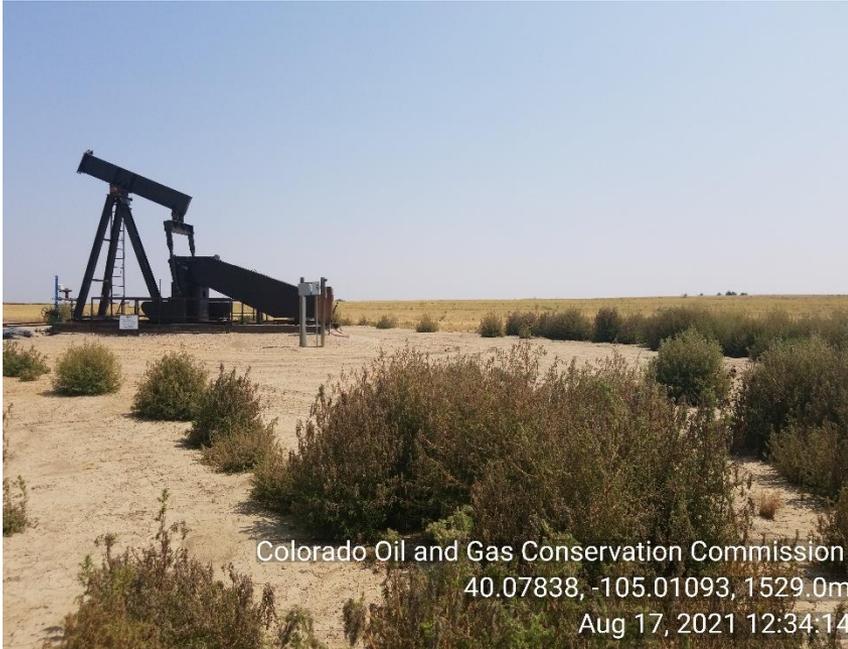
Photo 1 loc pic Weeds on site

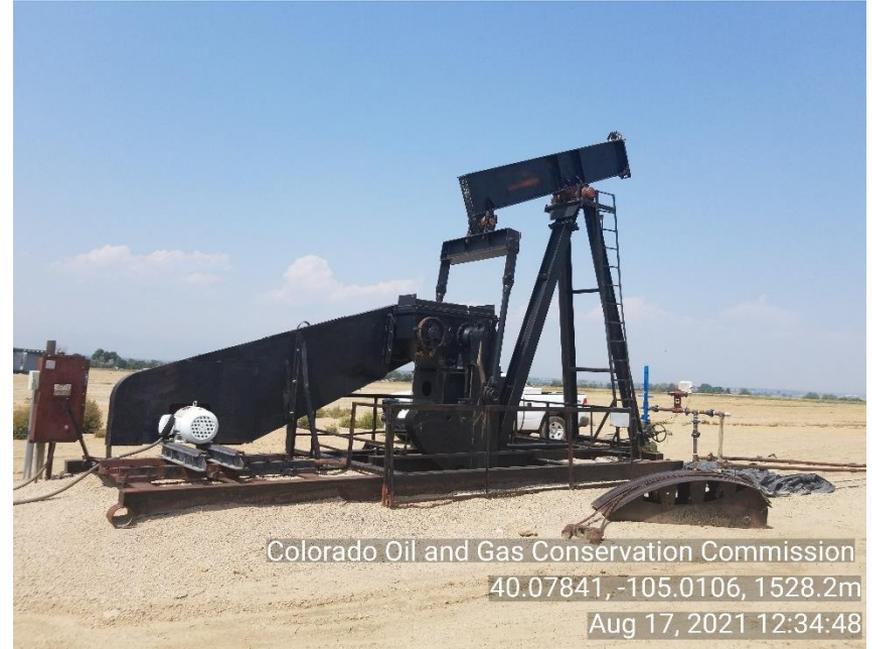
Photo 2 Unused equipment PU and associated equipment.

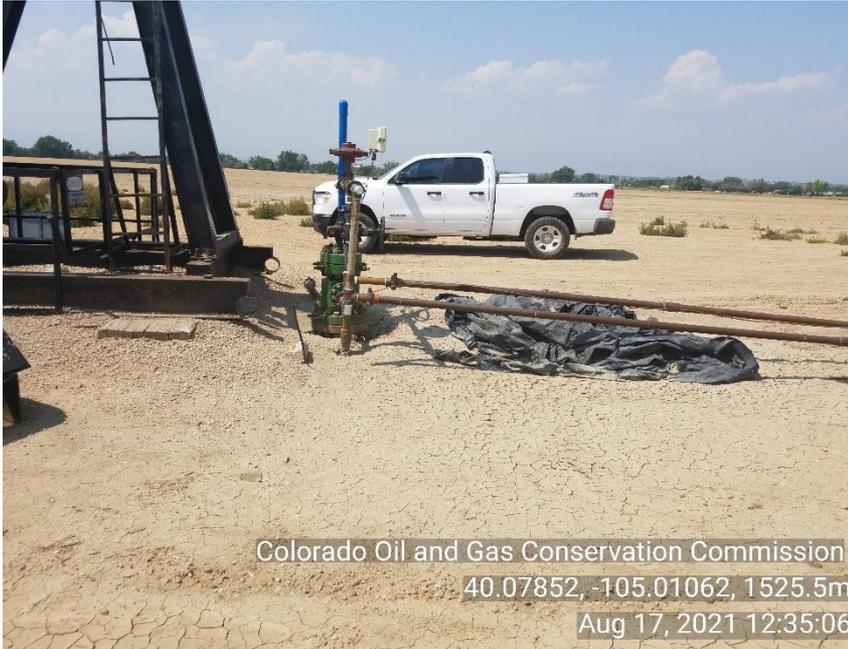
Photo 3 Trash: black tarp

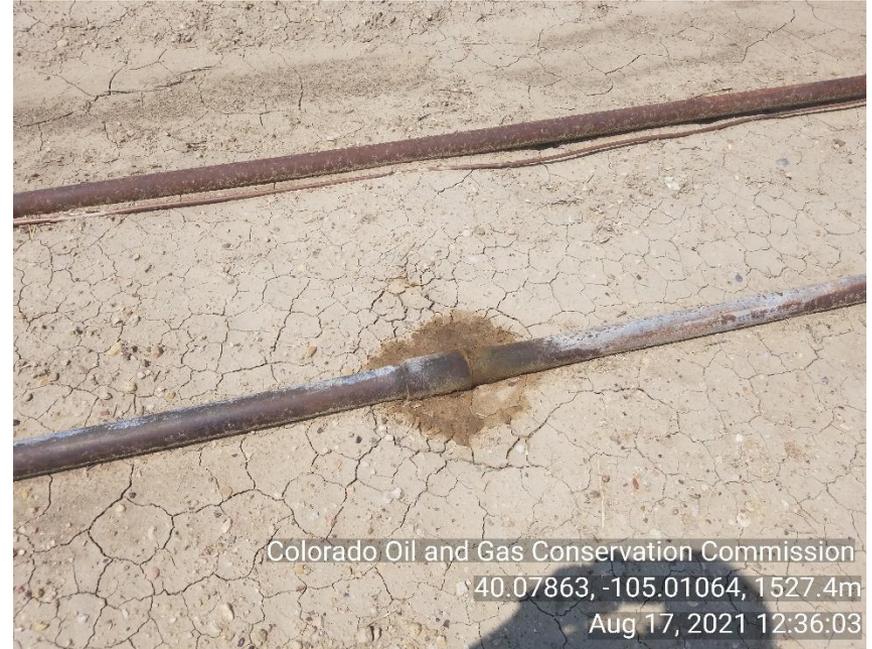
Photo 4 Stained soil and mechanical issue 2" piping to separator.

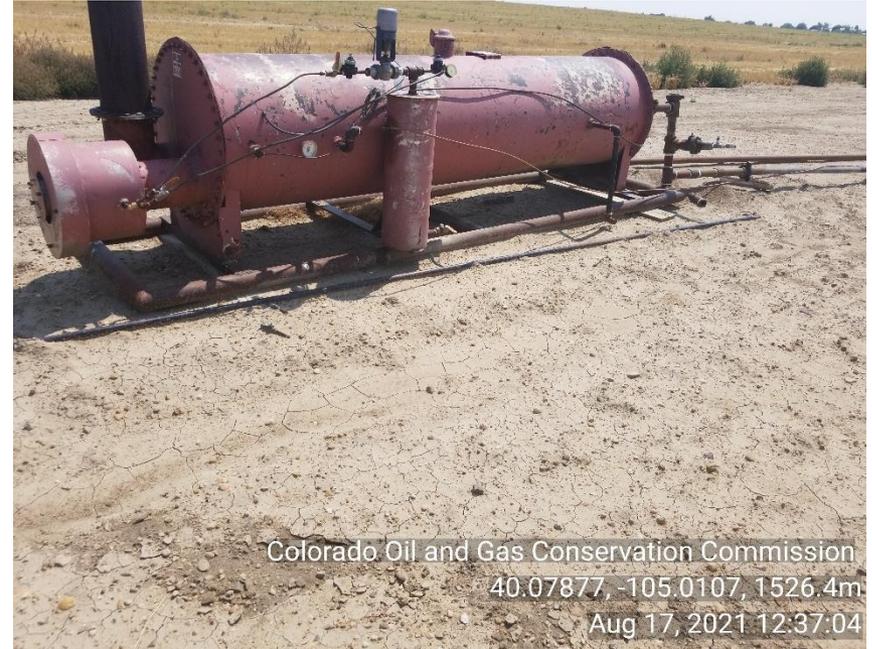
Photo 6 unused equipment: 1" piping and parts around Hoz Separator.
