Inspection Photos

API: 071-07085

Operator: EVERGREEN NATURAL RESOURCES

Inspection Date: 8/16/2021

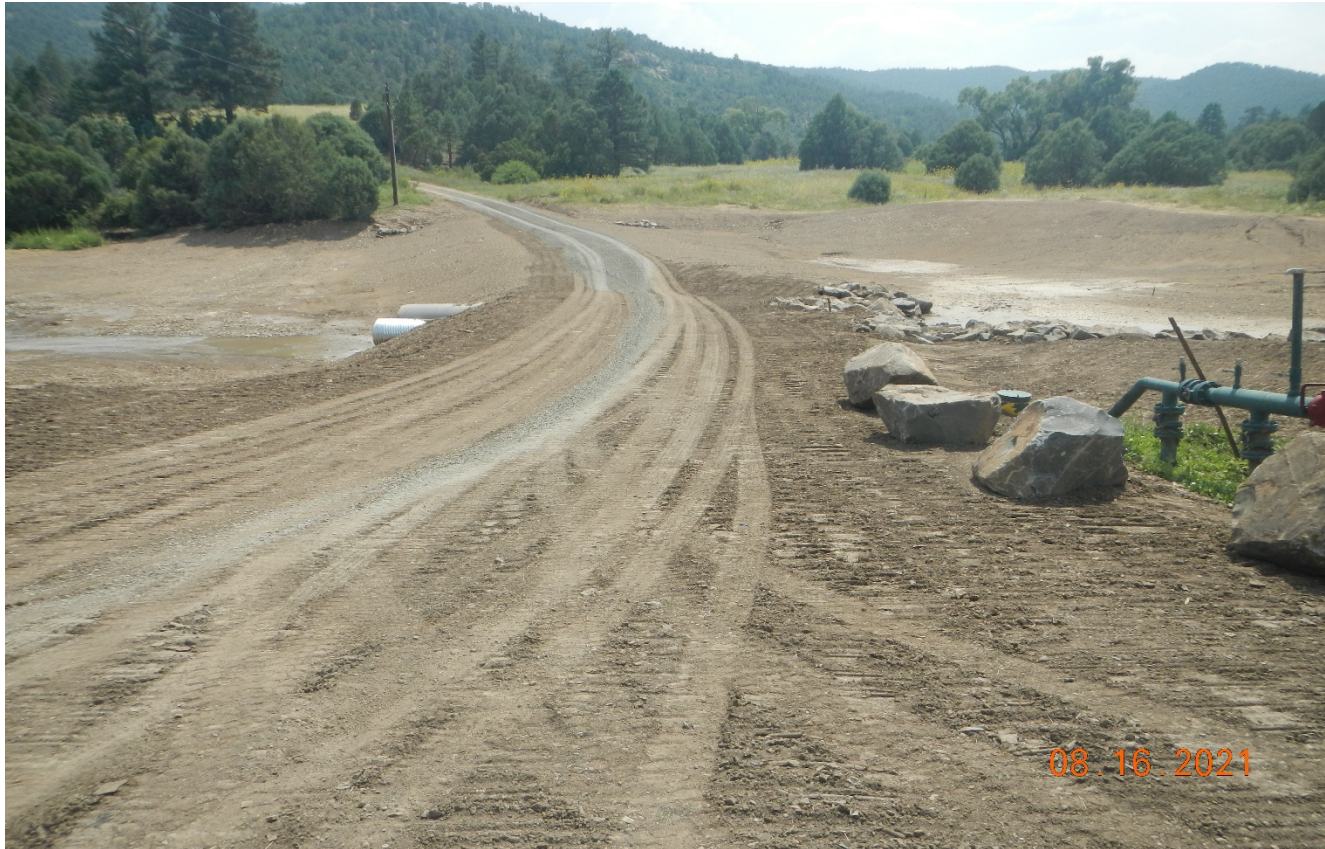
Photo 1. Facing south toward the access road stream crossing which was washed out during the flood event.

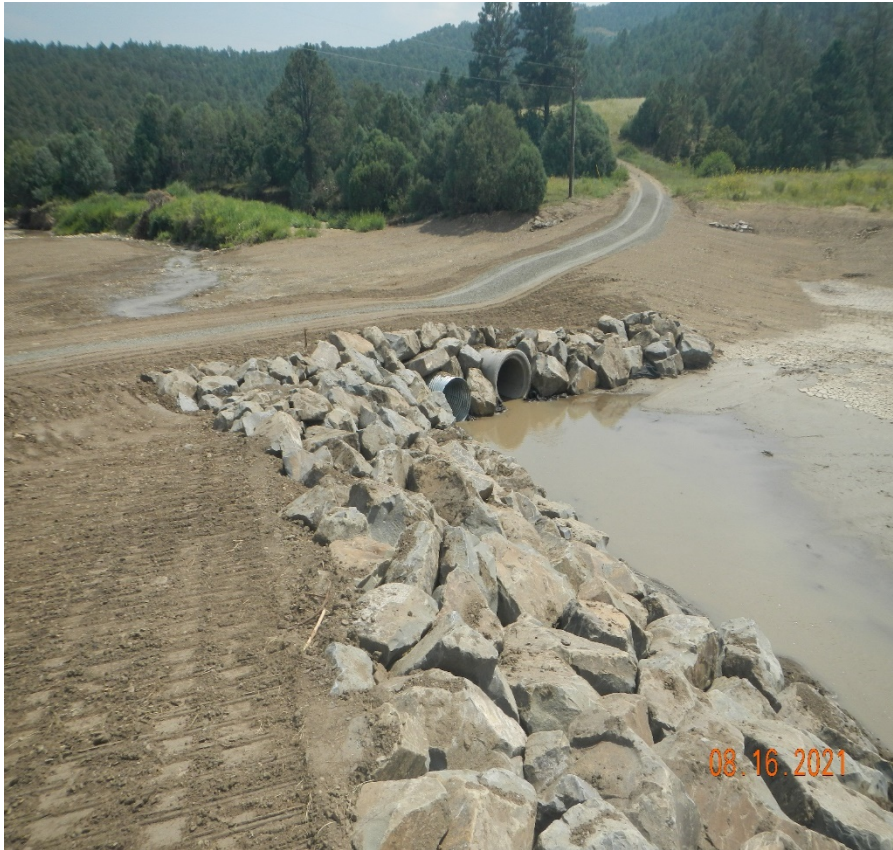
Photo 2. There are two culverts installed at the stream crossing. This appears to be inadequate as the prior cement culvert shown in the photo on the right had 3 large outlets.

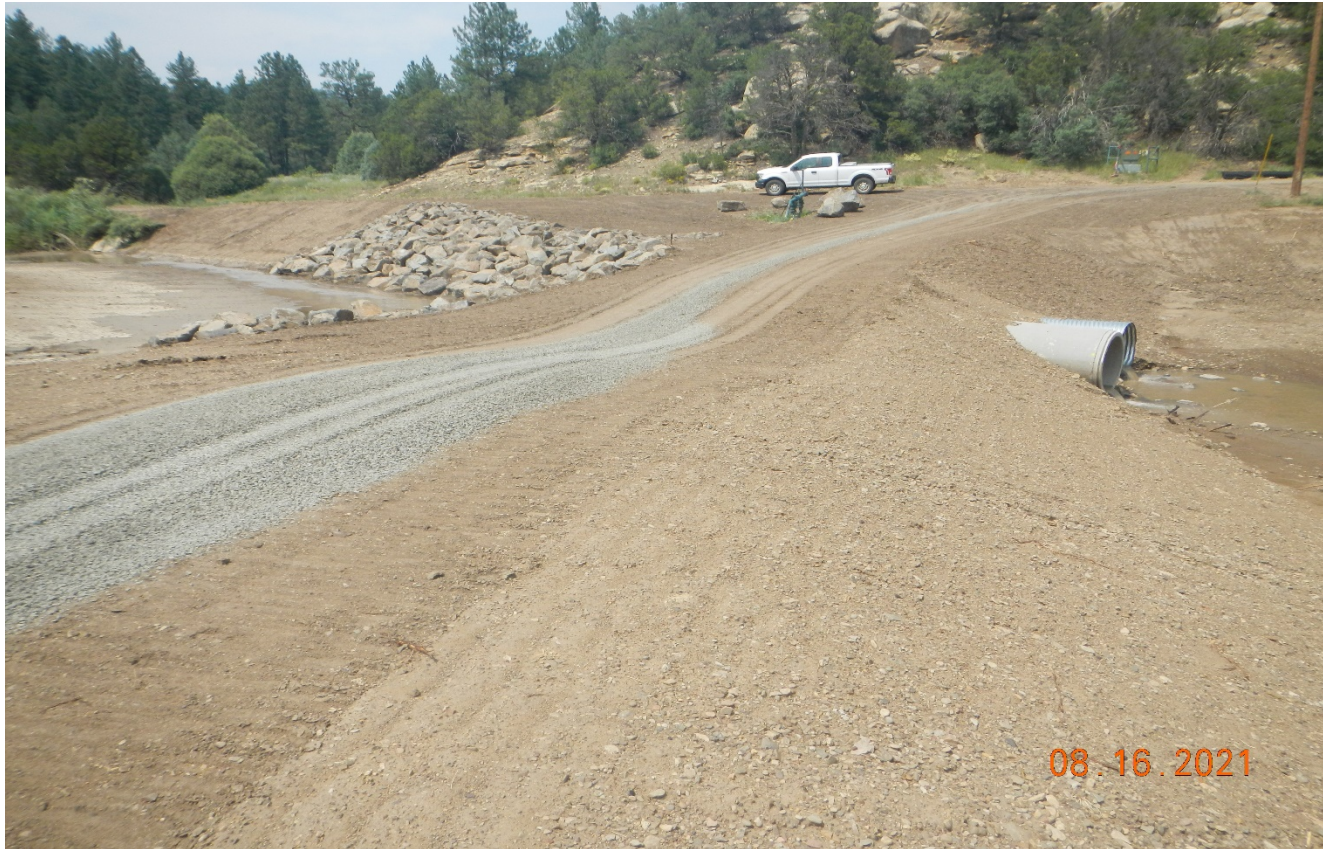
Photo 3. Facing northwest at the stream crossing. There is no bank stabilization at the outlet side.

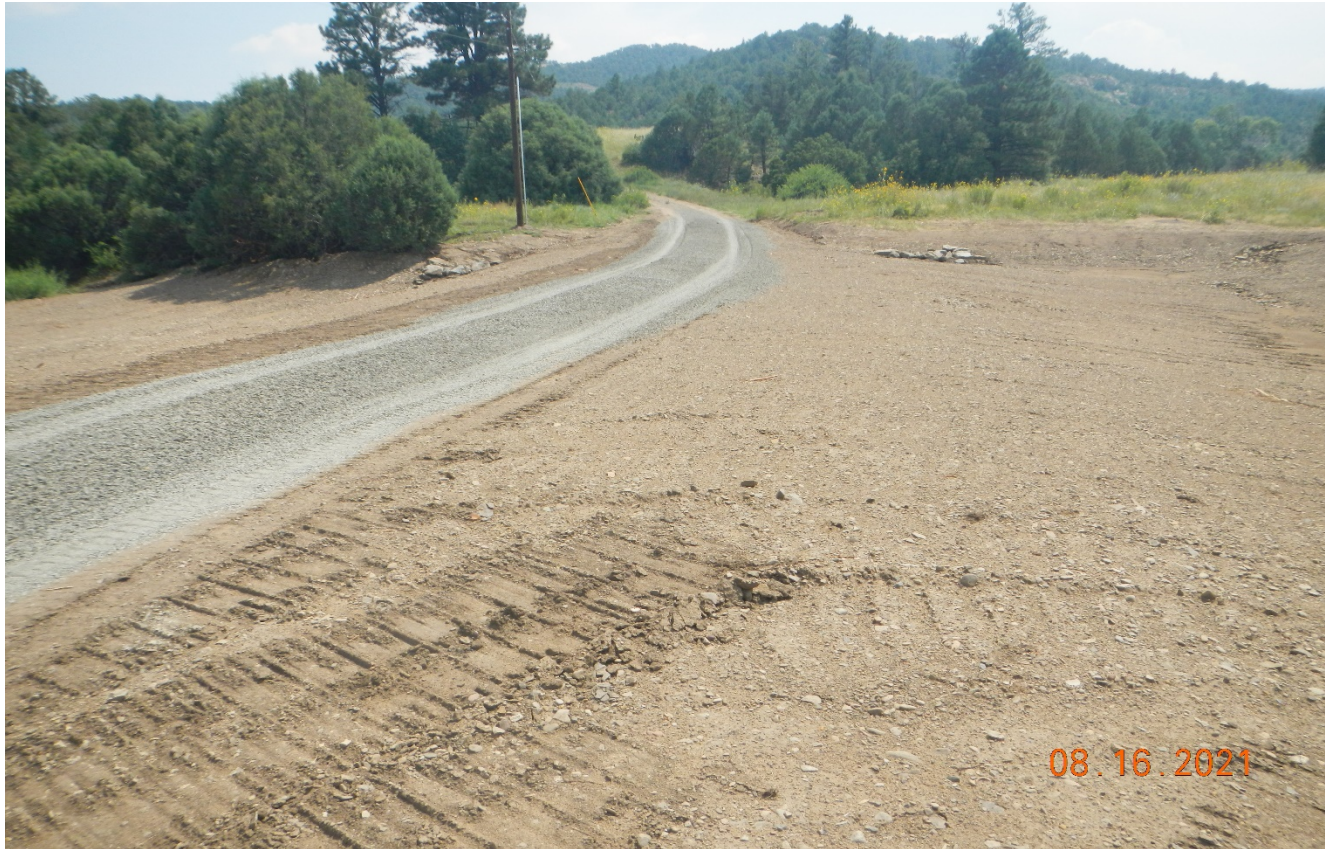
Photo 4. Facing southeast along the access road. Gravel was being hauled to the road during inspection. All disturbed areas will need to be seeded and stabilized.

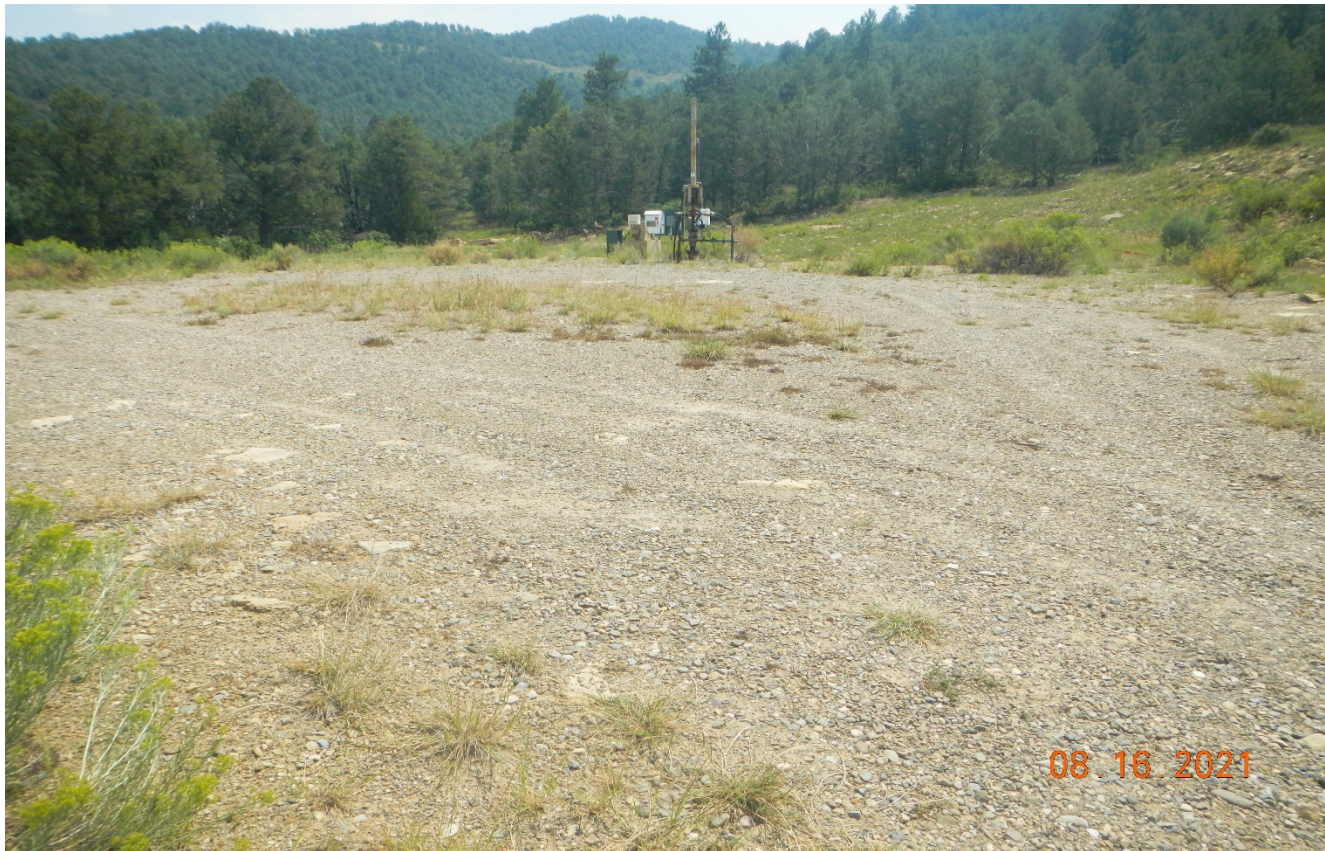
Photo 5. Facing southeast toward the well site.
