# Inspection Photos

API: 071-07604

Operator: EVERGREEN NATURAL RESOURCES

Inspection Date: 8/16/2021

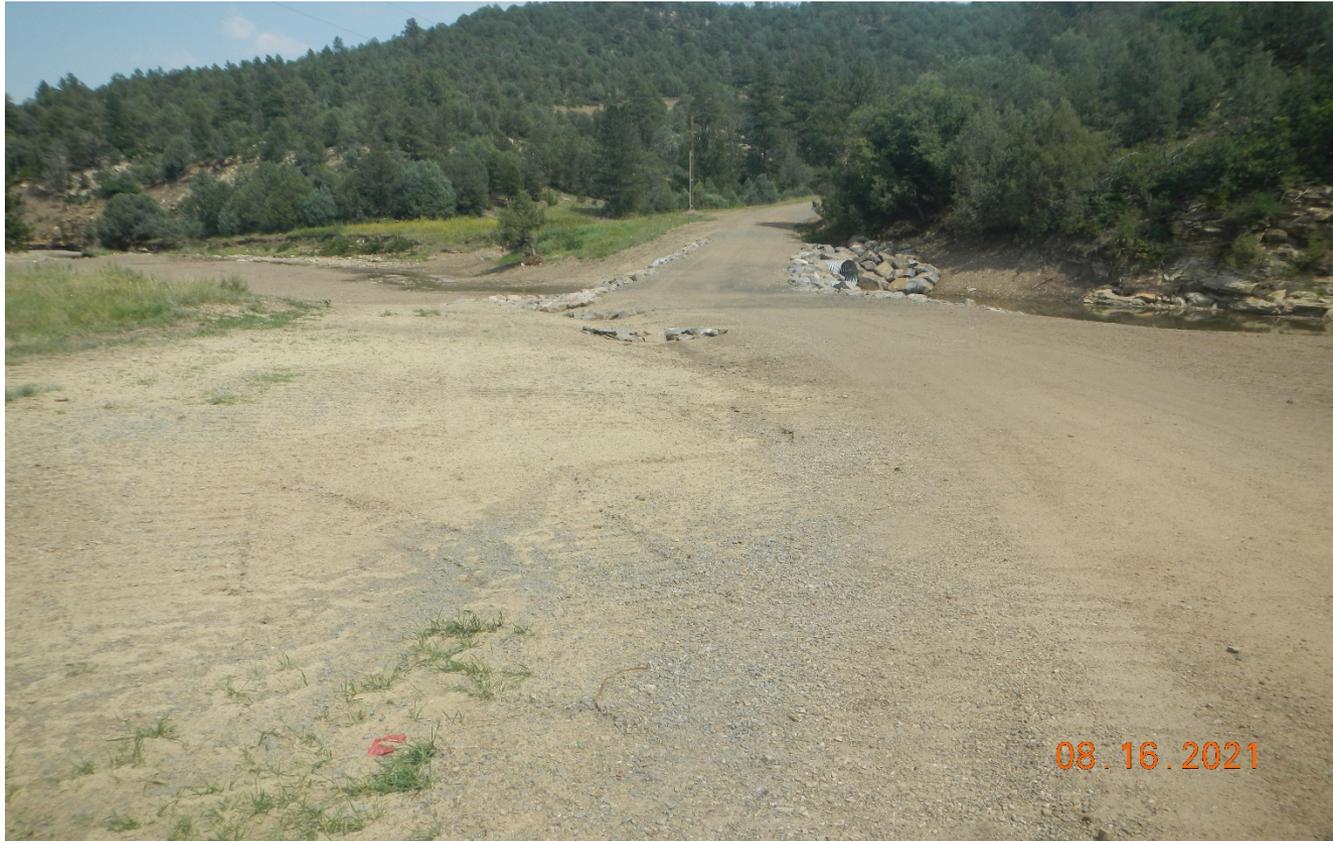
**Photo 1.** Facing east toward the access road stream crossing which was washed out during the flood event.

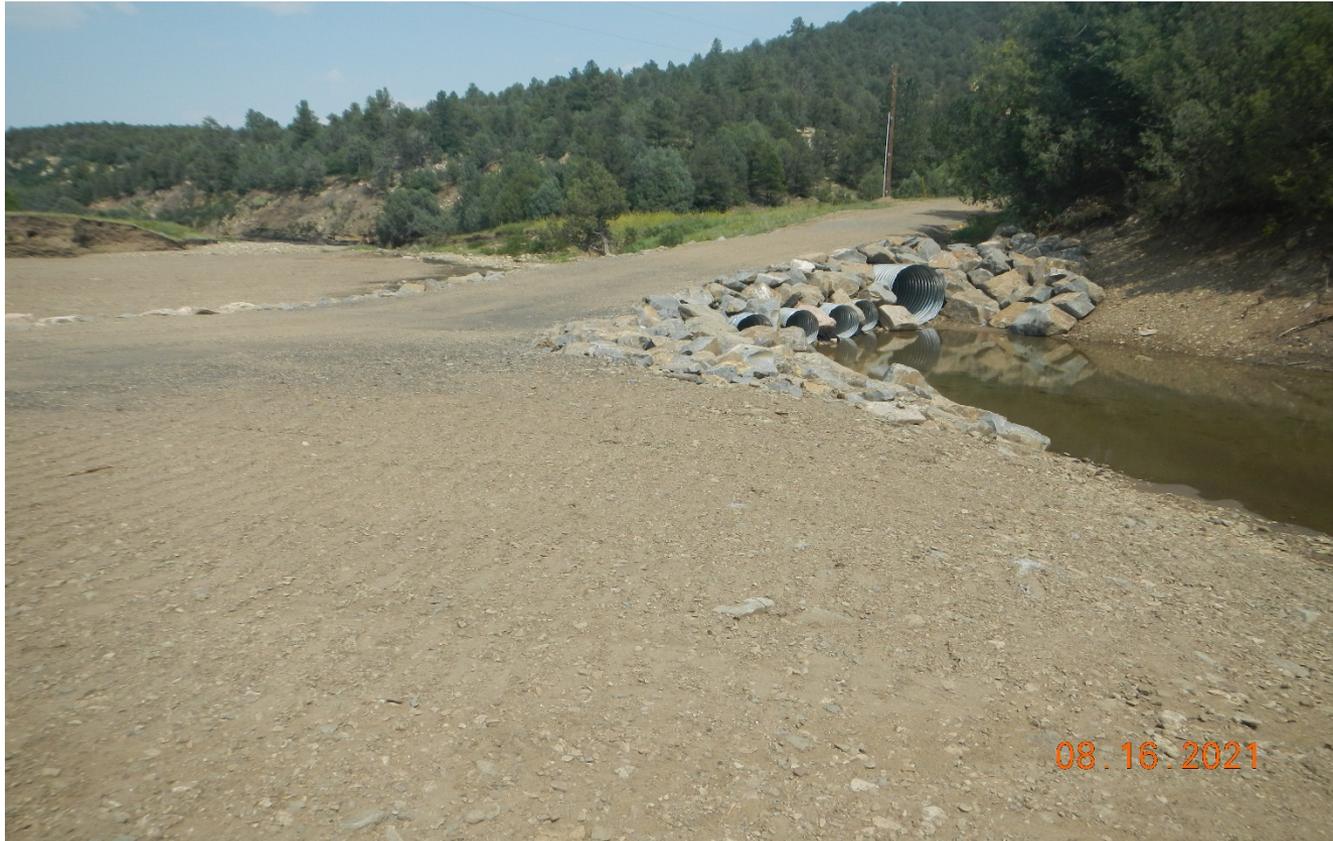
**Photo 2.** There are multiple culverts installed and rock rip/rap was installed for bank stabilization. The culverts are multiple sizes and it is unknown if this was an adequate engineered practice.

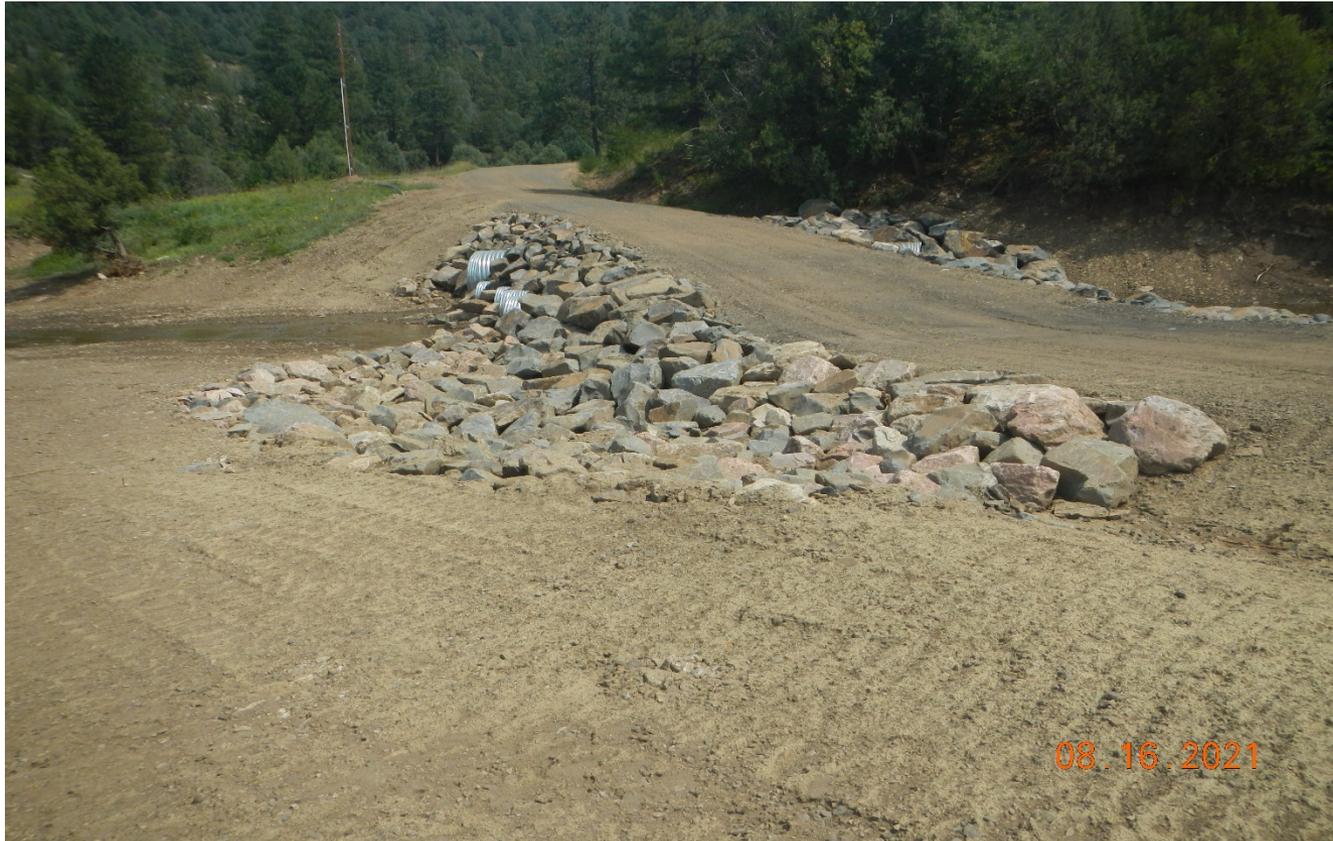
**Photo 3.** Facing east at the stream crossing. There is bank stabilization along the outlet side of the stream crossing.

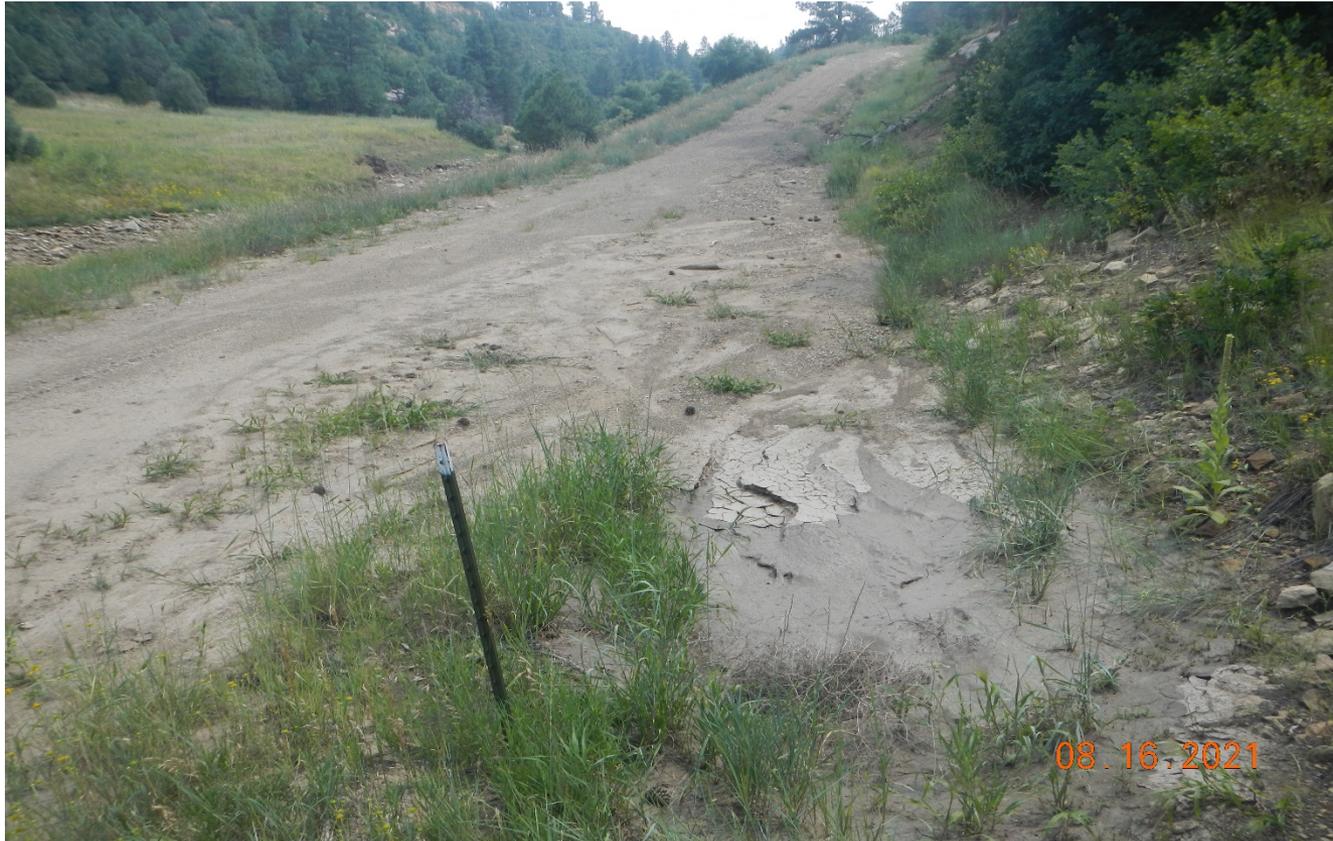
**Photo 4.** Facing southeast along the access road. The culverts along the access road are filled in with sediment.

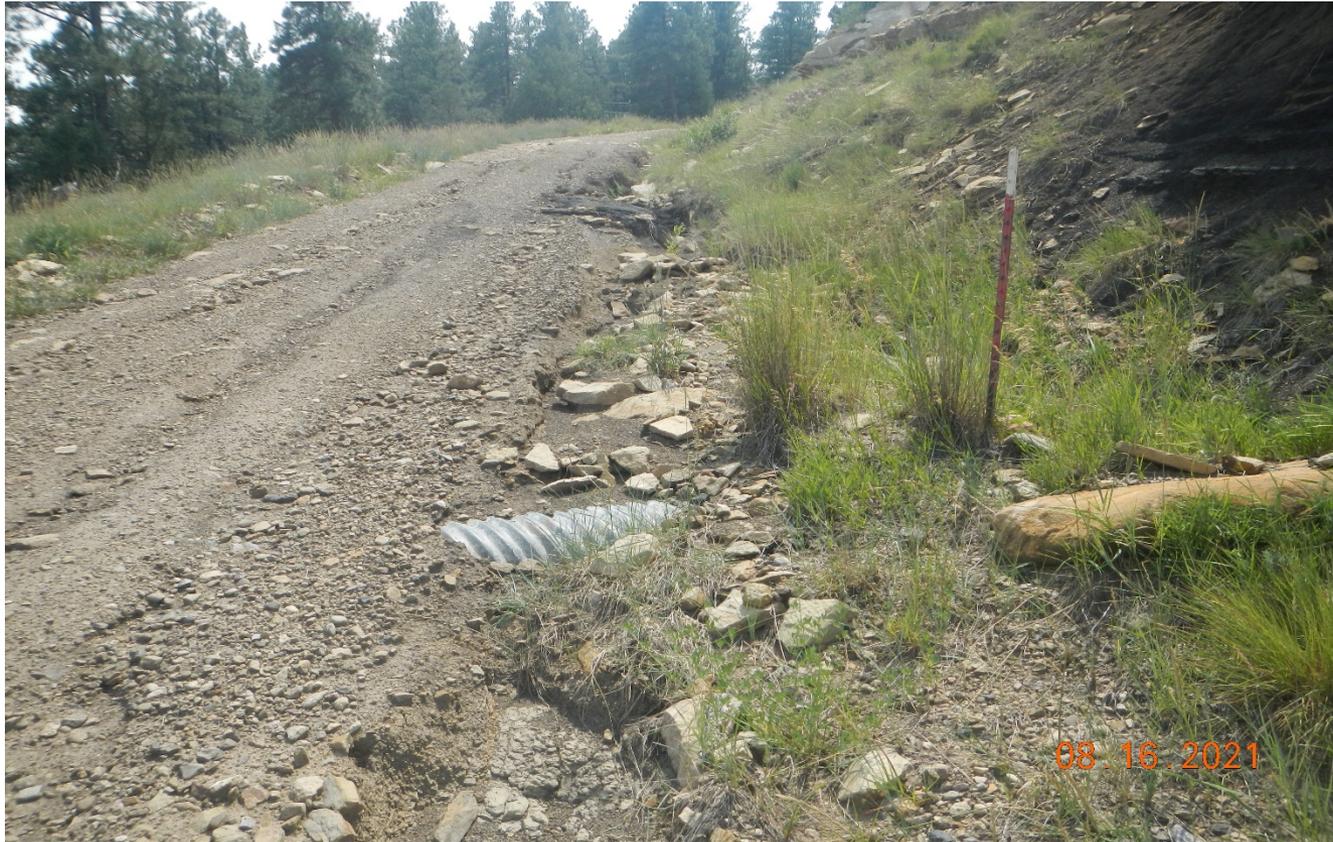
**Photo 5.** The culverts along the access road are filled in with sediment.

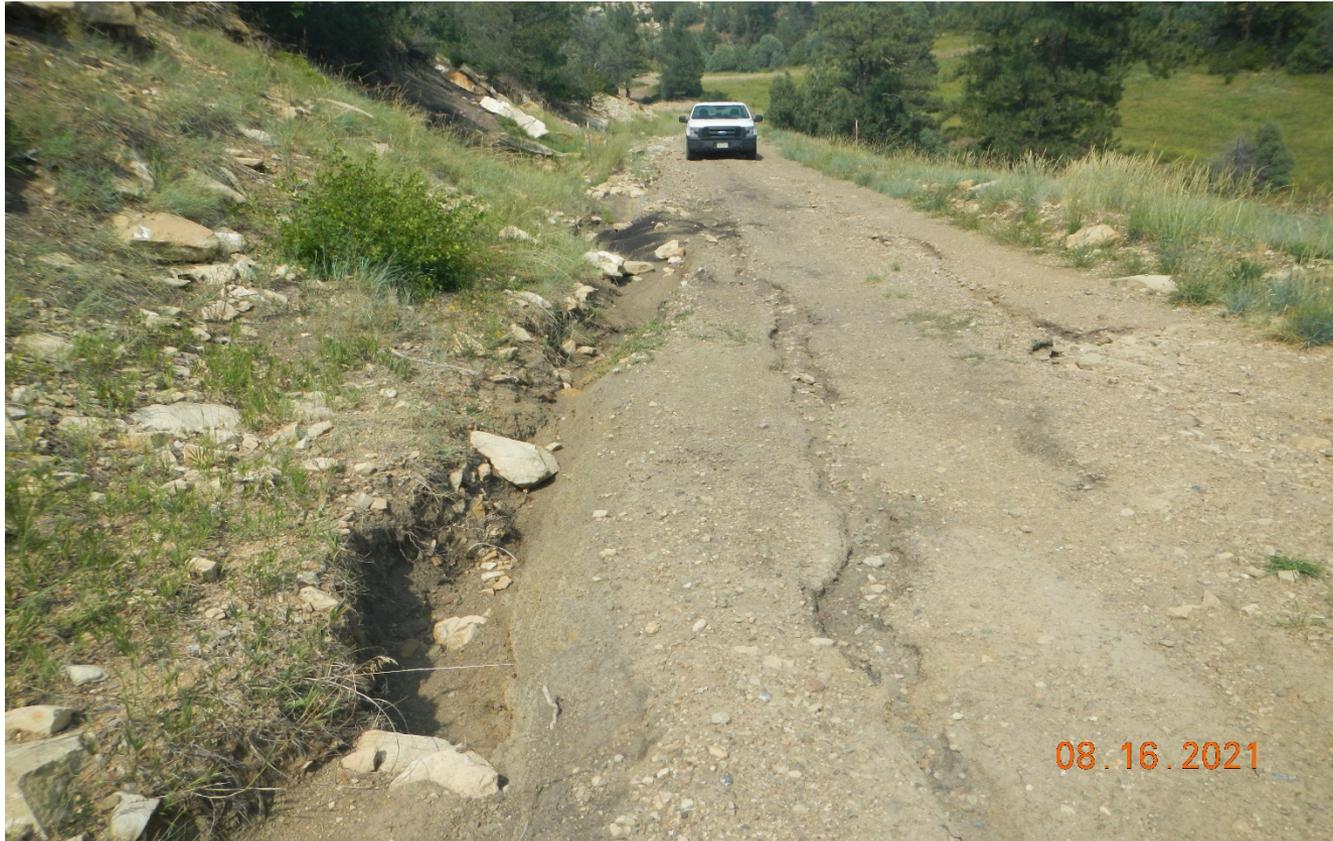
**Photo 6.** Facing back down the road. There is erosion along the road side and stormwater is bypassing culverts which will cause further erosion. BMP's need to be repaired.

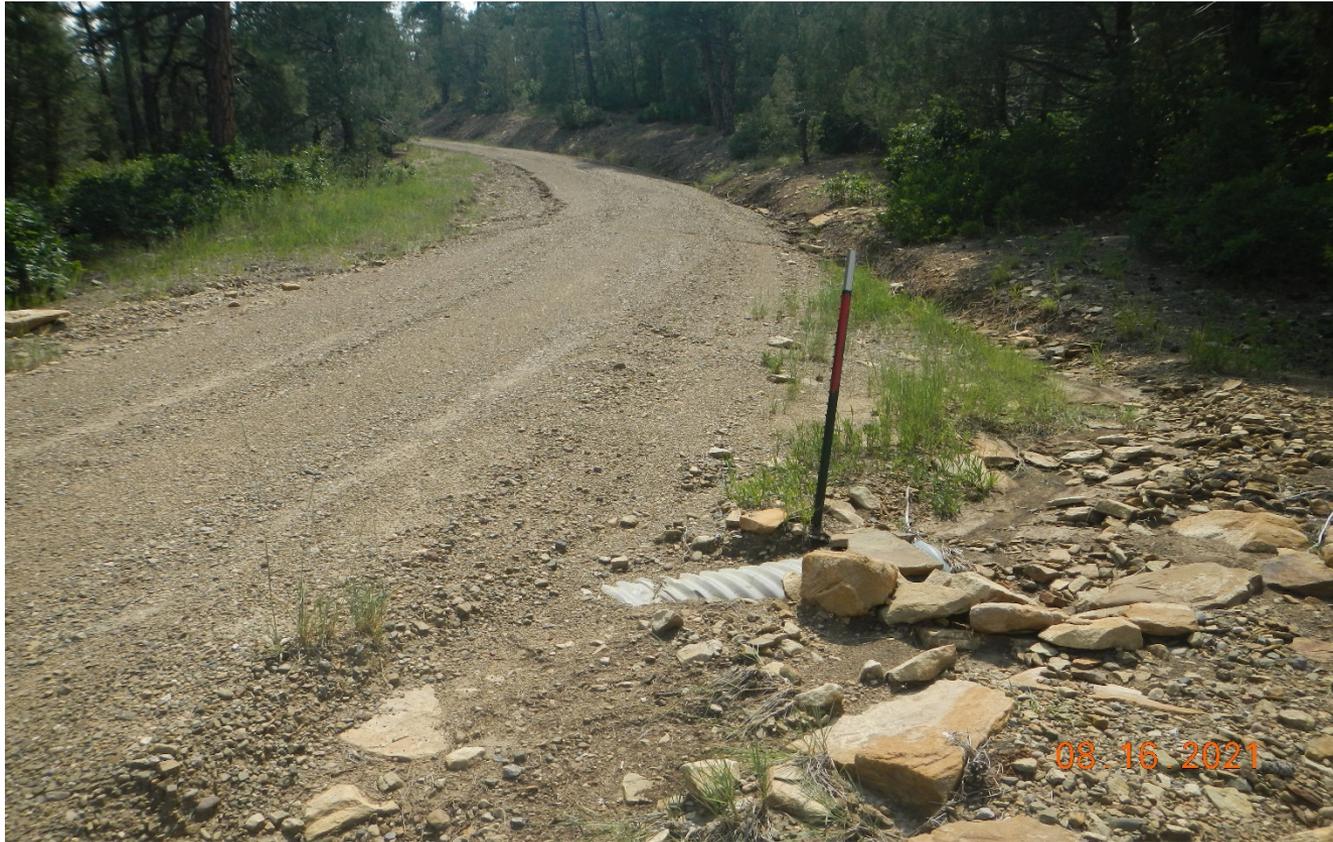
**Photo 7.** Another culvert further along the road is filled in with sediment.
