Inspection Photos

API: 071-08095

Operator: EVERGREEN NATURAL RESOURCES

Inspection Date: 8/16/2021

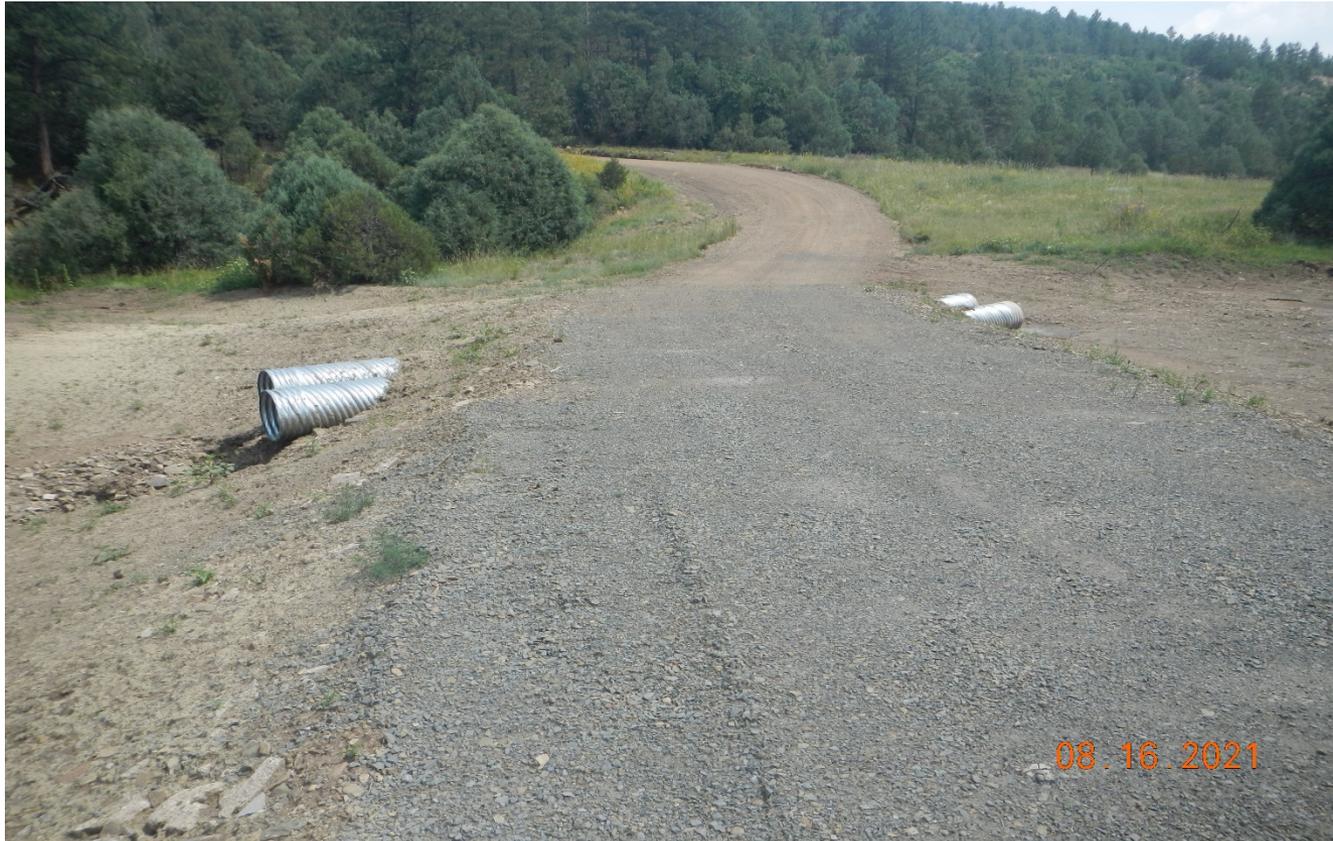
Photo 1. Facing east at the drainage crossing. This area was damage in the flood event where exposed pipe lines were observed. This area has been repaired.

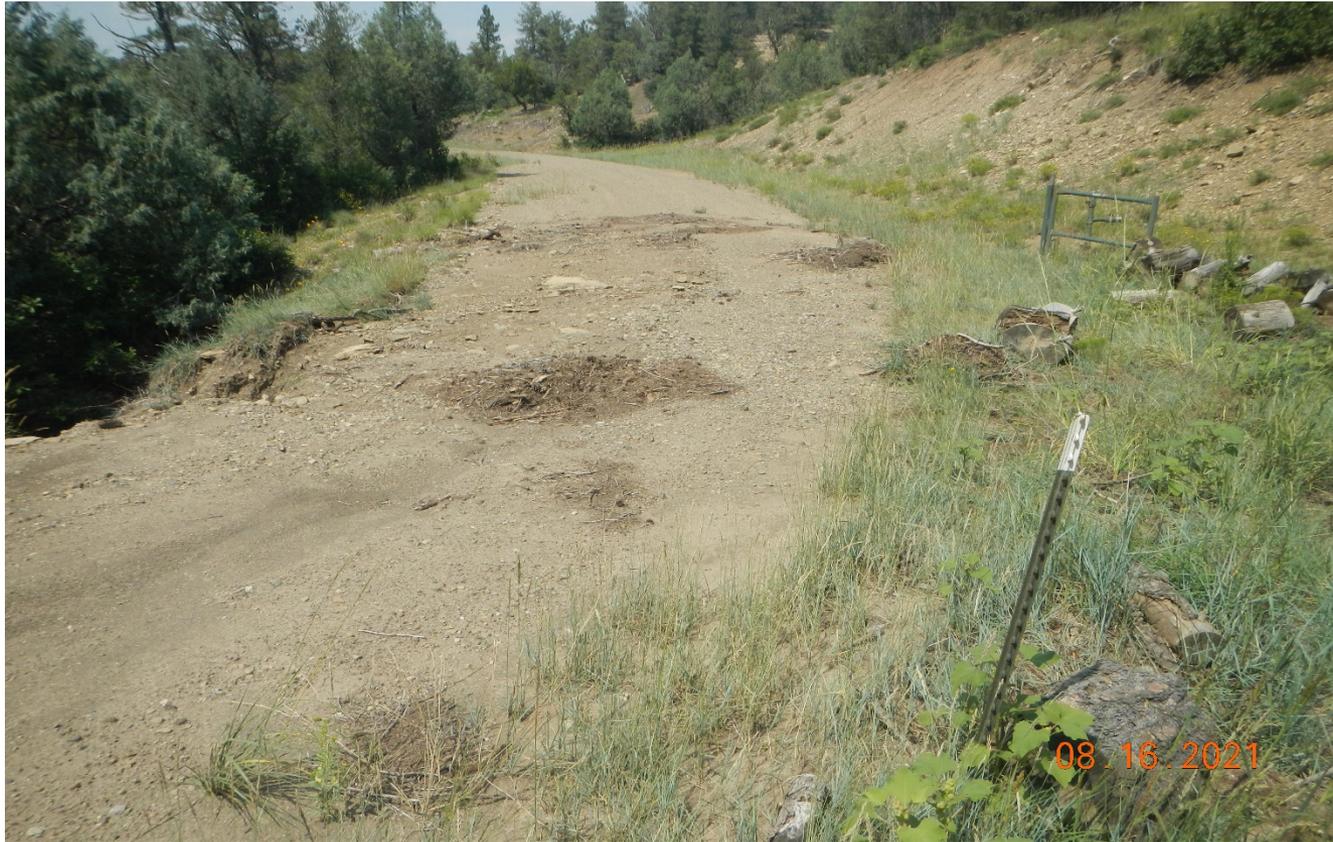
Photo 2. Further along the road at this drainage, the culvert plugged up and stormwater had flown over the road. The culvert needs to be repaired at this drainage area.

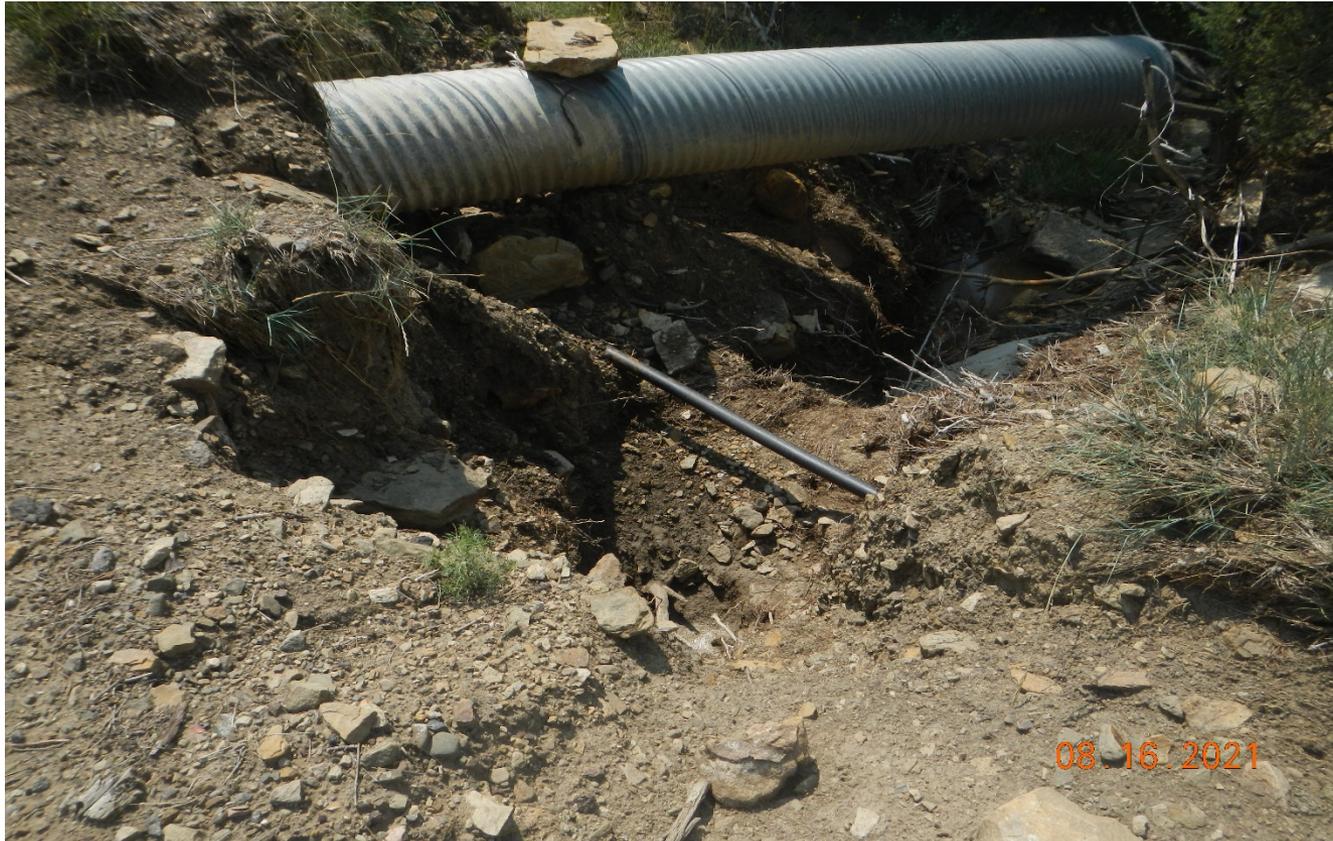
Photo 3. The same culvert outlet has eroded and exposed a pipeline. This area needs to be repaired.

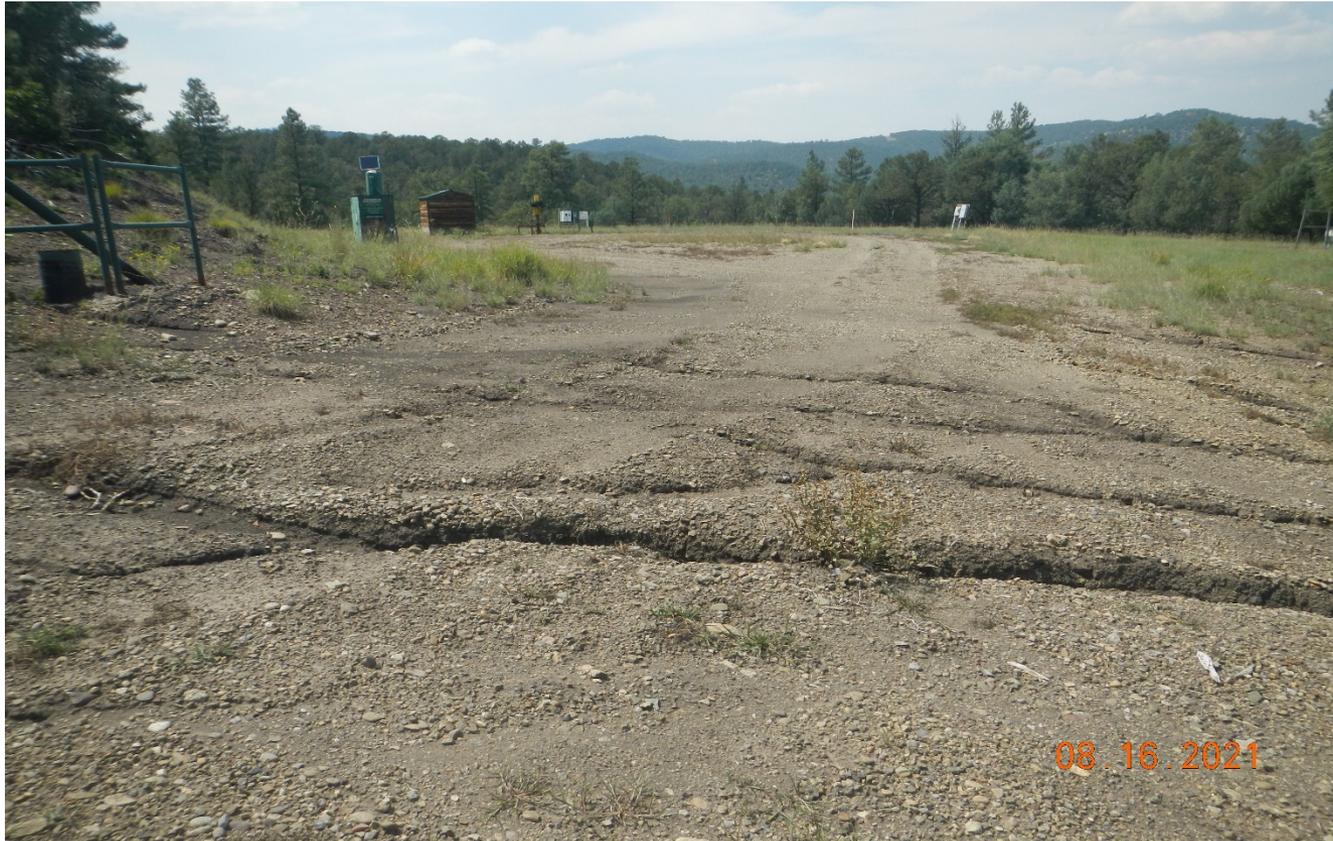
Photo 4. Facing west toward the well site. There is erosion across the access road which needs to be repaired.

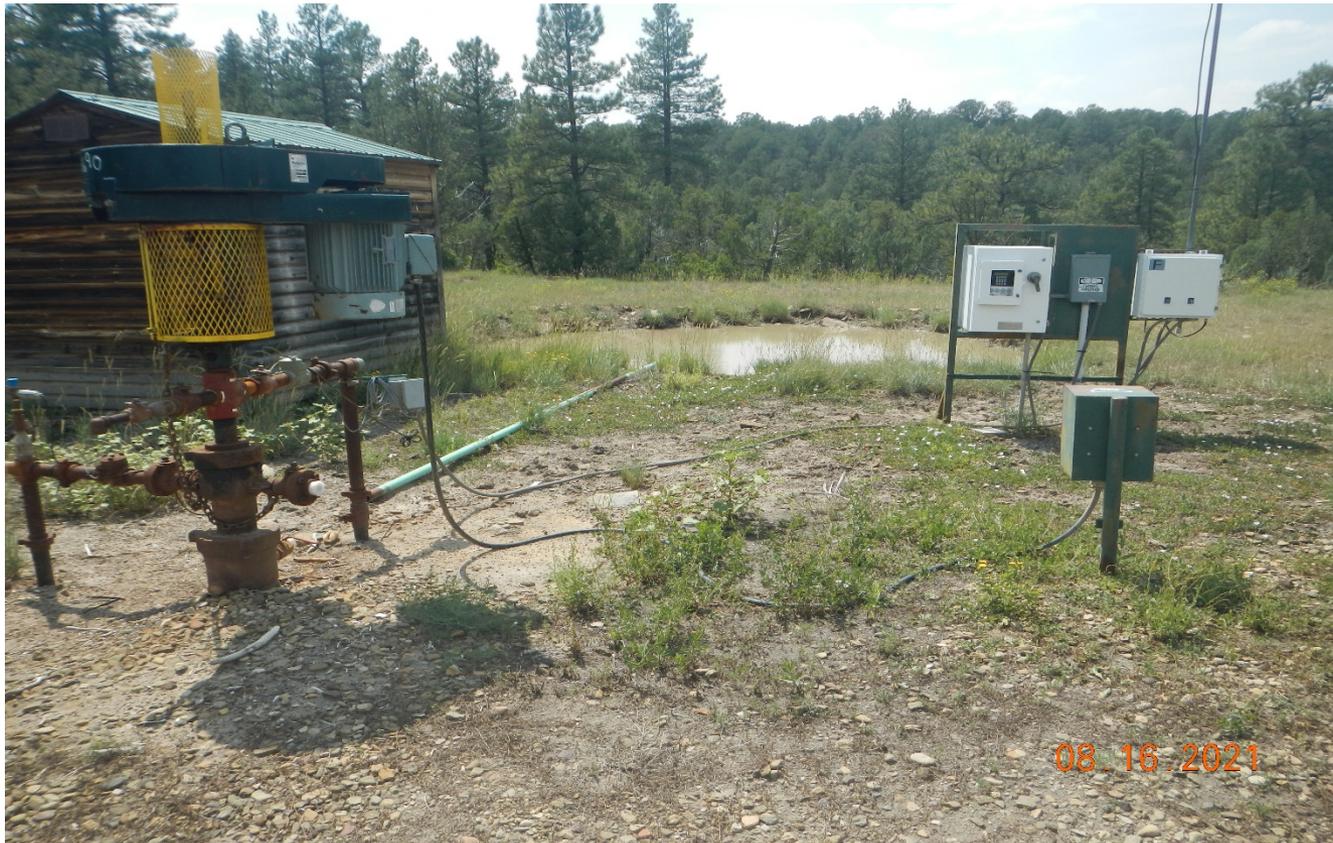
Photo 5. Facing toward the well and PW pit. The water level is near 2 ft. freeboard.
