Inspection Photos

API: 071-08098

Operator: EVERGREEN NATURAL RESOURCES

Inspection Date: 8/16/2021

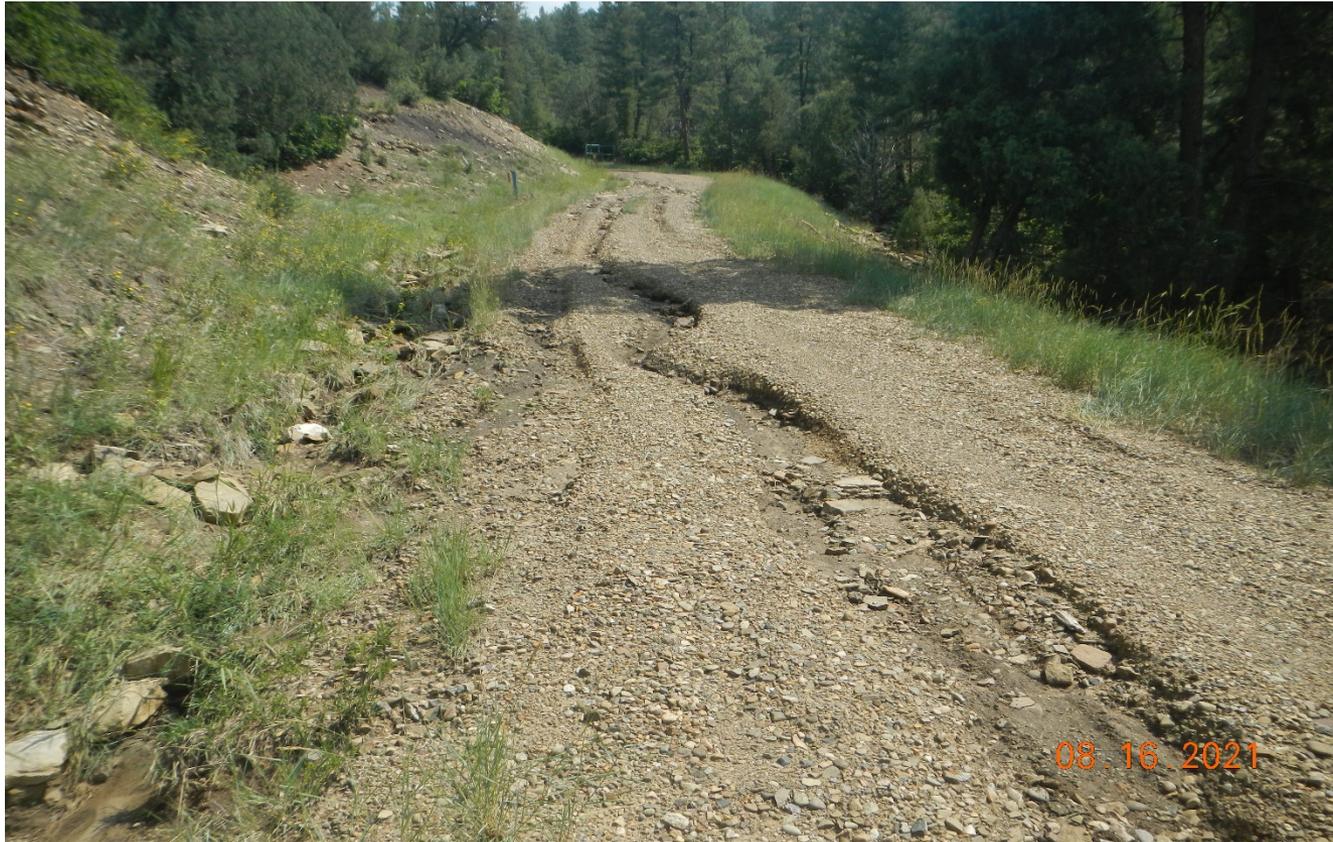
Photo 1. There is stormwater erosion occurring down the road. The road needs to be repaired and stormwater diverted off the road and toward culverts.

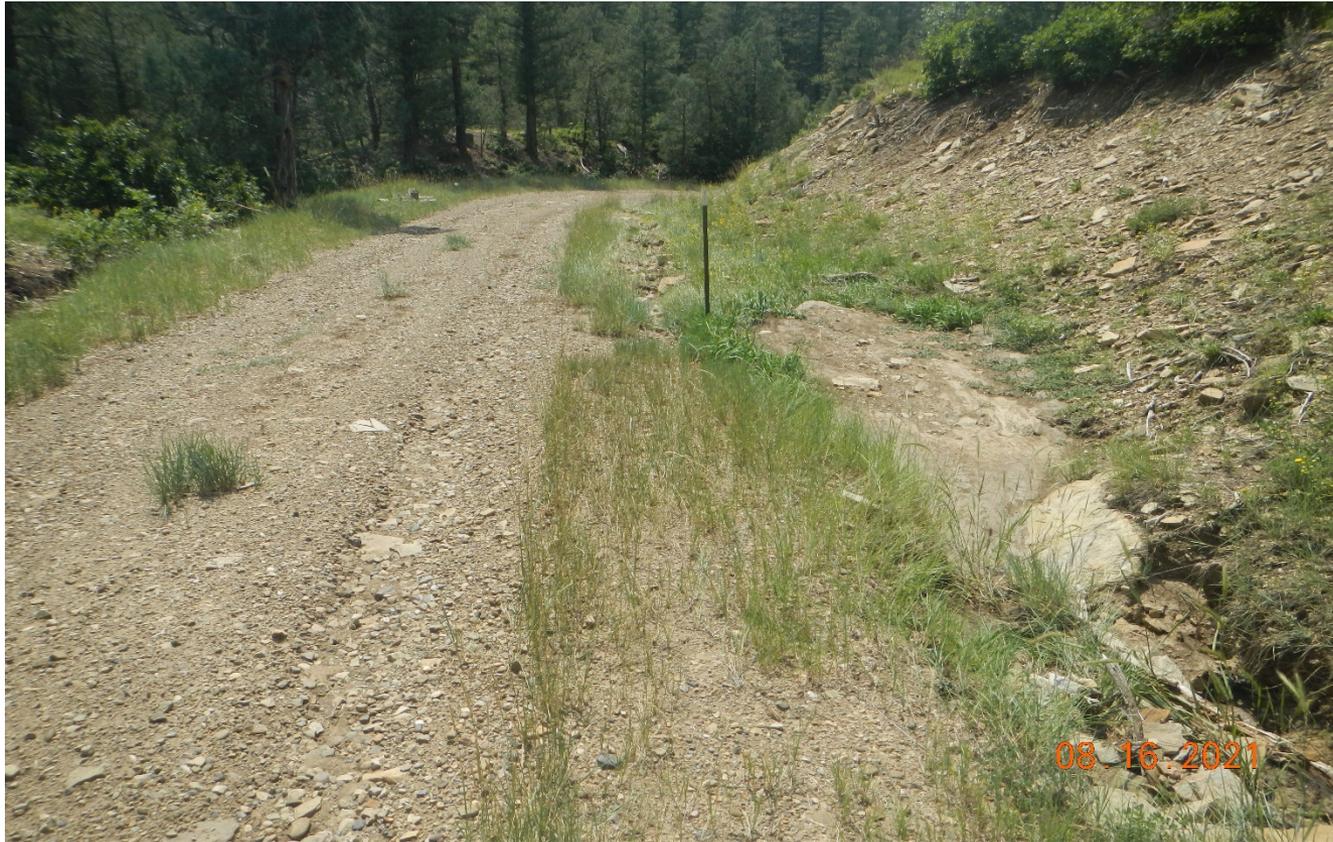
Photo 2. There are culverts along the road that have filled in with sediment and need maintenance.

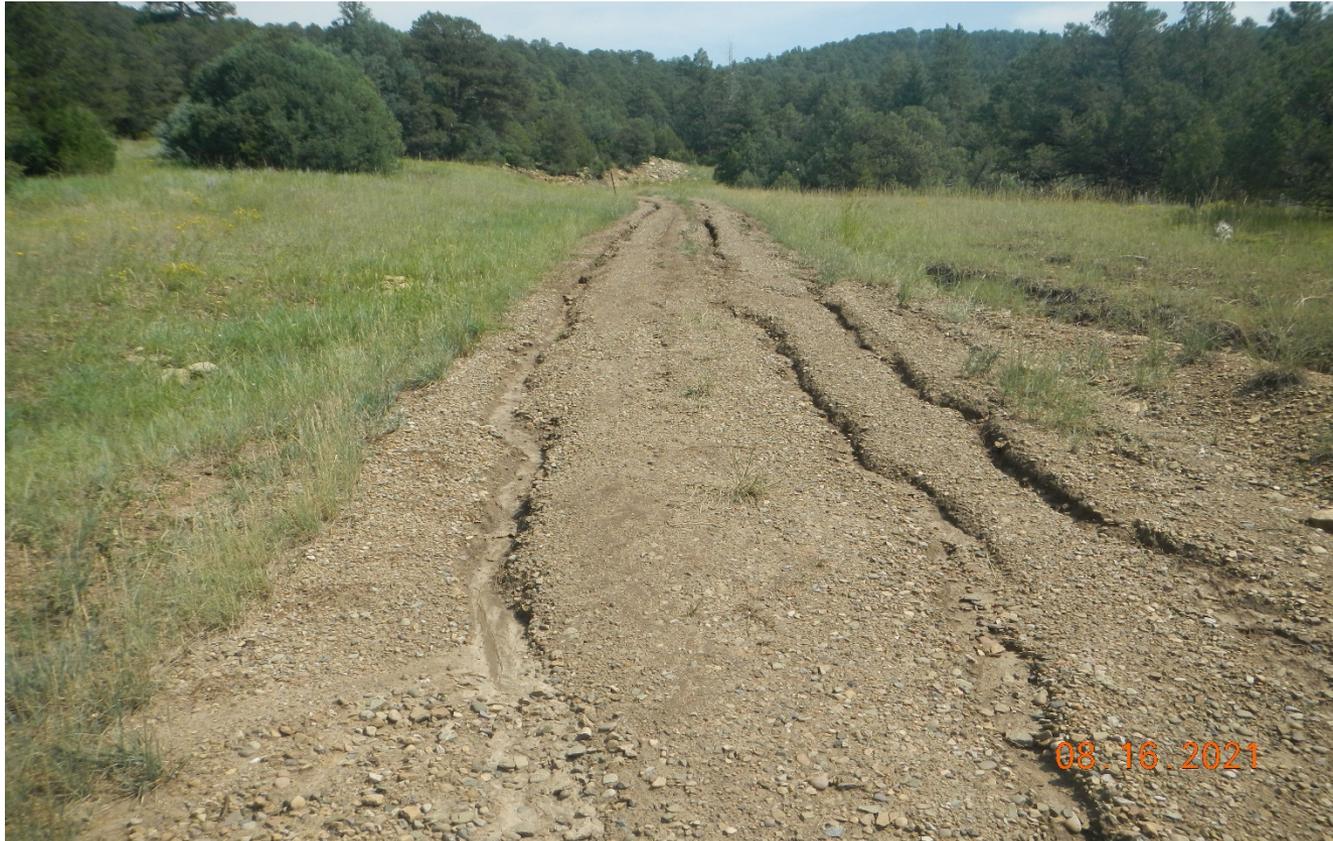
Photo 3. There is stormwater erosion occurring down the road. The road needs to be repaired and stormwater diverted off the road.
