**Inspection Photos
UPRR 42 Pan Am F #4
Spill ID 480343 (AC)**

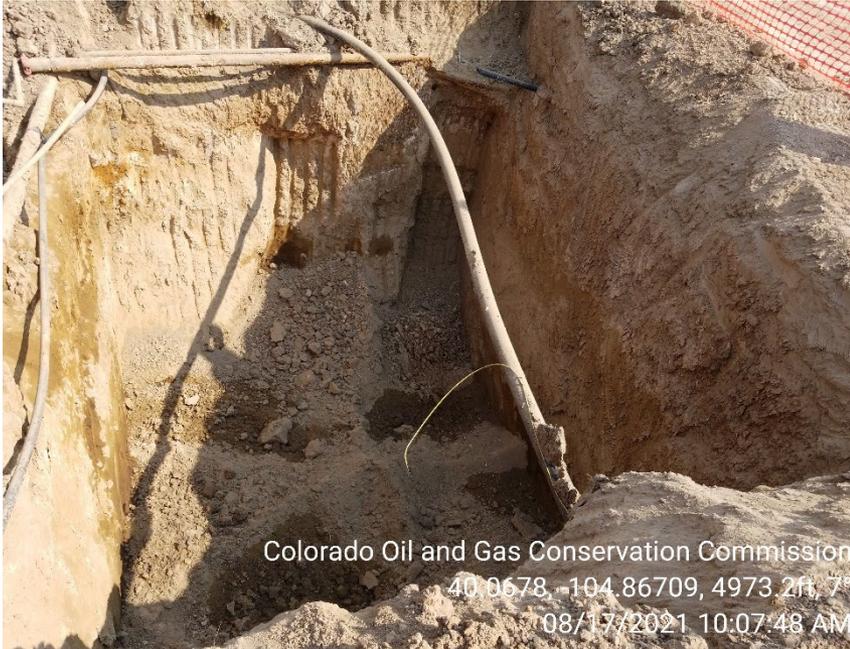
Photo 1 – Spill excavation is open. Impacts remain in-situ.

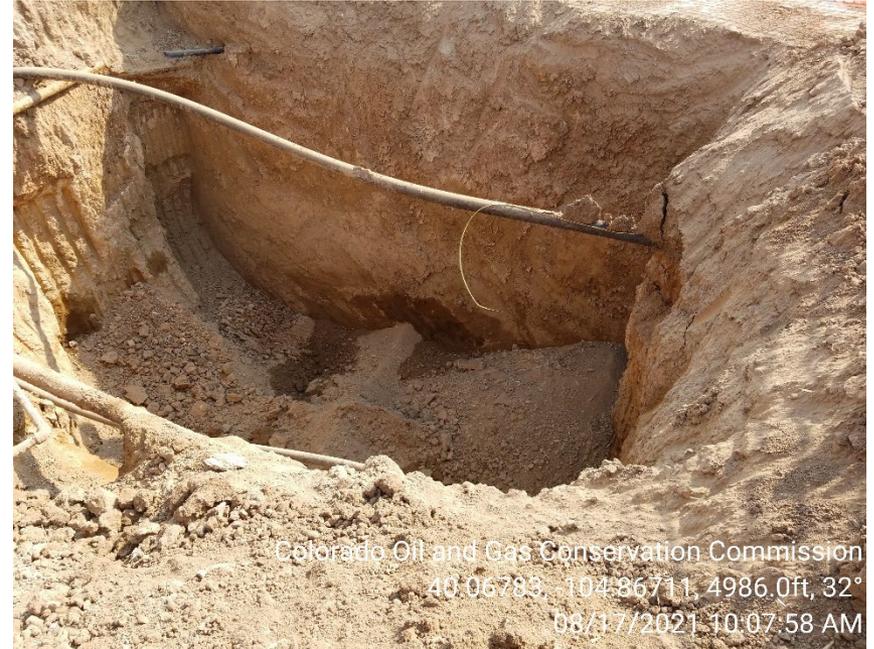
Photo 2 – Spill excavation is open. Impacts remain in-situ. Seepage of groundwater was observed in the lowest point on the floor/sidewall of the excavation.

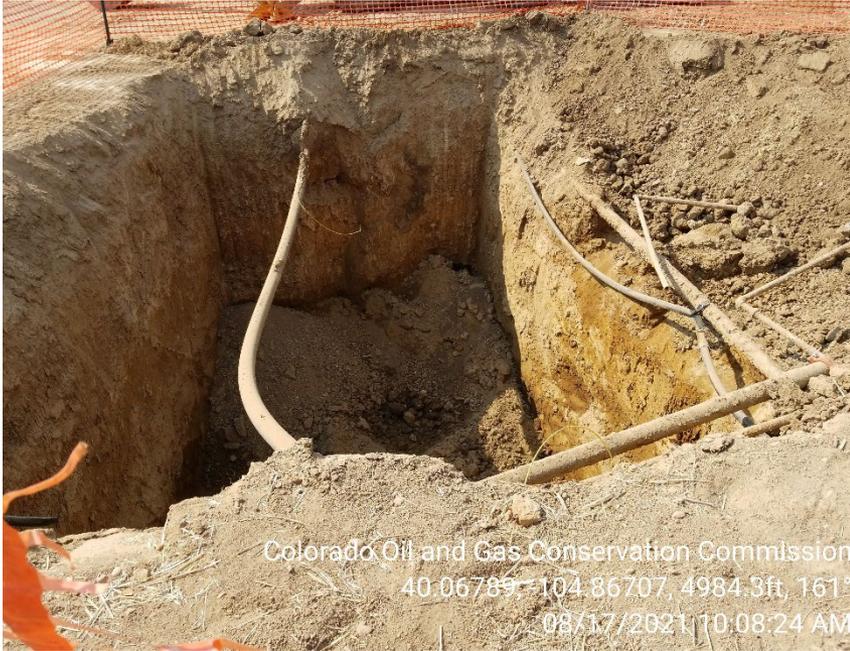
Photo 3 – Spill excavation is open. Impacts remain in-situ.

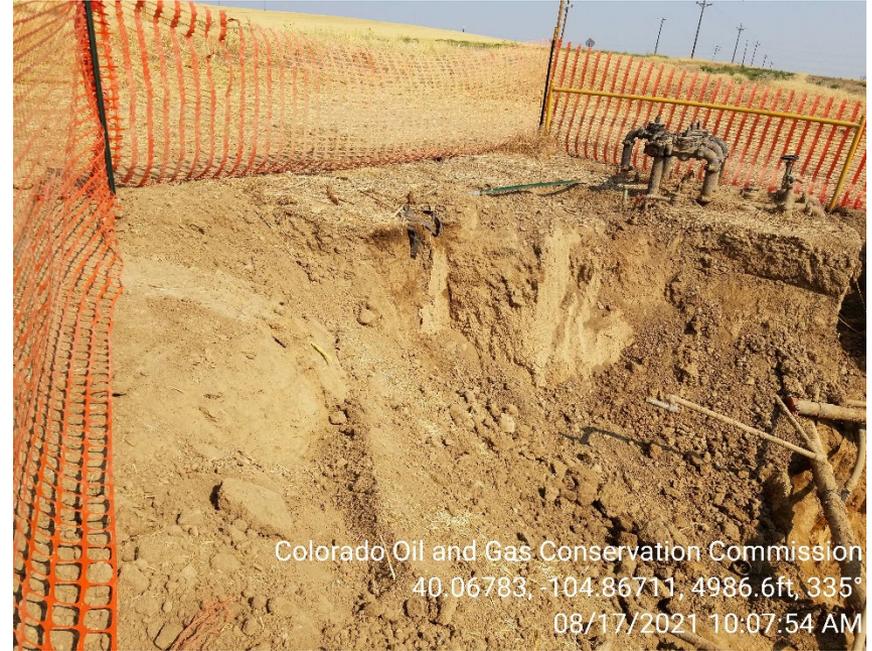
Photo 4 – Small amount of soil staining remains on surface. Fencing up around open excavation.
