Inspection Photos

Operator: Arkoma/Catamount
API: 067-10021
Date: 8/12/2021

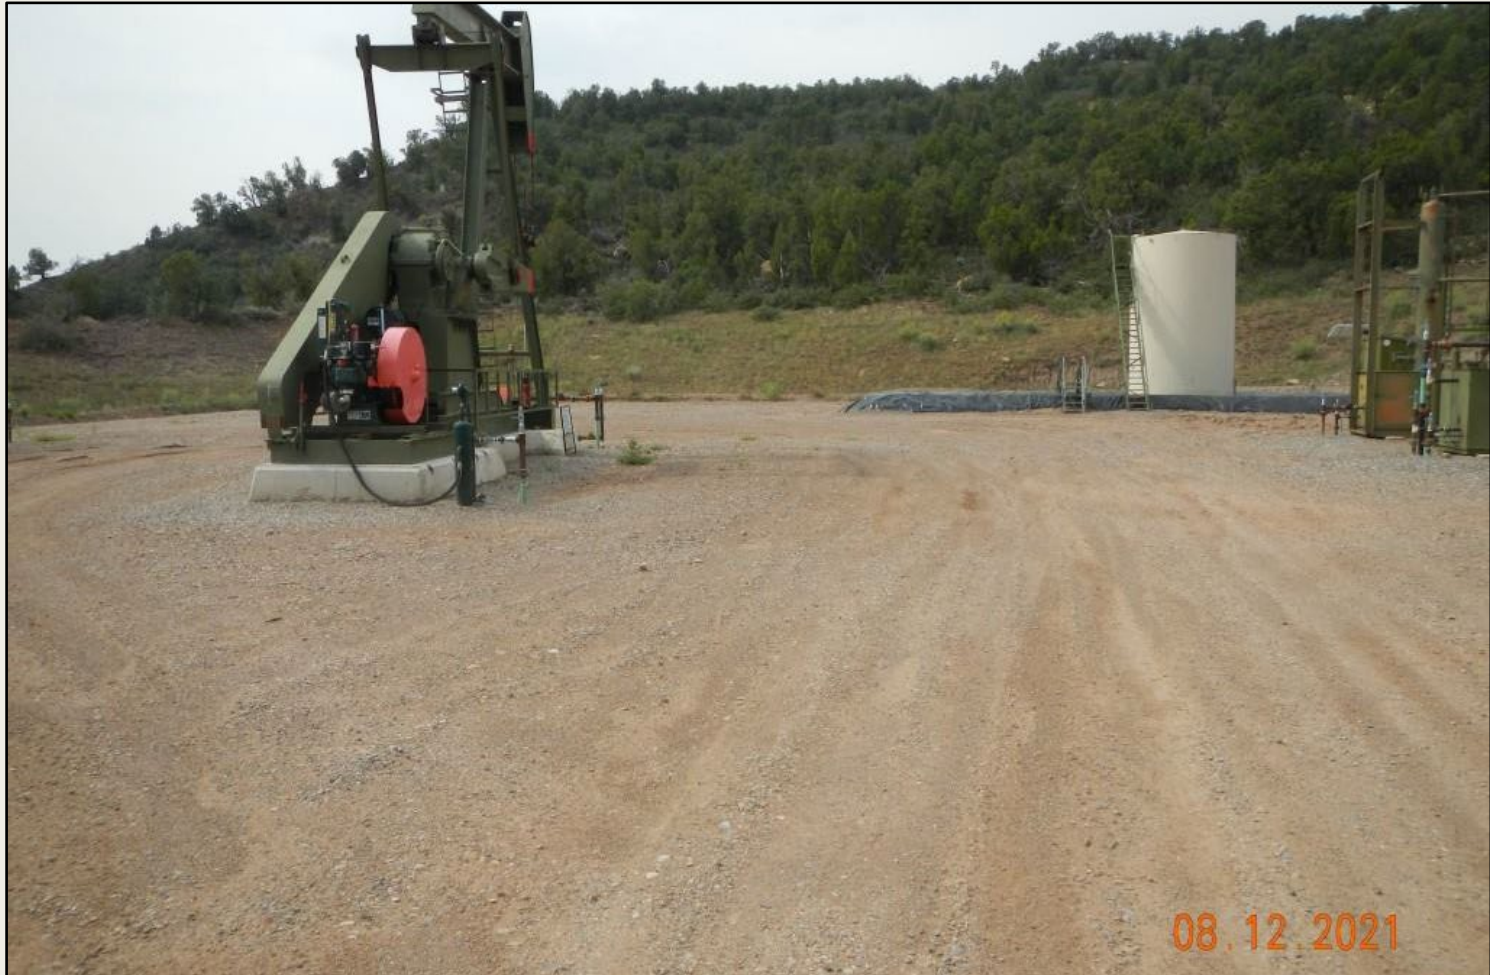
Photo 1. View of the project area from the well pad entrance facing southward.

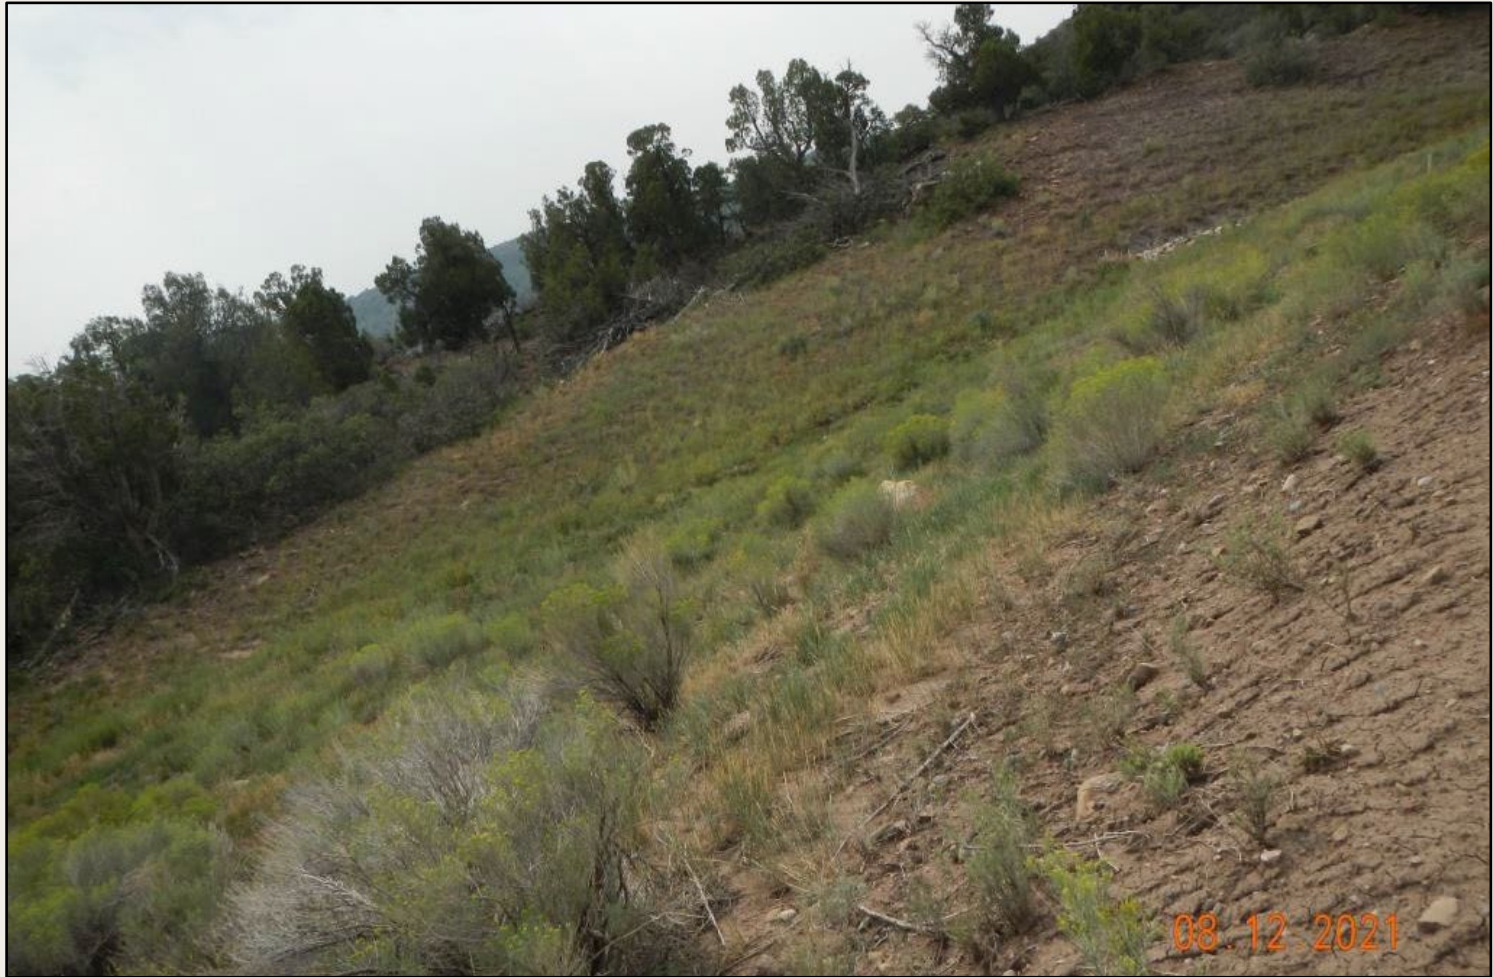
Photo 2. View of the eastern project area from the northeastern corner facing southward. Revegetation is progressing, largely with crested wheatgrass, smooth brome, and western wheatgrass.

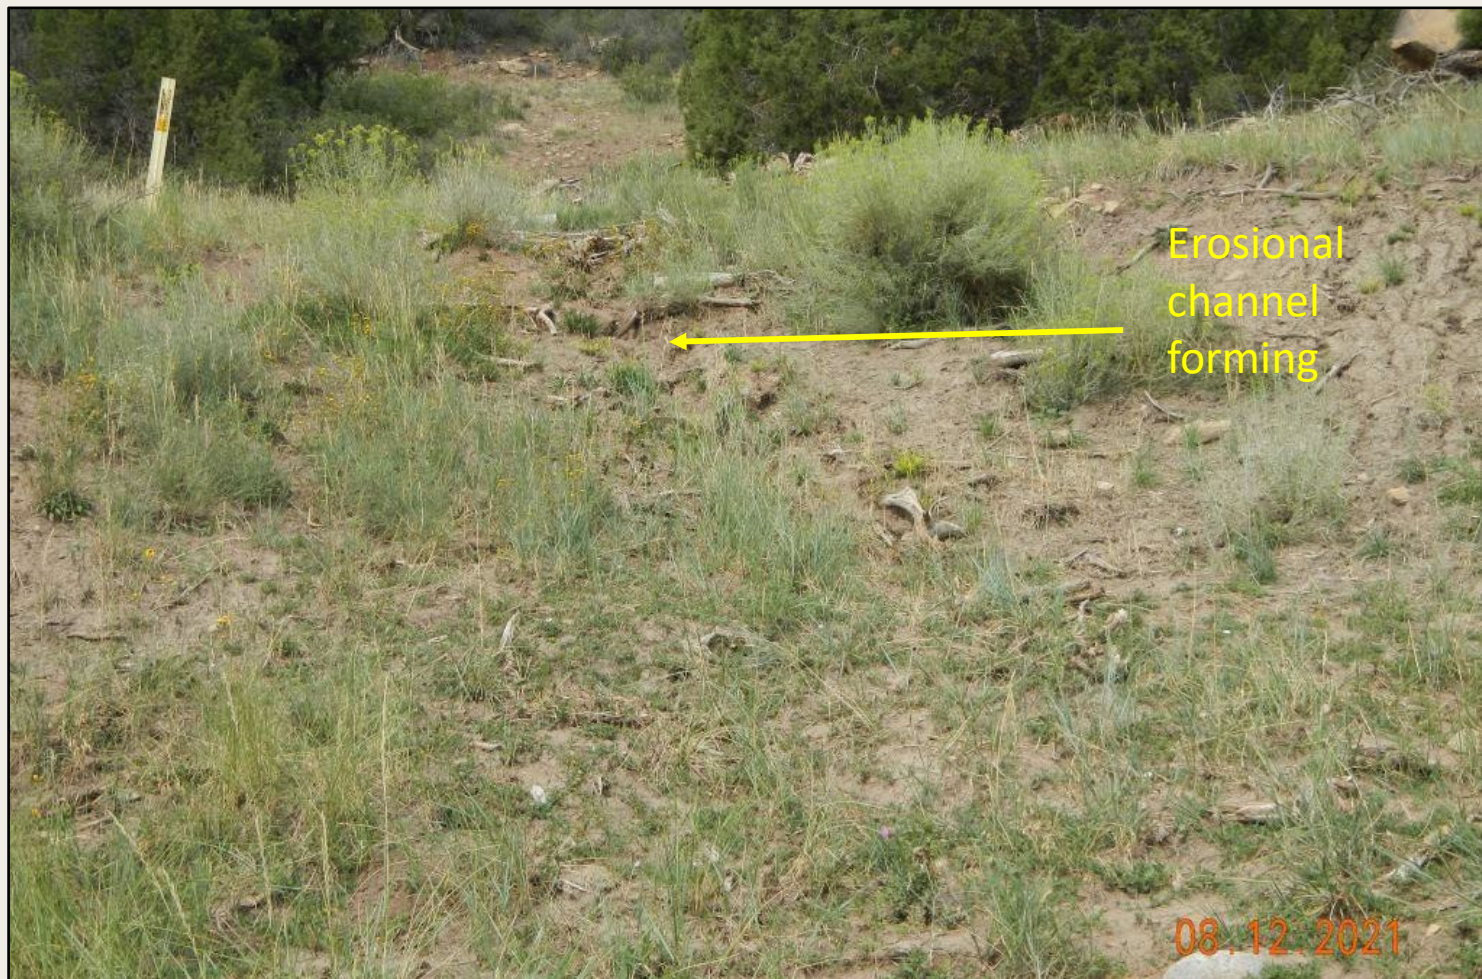
Photo 3. View of erosional channel forming within the flowline ROW, approximately 1 foot wide and deep, needs stabilization.

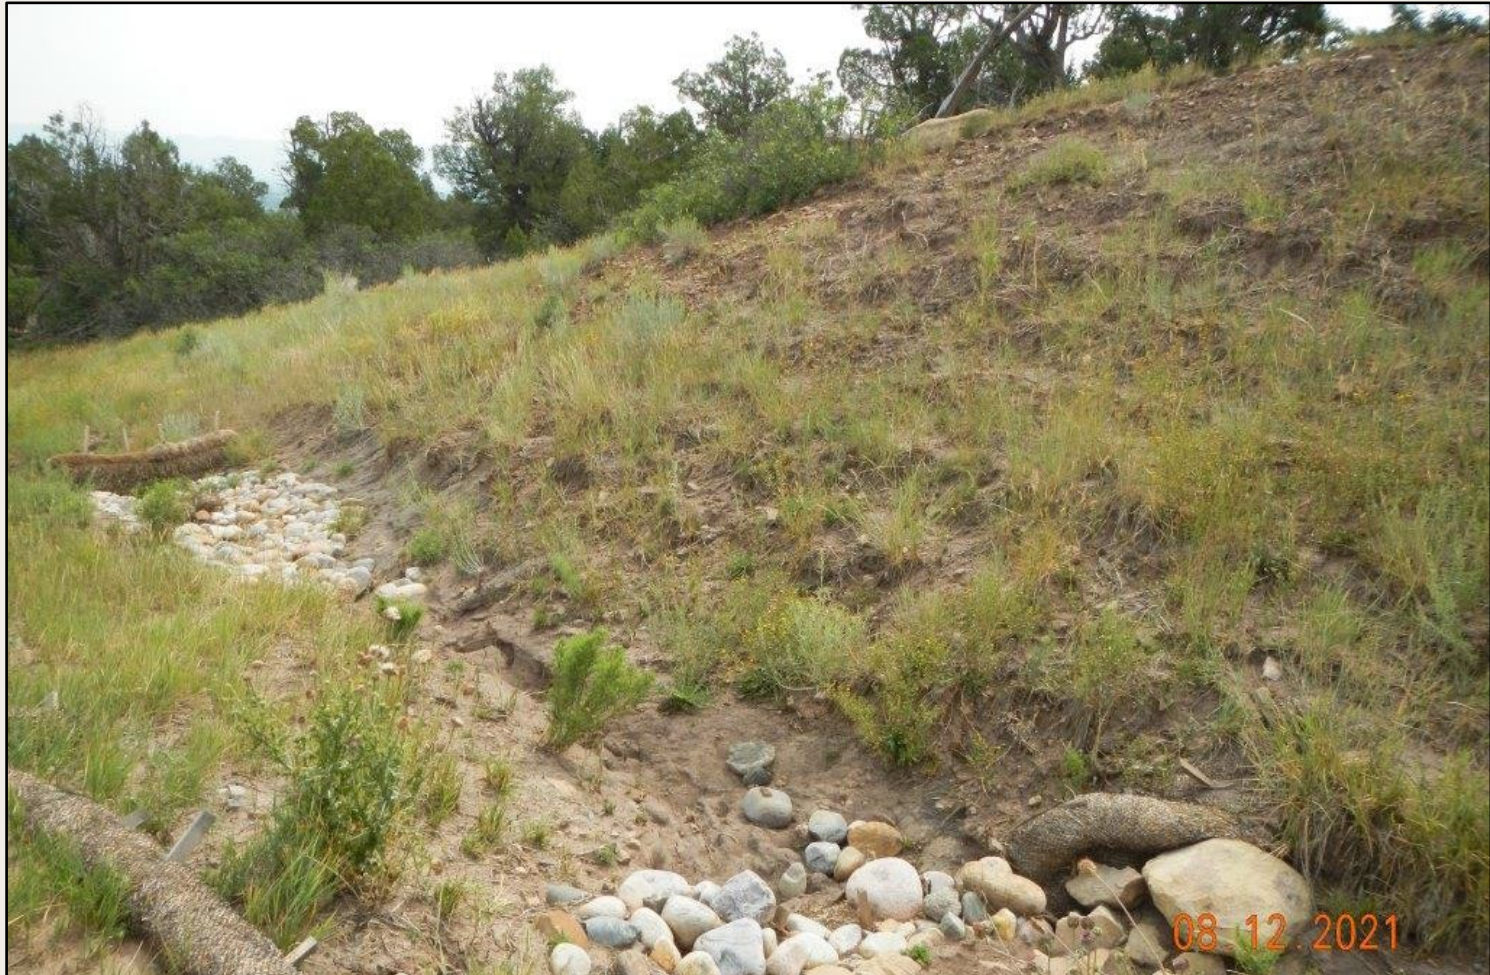
Photo 4. View of stormwater BMPs within the southeastern project area straw bales and wattles need maintenance and reinforcement.
