# Inspection Photos

Operator: Arkoma/Catamount  
API: 067-05294  
Date: 8/12/2021

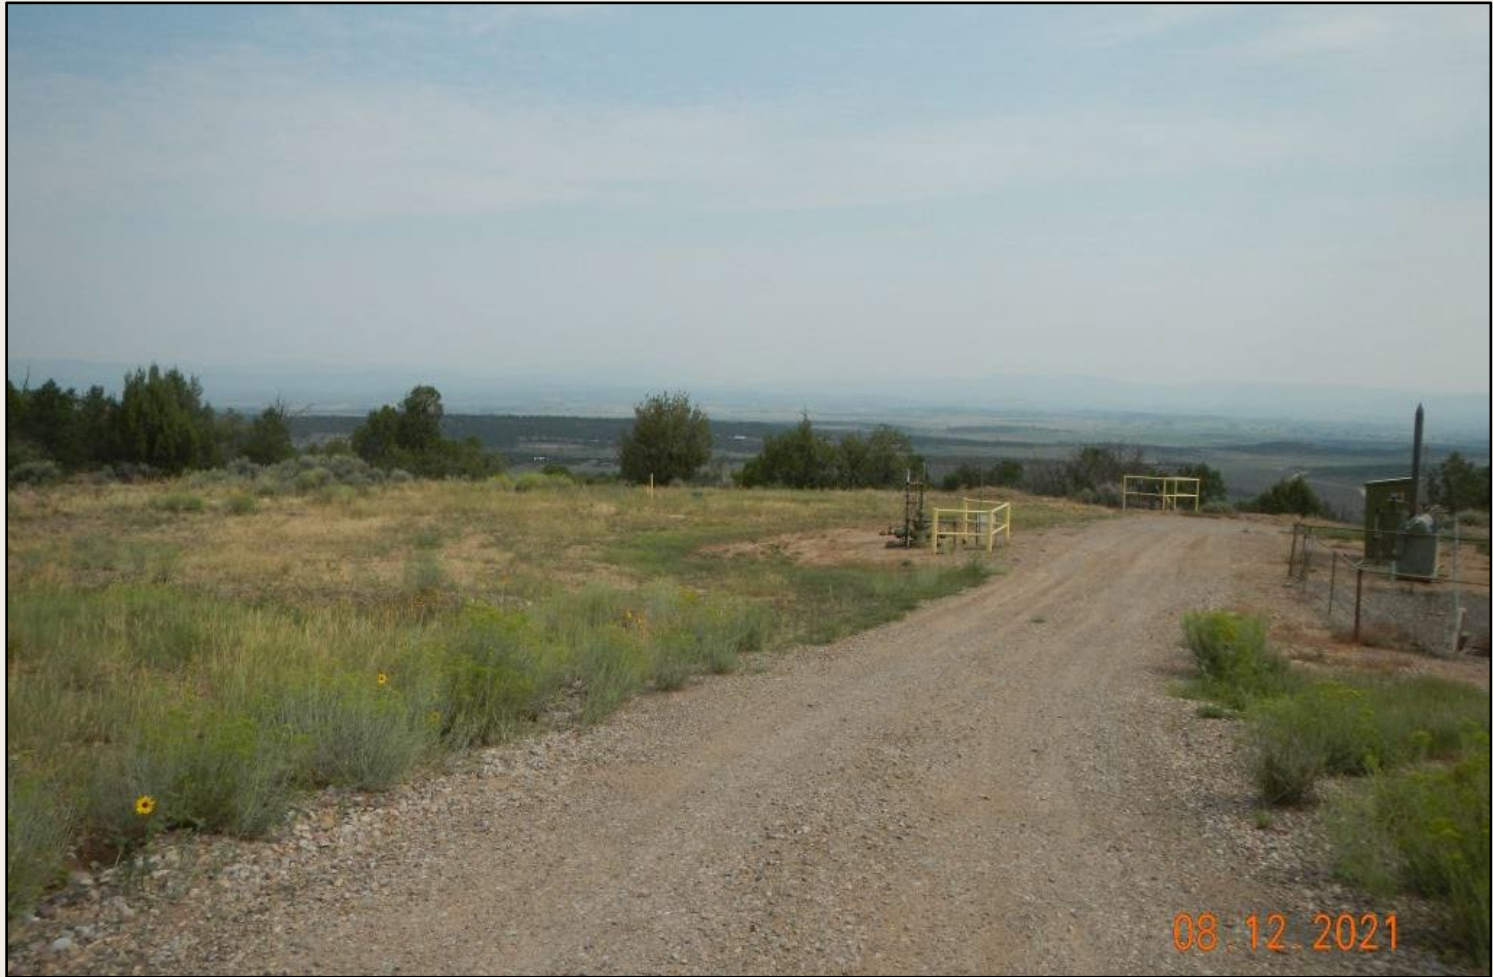
Photo 1. View of the project area from the well pad entrance facing northward.

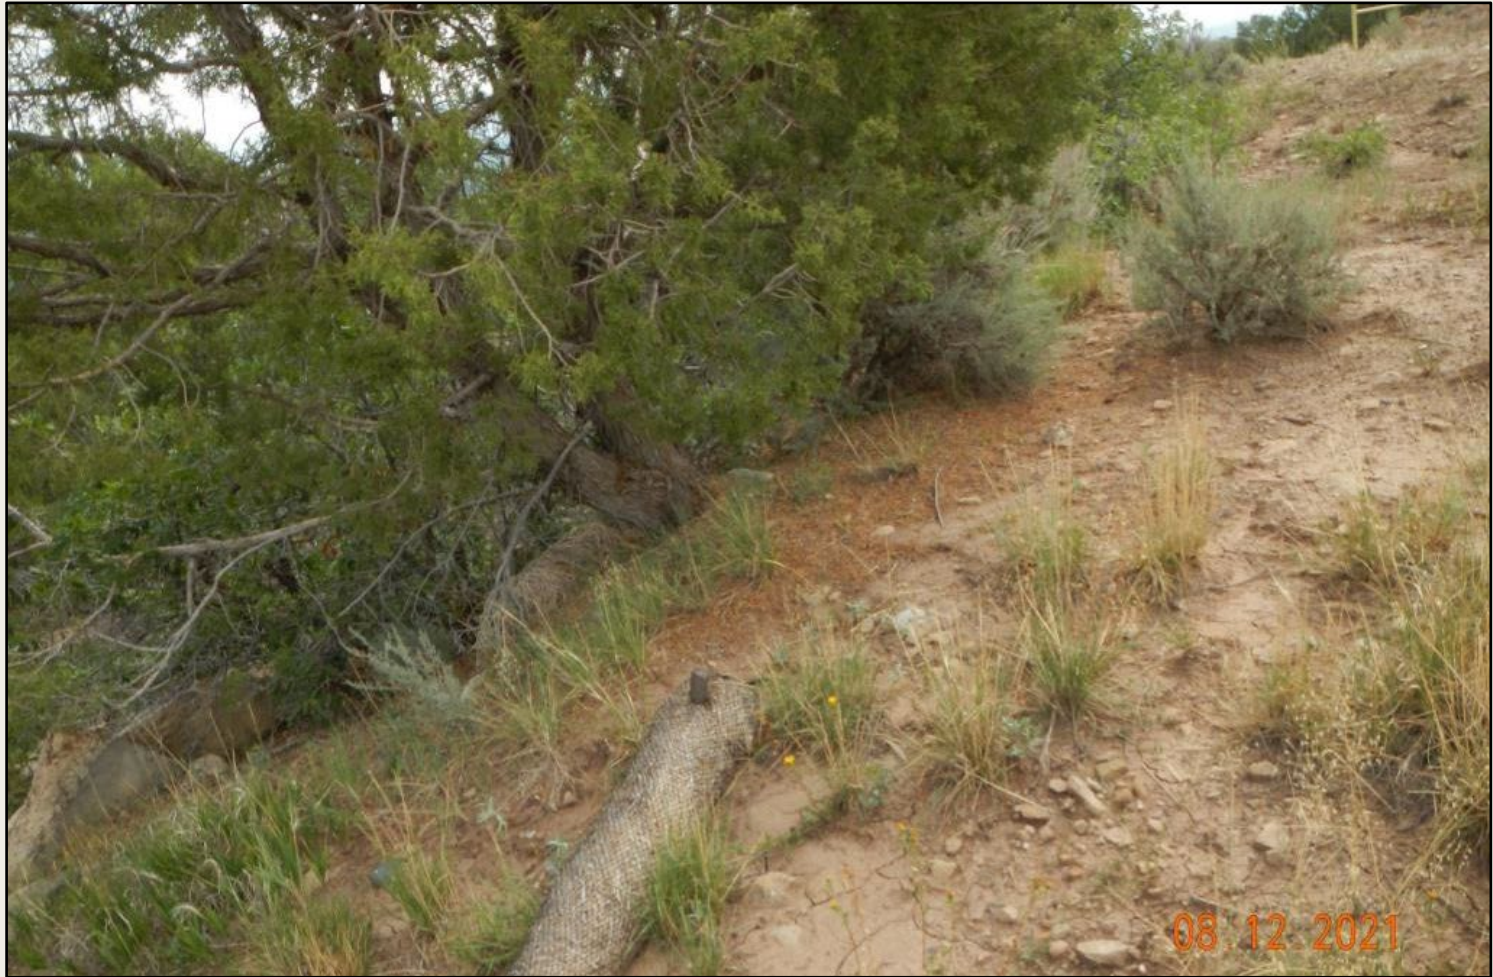
Photo 2. View of the northern project area from the northwestern corner facing eastward.

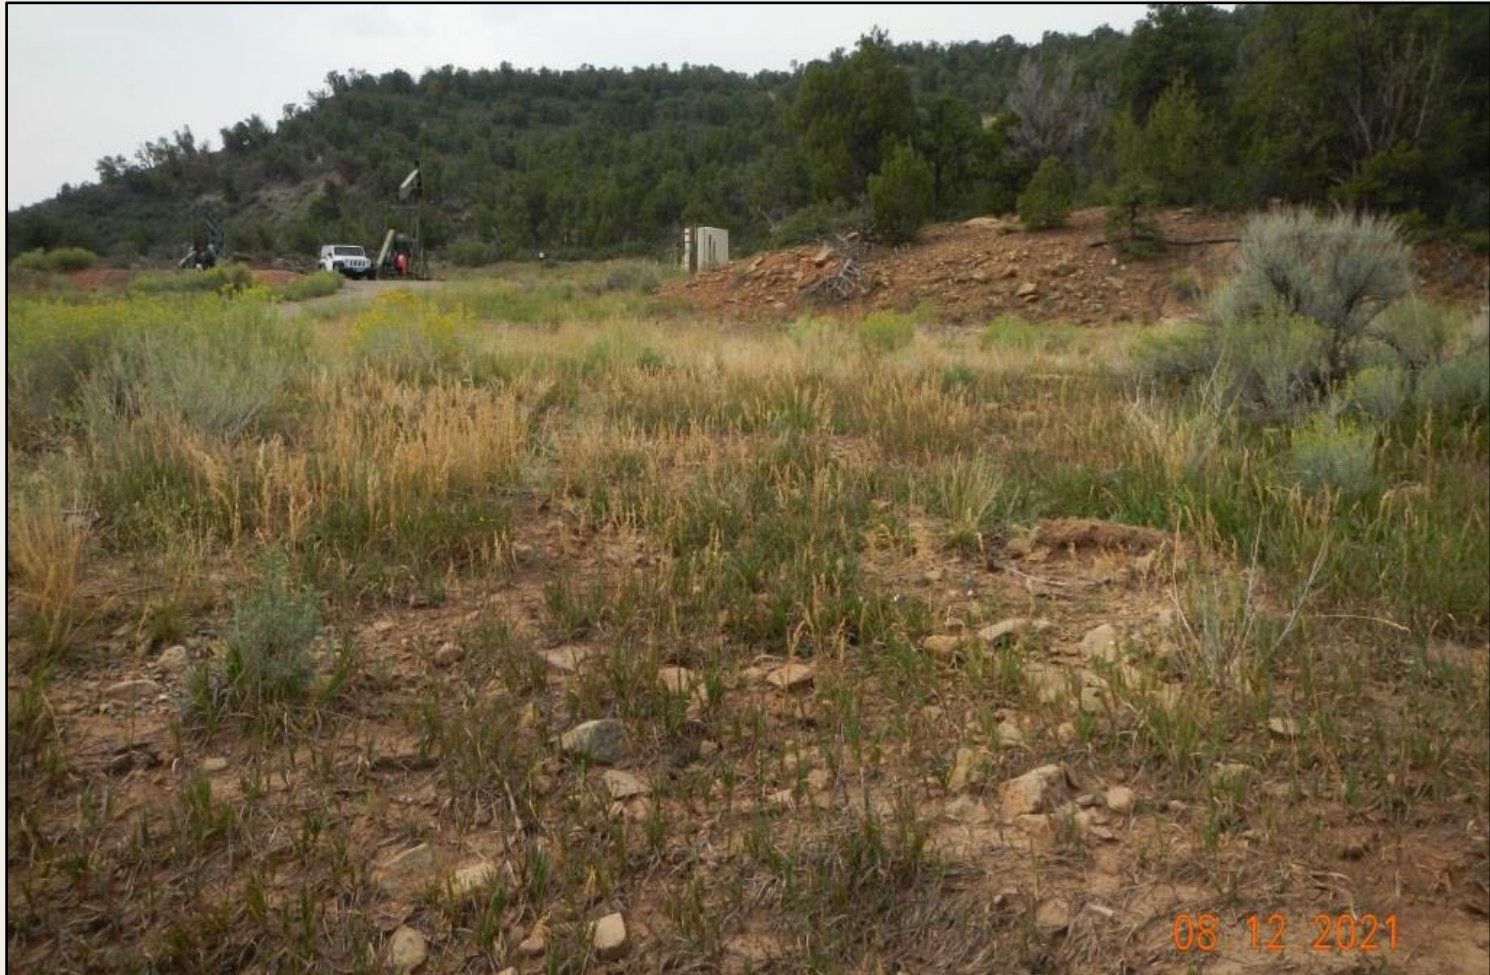
Photo 3. View of the western project area from the northwestern corner facing southward. Revegetation is progressing with smooth brome, western wheatgrass, and rubber rabbitbrush.

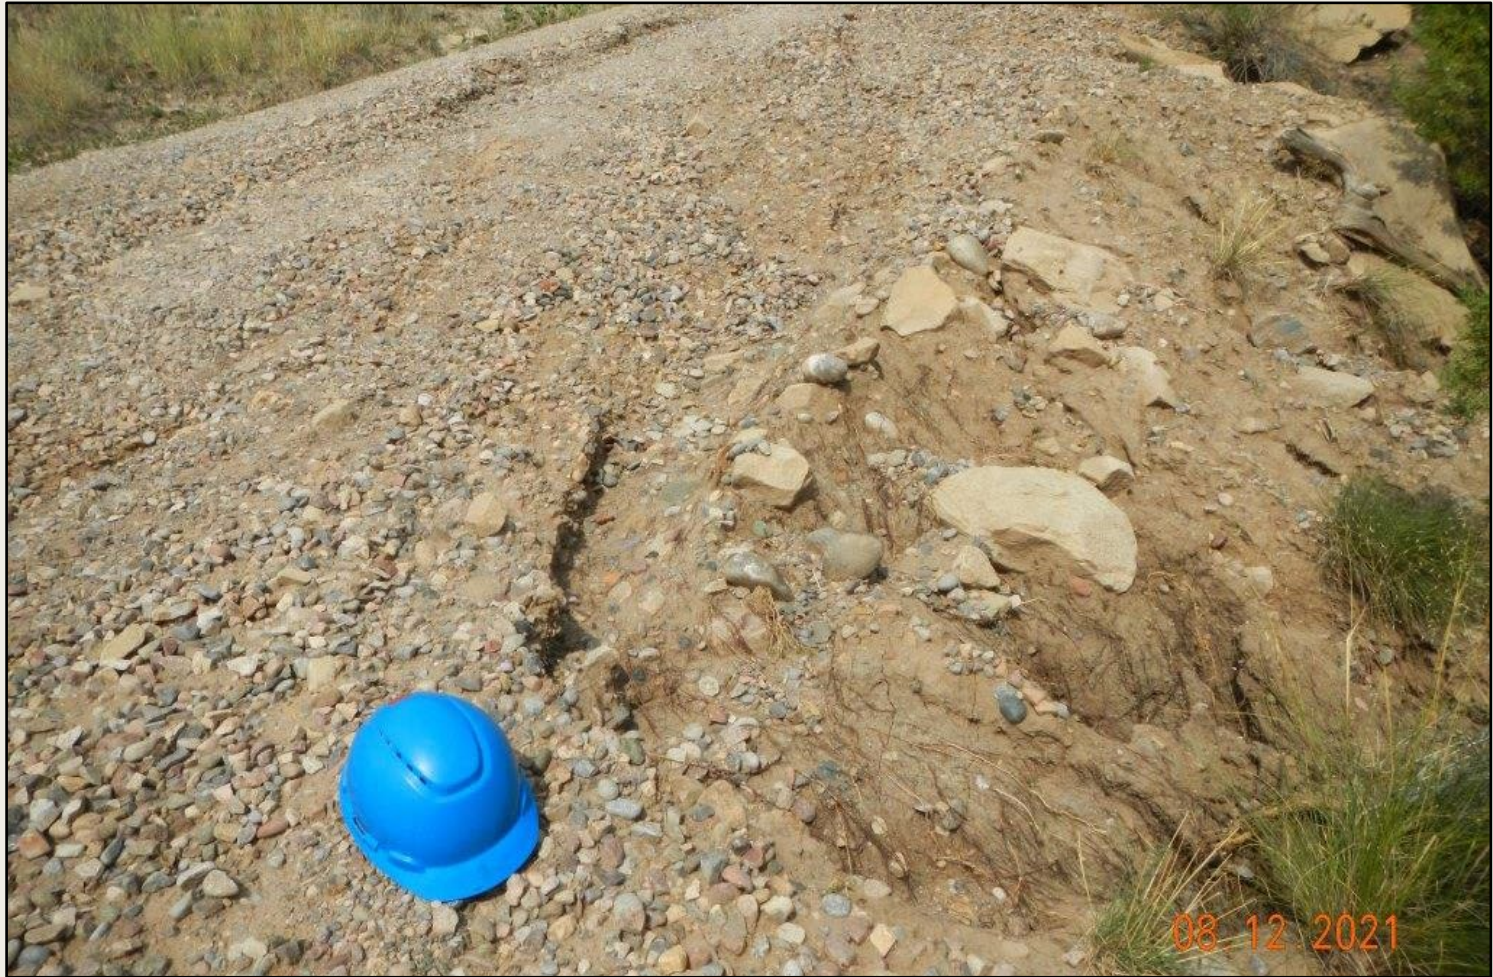
Photo 4. View of area along the access road where improperly diverged flows have eroded the road surface and hillside (facing upslope). Gravel is washed downslope approximately 50 feet.

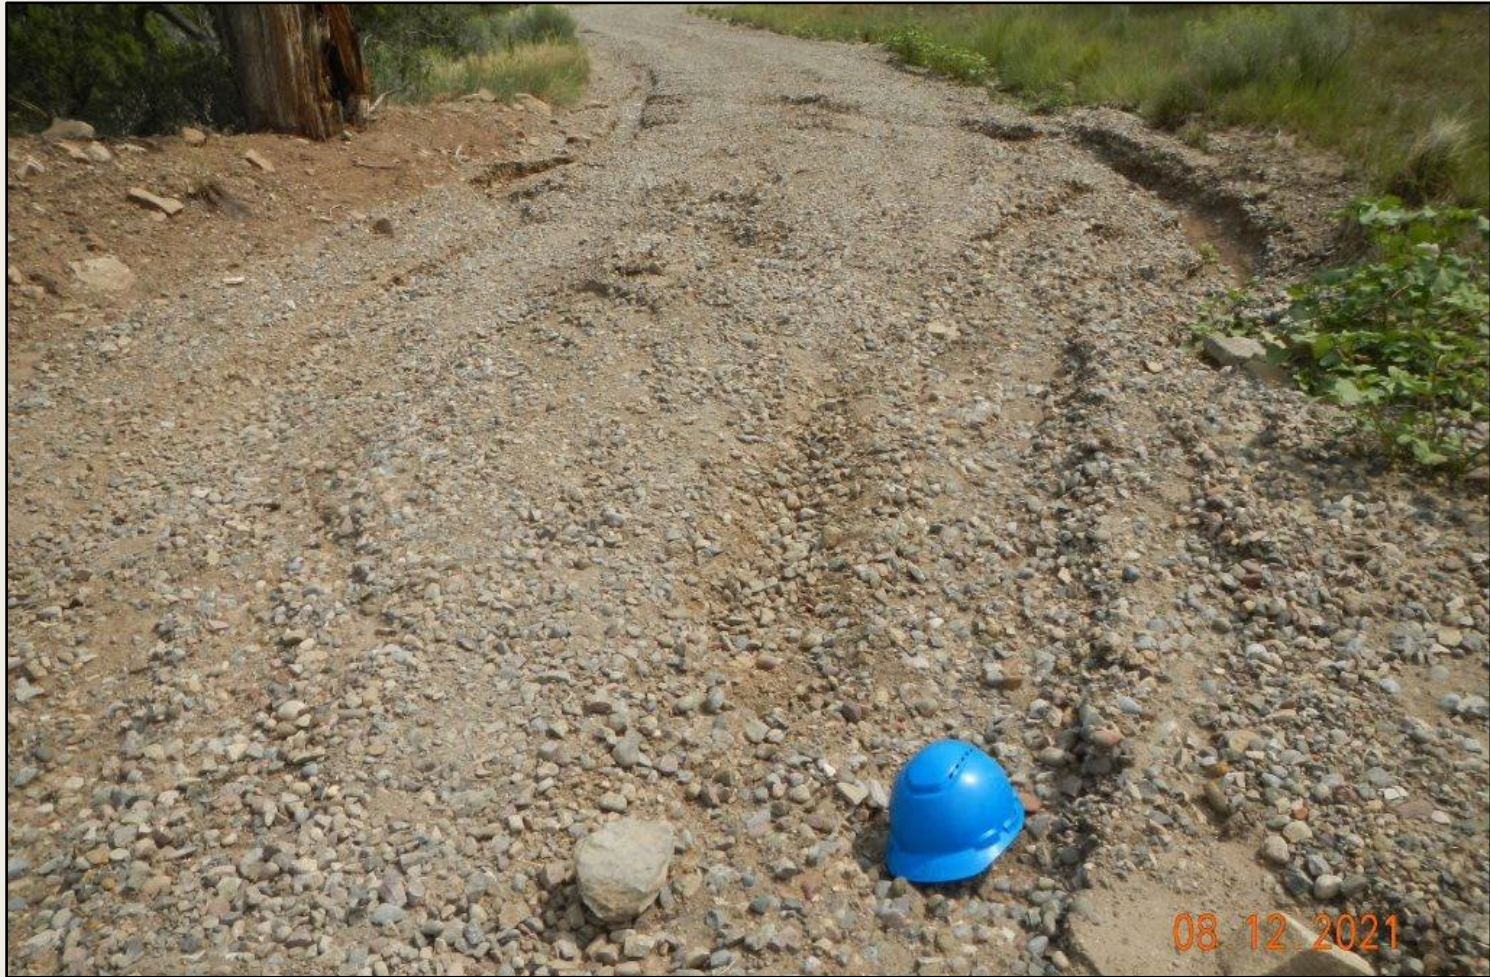
Photo 5. View of area where stormwater flows have washed out the road surface, depositing fill and gravel down-slope.

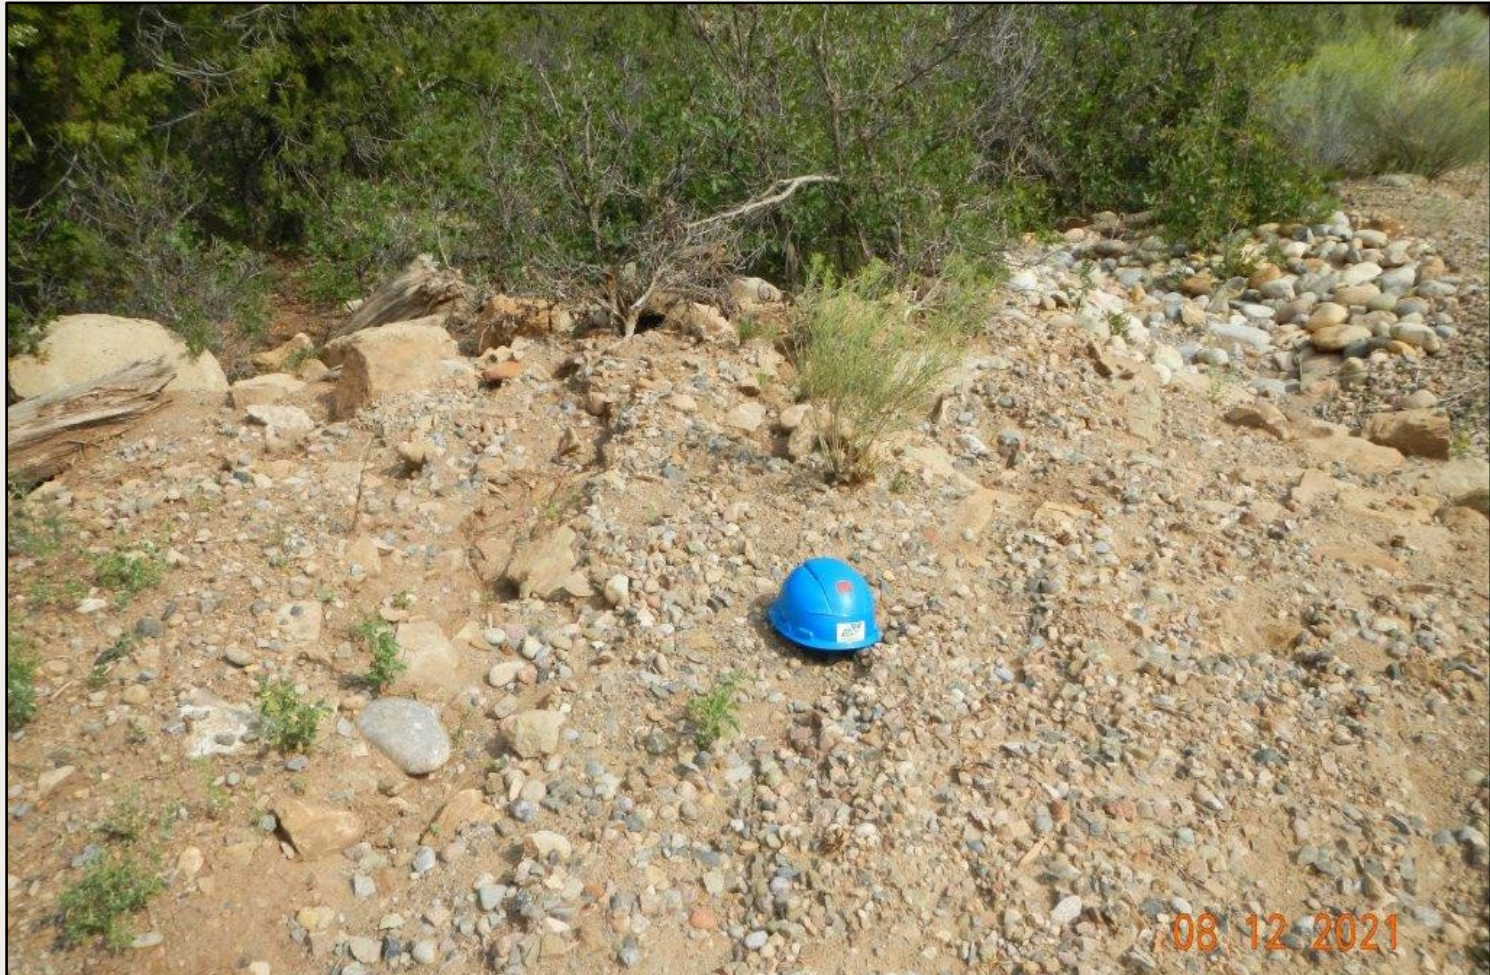
Photo 6. View of another area on the access showing where gravel and fill material is discharging from the access road.

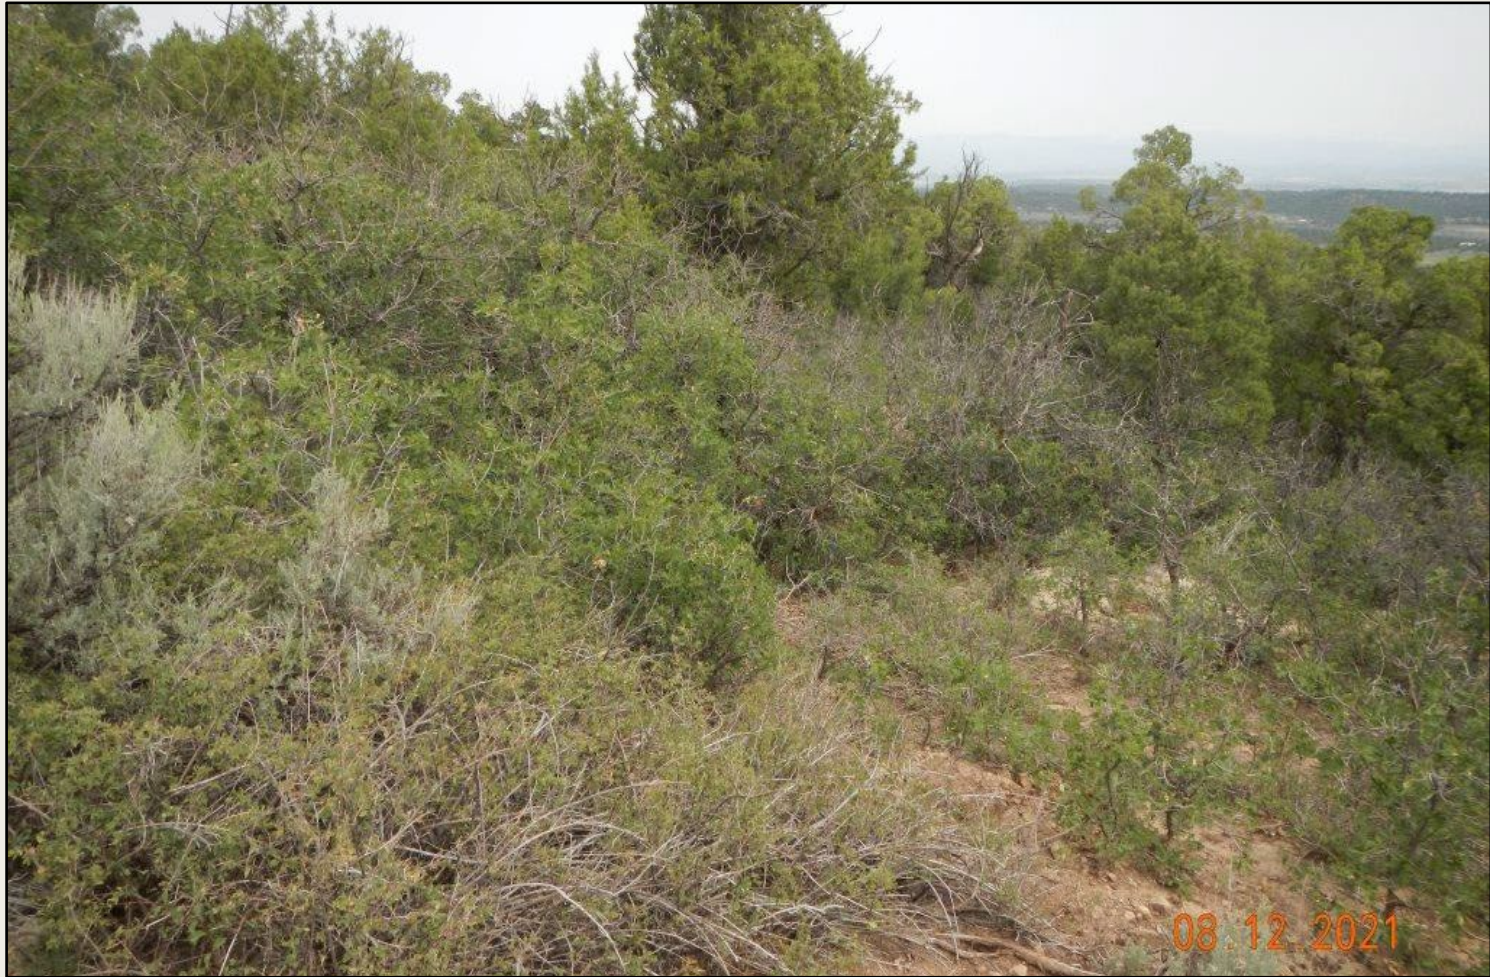
Photo 7. View of the reference area comprised pinyon and juniper woodland with understory of gambel oak, sagebrush, antelope bitterbrush, and squirreltail.
