Inspection Photos

Operator: Arkoma/Catamount
API: 067-10018
Date: 8/12/2021

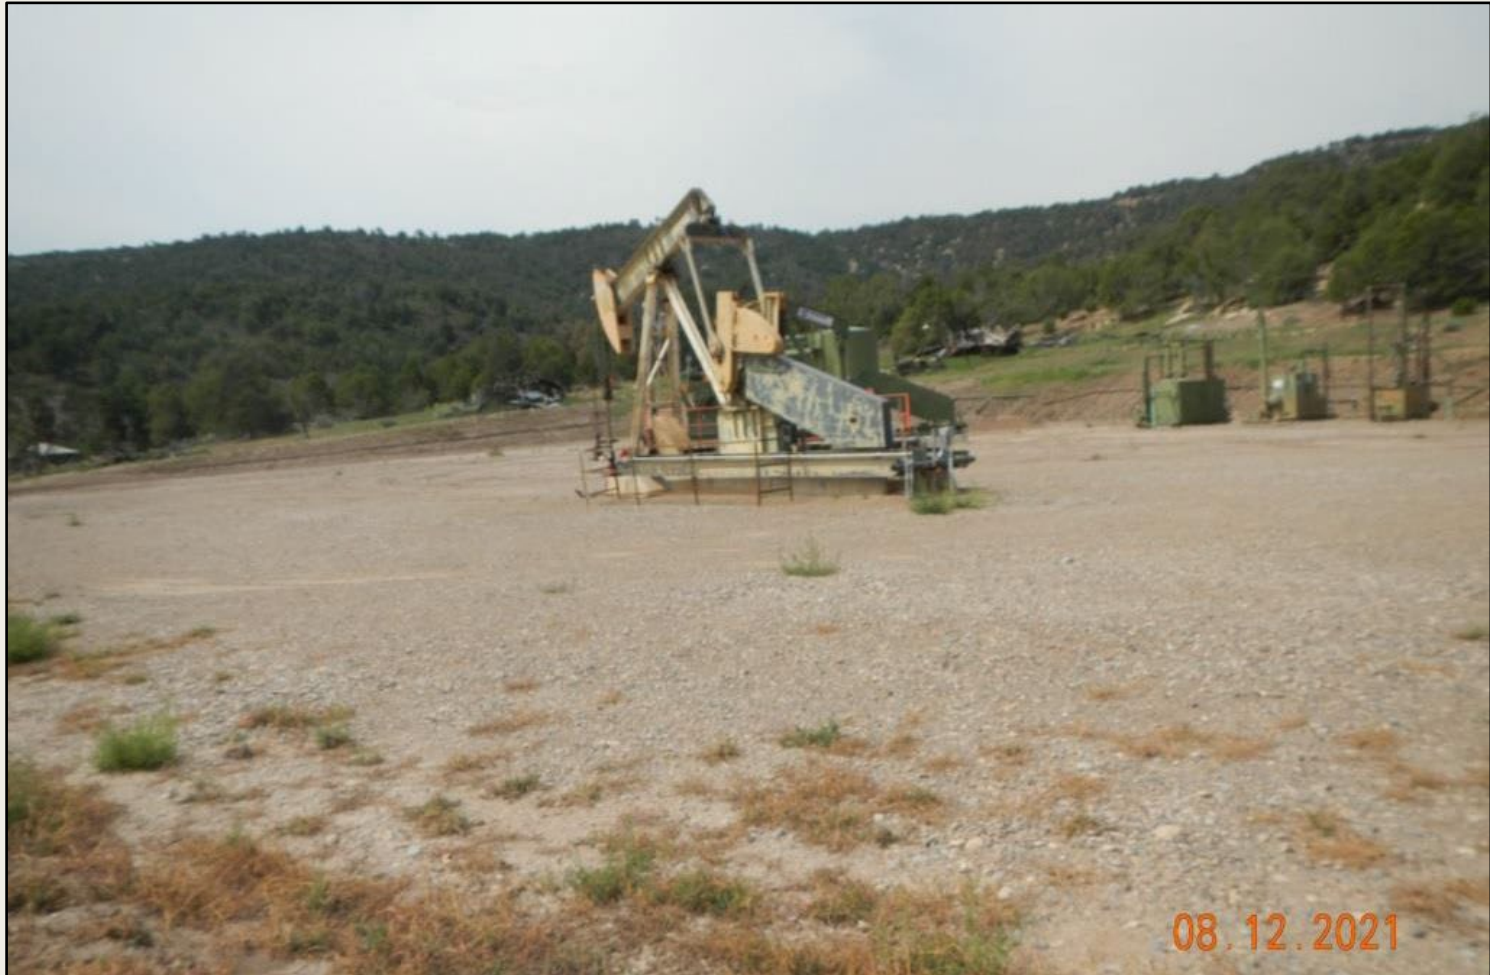
Photo 1. View of the project area from the northeastern corner facing center.

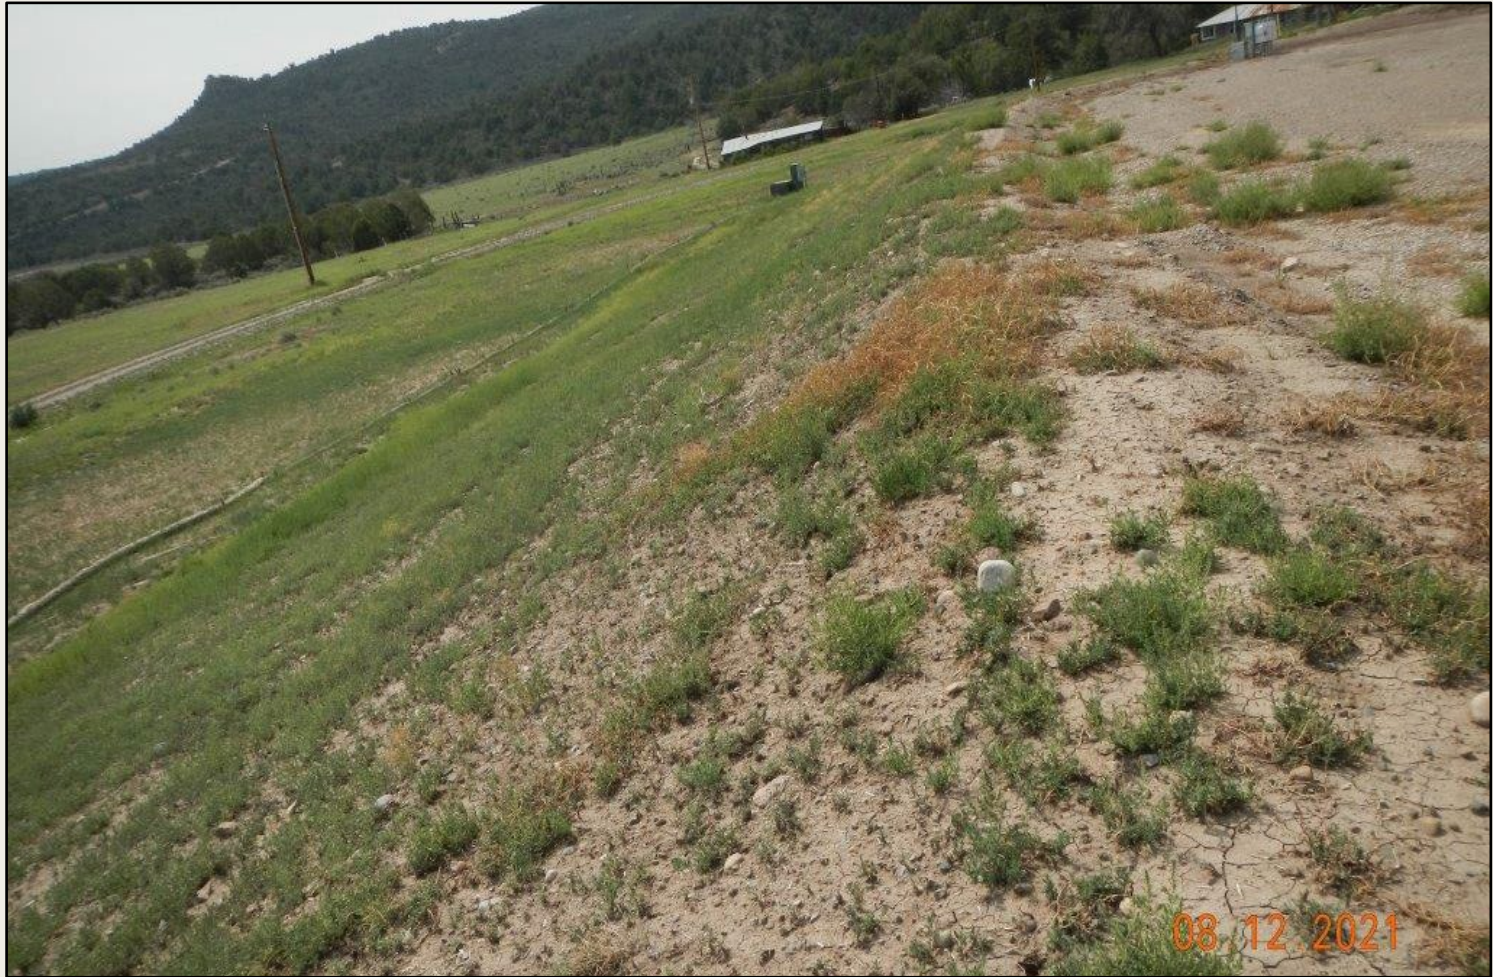
Photo 2. View of the eastern project area from the northeastern corner facing southward. Visible vegetation is comprised of kochia. Little to no desirable vegetation observed.

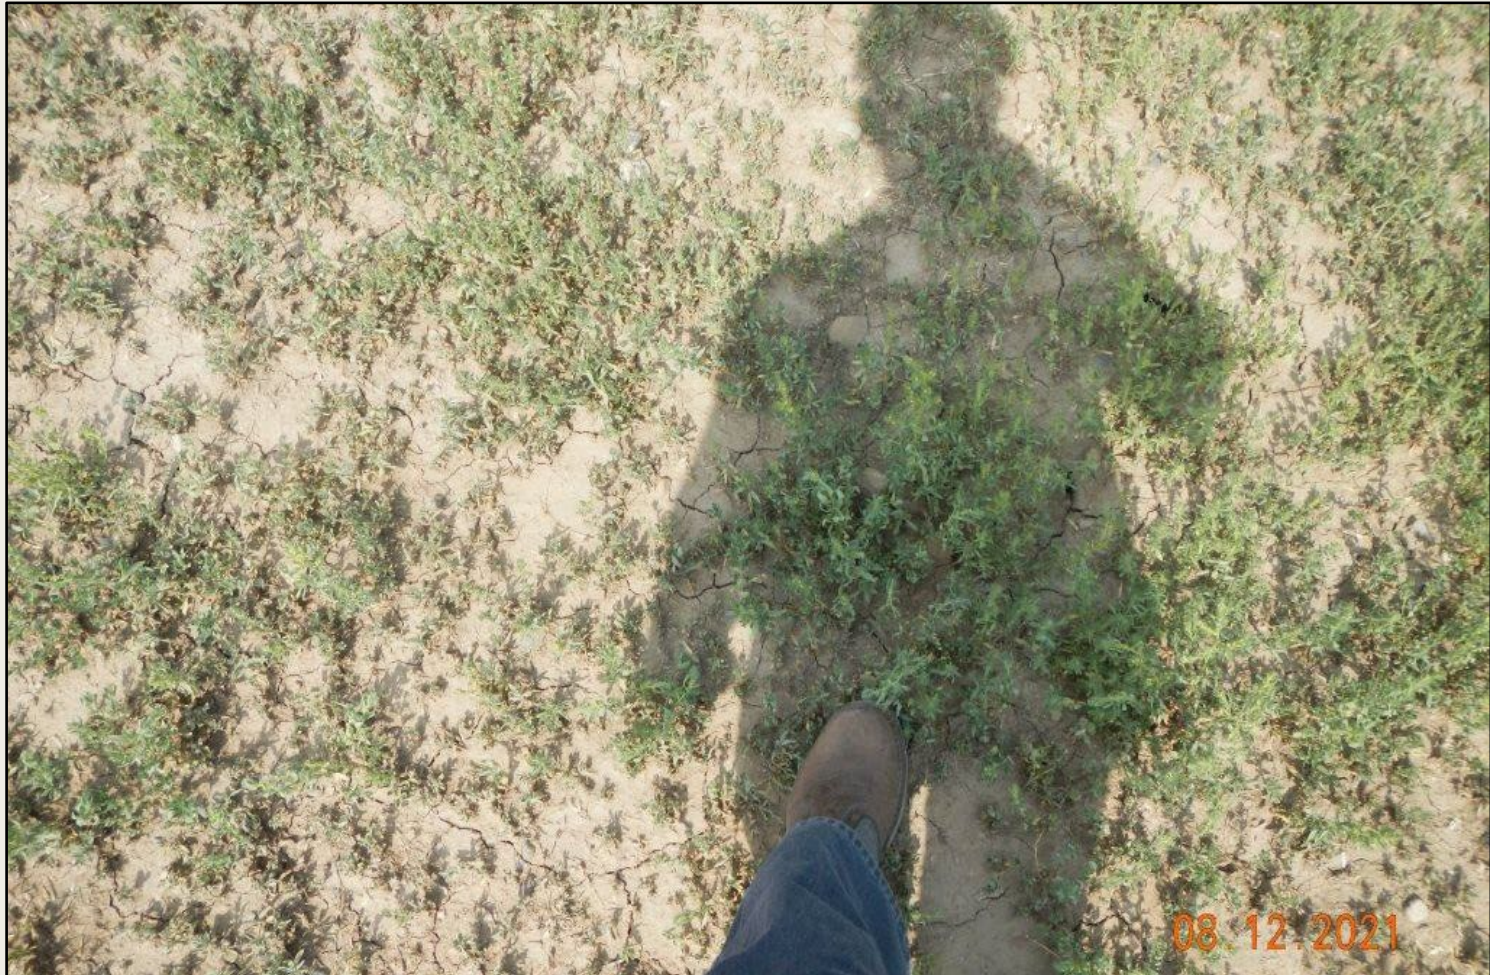
Photo 3. Aerial view of vegetation within the interim reclamation area, comprised of dense kochia weeds.

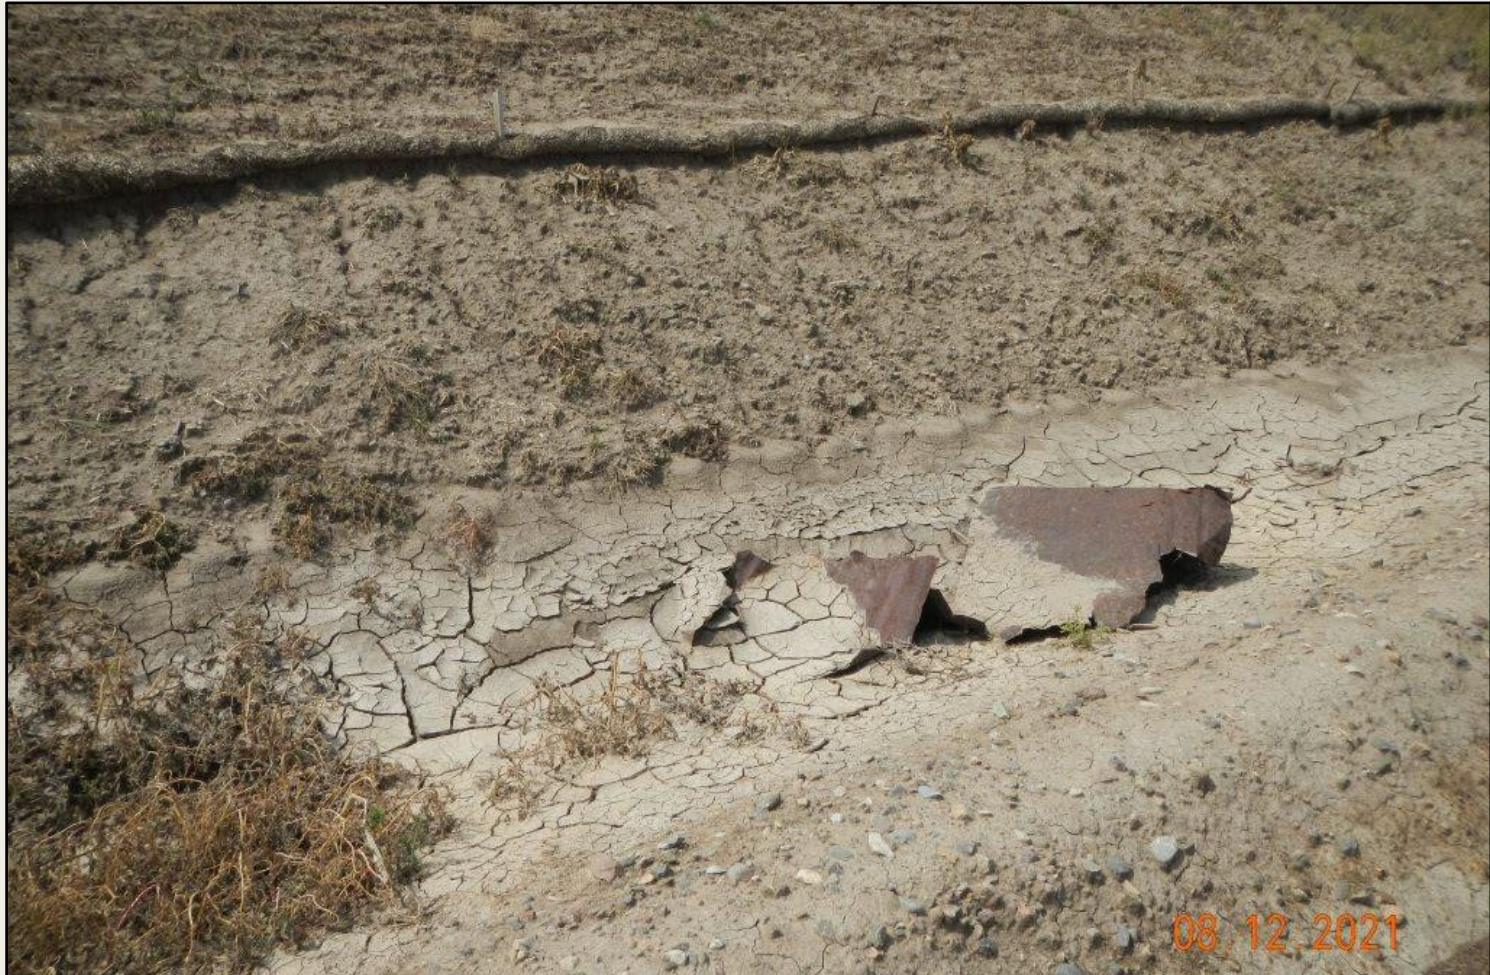
Photo 4. View of debris washed down from above the project area, within the southern diversion.

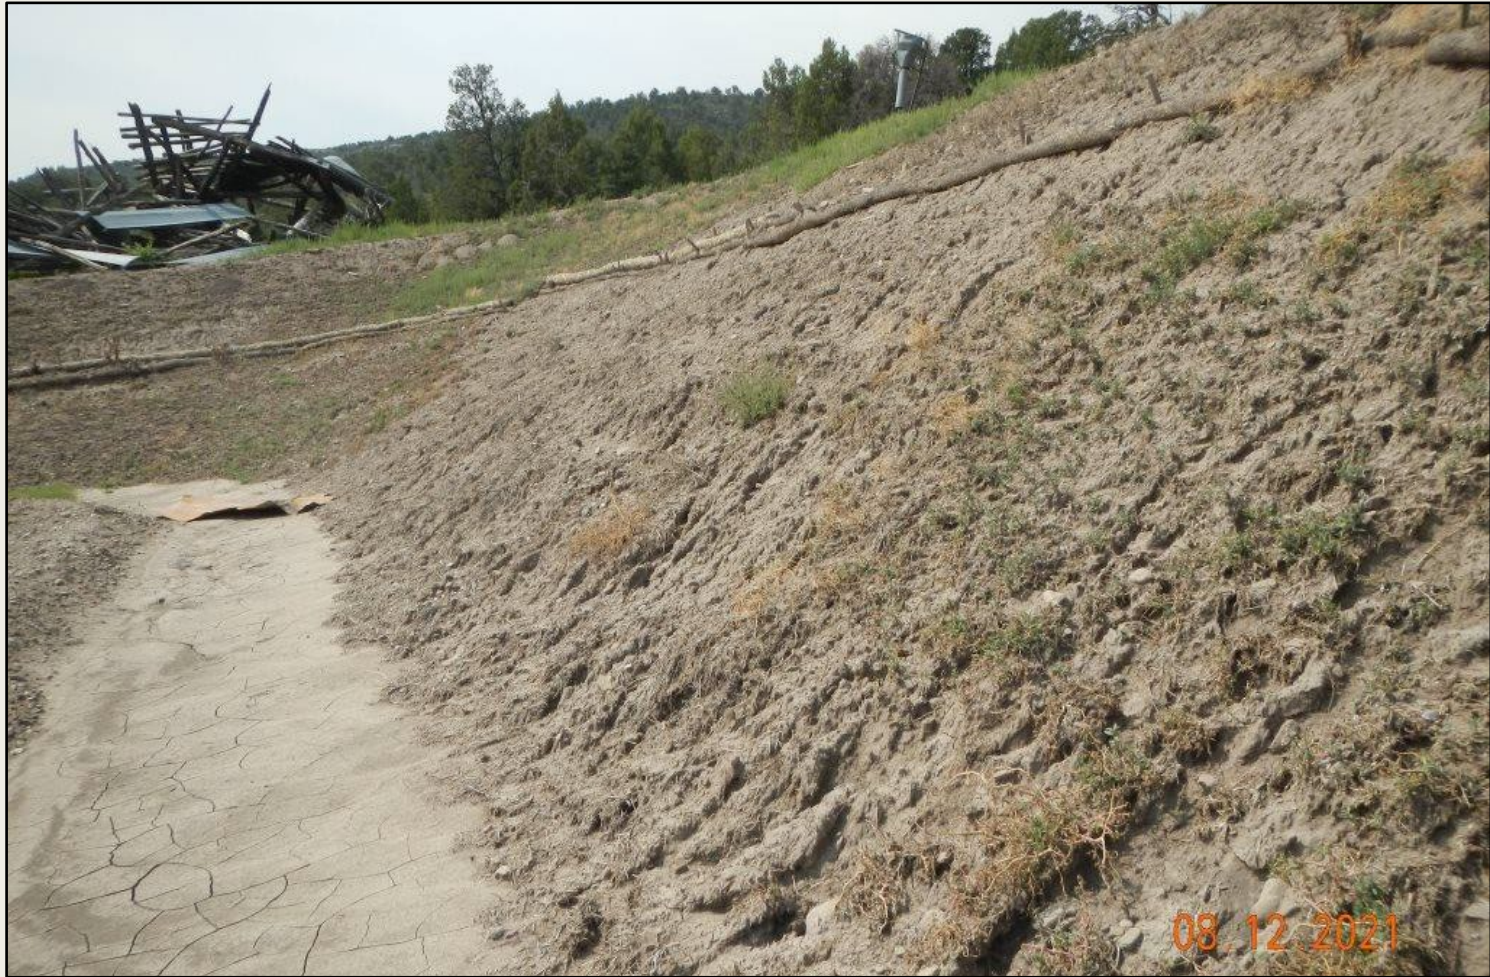
Photo 5. View of area along the well pad cut-slope with rilling and debris deposition, facing southward.

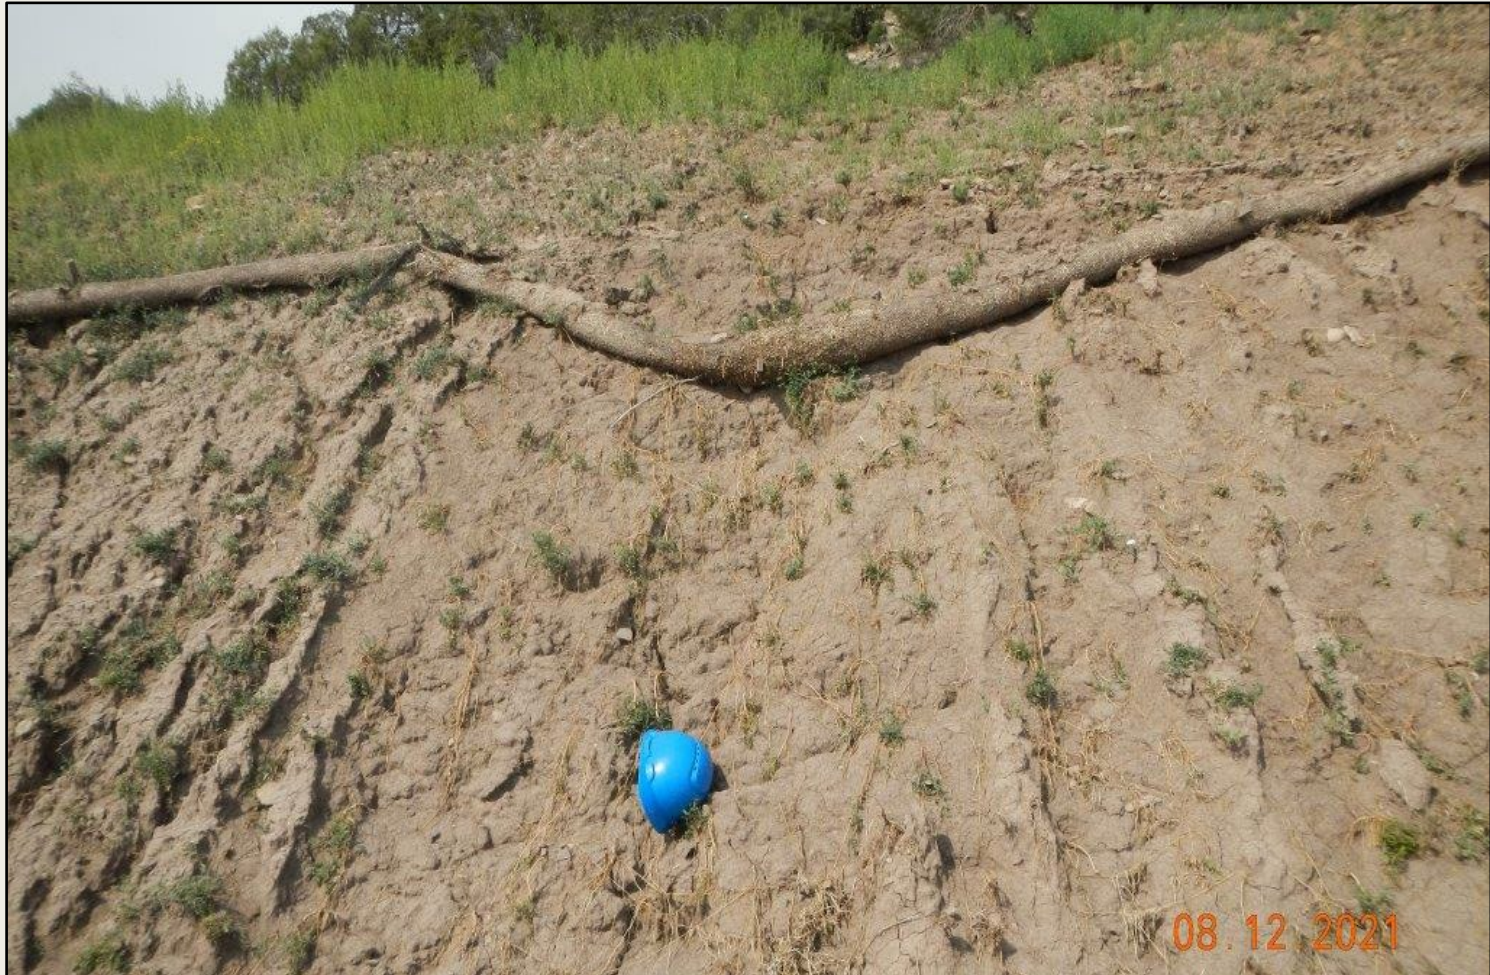
Photo 6. Another view of area on the well pad cut-slope with significant rilling and channeling (up to 1 foot wide and deep).

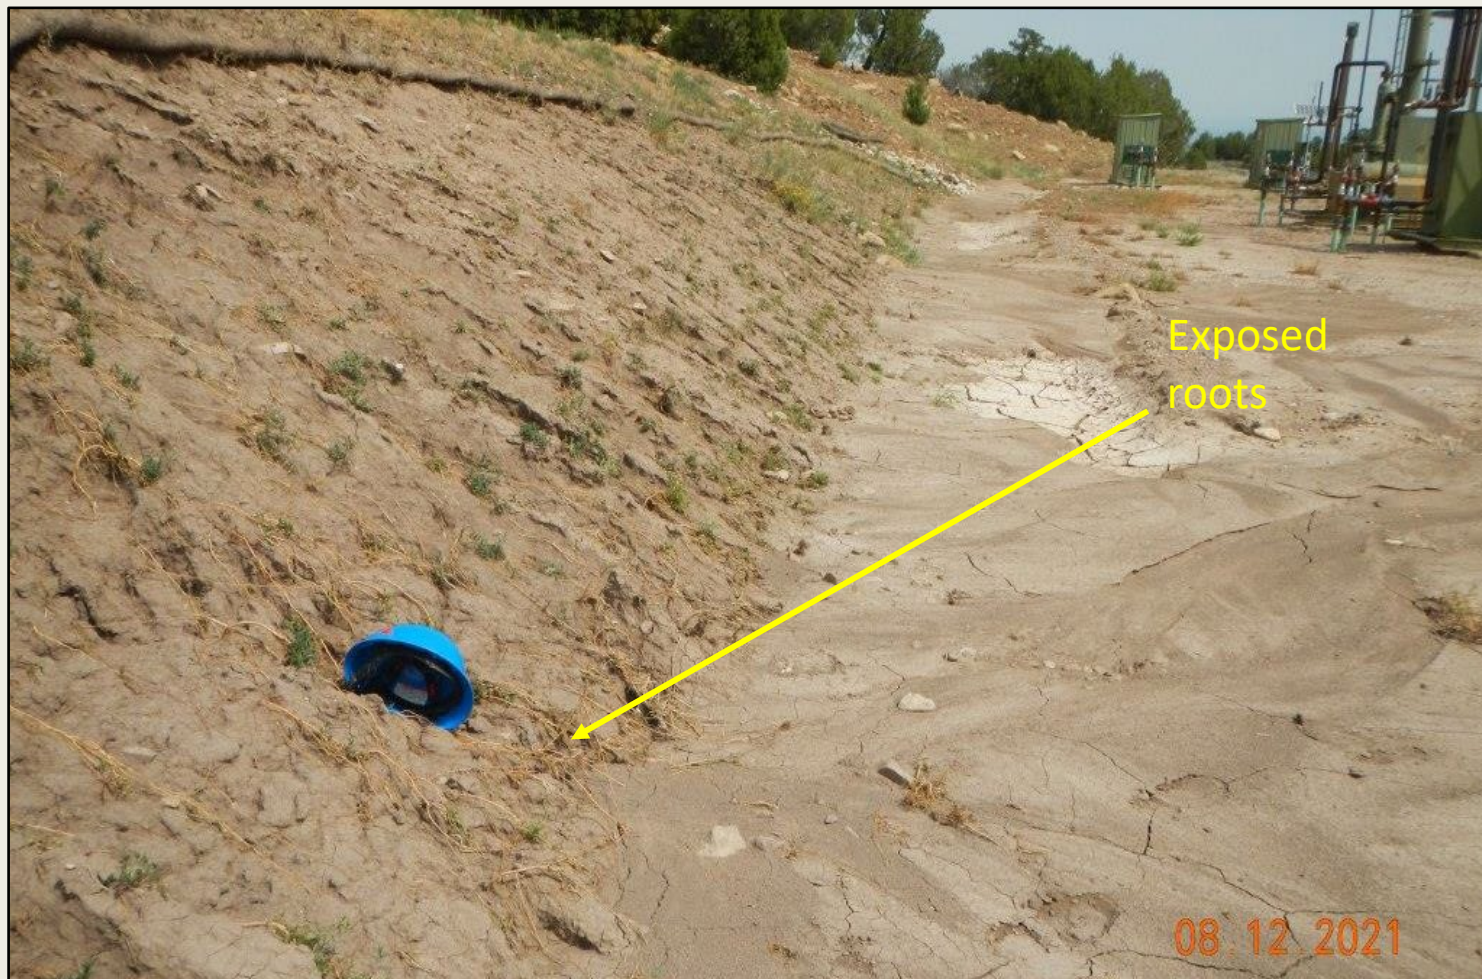
Photo 7. View of rilling, exposed roots, and sediment deposition at the toe of the cut-slope.

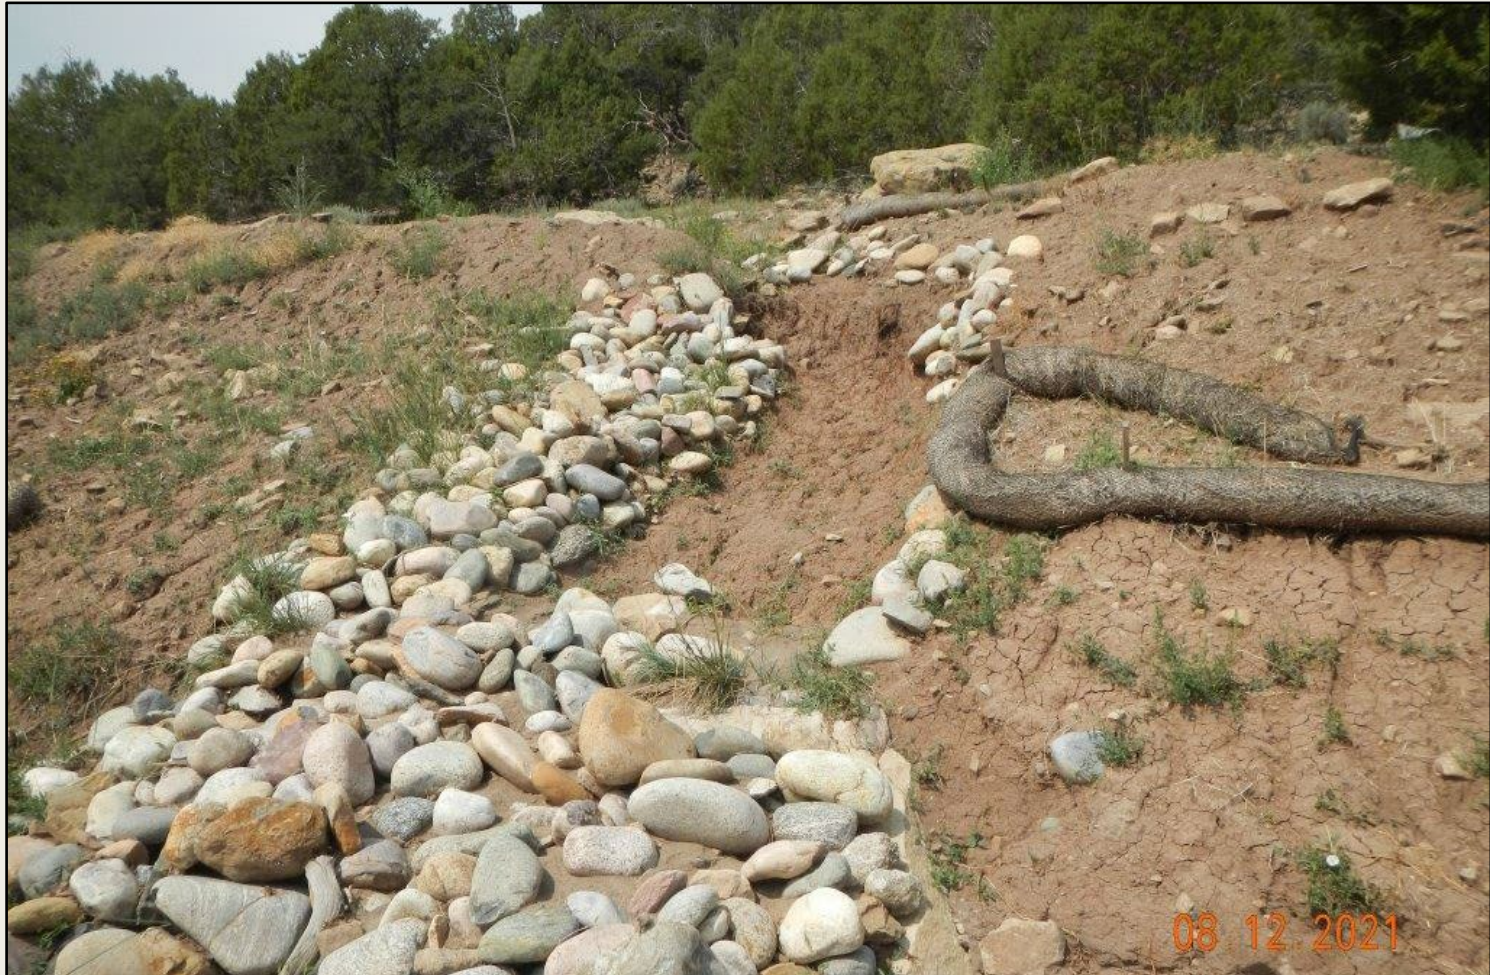
Photo 8. View of eroded BMP within the northwestern project area where cobble and wattles are washed out.

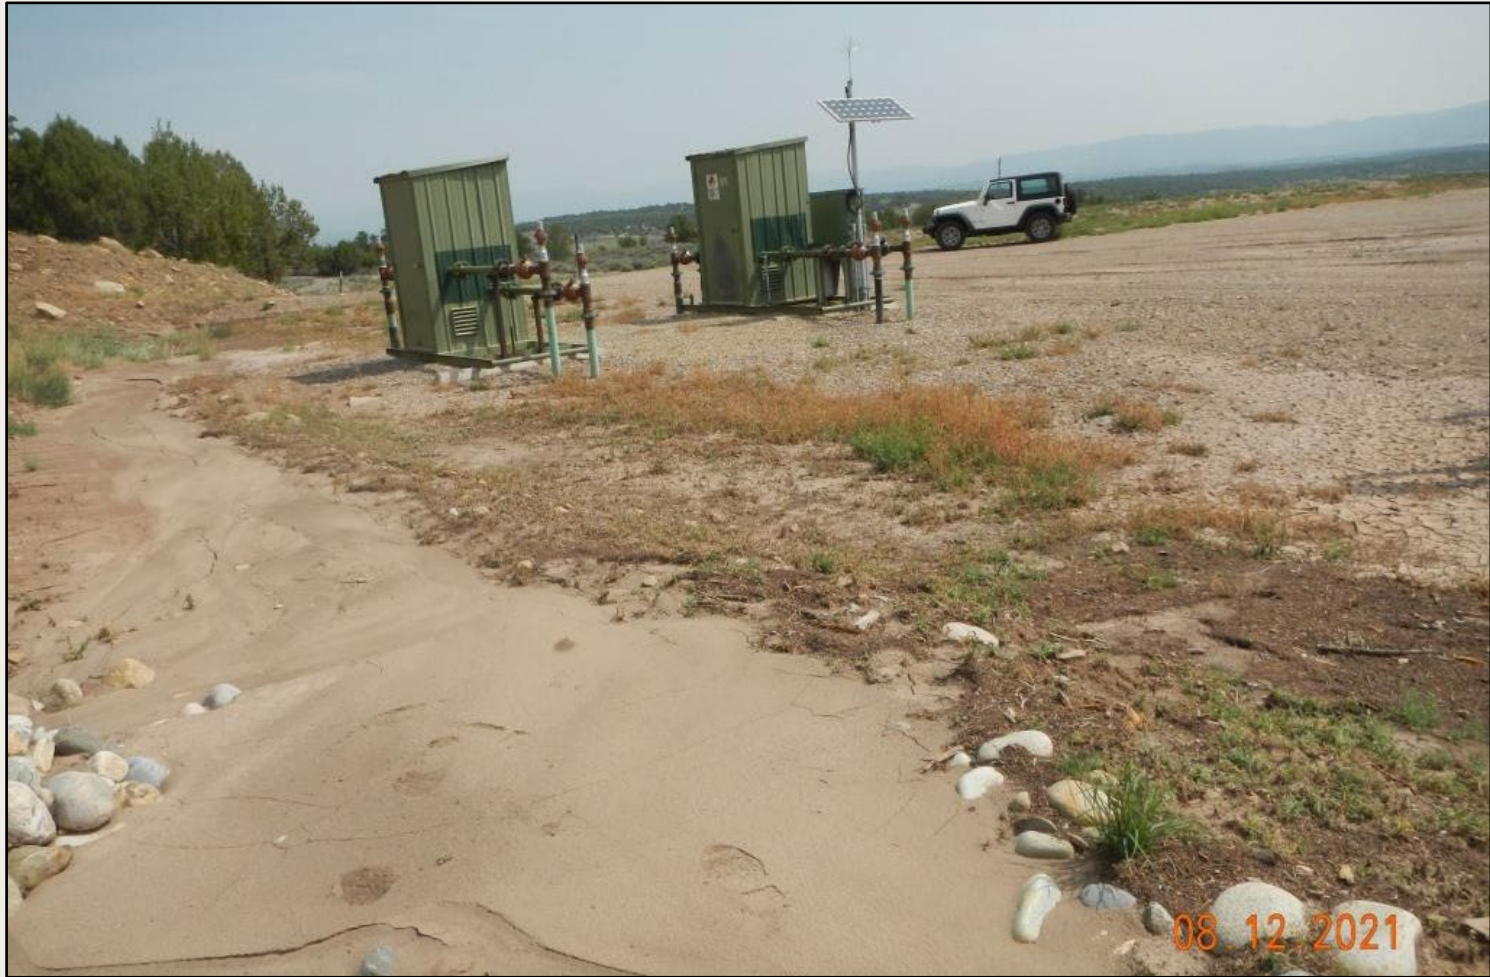
Photo 9. View of sediment deposition observed below failed BMP in Photo 8.
